**Tree report for Mr & Mrs Houldsworth, of 80 Brownhill Road, Chandlers Ford to support a planning application to fell 2 x Scots Pines at this address.**

Report by Ivan Gurdler.

Date of report: 11th February 2022

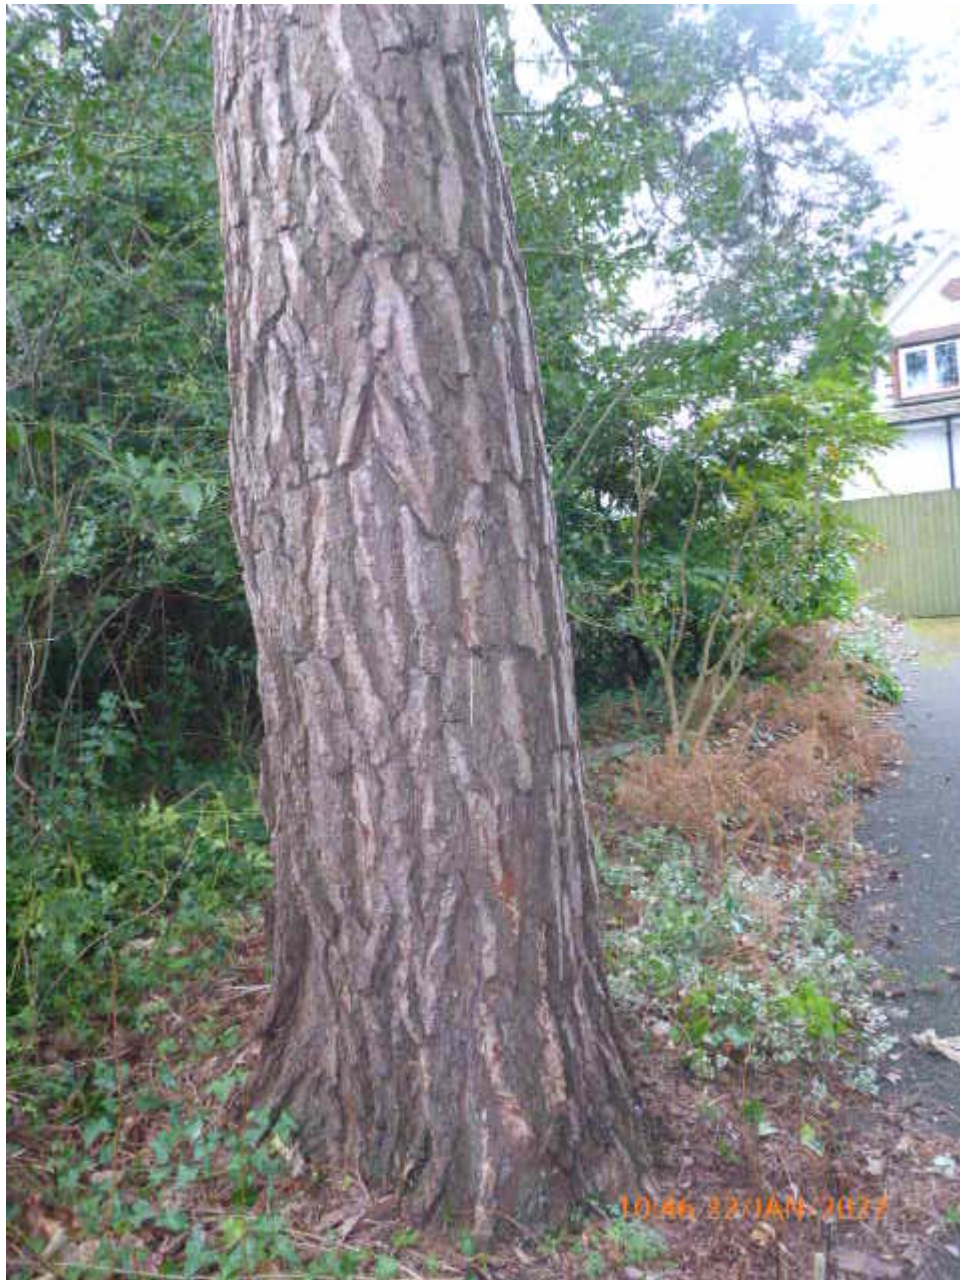
T2 is growing in close proximity of T1. The lower stem of the tree has swelling entirely around the lower stem of the tree up to a height of 3m above ground level. The swelling is similar to the symptoms shown in trees by bottle butt fungi. Although it's my professional opinion that the swelling is caused by the effects of the trees heartwood becoming colonised with *Phaeolus schweinitzii*.

T2 is a mature specimen in very close to the public highway and is within striking distance of neighbouring property. The decay at the base of T2 is in the form of degraded heartwood which will reduce the trees structural integrity under wind loading rendering it liable to whole tree failure from brittle fracture at the base of the tree.

Lower stem of T2  
showing swelling.

I would strongly recommend the removal of T2 as soon as possible because of the high level of risk T2 now poses to the adjacent highway and neighbouring properties. In addition I would recommend at the same time as the removal of T2, the removal of T1 because of its vulnerability of wind throw if retained.

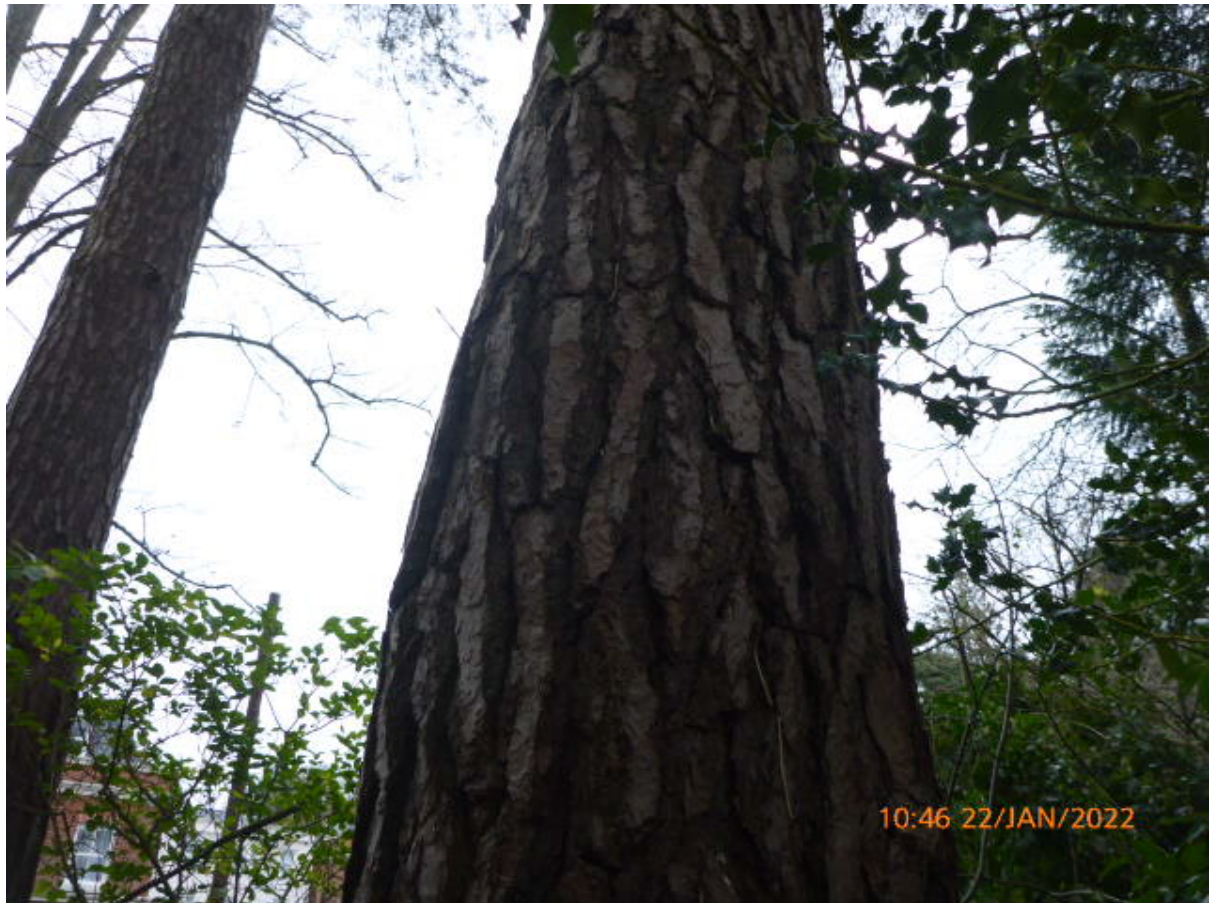
Close up image of lower stem swelling of T2

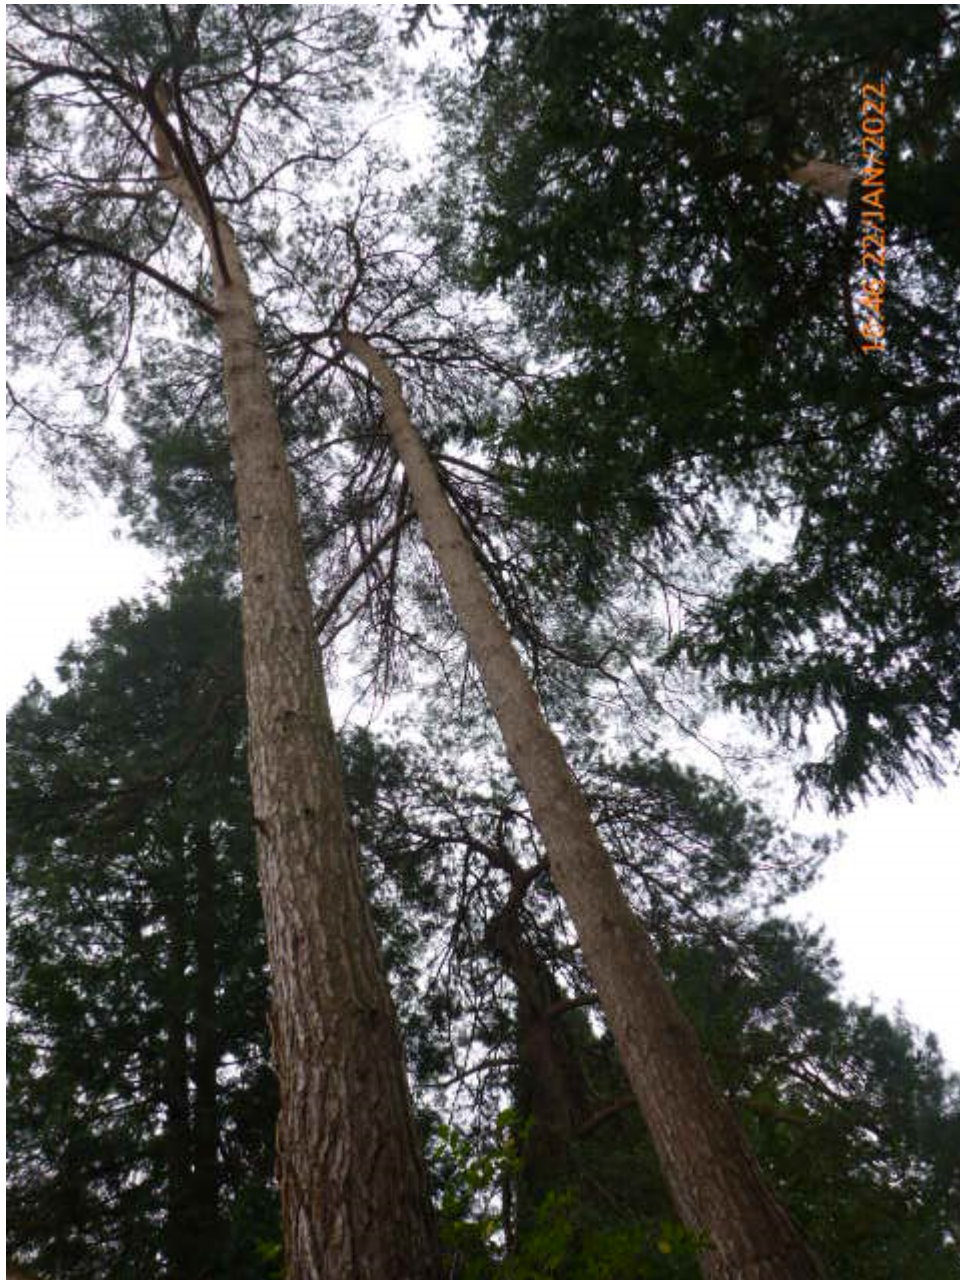
Both trees are mature specimens of approximately 20m high. Both trees have formed a closed canopy where they growing in close proximity to each other. The vitality of both trees appears to be fair but both canopies of the trees appear to be thinning.

Canopies of  
T1 & T2
