# Site Investigation Report

114239.1.TSI

| Client | Sedgwick |

**Brief** Auger were commissioned by Sedgwick to undertake a site investigation within the area of concern at the property.

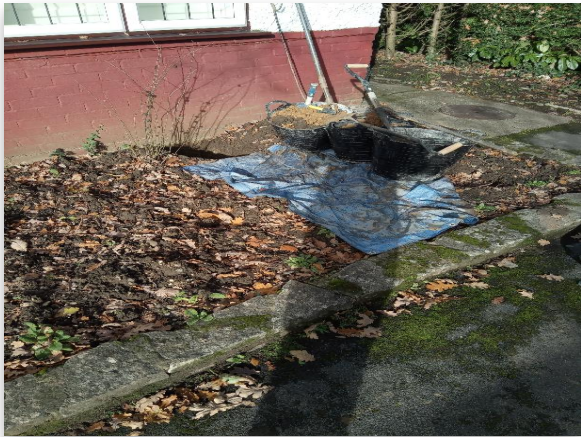
Fig 1.1: Trial Hole 1 Location

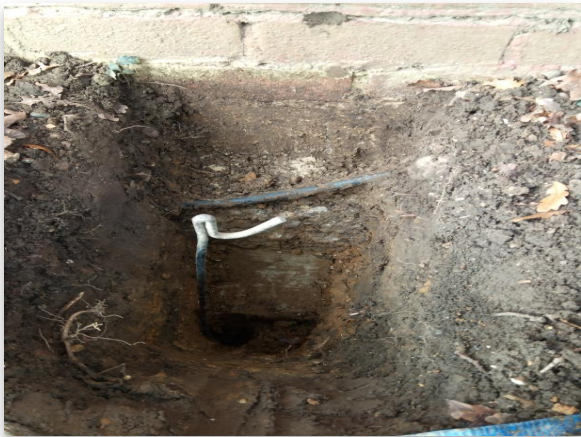
Fig 1.2: Trial Hole 1 Footing

| Depth<br>(m) | Symbolic Log | Strata Description | Insitu Tests | | Soil<br>Sample | Root<br>Sample |
|---|---|---|---|--|---|---|
| | | Brickwork | | | | |
| | | Original Concrete | | | | |
| 0.5 | | Concrete underpinning | | | | |

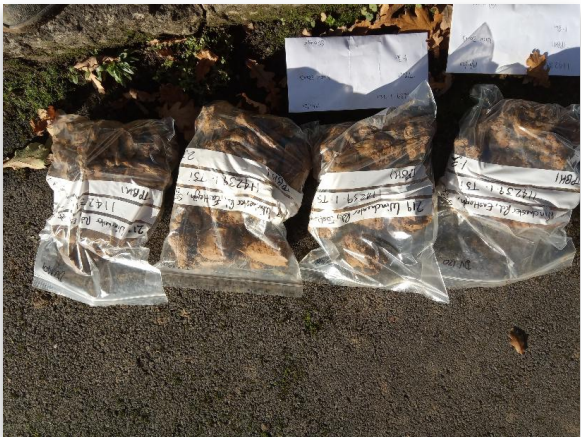
Fig 2.1: Soil samples collected

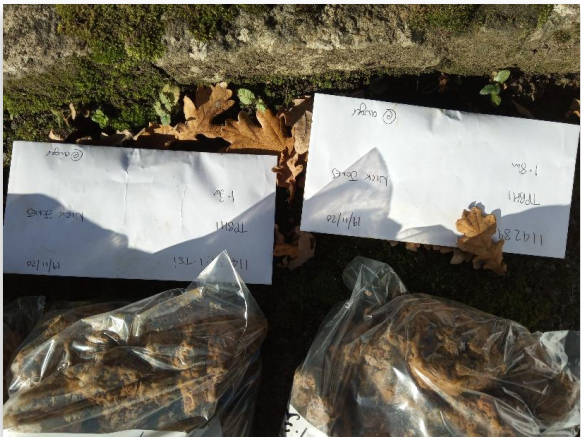
Fig 2.2: Root samples collected

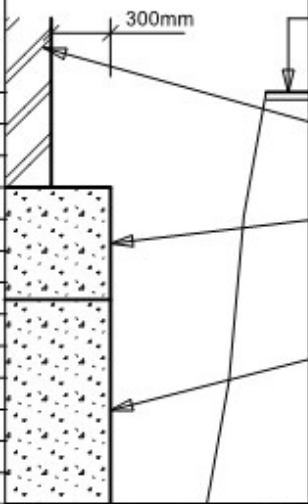
# Trial Hole Log No.1

| Depth<br>(m) | Symbolic Log | Strata Description | Insitu Tests | | Soil<br>Sample | Root<br>Sample |
|---|---|---|---|--|---|---|
| | | Soil (Border) | | | | |
| 1.5 | | Dry very stiff Brown fine gravelly sandy silty CLAY | 120kpa | | Soil<br>@ 1.3m | Root<br>@ 1.3m |
| 2.0 | | | 128kpa | | Soil<br>@ 1.8m | Root<br>@ 1.8m |
| 2.5 | | Brown fine to medium gravelly sandy silty CLAY | 140kpa | | Soil<br>@ 2.3m | |
| 3.0 | | Brown sandy silty CLAY | 140kpa | | Soil<br>@ 2.8m | |
| 3.5 | | TRIAL HOLE TERMINATED | 140kpa | | | |
