# ARBORICULTURAL ASSESSMENT REPORT

| | <b>Risk Address:</b> | 219 Winchester Road, Chandler's Ford, Eastleigh, SO53 2DX |
| <b>Refs:</b> | <b>PRI Ref:</b> | 176927 |

| <b>Arborist Name:</b> | Ryan Ollman | <b>Date:</b> | 26/01/2021 |

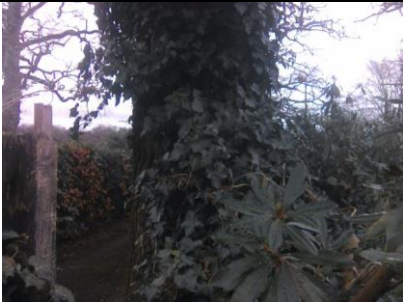
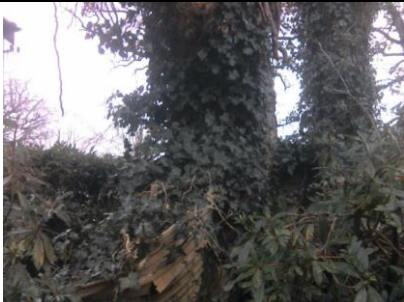
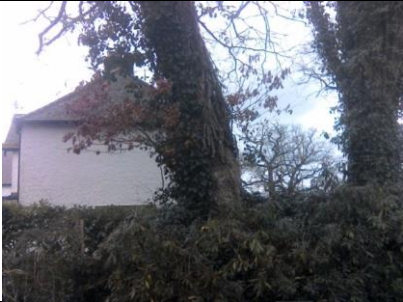
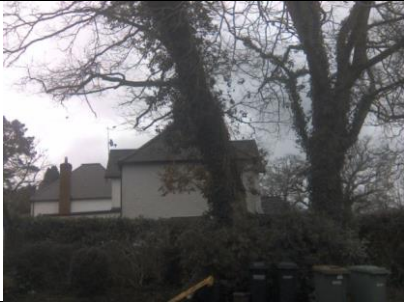
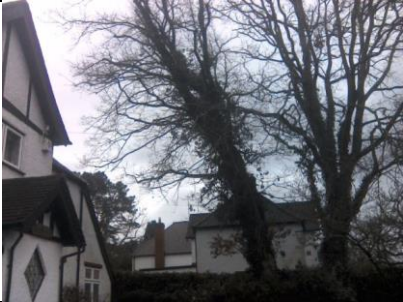
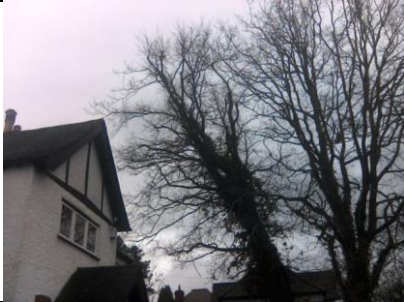
| Tree No | Common Name | Age Class | Condition | Height (m) | Crown Spread (m) | Stem diam. (mm) | Dist to bldg. (m) | Roots Implicated | Pruning history | Recommendation | Tree work constraints | Notes | Owner address | Owner |
|---|---|---|---|---|---|---|---|---|---|---|---|---|---|---|
| T1 | Oak | Mature | Fair | 18.5* | 10.5 | 750* | 5.8 | Y | Subject to past management.<br>No significant recent management. | Fell and treat stump (deciduous).<br>Fence needed. | Phone/Power lines through crown. | TPO tree.<br>Located on boundary line.<br><br>Main stem covered in Ivy. | 219 Winchester Road<br>Chandler's Ford<br>Eastleigh<br>SO53 2DX | PH |

| T1 - Oak | T1 - Oak |

| Tree No: | Species | Works Required |
|---|---|---|
| T1 | Oak | Fell and treat stump (deciduous). Fence needed. |

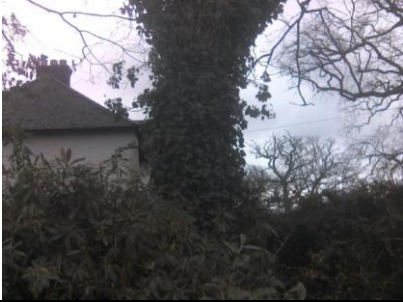
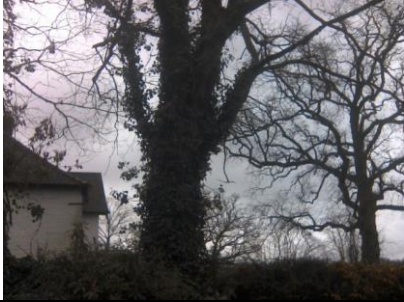
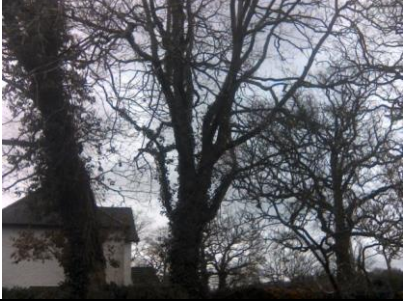
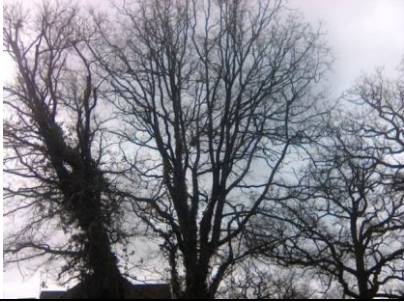
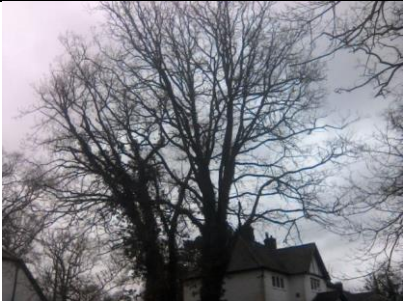
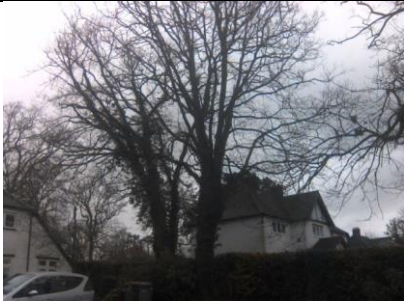
| Tree No | Common Name | Age Class | Condition | Height (m) | Crown Spread (m) | Stem diam. (mm) | Dist to bldg. (m) | Roots Implicated | Pruning history | Recommendation | Tree work constraints | Notes | Owner address | Owner |
|---|---|---|---|---|---|---|---|---|---|---|---|---|---|---|
| T2 | Oak | Mature | Fair | 21* | 13.25 | 650* | 7.9 | Y | No significant past tree works. | Fell and treat stump (deciduous).<br>Fence needed. | Phone/Power lines through crown. | TPO tree.<br>Located on boundary line.<br><br>Main stem covered in Ivy. | 219 Winchester Road<br>Chandler's Ford<br>Eastleigh<br>SO53 2DX | PH |

| T2 - Oak | T2 - Oak |

| Tree No: | Species | Works Required |
|---|---|---|
| T2 | Oak | Fell and treat stump (deciduous). Fence needed. |

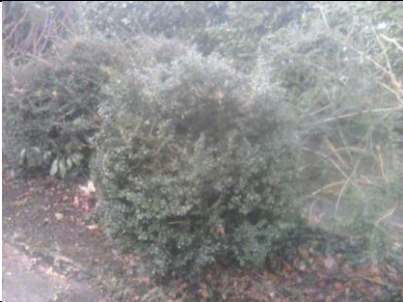
| Tree No | Common Name | Age Class | Condition | Height (m) | Crown Spread (m) | Stem diam. (mm) | Dist to bldg. (m) | Roots Implicated | Pruning history | Recommendation | Tree work constraints | Notes | Owner address | Owner |
|---|---|---|---|---|---|---|---|---|---|---|---|---|---|---|
| S1 | Box | Mature | Fair | 1.3 | 0.70 | 35 | 2.1 | N | Subject to past management. | No work required. | | | 219 Winchester Road<br>Chandler's Ford<br>Eastleigh<br>SO53 2DX | PH |

| S1 - Box | H1 - Cypress |

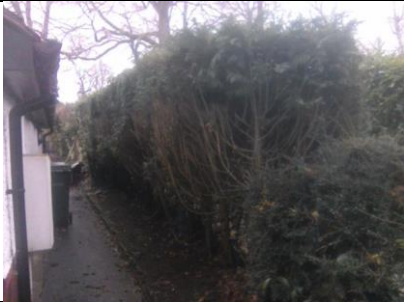
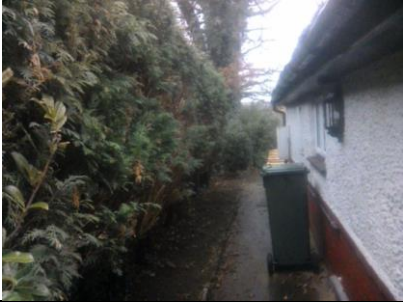
| Tree No | Common Name | Age Class | Condition | Height (m) | Crown Spread (m) | Stem diam. (mm) | Dist to bldg. (m) | Roots Implicated | Pruning history | Recommendation | Tree work constraints | Notes | Owner address | Owner |
|---|---|---|---|---|---|---|---|---|---|---|---|---|---|---|
| H1 | Cypress | Mature | Fair | 1.9 | 1.10 | 75* | 1.7 | N | managed as a hedge. | No work required. | | | 219 Winchester Road<br>Chandler's Ford<br>Eastleigh<br>SO53 2DX | PH |

| H1 - Cypress | HG1 - Mixed species group |

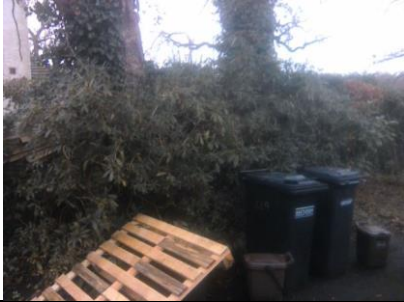
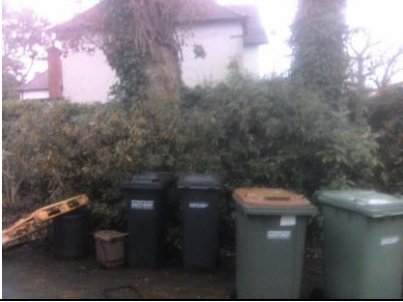
| Tree No | Common Name | Age Class | Condition | Height (m) | Crown Spread (m) | Stem diam. (mm) | Dist to bldg. (m) | Roots Implicated | Pruning history | Recommendation | Tree work constraints | Notes | Owner address | Owner |
|---|---|---|---|---|---|---|---|---|---|---|---|---|---|---|
| HG1 | Mixed species group | Mature | Fair | 1.8 | 1.8 | 40 | 5.1 | N | Managed as a hedge. | No work required. | | Group consists of rhododendron and laurel. | 219 Winchester Road<br>Chandler's Ford<br>Eastleigh<br>SO53 2DX | PH |

| HG1 - Mixed species group | H2 - Cotoneaster |

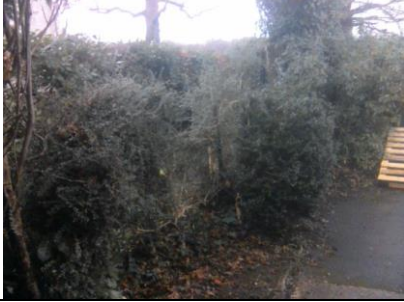
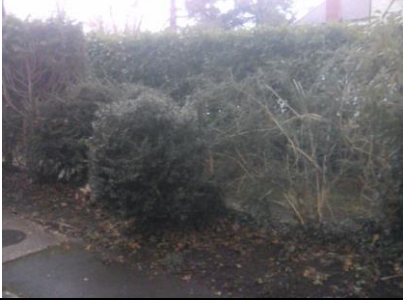
| Tree No | Common Name | Age Class | Condition | Height (m) | Crown Spread (m) | Stem diam. (mm) | Dist to bldg. (m) | Roots Implicated | Pruning history | Recommendation | Tree work constraints | Notes | Owner address | Owner |
|---|---|---|---|---|---|---|---|---|---|---|---|---|---|---|
| H2 | Cotoneaster | Mature | Fair | 1.5 | 0.50 | 20 | 2 | N | Managed as a hedge. | No work required. | | | 219 Winchester Road<br>Chandler's Ford<br>Eastleigh<br>SO53 2DX | PH |

| H2 - Cotoneaster | T3 - Magnolia |

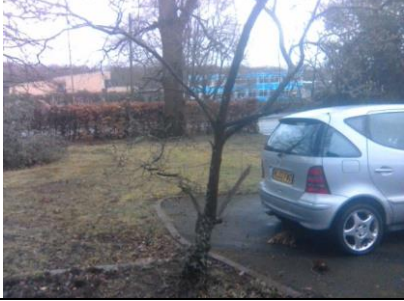
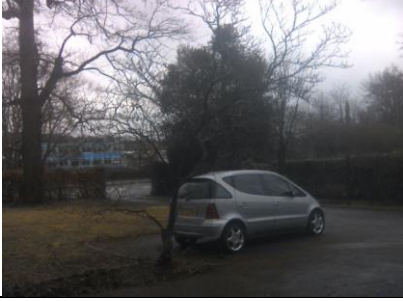
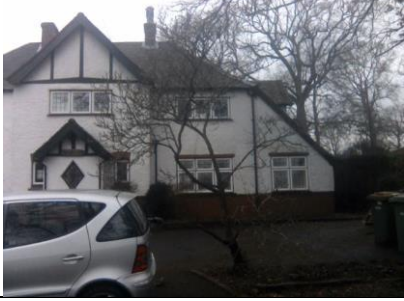
| Tree No | Common Name | Age Class | Condition | Height (m) | Crown Spread (m) | Stem diam. (mm) | Dist to bldg. (m) | Roots Implicated | Pruning history | Recommendation | Tree work constraints | Notes | Owner address | Owner |
|---|---|---|---|---|---|---|---|---|---|---|---|---|---|---|
| T3 | Magnolia | Mature | Fair | 3 | 4.4 | 90 | 8.6 | N | Subject to past management. | No work required. | | | 219 Winchester Road<br>Chandler's Ford<br>Eastleigh<br>SO53 2DX | PH |

| T3 - Magnolia | | T3 - Magnolia | |

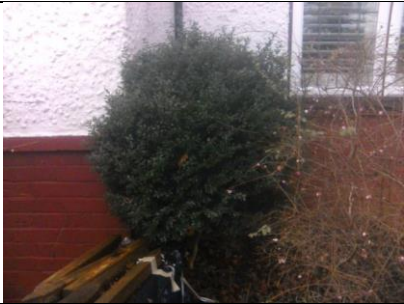
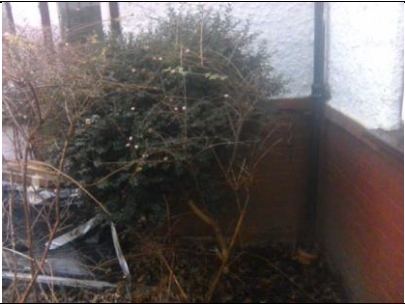
| Tree No | Common Name | Age Class | Condition | Height (m) | Crown Spread (m) | Stem diam. (mm) | Dist to bldg. (m) | Roots Implicated | Pruning history | Recommendation | Tree work constraints | Notes | Owner address | Owner |
|---|---|---|---|---|---|---|---|---|---|---|---|---|---|---|
| S2 | Box | Early Mature | Good | 1.5 | 0.70 | 40 | 0.5 | N | Subject to past management. | No work required. | | | 219 Winchester Road<br>Chandler's Ford<br>Eastleigh<br>SO53 2DX | PH |

| S2 - Box | | S2 - Box | |

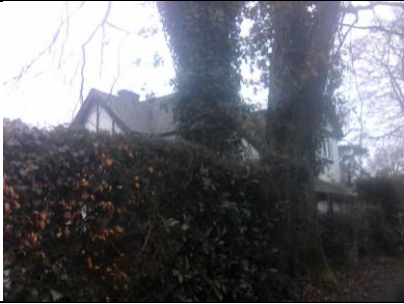
| T2 - Oak | | T1 - Oak | |

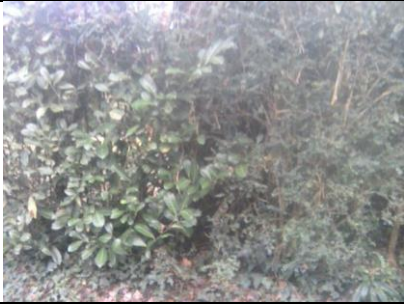
| T2 - Oak | | | |
