# Arboricultural inspection record for one oak tree

**Site Address: 69 Merdon Avenue,  
Chandlers' Ford, SO53 1GD**

**Date: 13<sup>th</sup> June 2022**

Kiss  
Tree  
Management  
Limited

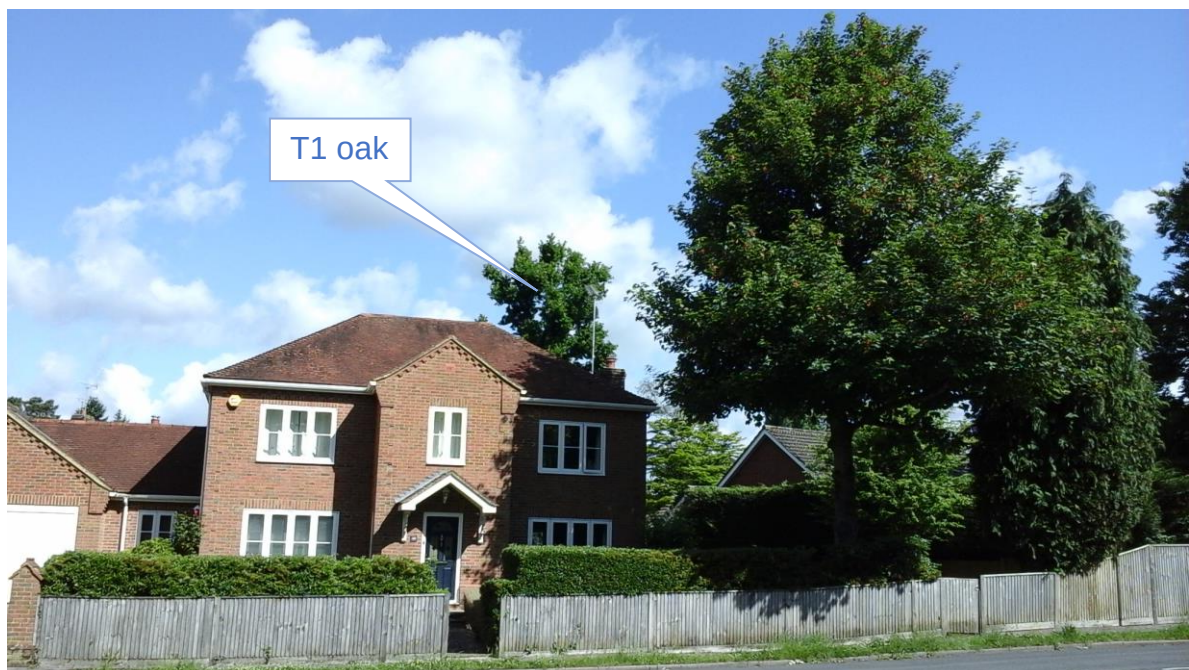
T1 viewed from road – visible above and to right end of roof line

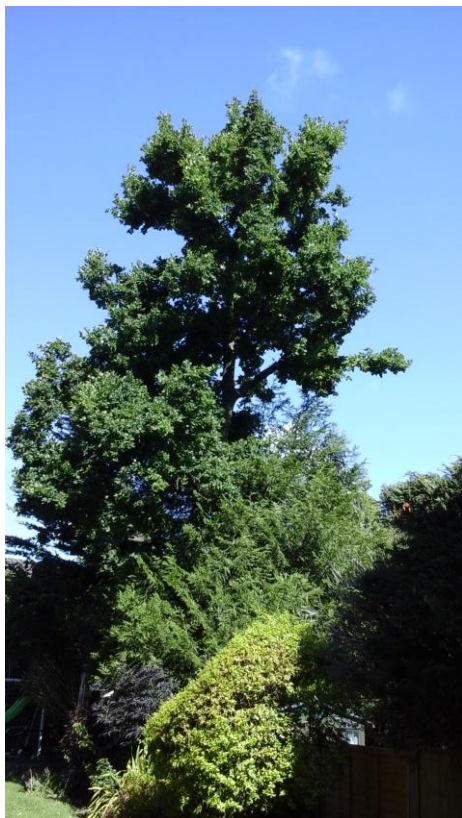
T1 in situ (note the retained pole of a dead cherry is to the left of the image – this isn't T1)

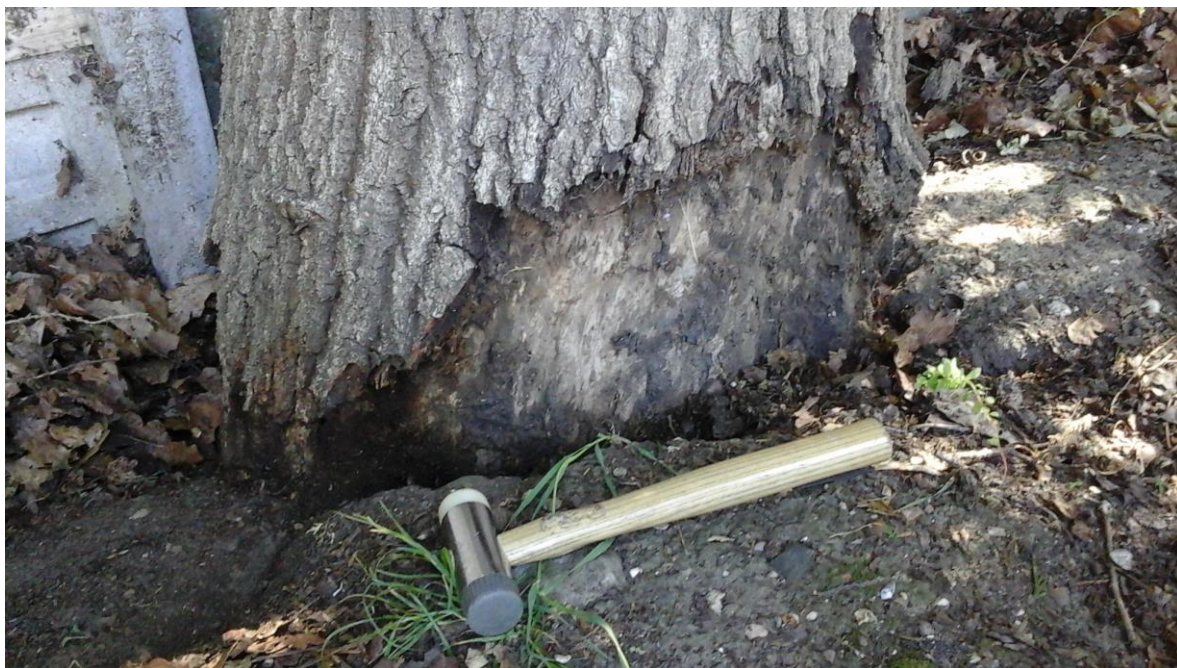
| Stem Base | Extensive necrosis at soil level: tree measures c.1700mm in circumference at stem base and c. 85% of the bark is detached exposing non-functioning sapwood. Only 2 narrow strips of functioning sapwood are supporting the canopy (which is looking surprisingly good).<br><br>The onset of degradation is at present on the west-southwest side underneath the soil level and behind the functional strip of xylem.<br><br>Fungal fruiting bodies have been recorded (client supplied photos of a spongy black residue in March but it was impossible to identify the genus from the images).<br><br>There are <i>Armillaria spp (Honey Fungus)</i> rhizomes on the dead cherry stem within 1m of base. |

South side of stem base – small section of vascular attachment to west side of stem.

| Management recommendations | <p>Fell to near ground level. Replace in next planting season.</p> <p>Replant with one of the following evergreen species near the position of T1: (several options discussed for biodiversity, screening and visual interest).</p> <ul style="list-style-type: none"> <li>• Strawberry Tree (<i>Arbutus unedo</i>)</li> <li>• <i>Osmanthus x burkwoodii</i></li> <li>• Highclere holly (<i>Ilex altaclerensis</i>) variegated - 'Golden King' with creamy margin</li> <li>• Mimosa (<i>Acacia dealbata</i>) - frothy yellow flowers in very early spring</li> <li>• Yew (<i>Taxus baccata</i>)</li> </ul> <p>Stock type: 10/12 or 12/14, or 1.5 multistem depending on species chosen.</p> |

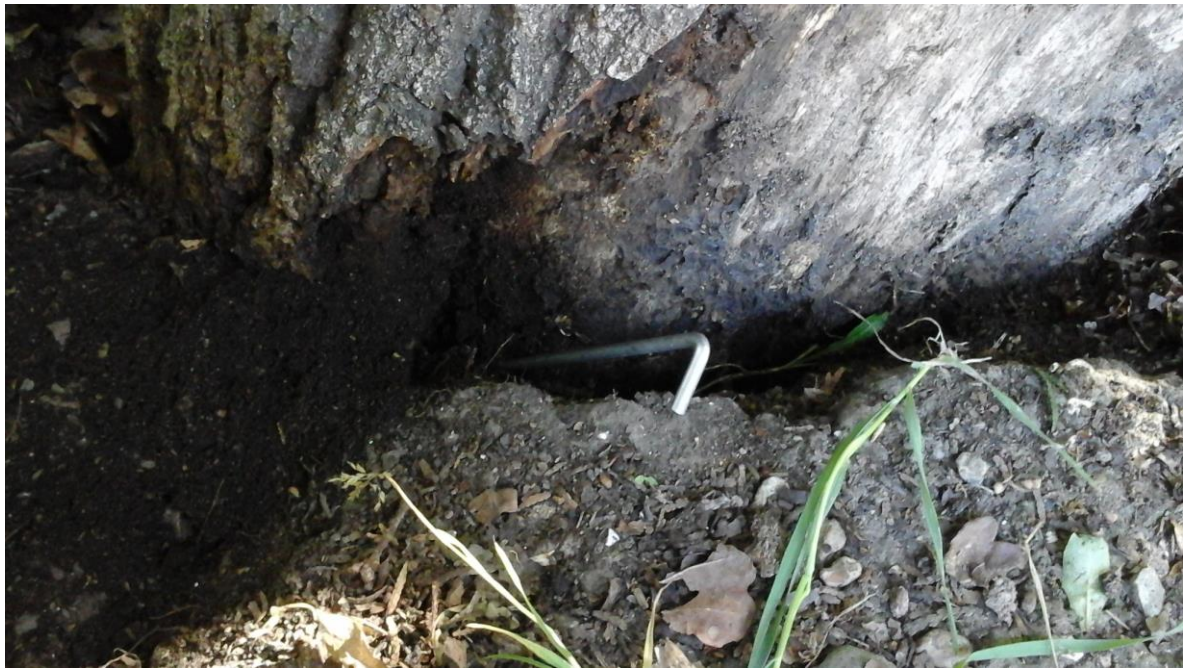
| Overall | <p>Tree will be unable to compartmentalise the extensive necrotic tissue at the stem base, and in time will degrade and lose its physical properties.</p> <p>Unable to determine condition of roots: clearly what remains of the vascular system is functional, but the long-term viability is in question from a structural perspective.</p> |

Degradation of exposed heartwood present on tension side and below the functional section.

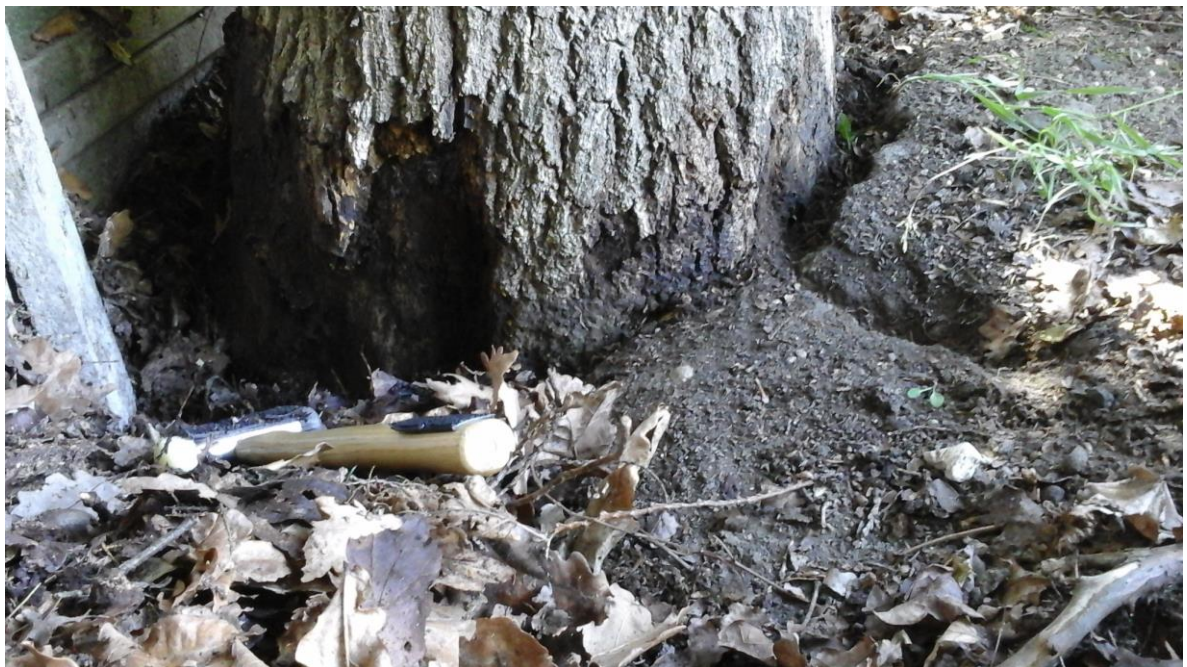
| Ground conditions | Historic soil level changes: anecdotally, the house was built in 1992 on land that used to be a car park. Tree would have been growing for some decades at this time.<br><br>It is likely the basal flare was buried at this point.<br><br>Subsequent changes with installation of a boundary fence close to the stem base with fence post positions within 0.4m of base. |

Tension side of stem base viewed from west-northwest. Fence support visible to left of image. Soil level changes apparent.

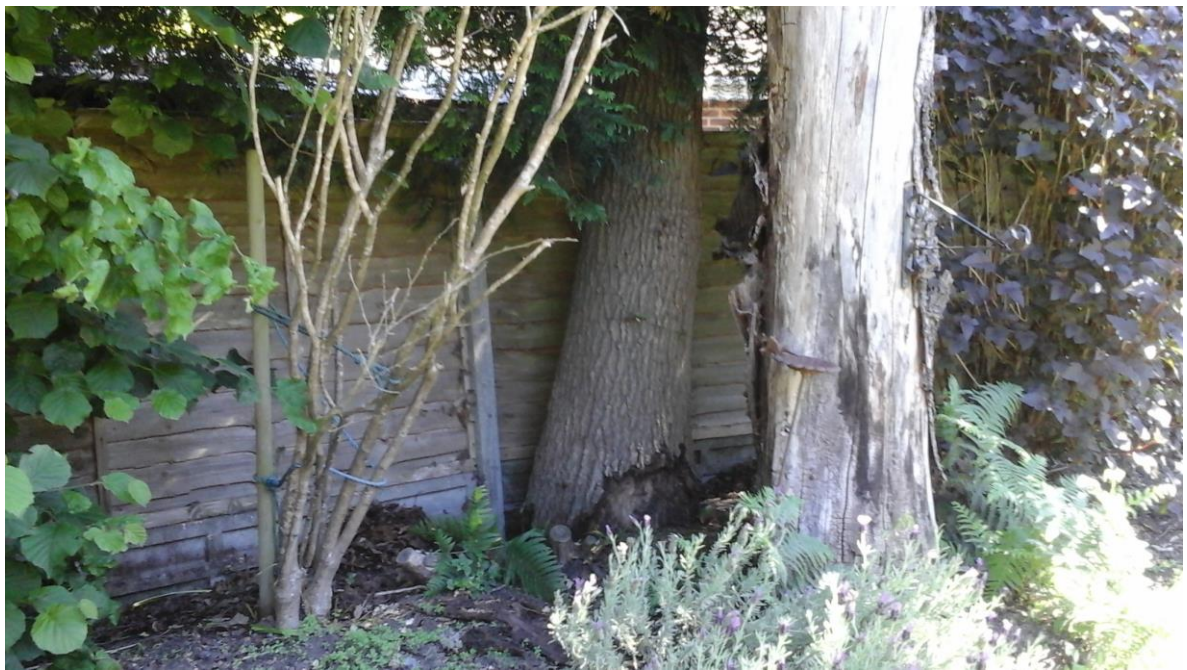
| Stem | Single straight stem at slight incline to neighbouring property to NE. Tree probably feels more imposing from the other side of the fence. |

Bottom section of stem showing slight lean to northeast. Dead cherry pole in front.

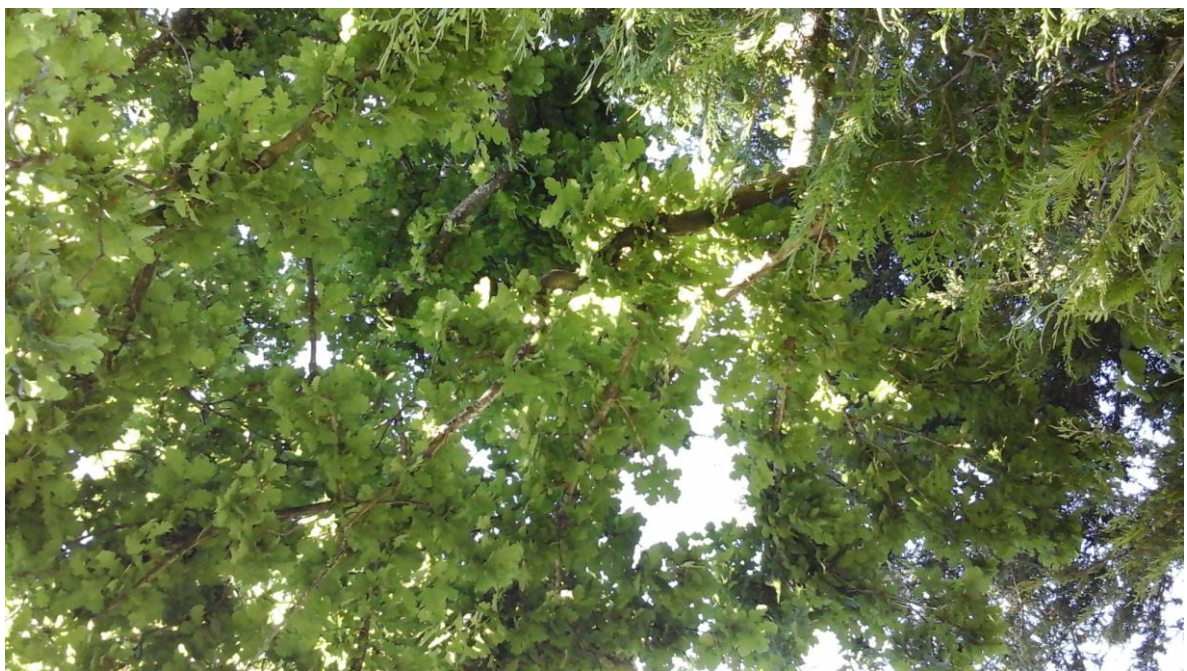
| Canopy | Reduced in 2020 under consent reference T/20/89393 to reduce overhang 1.5-2.0m.<br><br>Canopy is showing signs of stress response: leaves are very tightly packed, though size and physiology appear normal.<br><br>Many recent epicormic shoots growing densely along all remaining scaffold branches. |

Canopy in good physiological condition, but extension growth is very short and leaves are tightly packed along branch length including a high volume of epicormic growth.
