Our Ref: 211433 - Let 2

**Re: Tree issues at 'Greywell', High Street, Bursledon**

Our Ref: KBS/211

**GREYWELL, BURSLEDON, SOUTHAMPTON**

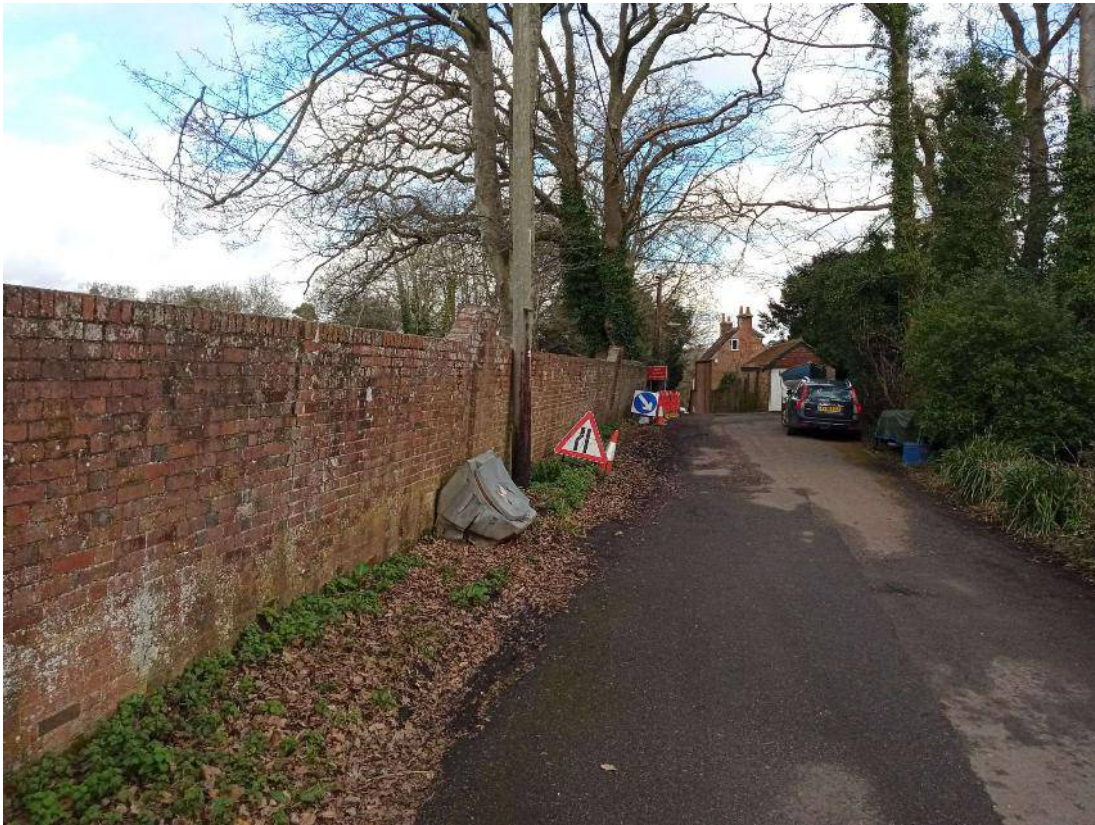
The wall was located along the boundary with the High Street and was of traditional brick construction. The visible part of the wall was two bricks thick, built as separate leaves with a soldier course on top and typically had a Sussex bond (also known as Flemish garden wall bond). Please refer to Photograph 1.

Photograph 1 – General view of Southern end of wall

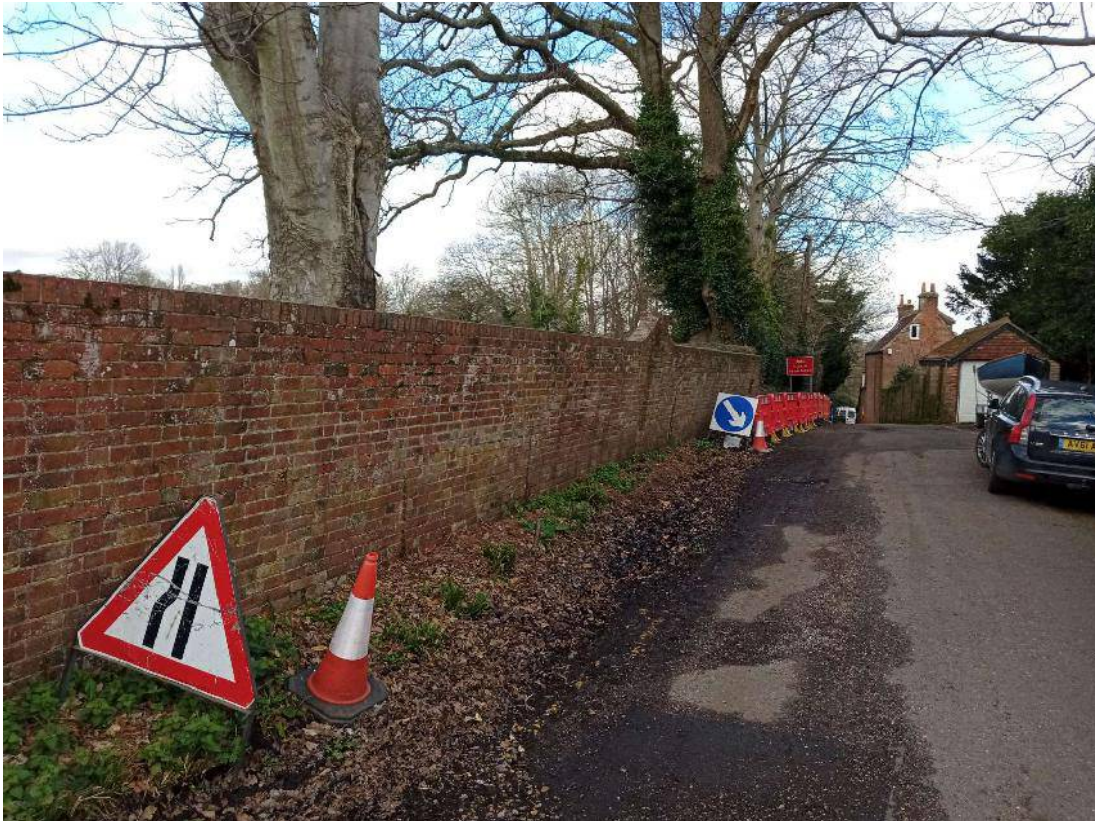
The stretch of the wall closest to the property, Length A, was 1800mm high when measured from the High Street and appeared to be the original construction. At the end closest to the property where the first oak tree occurred, the wall was found to be 110mm out of plumb when measured along a 900mm long spirit level with the top of the wall leaning outwards towards the highway. Please refer to Photographs 2 and 3.

Photograph 2 – General view of wall Length A

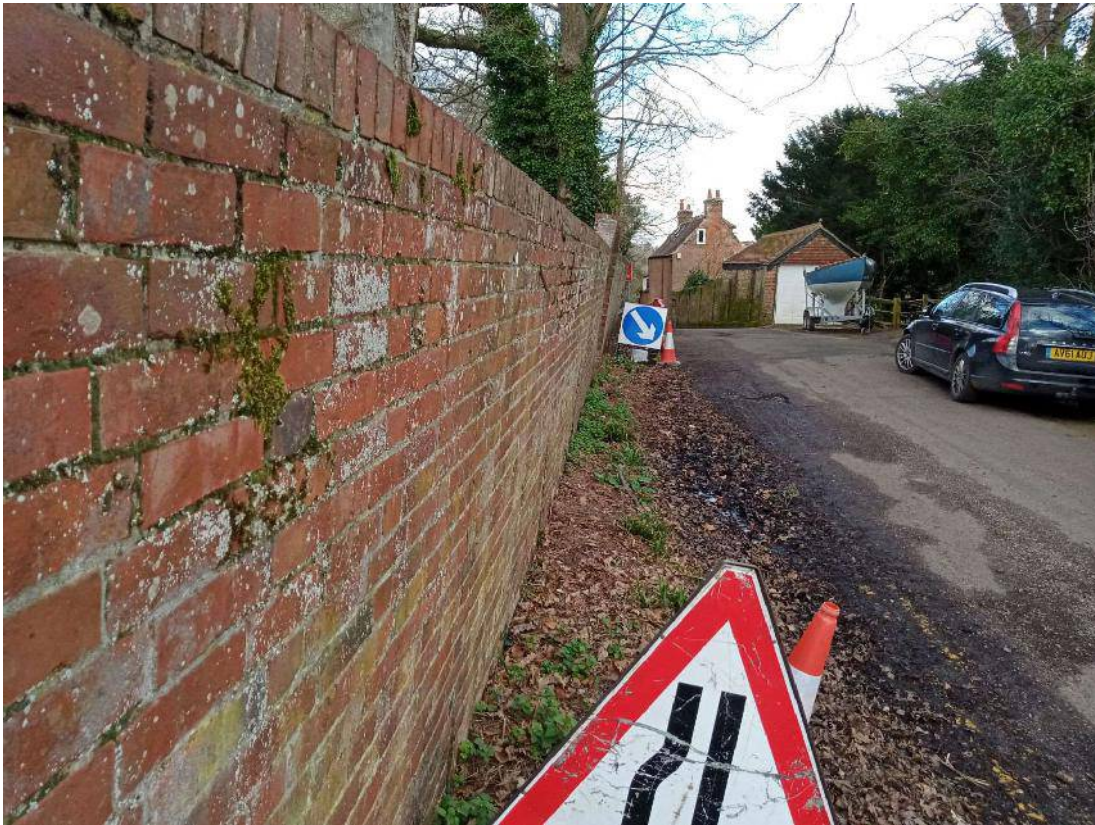
Photograph 3 – View along wall Length A

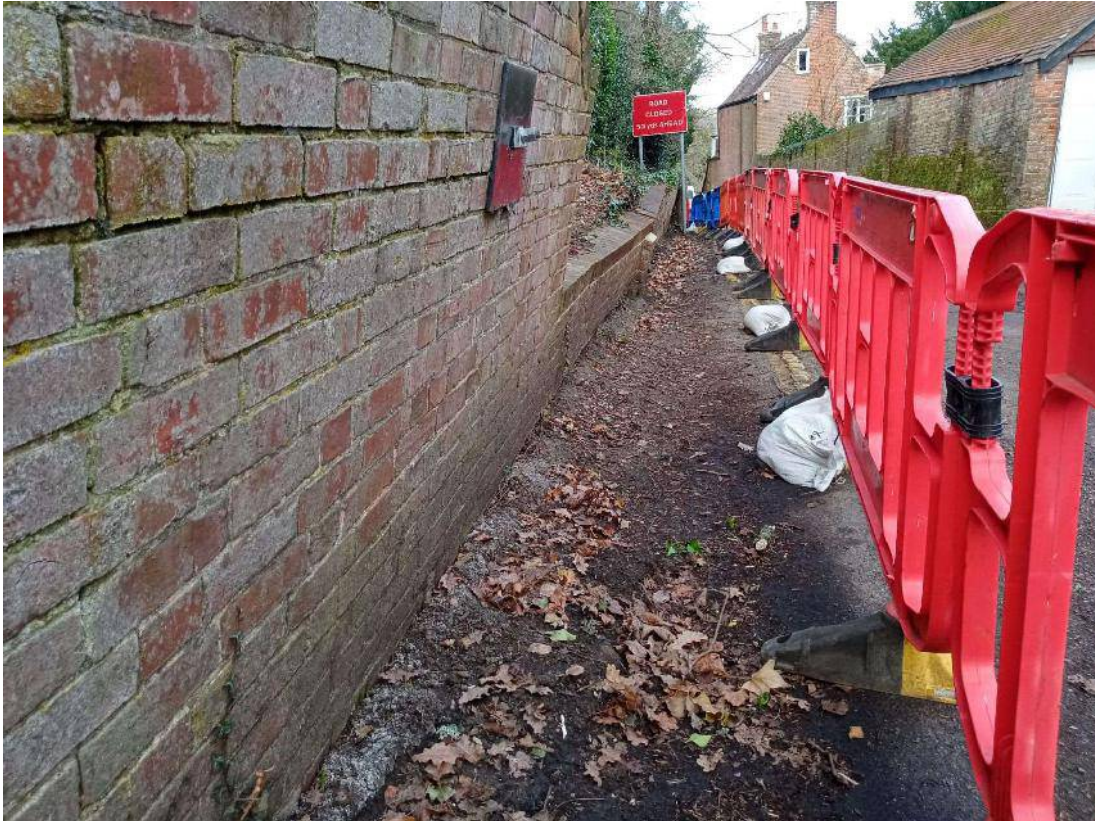
Adjacent to the second oak tree, the amount of lateral displacement in the 1800mm high wall had increased to 180mm when measured along a 900mm long spirit level. A step in the height of the wall occurred at this point, with it then dropping to be only 600mm high. The lower section of the wall was found to be 250mm out of alignment. It was noted that the end of what appears to be a ground anchor with a pattress plate had been installed close to where the step in height occurred. Please refer to Photograph 4.

Photograph 4 – View along junction between wall Lengths A & B showing step in height

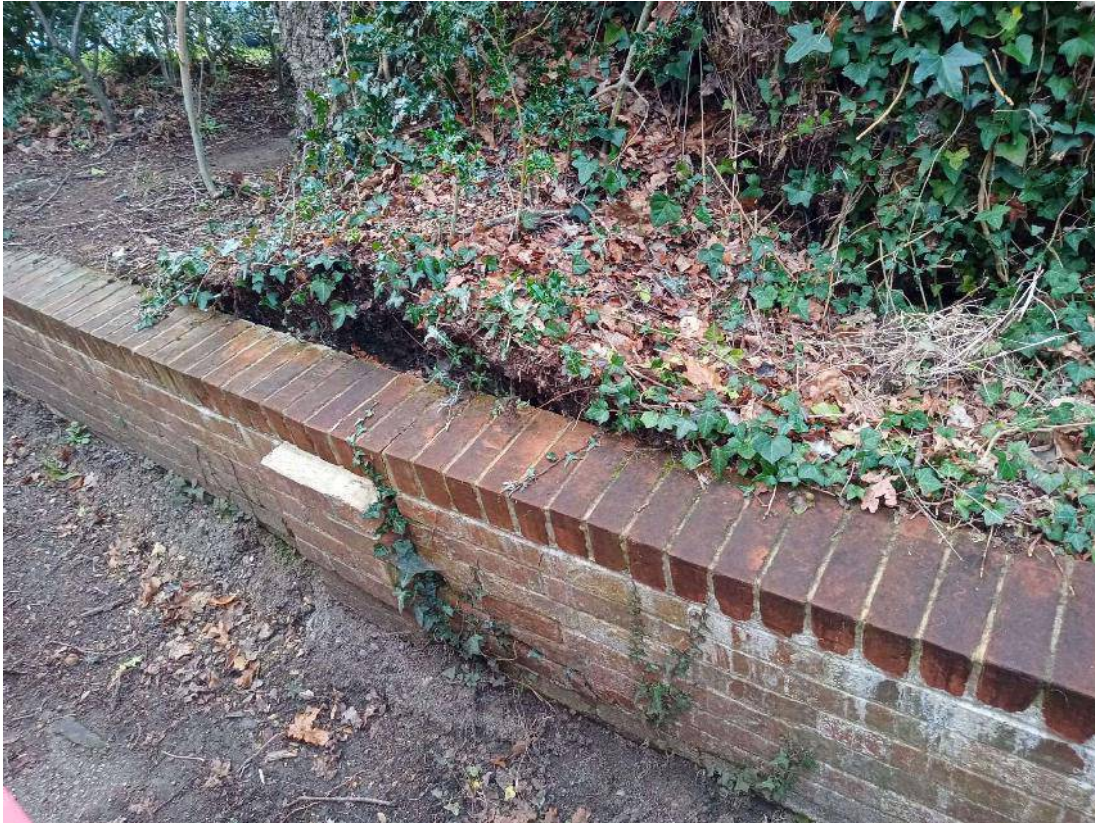
The second stretch of wall, Length B, increased from being 600mm high at the southern end to 1200mm high at the northern end. In the central section of this wall horizontal shear failure was noted with a local displacement in the brickwork of 25mm. At the Northern end of the wall, the wall was again found to be 250mm out of alignment. Please refer to Photographs 5 and 6.

Photograph 5 – Proximity of mature tree behind wall in Length B

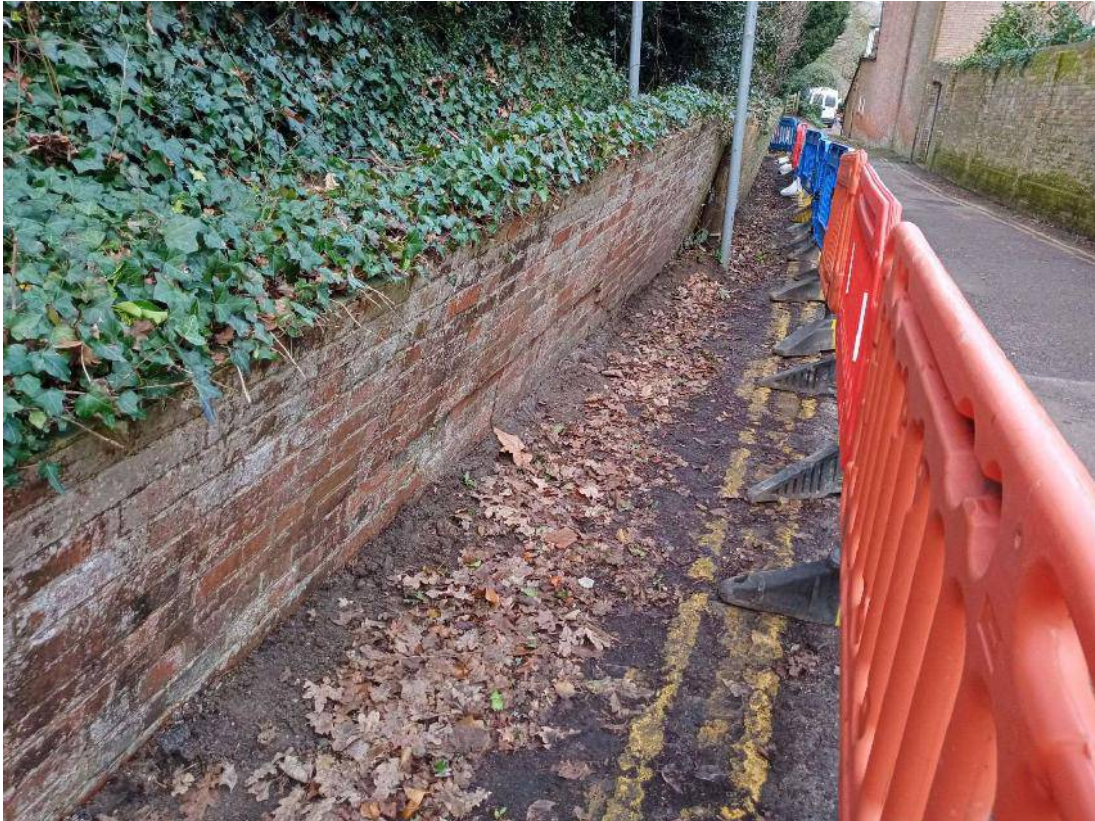
Photograph 6 – View along wall Length B showing shear failure along base of wall

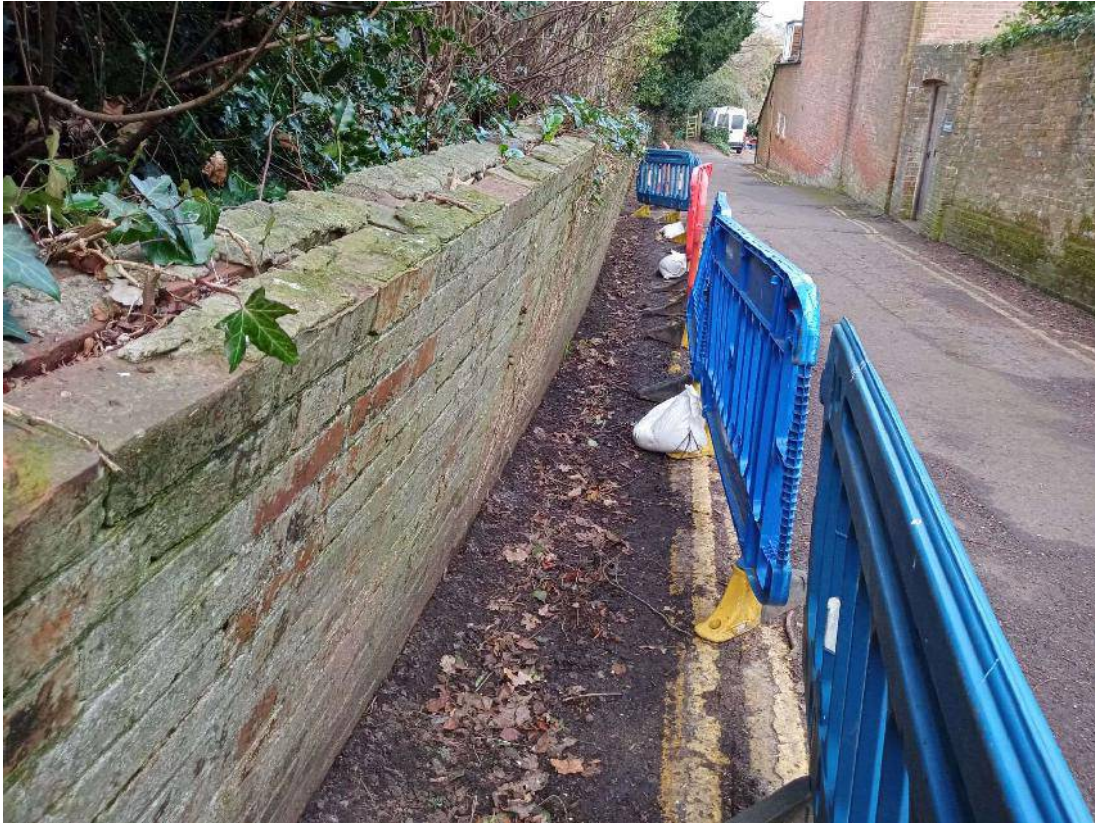
The last stretch of the wall between the two mature trees was fairly constant in height, increasing to be 1300mm high at the Northern end. At this point the wall was 230mm out of alignment. Please refer to Photograph 7. Again, horizontal shear failure was noted in the base of this wall, occurring close to the third of the mature trees.

Photograph 7 – View along wall Length C

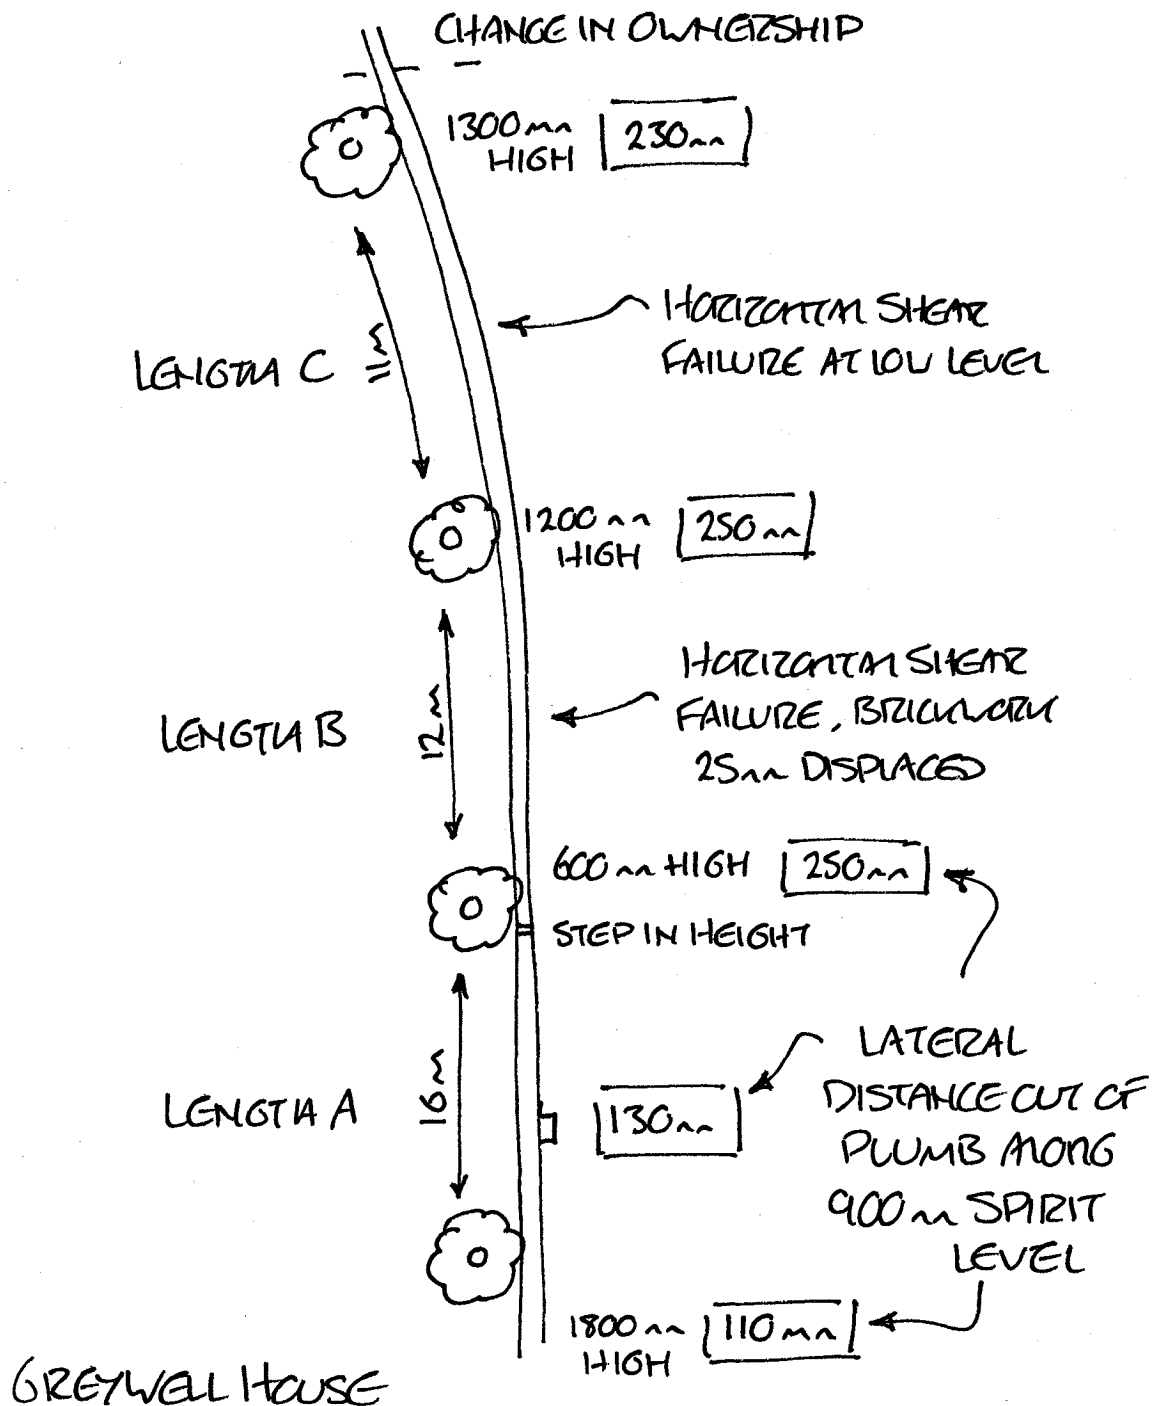
211/SK01

A plan view of the wall, labelled SK01, is attached to illustrate the length and heights of the wall relative to the existing trees with the extent of lateral movement recorded. The three sections of the wall have been labelled for ease of reference.

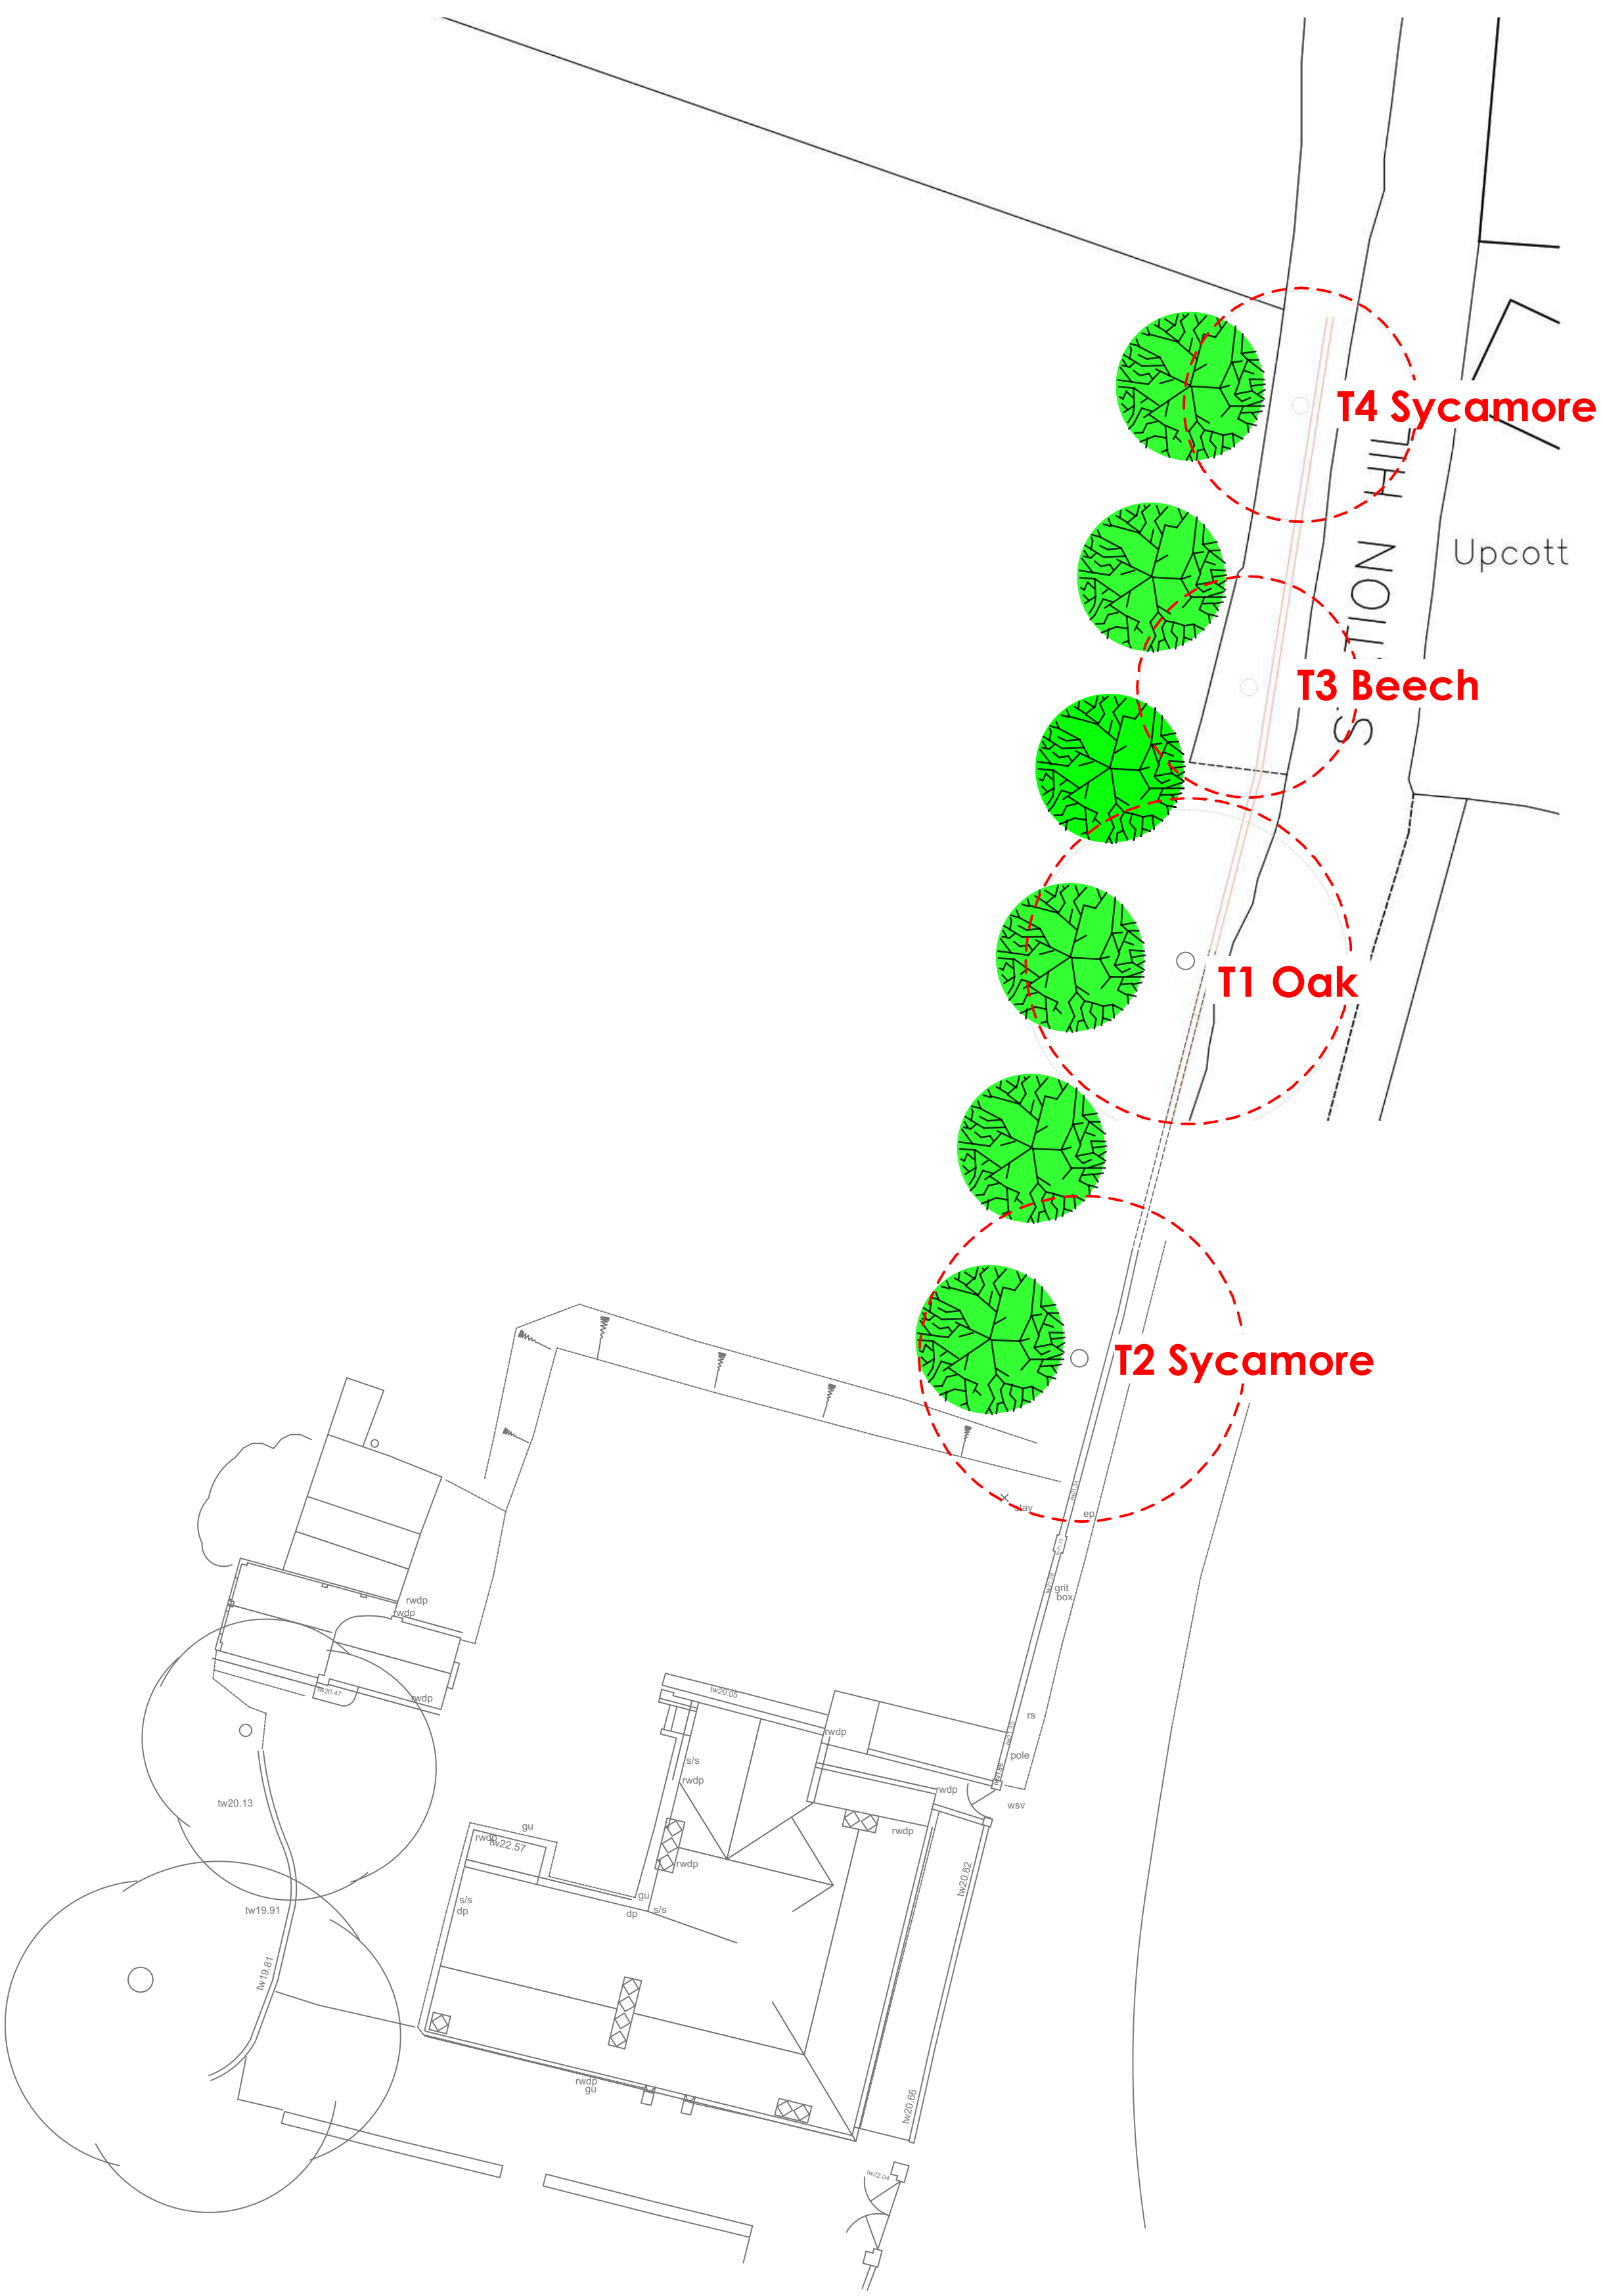
ECO 3 - TREE ISSUES AT 'GREYWELL',  
HIGH STREET, BURSLEDON

The approximate position of the four trees discussed in this report are shown on the plan 'ECO 3' (attachment 3). This shows the position of trees T1 and T2 which were originally indicated for removal under the refused tree work application, along with the two additional trees highlighted in the structural engineer's report and shown as trees T3 (beech) and T4 (sycamore). I revisited the site on 15 June 2022 to inspect trees T3 and T4 and have included some photographs taken during my visit as attachment 4.

I am in agreement with Mr Sargent's view on the trees, in that It is difficult to see a scenario where the trees can be retained in an acceptable condition and the wall rebuilt. My recommendation is therefore that a new tree work application is submitted to the council for the removal of the trees (T1 to T4) in order for the wall to be demolished and rebuilt. It is likely that the council will require compensatory tree planting in the event that they are minded to grant consent for the tree removals and I have indicated on the attached plan what I believe to be acceptable mitigation planting in this respect.

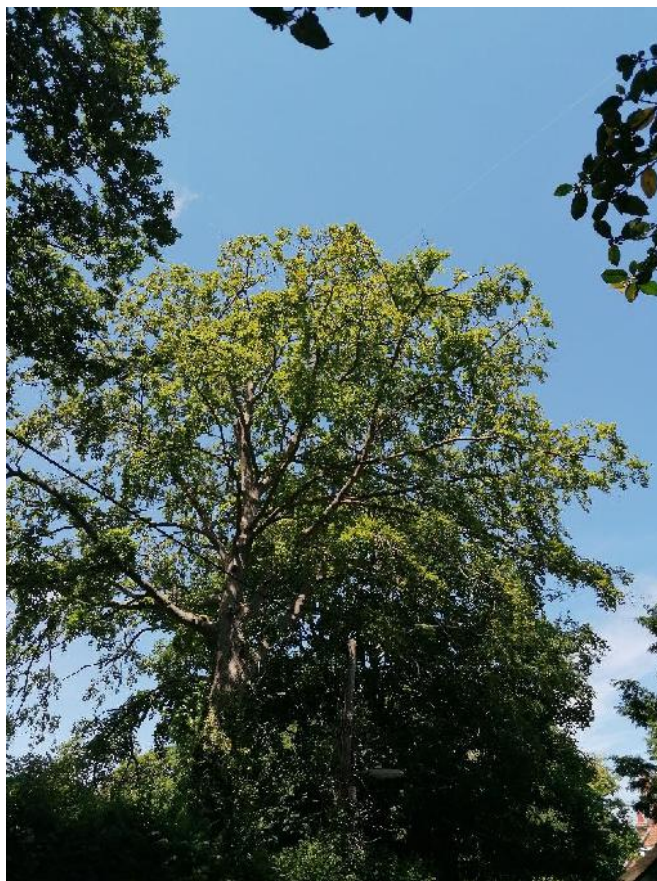
Access to trees T3 and T4 was hindered by the position of existing hedging ivy on the stem of both trees. However, it was clear to me that tree T3 (beech) was in poor condition, with canopy symptoms indicating significant declining vitality (photograph 1, attachment 4). Closer inspection revealed an occluding cavity (with decay) on the lower main stem on its eastern side and this wound appeared to be infected with *Kretzschmaria deusta* (photographs 2 and 3, attachment 4.) The presence of the ivy on the main stem and scaffold branches of tree T4 (sycamore) hindered a proper inspection. However, although the canopy of the tree was a little unbalanced due to its proximity to tree T3, it otherwise appeared to be in good condition, with no obvious canopy symptoms indicating poor tree health.

**Photograph 1:** Canopy of tree T3

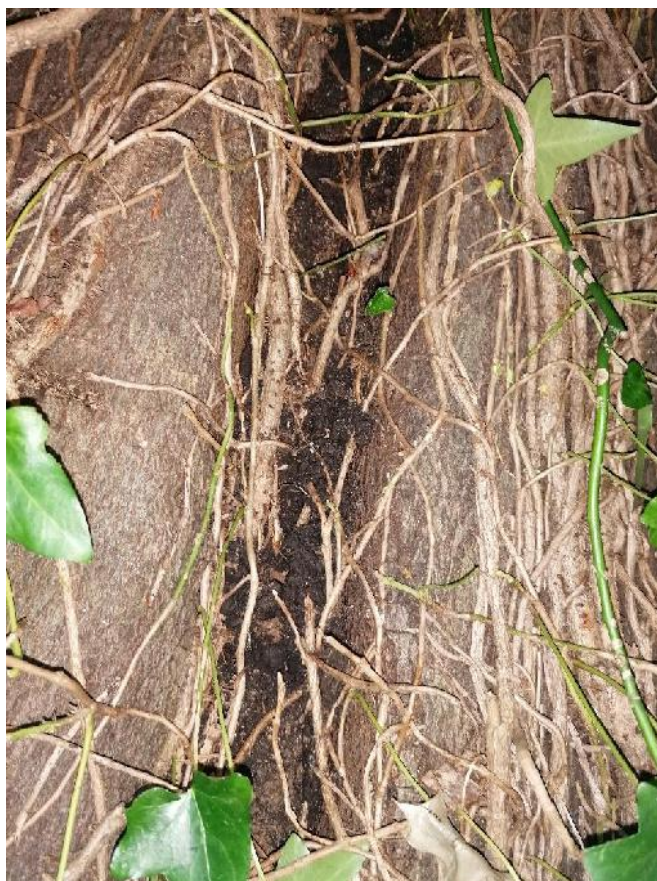
**Photograph 2:** Wound with decay main stem tree T3

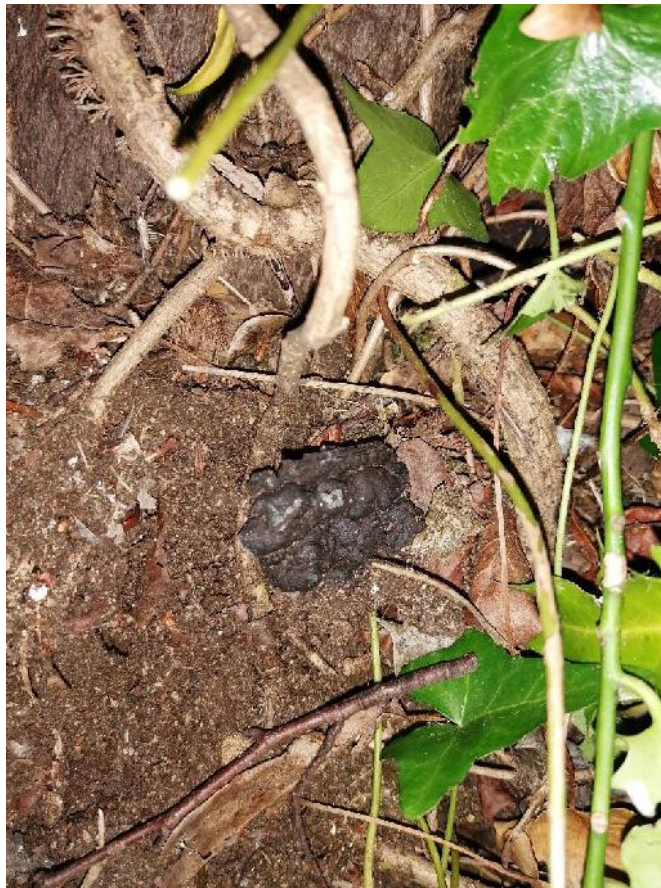
I set out my views on trees T1 and T2 in my earlier report (ecourban reference '211433 – Let 1') and this is appended at the end of this document as attachment 5. With regard to the trees that I looked at on 15 June 2022, the infection of tree T3 with *Kretzschmaria deusta* is a significant concern, as this is a serious fungal pathogen in respect of tree safety. Given the proximity of the tree to the highway, my view is that the tree should be removed as soon as possible in order to maintain acceptable levels of risk, irrespective of any issues surrounding the rebuilding of the wall. In respect of tree T4, although this tree could be retained in acceptable condition, clearly the issue of the wall and its relationship with the tree needs to be addressed in order to allow the wall to be rebuilt.

**Photograph 3:** Close up of fungal fruit body main stem tree T<sub>3</sub>

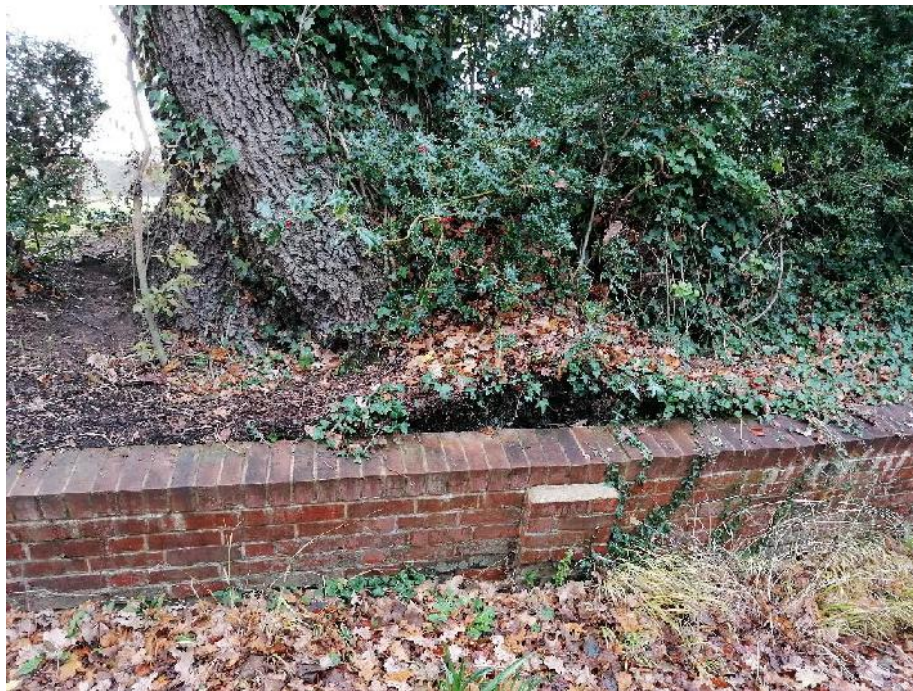
Tree T1 (oak) is the more northerly of the two trees. It is around 20m in height and is twin stemmed at around 1.4m above ground level, with conjoined trunks at around 2m. The stem diameters at 1.5m were approximately 84cm and 105cm respectively. The tree is positioned in close proximity to the nearby wall and the tree appeared to be exhibiting some root plate displacement (photograph 1). The wall is leaning in an easterly direction toward the nearby highway (photograph 2), with the road sitting at a lower level than the ground around the tree. The tree canopy appeared in rather poor condition, with large amounts of deadwood (particularly over the highway) and some localised dieback of branch extremities (photograph 3). I found a number of fungal fruiting bodies around the base of the tree (photograph 4), which on examination I believe to be *Collybia fusipes*.

**Photograph 1:** Tree T1 and wall

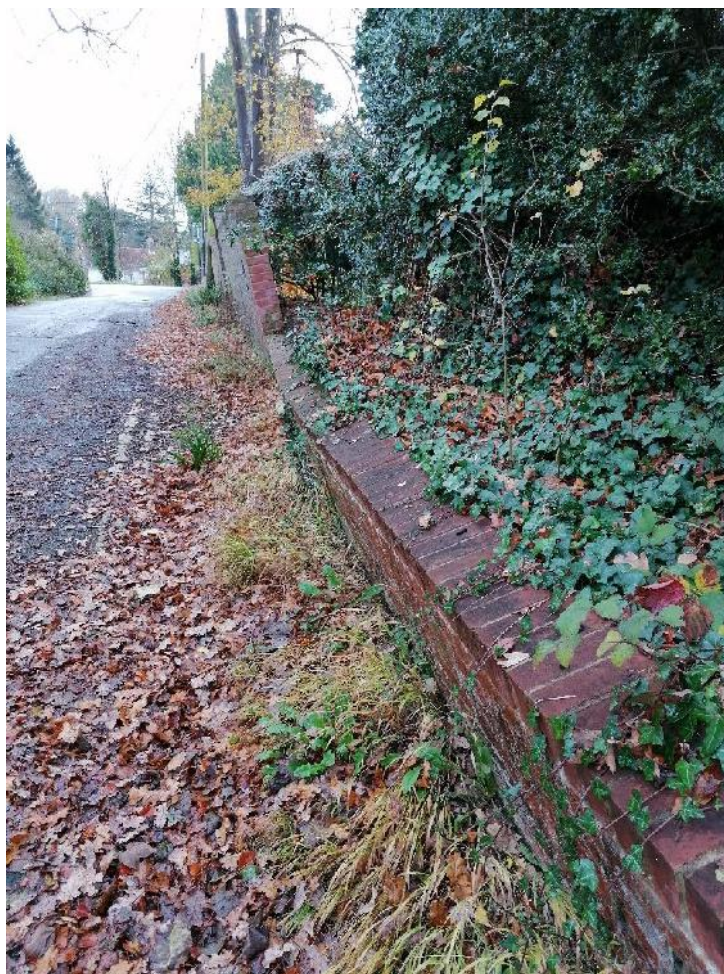
**Photograph 2:** Leaning wall adjacent to tree T1

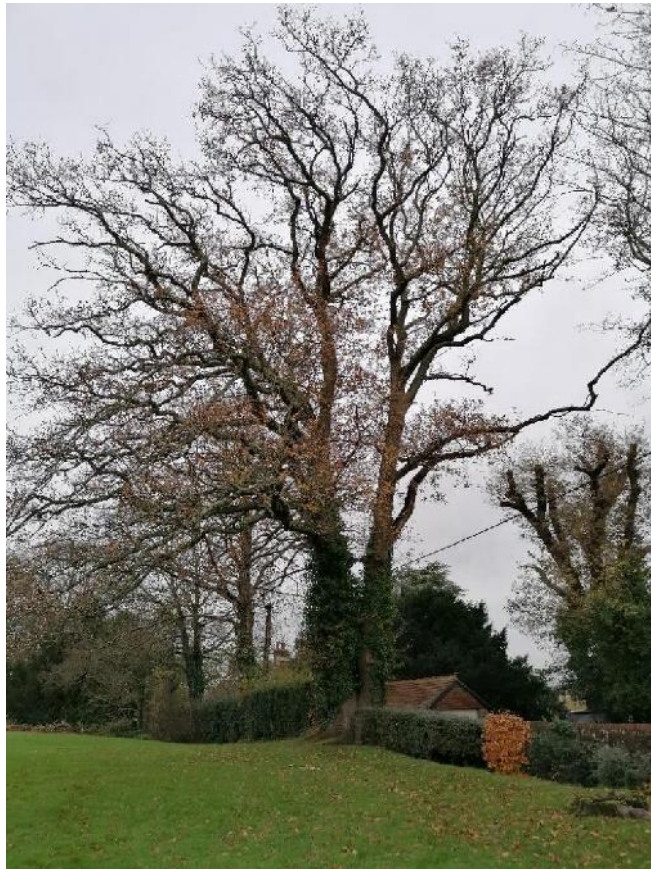
**Photograph 3:** Canopy of tree T1

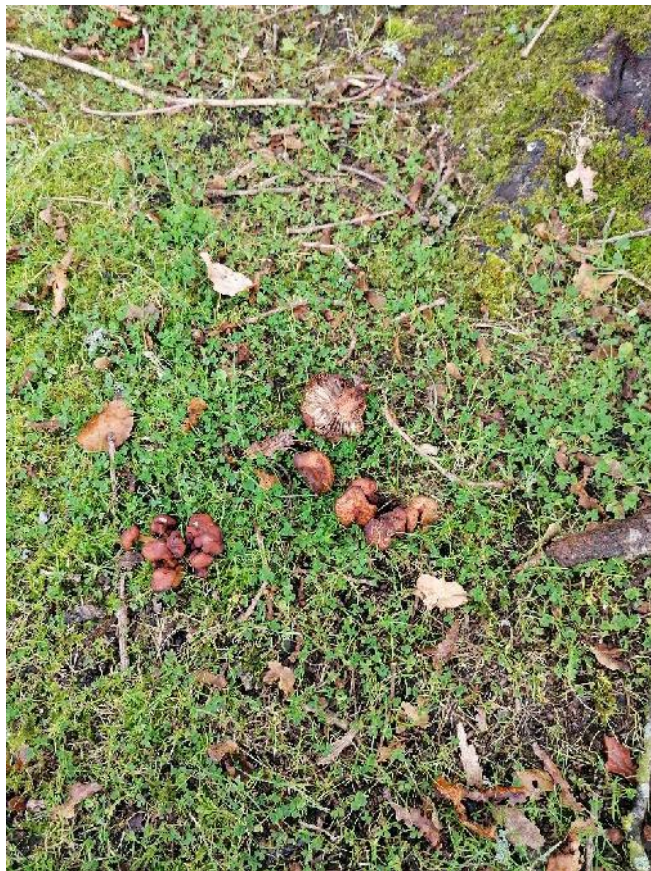
**Photograph 4:** Fungal fruiting bodies around tree T1

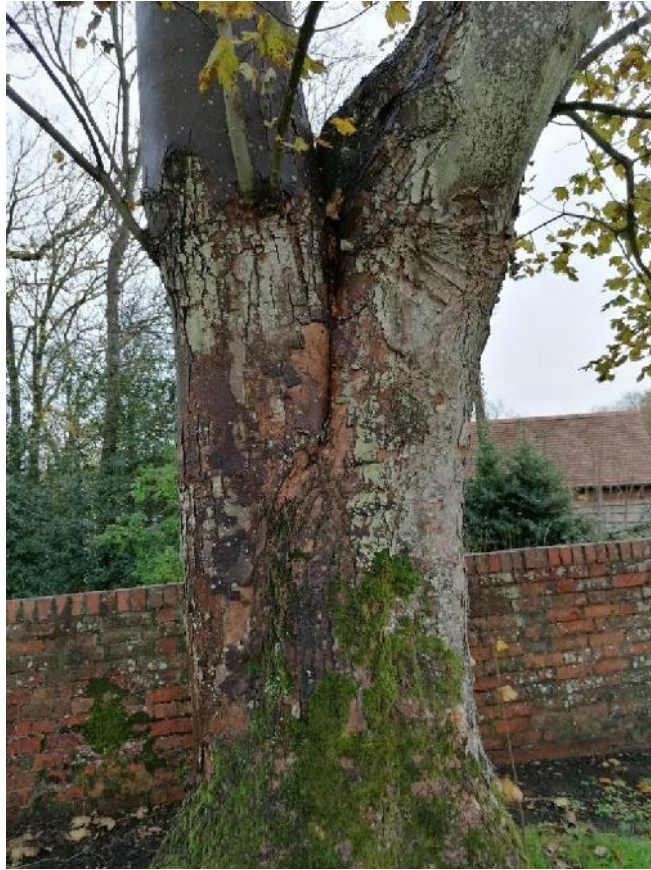
Tree T2 (sycamore) is located further to the south of tree T1. It is also around 20m in height and is also twin stemmed, with the main stem having an estimated diameter of about 90cm just below the main fork. The angle between the forks was very acute, resulting in a noticeable zone of 'bark to bark' contact (photograph 5). I noted that the tree was also in close proximity to the nearby wall and that this part of the wall was also leaning at a significant angle eastward toward the highway, which is again positioned at a lower level than the tree. A nearby utility pole to the south of the tree supported an overhead service (electricity) running in a north/south orientation and the leaning wall appeared to be supported by the utility pole (photograph 6).

**Photograph 5:** Main trunk tree T2 with tight fork

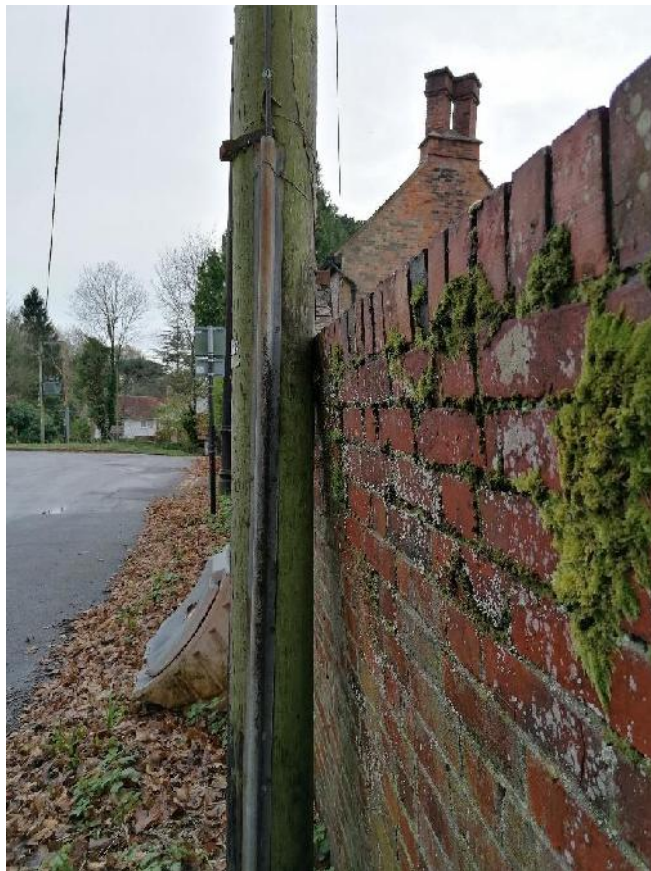
**Photograph 6:** Leaning wall and utility poll close to tree T2
