Our Ref: 211433 - Let 2

**Re: Tree issues at 'Greywell', High Street, Bursledon**

Our Ref: KBS/211

**GREYWELL, BURSLEDON, SOUTHAMPTON**

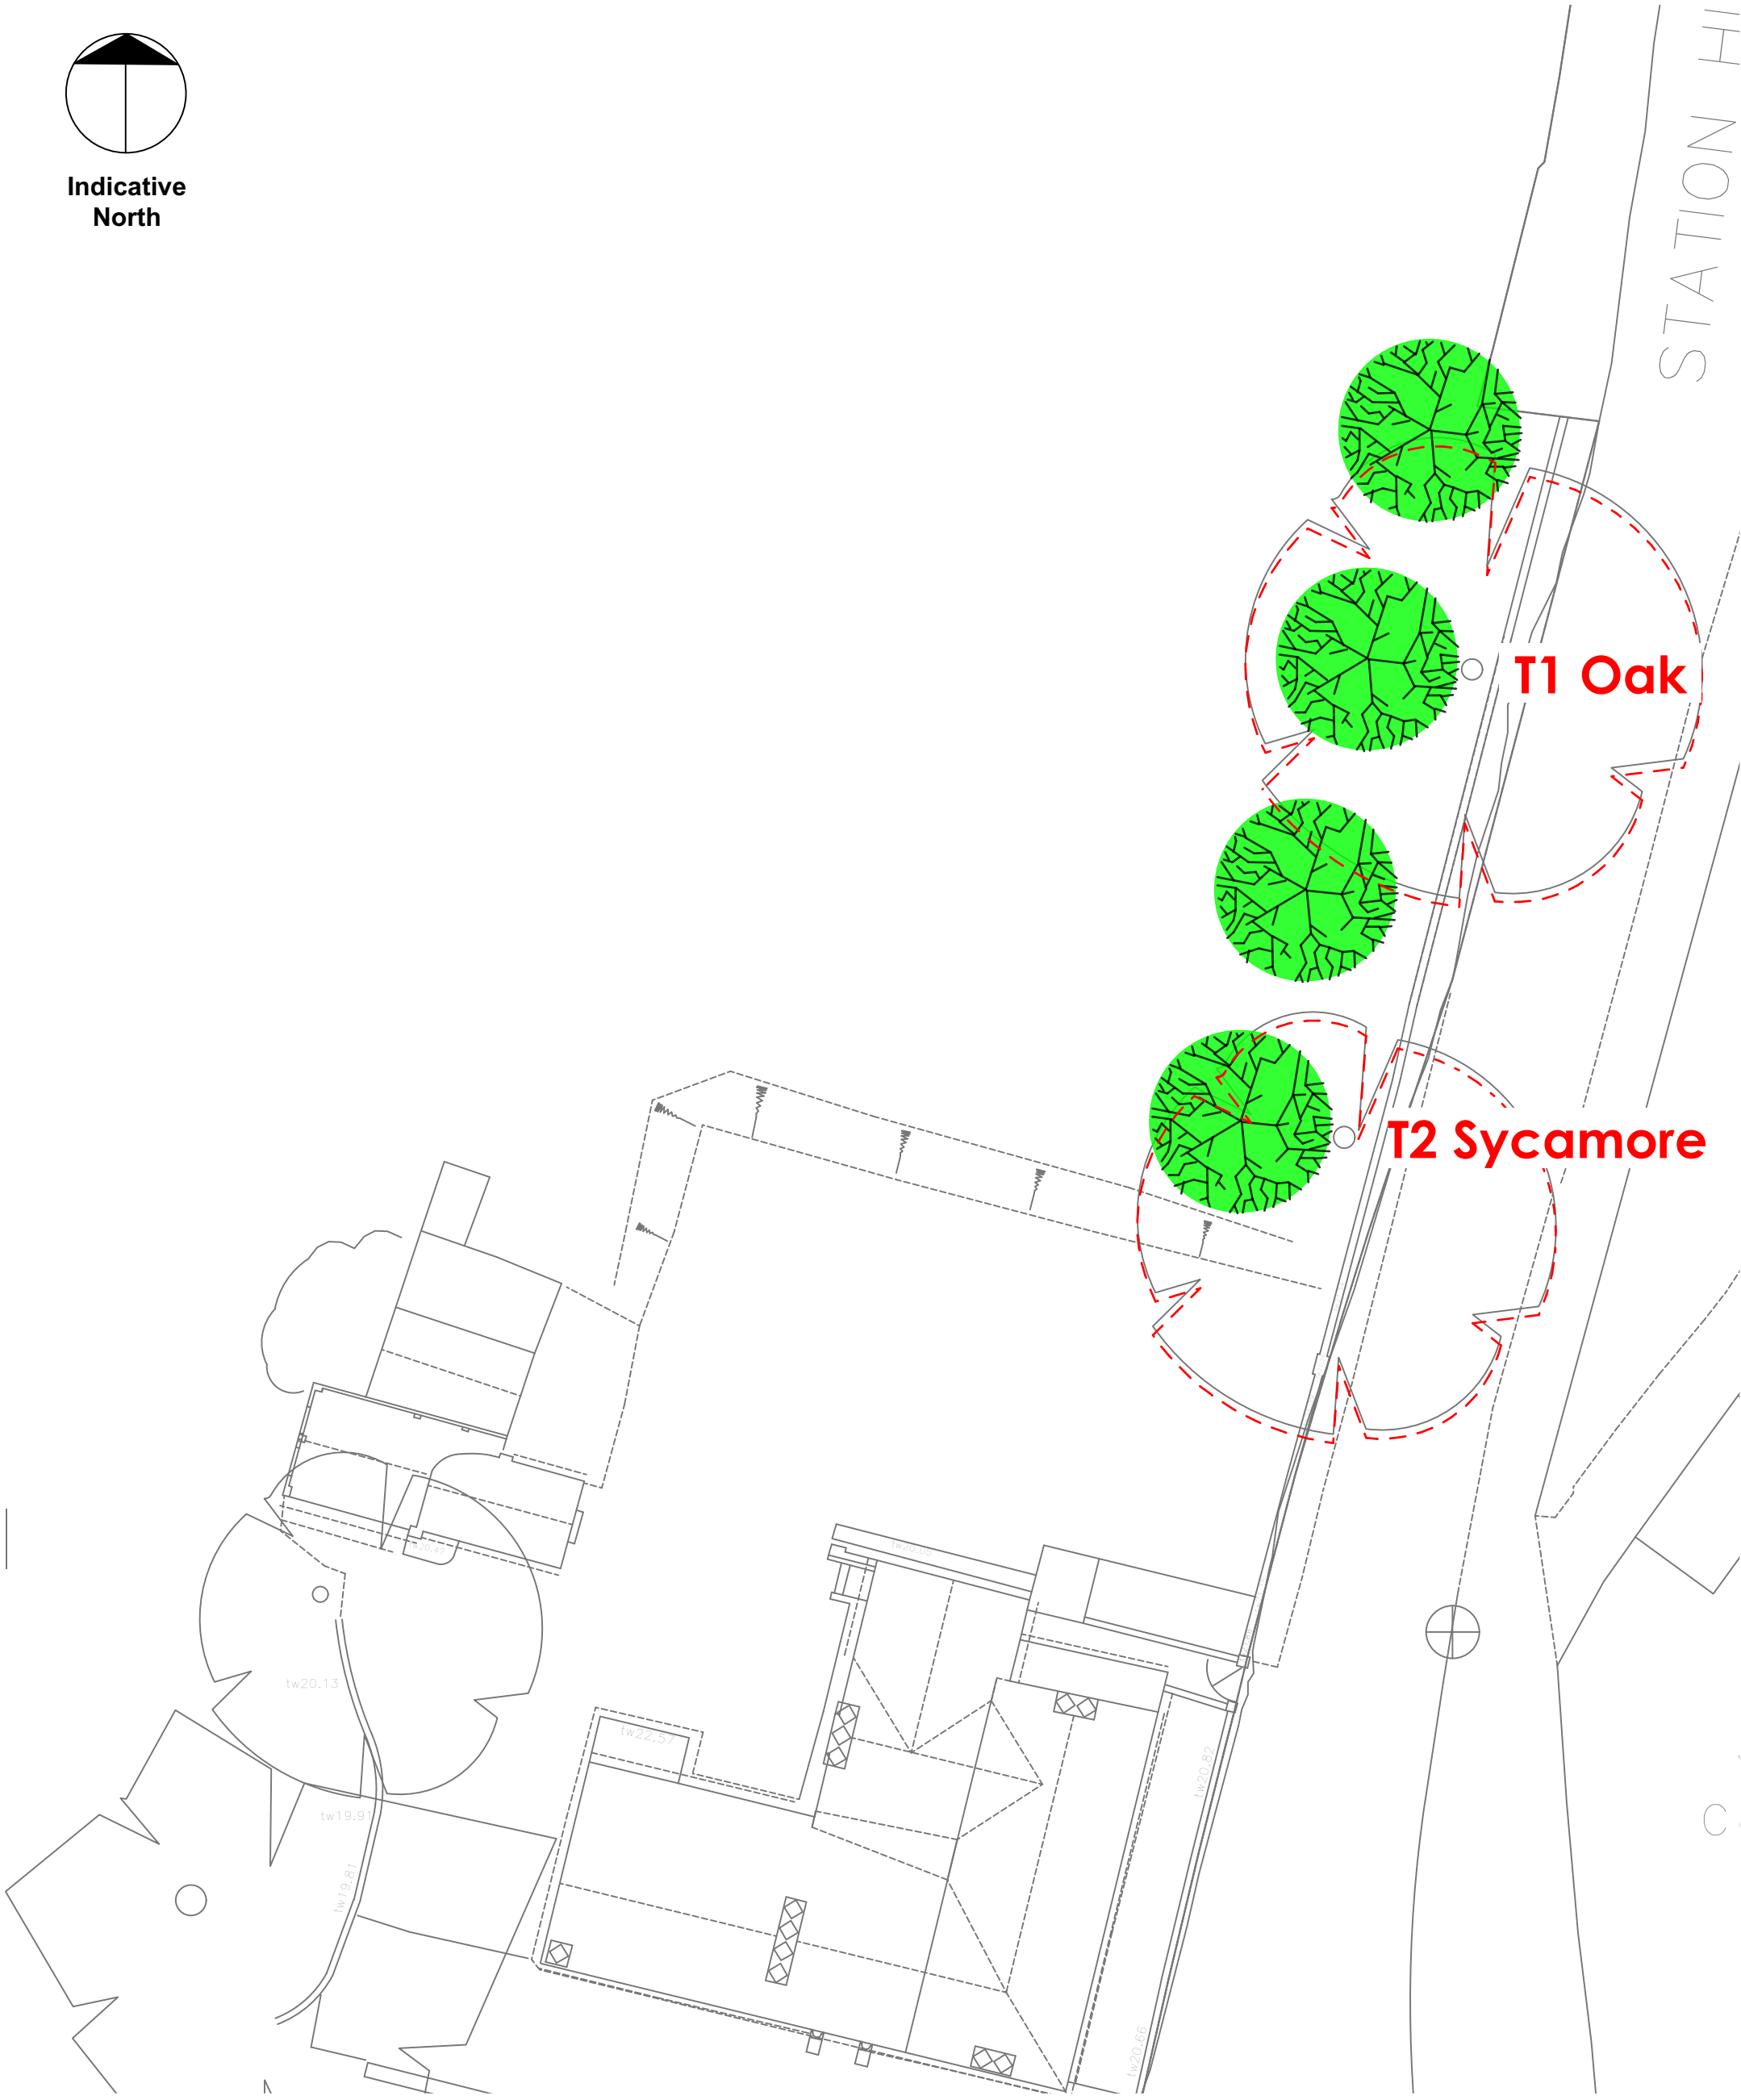
I visited on 3 December 2021 and the trees I looked at are an oak (*Quercus robur*) and a sycamore (*Acer pseudoplatanus*) located on the eastern site boundary. Their approximate positions are shown on the attached plan (drawing reference 'ECO 2) and I have added in some tree numbering to assist with identification. I understand from our discussions that the building ('Greywell') and the wall are both listed due to their architectural and historic interest and the site also sits within Old Bursledon Conservation Area (OBCA). Reference to the councils online mapping system indicates that a Tree Preservation Order (TPO) is in force across a large part of the site (Council reference '175-H') and this covers 'All Tree Species'.

Having considered the issues in some detail, my view would be to accept the loss of the trees now, which would allow the wall to be rebuilt. The removal of the trees will have some implications in the locality, but with replacement planting, I feel that this is a sensible and sustainable way forward. I have indicated new trees on a '2 for 1' basis to create a linear formation, which I feel over time will mature into a useful arboricultural/landscape feature in the locality. I have positioned these new trees so as to reduce the likelihood of any implications on the wall or overhead service in the future.
