Our Ref: **22070-Let1-160522-JB**

**Re: Replacement tree house at the above address**

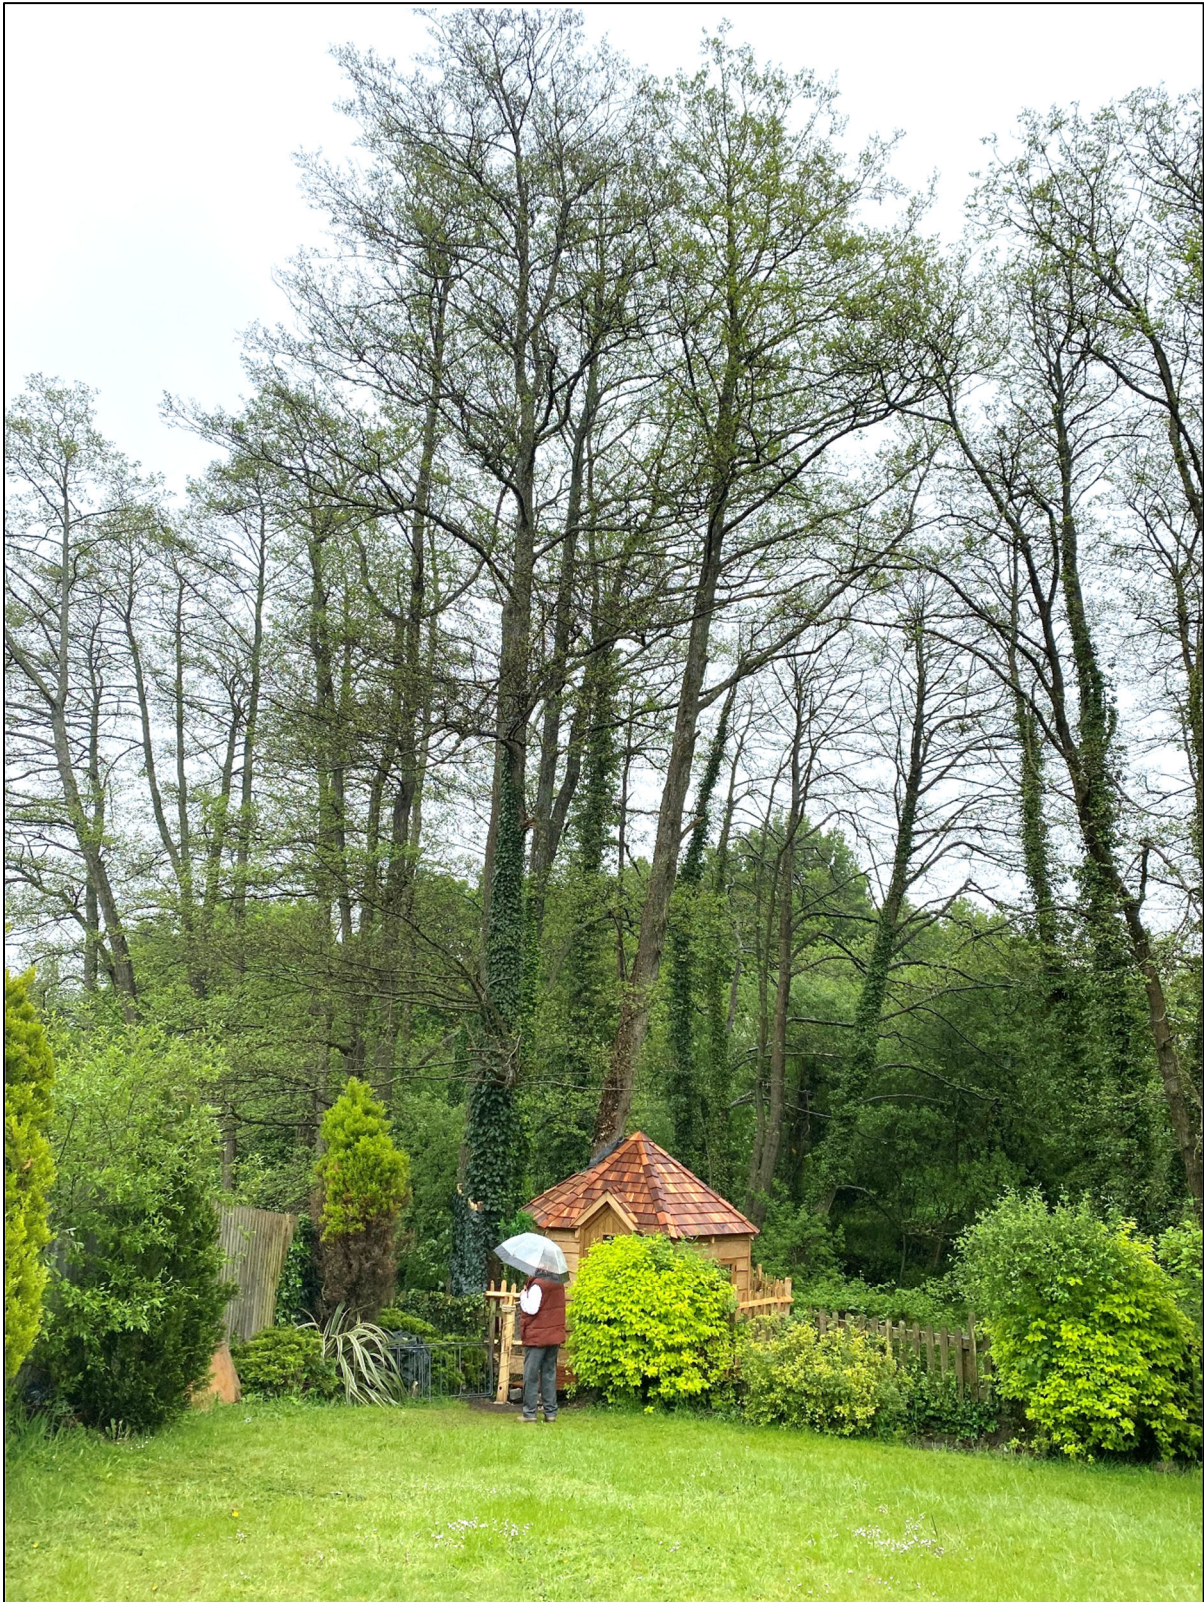
The tree house is set at the end of a lawned rear garden and fits around a single alder tree with two trunks (Figure 1). The tree is part of a woodland group of similar trees up to about 50 cm trunk diameter and up to about 20–25 m in height. All the trees appeared to be in normal health with no obvious signs of decline, and the new leaves had just started emerging when I visited.

**Figure 1:** View of the tree house and the adjacent trees looking down the garden towards the woodland at the end.

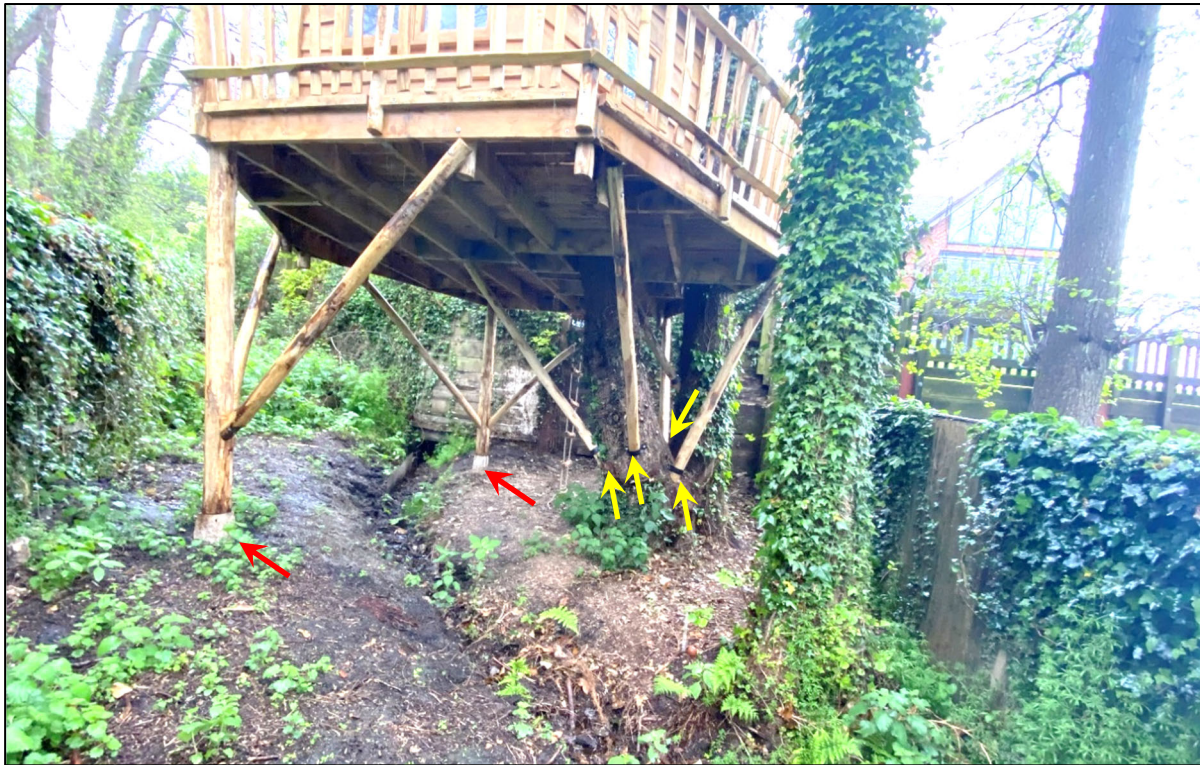
The land at the far end of the rear garden slopes away steeply beyond the relatively flat main garden area, which is retained, with a drop of about 2–3 m to the lower level beyond. The supports for the tree house structure are at this lower level, which cannot be easily accessed from the main garden area. The primary supports for the tree house are rustic wood poles that sit on two small concrete piles set into the ground that rise to the main structure, where the floor sits at around the ground level of the formal garden (Figure 2). There is no obvious disturbance around these piles and no evidence of excavation beyond their small footprint (about 20 cm square).

Additionally, there are five metal brackets screwed into the lower trunk of the tree with wood stabilising supports rising to the structure above. The two trunks of the tree go through the tree house floor with space around each allowed to accommodate trunk movements in the wind. The supporting brackets press against the bark of the trunk and have not been cut into the wood, with no obvious damage other than the screws going into the wood.

In terms of any adverse impact on the trees, my observations indicate that there was no significant excavation to install the two concrete supporting piles, and I cannot see any significant harm arising from that work. Trees can easily cope with such minor disturbance and my opinion is that these incursions are so small that there has not been any significant adverse impact on any of the adjacent trees from that work.

**Figure 2:** View of the tree house from beneath looking towards the house and the retaining structure at the end of the garden, with the small concrete piles shown by the red arrows. There are further supports fixed to the tree trunk with brackets shown by the yellow arrows.

The five metal brackets screwed into the tree trunk will have caused some damage to the wood. However, these seem to be no more than often seen with fences attached to tree trunks, and healthy trees can normally cope with such small levels of damage without any adverse impacts on health. Although there has been some damage to the trunks from this work, it is so small and minor that I am confident that these trees are healthy enough to be able to recover without any obvious adverse impacts. It would be possible to remove the brackets and install additional piles to replace the lost supports, but I don't think it is necessary in this situation. Indeed, removing the brackets will not remove the damage, and leaving them in place will not cause any more damage because trees have the capacity to grow around such attachments.

In summary, although some damage has occurred to the trees, it is so minor that there is no realistic prospect of it having any significant adverse impact on their health or safe useful life expectancy. For that reason, my opinion is that no further action is necessary from a tree health and safety perspective.
