# Arboricultural Implications Assessment and Method Statement for 'Greywell', High Street, Bursledon

**'Greywell', High Street, Bursledon**

Report Ref: **211433 - AIA**

Report Date: **24 June 2022**

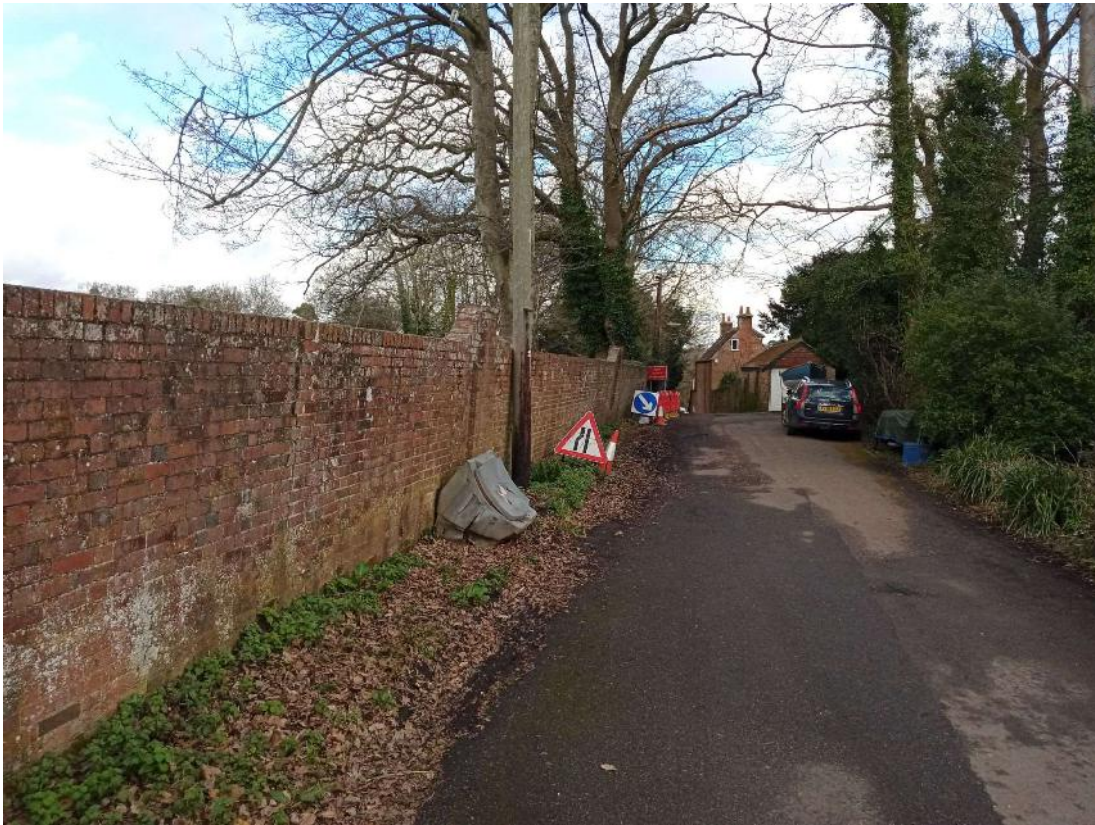
Photograph 1 – General view of Southern end of wall

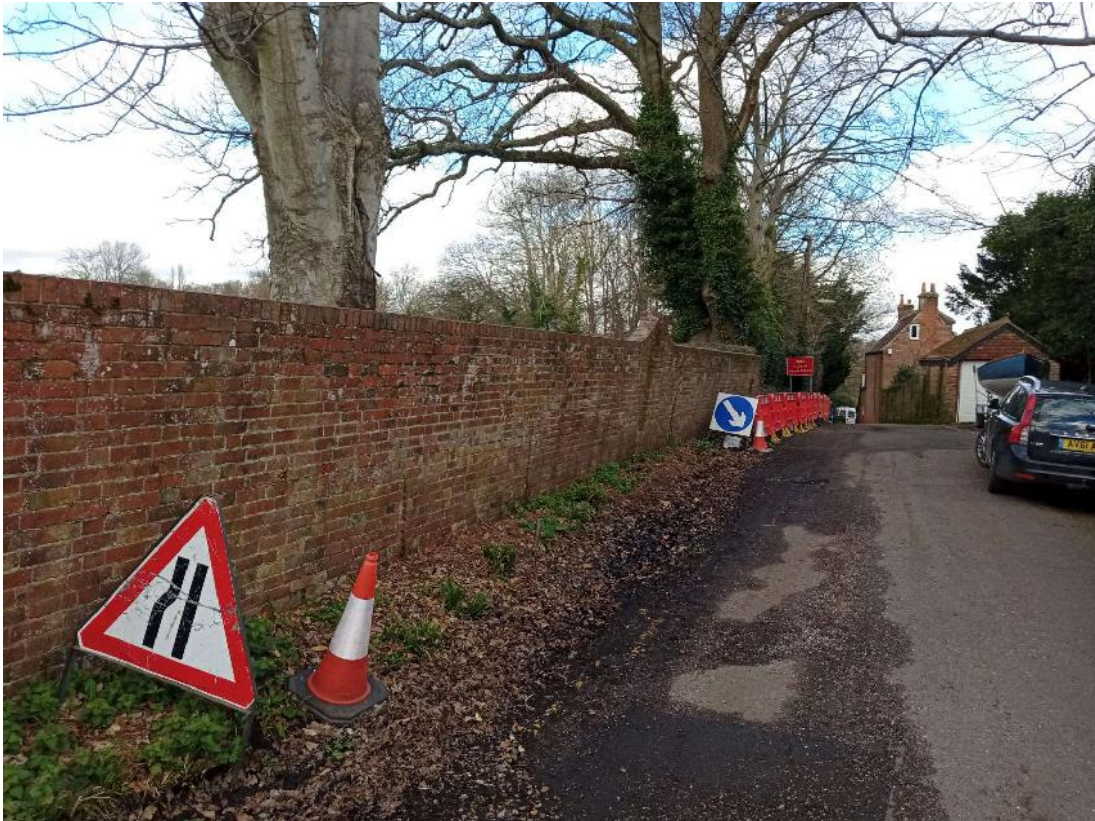
The stretch of the wall closest to the property, Length A, was 1800mm high when measured from the High Street and appeared to be the original construction. At the end closest to the property where the first oak tree occurred, the wall was found to be 110mm out of plumb when measured along a 900mm long spirit level with the top of the wall leaning outwards towards the highway. Please refer to Photographs 2 and 3.

Photograph 2 – General view of wall Length A

Given the extent of lateral displacement coupled with the shear failures, we would deem the wall to be structurally unstable and beyond repair. The wall along this length will therefore require demolition and reconstruction.

The main contributing factor to the displacement in the wall is the four mature trees located close to the back of the wall on the retained side. These trees will also prevent the wall from being reconstructed back in its original corrected position as they now foul the original line of the wall. We would therefore recommend that the trees be removed before the wall is rebuilt.

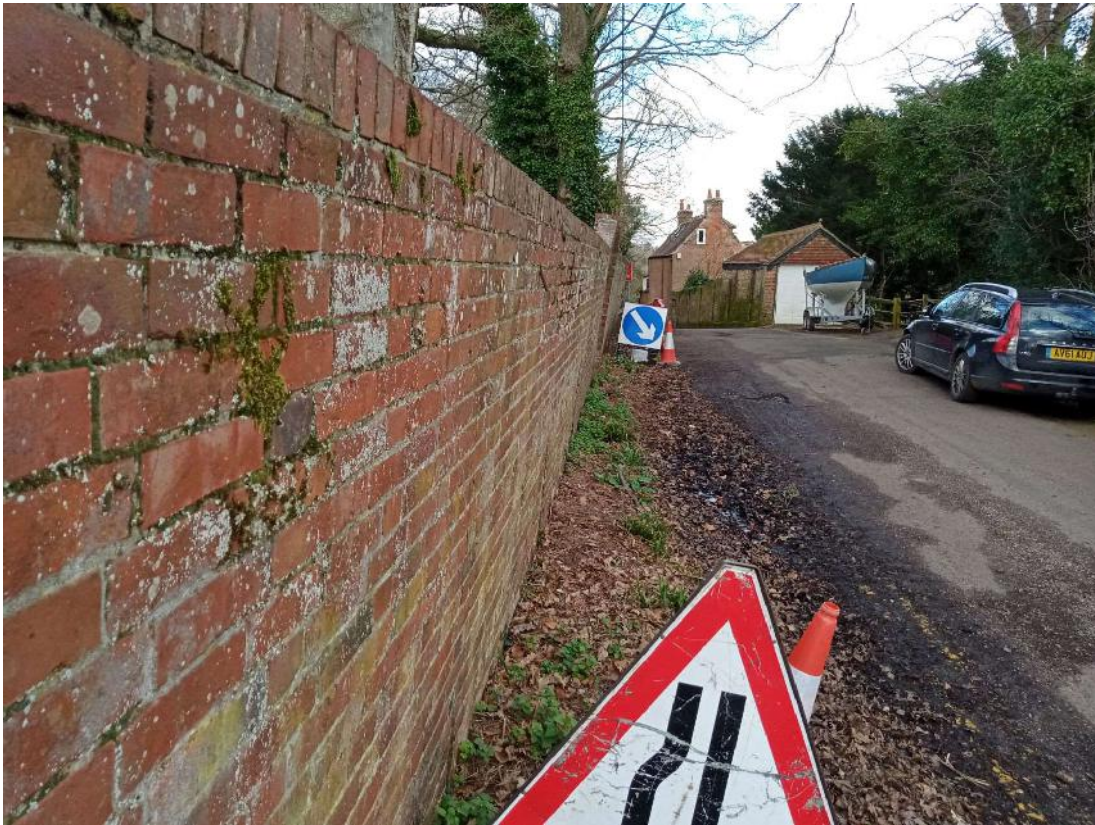
Photograph 3 – View along wall Length A

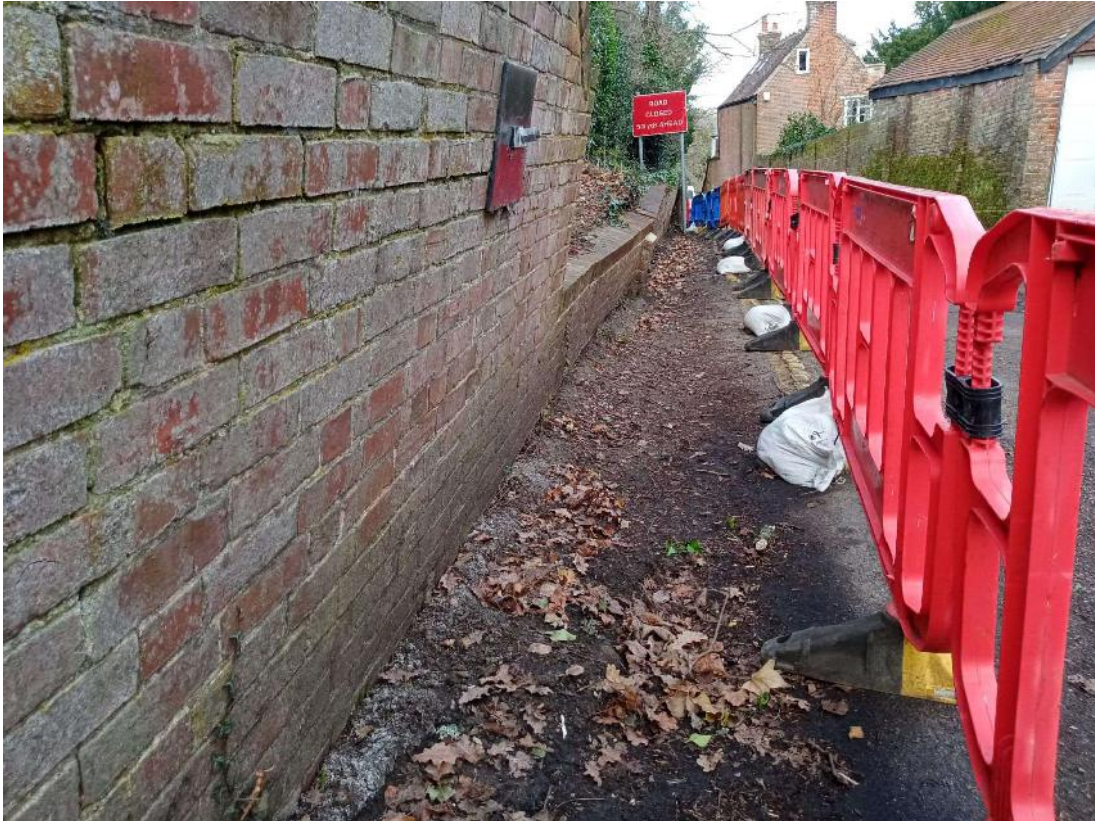
Adjacent to the second oak tree, the amount of lateral displacement in the 1800mm high wall had increased to 180mm when measured along a 900mm long spirit level. A step in the height of the wall occurred at this point, with it then dropping to be only 600mm high. The lower section of the wall was found to be 250mm out of alignment. It was noted that the end of what appears to be a ground anchor with a pattress plate had been installed close to where the step in height occurred. Please refer to Photograph 4.

Photograph 4 – View along junction between wall Lengths A & B showing step in height

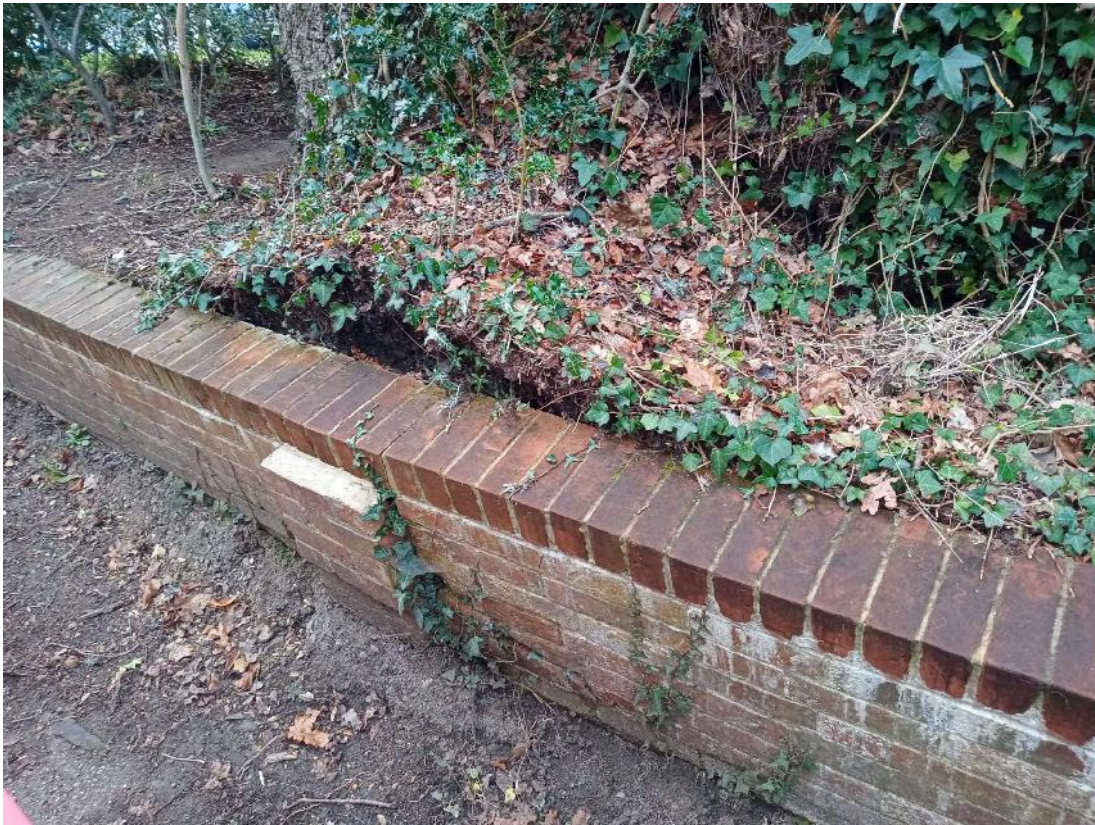
The second stretch of wall, Length B, increased from being 600mm high at the southern end to 1200mm high at the northern end. In the central section of this wall horizontal shear failure was noted with a local displacement in the brickwork of 25mm. At the Northern end of the wall, the wall was again found to be 250mm out of alignment. Please refer to Photographs 5 and 6.

The lateral forces acting on the wall that will have contributed to this displacement will primarily be from the retained material behind the wall and the root bowl of the mature trees. For a retained height of no more than 800mm, the BRE have produced a publication which states that a 215mm solid brick wall would be adequate. As the retained height is less than this, the current wall should have been suitable. It is therefore more likely that the lateral displacement has been caused by the trees. This is clearly evident in Photograph 5, where the tree is so close to the wall that the root bowl has locally pushed the wall towards the highway.

Photograph 5 – Proximity of mature tree behind wall in Length B

Replacement trees can be provided if desired, but at a greater distance from the wall to ensure that the boundary wall is outside the zone of influence of the trees so that the trees are no longer a destructive factor.

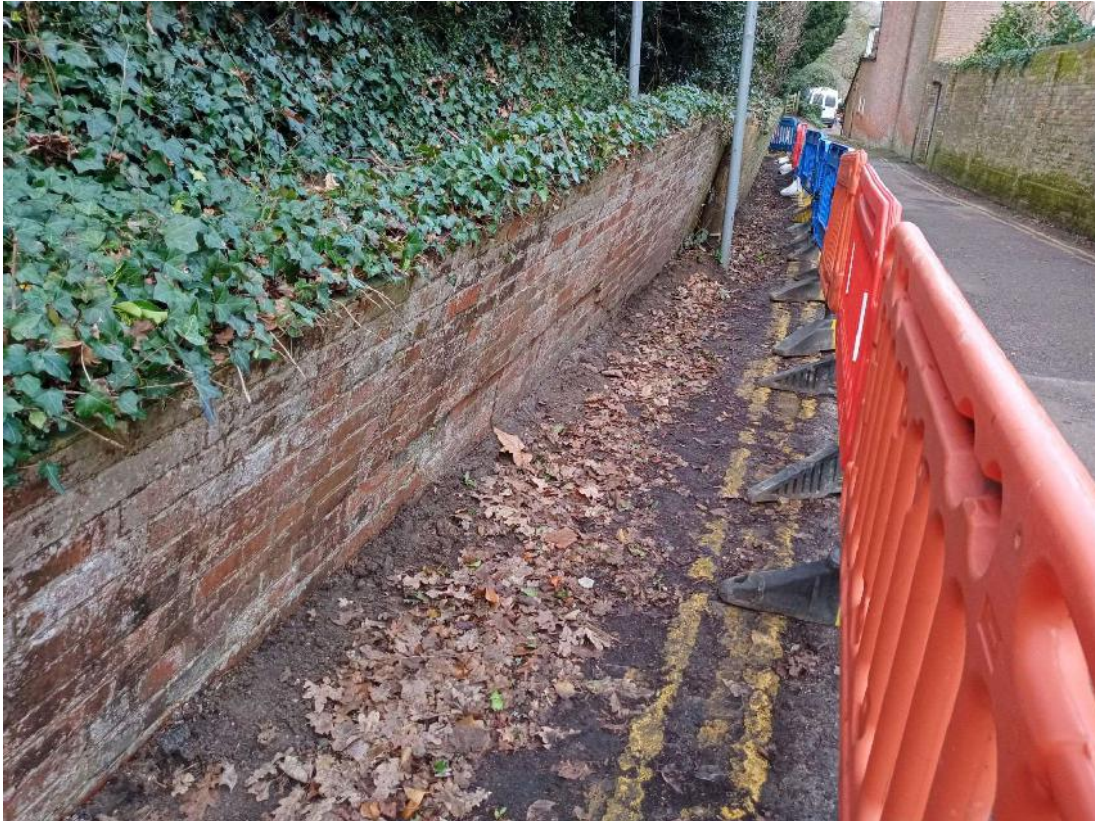
In addition, shear failures have occurred in the wall with the brickwork being locally displaced by up to 25mm relative to the adjacent surrounding brickwork.

Photograph 6 – View along wall Length B showing shear failure along base of wall

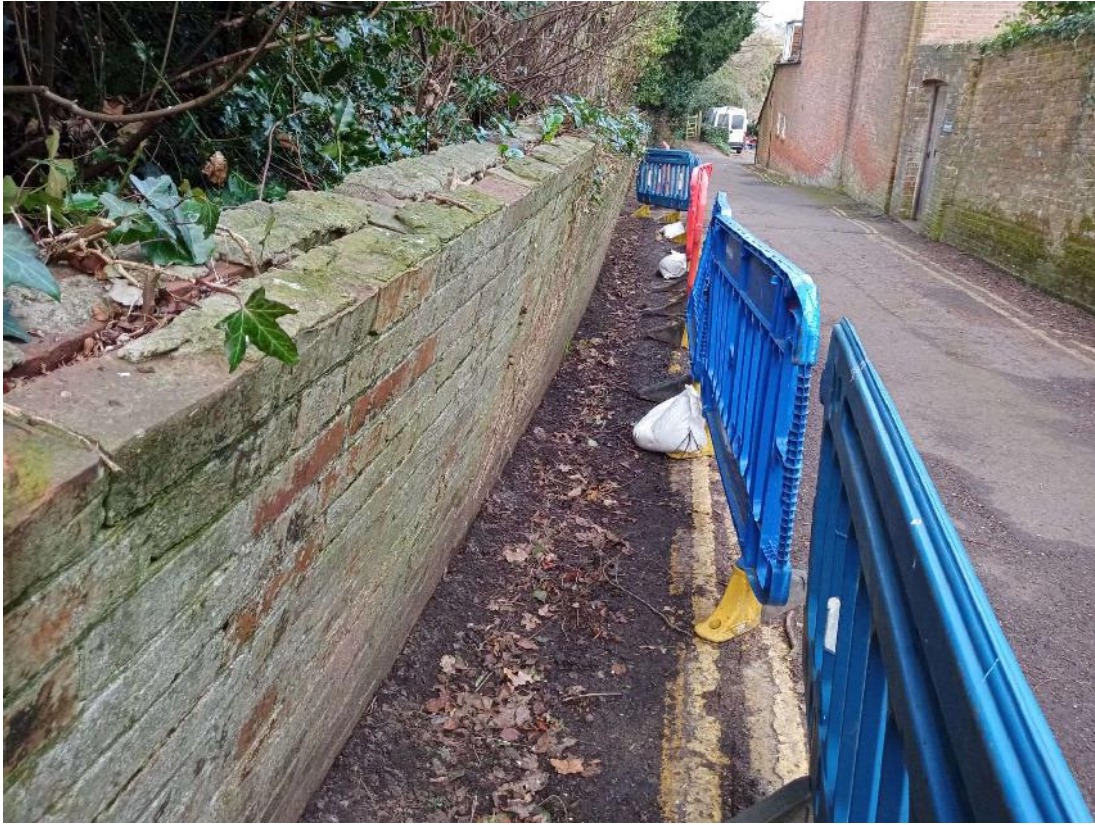
The last stretch of the wall between the two mature trees was fairly constant in height, increasing to be 1300mm high at the Northern end. At this point the wall was 230mm out of alignment. Please refer to Photograph 7. Again, horizontal shear failure was noted in the base of this wall, occurring close to the third of the mature trees.

Photograph 7 – View along wall Length C
