## **ARBORICULTURAL REPORT**

**Hampshire House Courtyard  
Hampshire Corporate Park  
Chandlers Ford  
SO53 3YX**

**Date – 3<sup>rd</sup> June 2022**

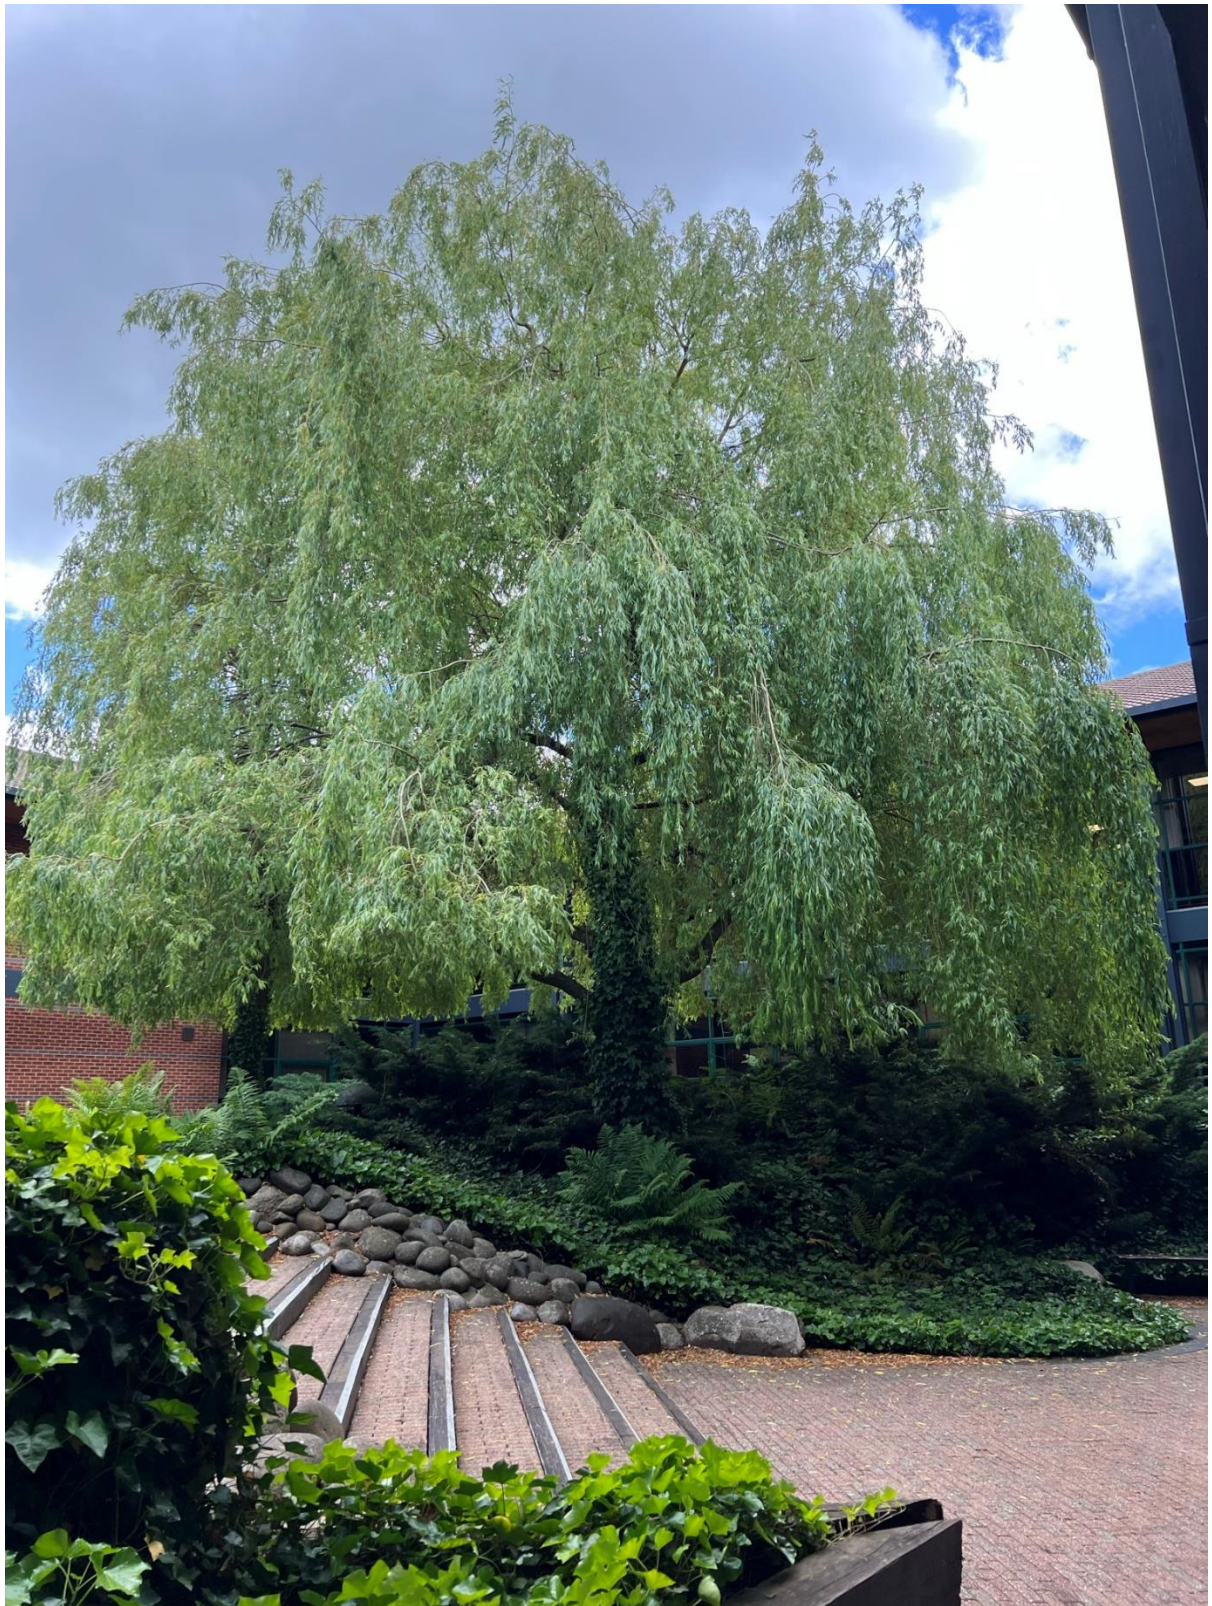
**Photograph 1:** Showing tree 1

The tree grows on a bank with a relatively straight trunk.

Ivy grows on the trunk.

There are numerous old pruning wounds throughout the crown which has been reduced in the past at a height of approximately 7m above ground level. The crown appeared to be in a good physiological state with typical minor deadwood throughout the crown.

This tree has the potential to significantly grow in both height and spread.

- 5.5 Removing the Willow T1 is unlikely to cause heave with the known information to date, the soil type is of a reasonably low clay content and the tree would appear to have been planted as part of the landscaping of the corporate park rather than being present before the park was built although it is unknown what was present on site prior to the park being built.

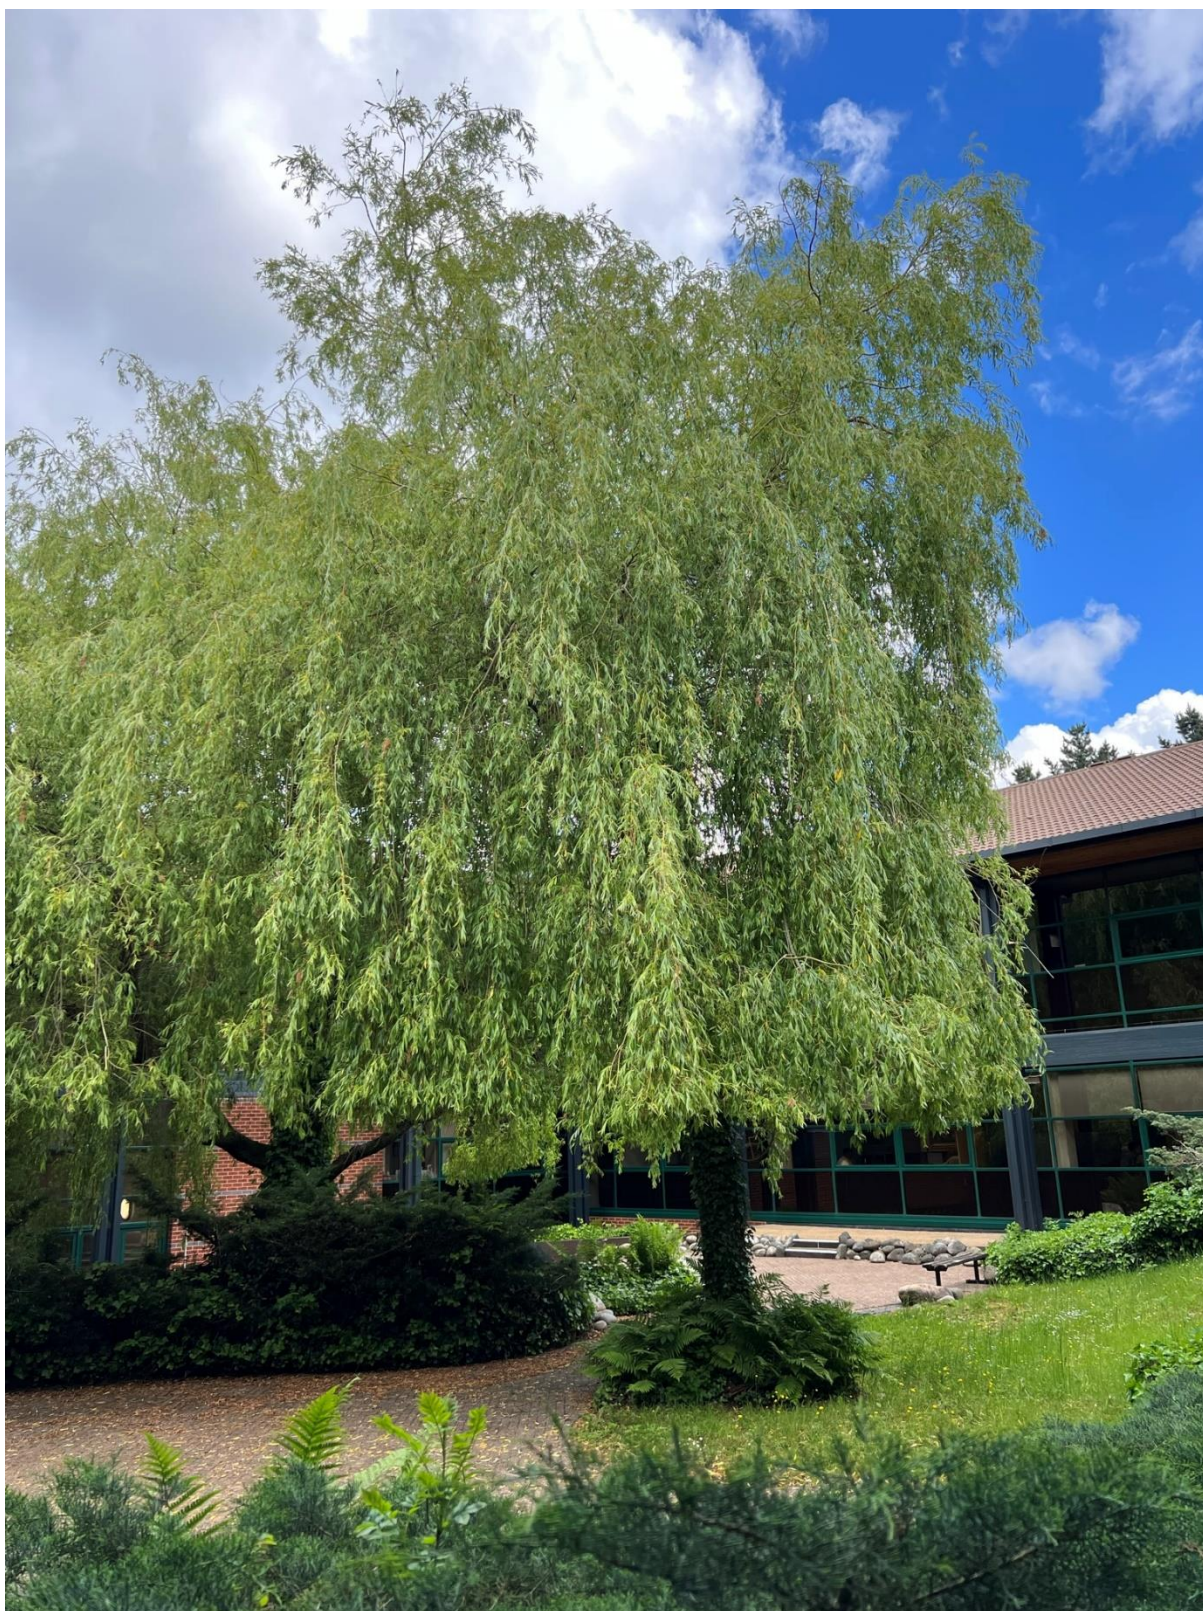
**Photograph 2:** Showing tree 2

- 3.5 **Tree 2 Weeping Willow – *Salix babylonica***  
The tree is considered to be an early mature age class tree with a height of approximately 9m and a trunk diameter of 370mm at 1.5m above ground level.

Several areas of the block paver paths are becoming dislodged which is likely to be as a result of the roots of the tree.

The tree grows towards the centre of the courtyard on the flat ground of the courtyard.

Ivy grows on the trunk.

There are numerous old pruning wounds throughout the crown which has been reduced in the past at a height of approximately 7m above ground level. The crown appeared to be in a good physiological state with typical minor deadwood throughout the crown, however the crown is weighted to the western side.

This tree has the potential to significantly grow in both height and spread.

- 5.6 If the Willow T2 is retained, it is our opinion that the tree will need to be cyclically pruned as has occurred historically to maintain and retain a relatively small crown.

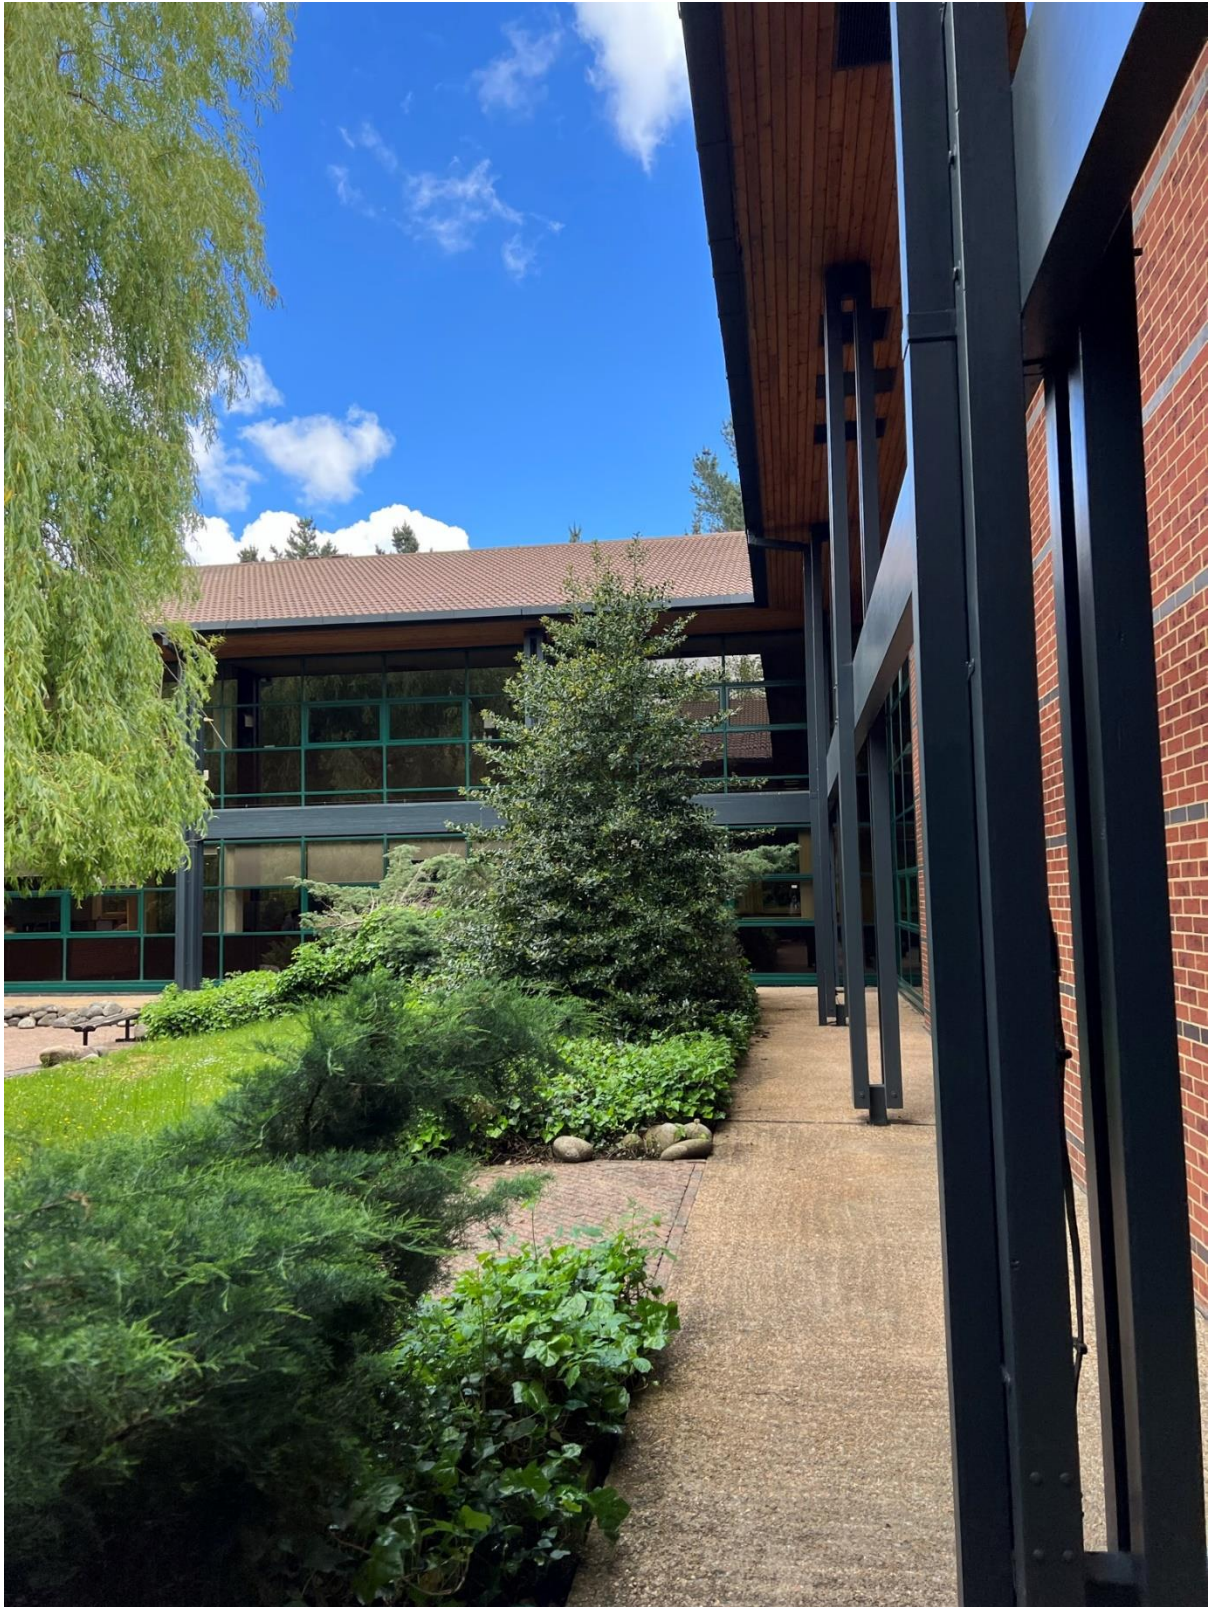
**Photograph 3:** Showing tree 3

### 3.6 **Tree 3 Common Holly – *Ilex Aquafolia***

The tree is considered to be a semi mature age class tree with a height of approximately 6m and a trunk diameter of 20, 60, 70 and 70mm at 1.5m above ground level.

This tree appears to be of natural self-set regeneration and not part of the original landscaping scheme.

The tree is multi stemmed at ground level.

The crown appeared to be in a good physiological state.

This tree has the potential to significantly grow in both height and spread.

- 5.7 The removal of the Holly T3, will not be a cause for concern as this tree is small and younger than the building.
- 5.8 It is our understanding that heave can only happen if the structure was built after the tree had the capacity to create a persistent moisture deficit, i.e., the building is younger than the tree. It takes a number of years for a persistent soil moisture deficit to develop, and it usually takes a number of years for that deficit to reduce through natural re-wetting and for the soil to expand back to its original condition at field capacity (its maximum water content). For that
