Our Ref: **211433 - Let 2 - Update**

**Re: Tree issues at 'Greywell', High Street, Bursledon**

**GREYWELL, BURSLEDON, SOUTHAMPTON**

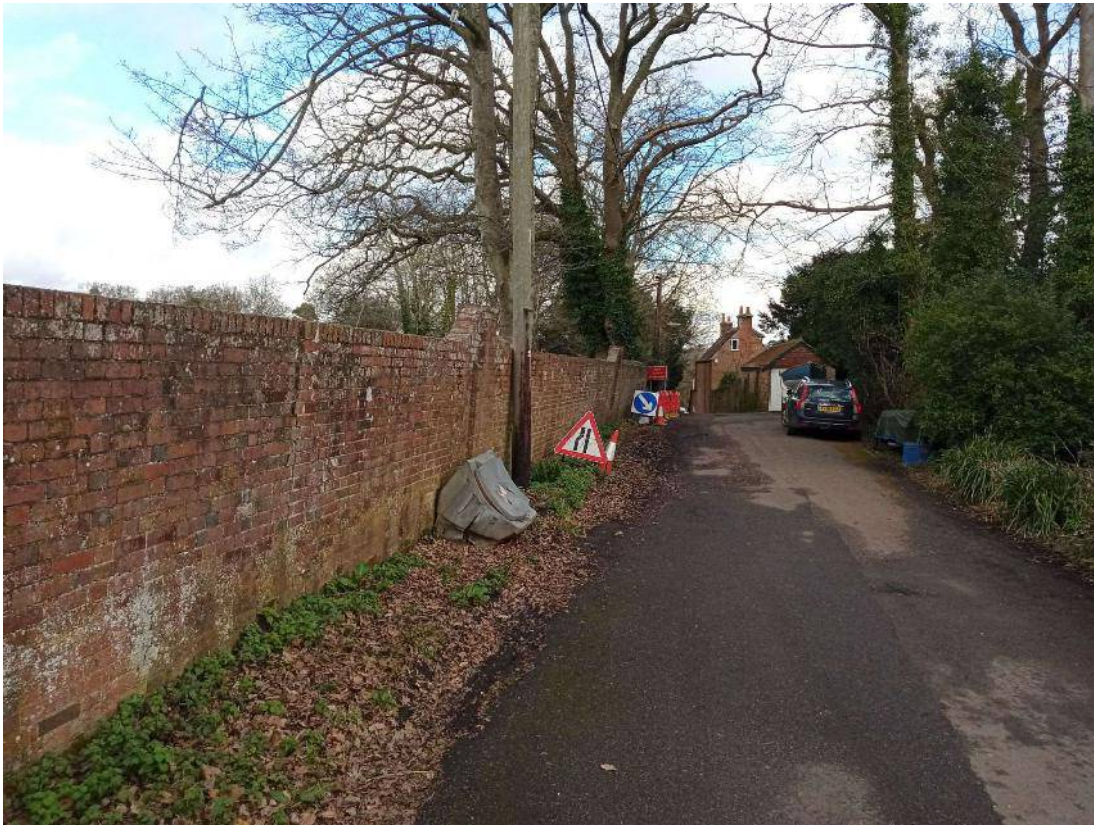
The wall was located along the boundary with the High Street and was of traditional brick construction. The visible part of the wall was two bricks thick, built as separate leaves with a soldier course on top and typically had a Sussex bond (also known as Flemish garden wall bond). Please refer to Photograph 1.

Photograph 1 – General view of Southern end of wall

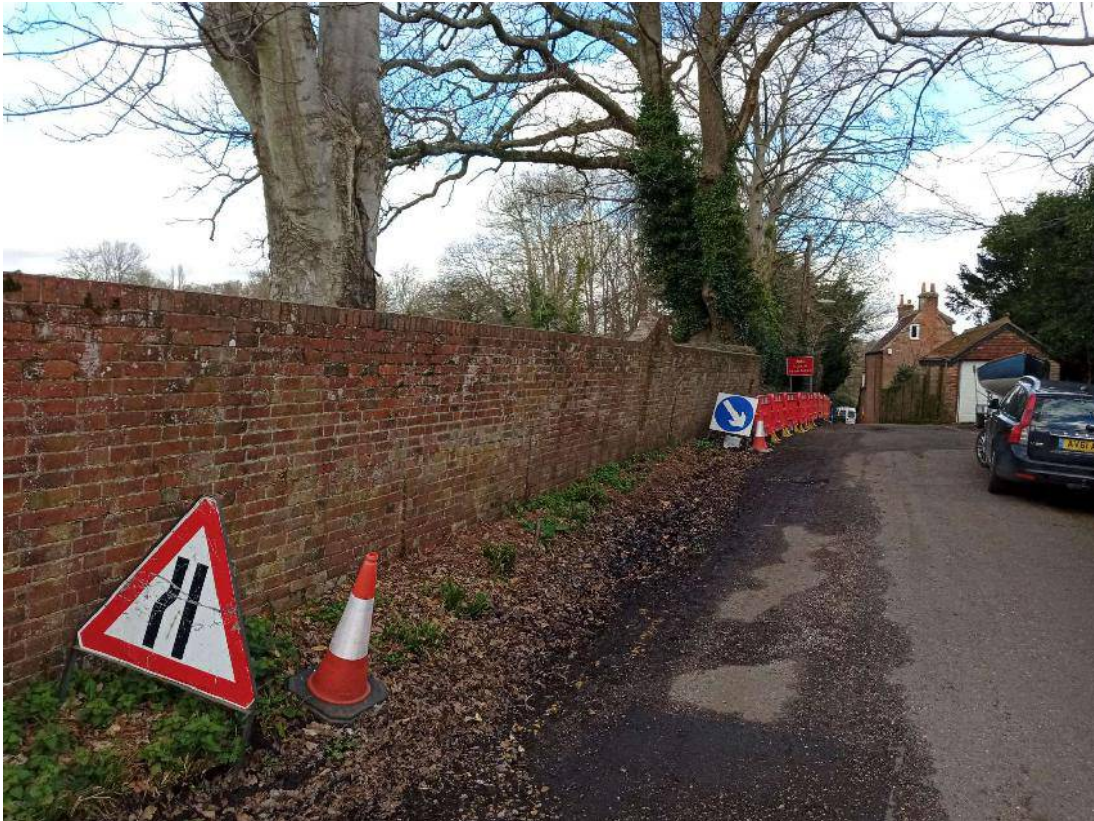
The stretch of the wall closest to the property, Length A, was 1800mm high when measured from the High Street and appeared to be the original construction. At the end closest to the property where the first oak tree occurred, the wall was found to be 110mm out of plumb when measured along a 900mm long spirit level with the top of the wall leaning outwards towards the highway. Please refer to Photographs 2 and 3.

Photograph 2 – General view of wall Length A

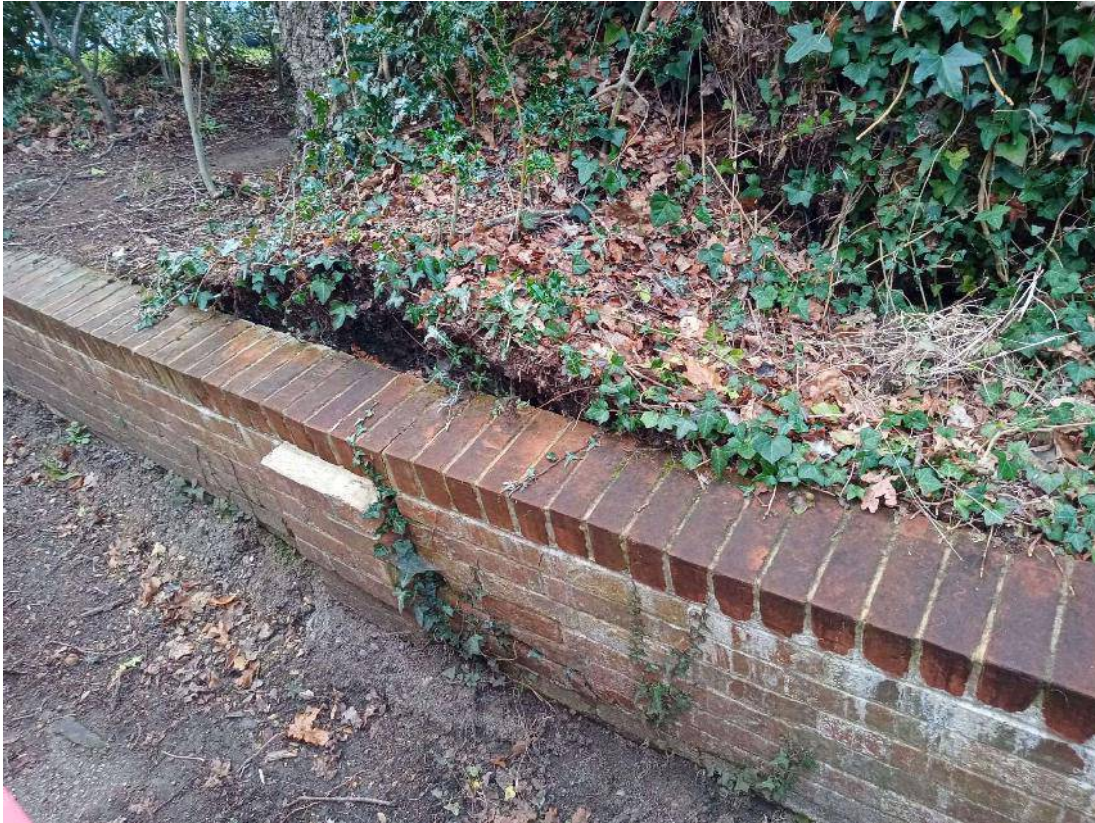
The second stretch of wall, Length B, increased from being 600mm high at the southern end to 1200mm high at the northern end. In the central section of this wall horizontal shear failure was noted with a local displacement in the brickwork of 25mm. At the Northern end of the wall, the wall was again found to be 250mm out of alignment. Please refer to Photographs 5 and 6.

Photograph 5 – Proximity of mature tree behind wall in Length B

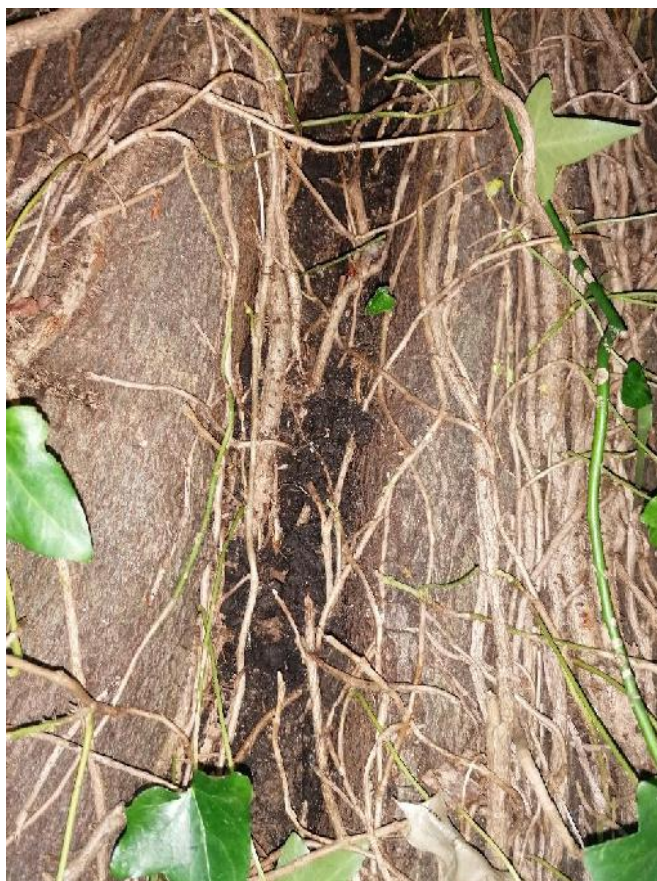
Access to trees T3 and T4 was hindered by the position of existing hedging ivy on the stem of both trees. However, it was clear to me that tree T3 (beech) was in poor condition, with canopy symptoms indicating significant declining vitality (photograph 1, attachment 4). Closer inspection revealed an occluding cavity (with decay) on the lower main stem on its eastern side and this wound appeared to be infected with *Kretzschmaria deusta* (photographs 2 and 3, attachment 4.) The presence of the ivy on the main stem and scaffold branches of tree T4 (sycamore) hindered a proper inspection. However, although the canopy of the tree was a little unbalanced due to its proximity to tree T3, it otherwise appeared to be in good condition, with no obvious canopy symptoms indicating poor tree health.

I set out my views on trees T1 and T2 in my earlier report (ecourban reference '211433 – Let 1') and this is appended at the end of this document as attachment 5. With regard to the trees that I looked at on 15 June 2022, the infection of tree T3 with *Kretzschmaria deusta* is a significant concern, as this is a serious fungal pathogen in respect of tree safety. Given the proximity of the tree to the highway, my view is that the tree should be removed as soon as possible in order to maintain acceptable levels of risk, irrespective of any issues surrounding the rebuilding of the wall. In respect of tree T4, although this tree could be retained in acceptable condition, clearly the issue of the wall and its relationship with the tree needs to be addressed in order to allow the wall to be rebuilt.

**Photograph 2:** Wound with decay main stem tree T<sub>3</sub>

I am in agreement with Mr Sargent's view on the trees, in that It is difficult to see a scenario where the trees can be retained in an acceptable condition and the wall rebuilt. My recommendation is therefore that a new tree work application is submitted to the council for the removal of the trees (T1 to T4) in order for the wall to be demolished and rebuilt. It is likely that the council will require compensatory tree planting in the event that they are minded to grant consent for the tree removals and I have indicated on the attached plan what I believe to be acceptable mitigation planting in this respect.
