# Drainage Investigation Report

**136084.1.UCC**

## Job Information

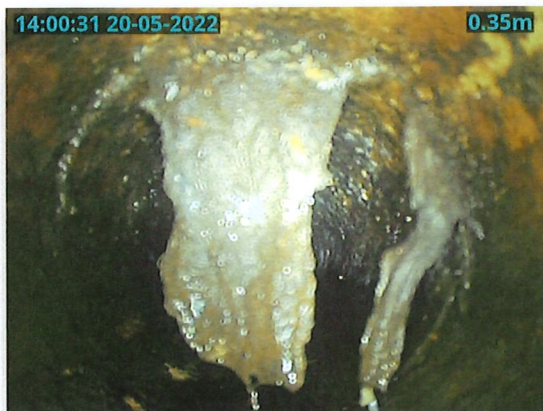
Our survey of line 1 revealed root ingress. The defects identified are affecting the function of the below ground drainage system.

Fig 1.1: This shows the root ingress located within the SVP pipework.

Install 6m of 100mm liner directly upstream of MH1.  
This lining repair should not enter the SVP rest bend.

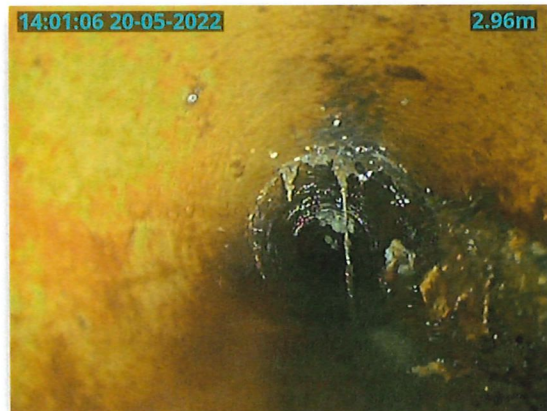
Fig 1.2: This shows the root ingress within the SVP pipework.

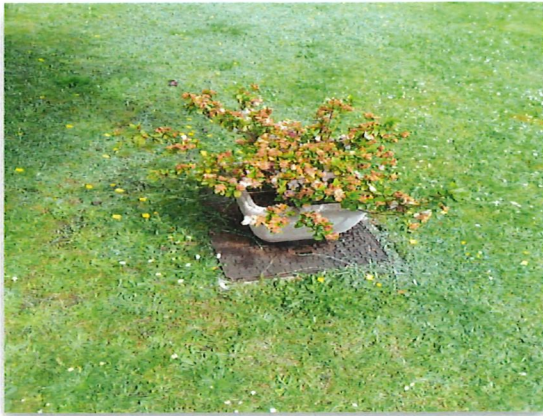
The customer should be made aware that the manhole located to the front of their property is the responsibility of the local water authority as it is part of a shared drainage system. This means that any defects that have been identified with the manhole are the sole responsibility of the local water authority.

Fig 2.1: This shows the manhole located at the front of the customers property.

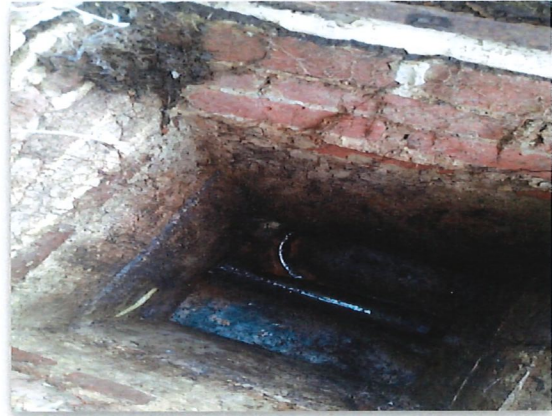
A visual inspection of the site revealed MHI, which was noted to be constructed out of brick, has root ingress.

The LWA defects are noted to be located in the manhole located at the front of the customers property. The customers local water authority is noted to be Southern water.

Fig 2.2: This shows the root ingress located within the manhole at the front of the customers property.

Our investigations revealed potential defects/issues with the LWA sections of pipework which are not the responsibility of the owner/customer. We would recommend that the customer contact the LWA and request that they attend to inspect and repair/resolve the issues highlighted. If the LWA decline to accept responsibility for individual sections of pipework please contact us directly so that we can assist/advise further.
