**VERIFICATION REPORT**

**BLOCKS A & D, HAMBLEWOOD,  
HEATH HOUSE LANE, HEDGE END,  
HAMPSHIRE, SO30 0LE**

**BARGATE HOMES**

| Reference: | GE20045/VR/BLOCKS A & D/AUG22 |

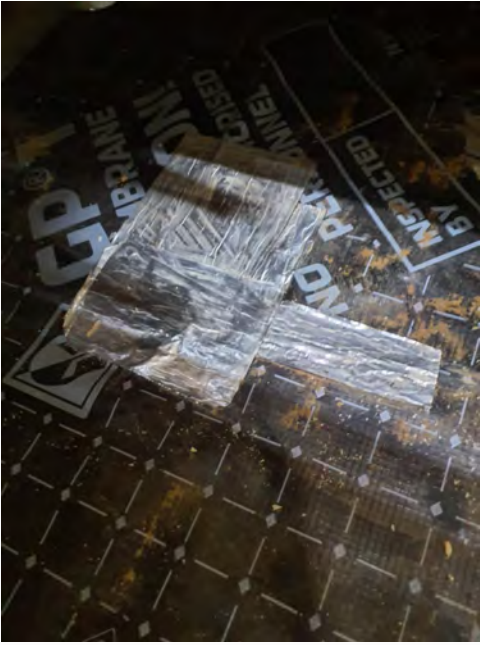
Block B Stairwell repair

Three defects were noted during the validation inspection undertaken on 26<sup>th</sup> July 2022, within the stairwell of both blocks where temporary scaffold handrails were in contact with the floor preventing the membrane from being installed/sealed, and within a separate ground floor room in Block A where the whole floor membrane had not been fully sealed to the perimeter membrane. Advice was given to the site manager to remove the scaffold poles from the floor to allow for the membrane to be installed and to fully seal the whole floor membrane to the perimeter membrane. It was also advised not to reinstall the scaffold handrails until the gas membrane was covered and protected. These areas were re-inspected by Geo-Environmental on 28<sup>th</sup> July 2022, to confirm that the remedial works were completed, and the installed membranes were fully sealed. It was noted that the bottom portion of the scaffold hand rails had been cut off to prevent them from causing any subsequent damage.
