Our Ref:MH/BurlingtonHouseBotleighGrangeOfficeCampus/Cond5/2795

29<sup>th</sup> July 2022

**TREES AT BOTLEIGH GRANGE OFFICE CAMPUS, GRANGE DRIVE, HEDGE END, SO30 2DF**

**Date of Inspection:** 27.07.22.

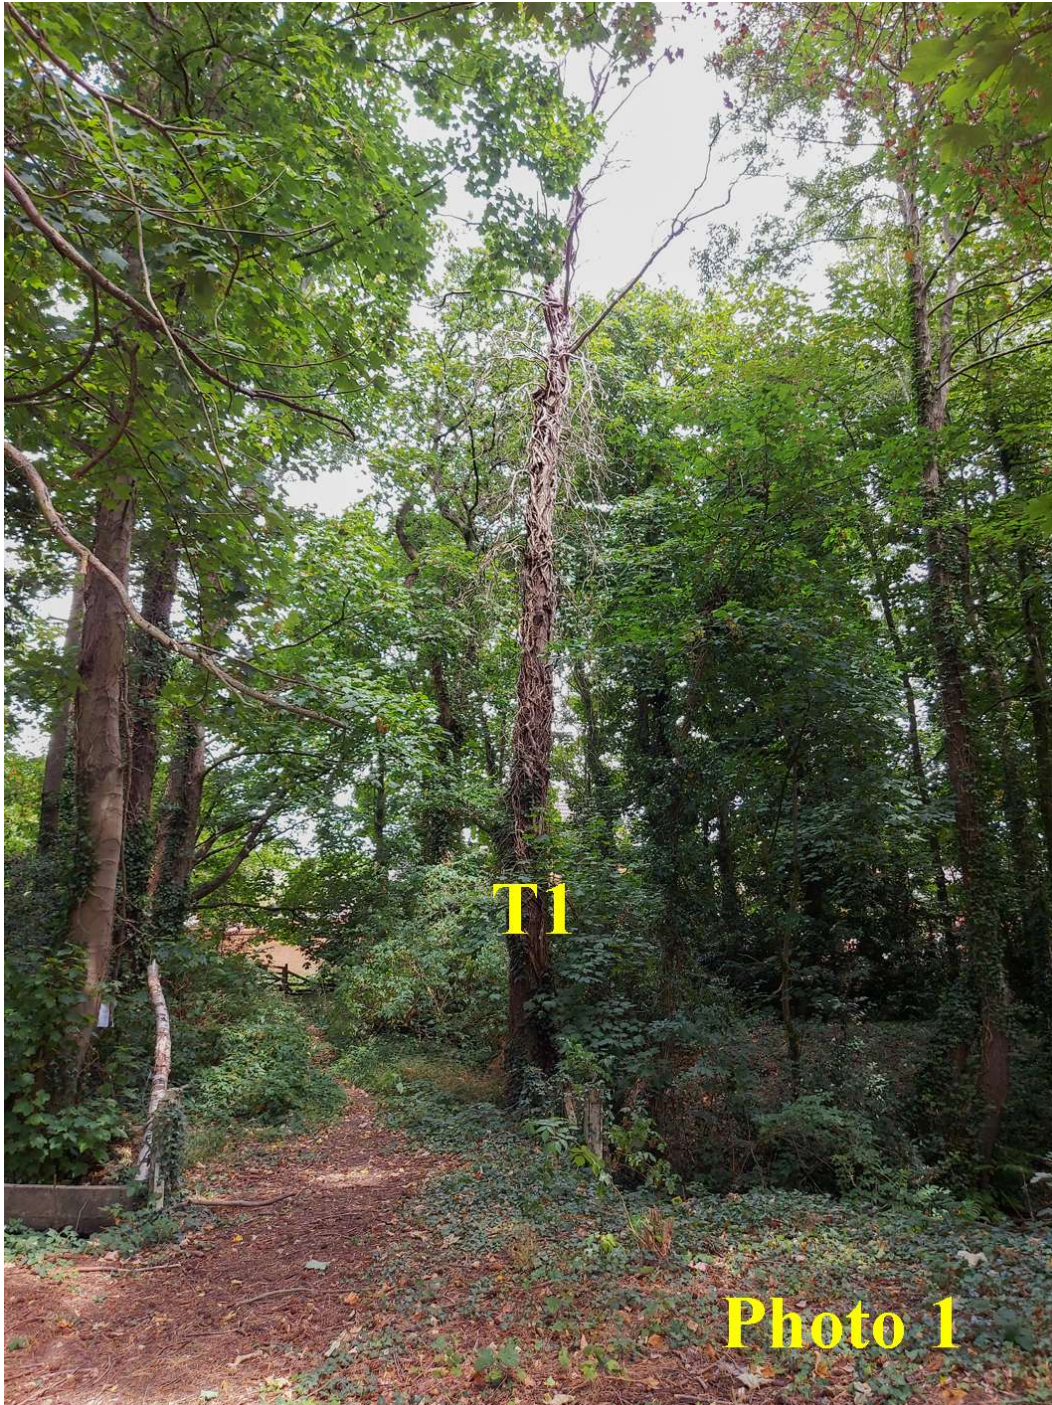
**T1** – Dead Alder adjacent to bridge - fell. Work to be done within 6 weeks

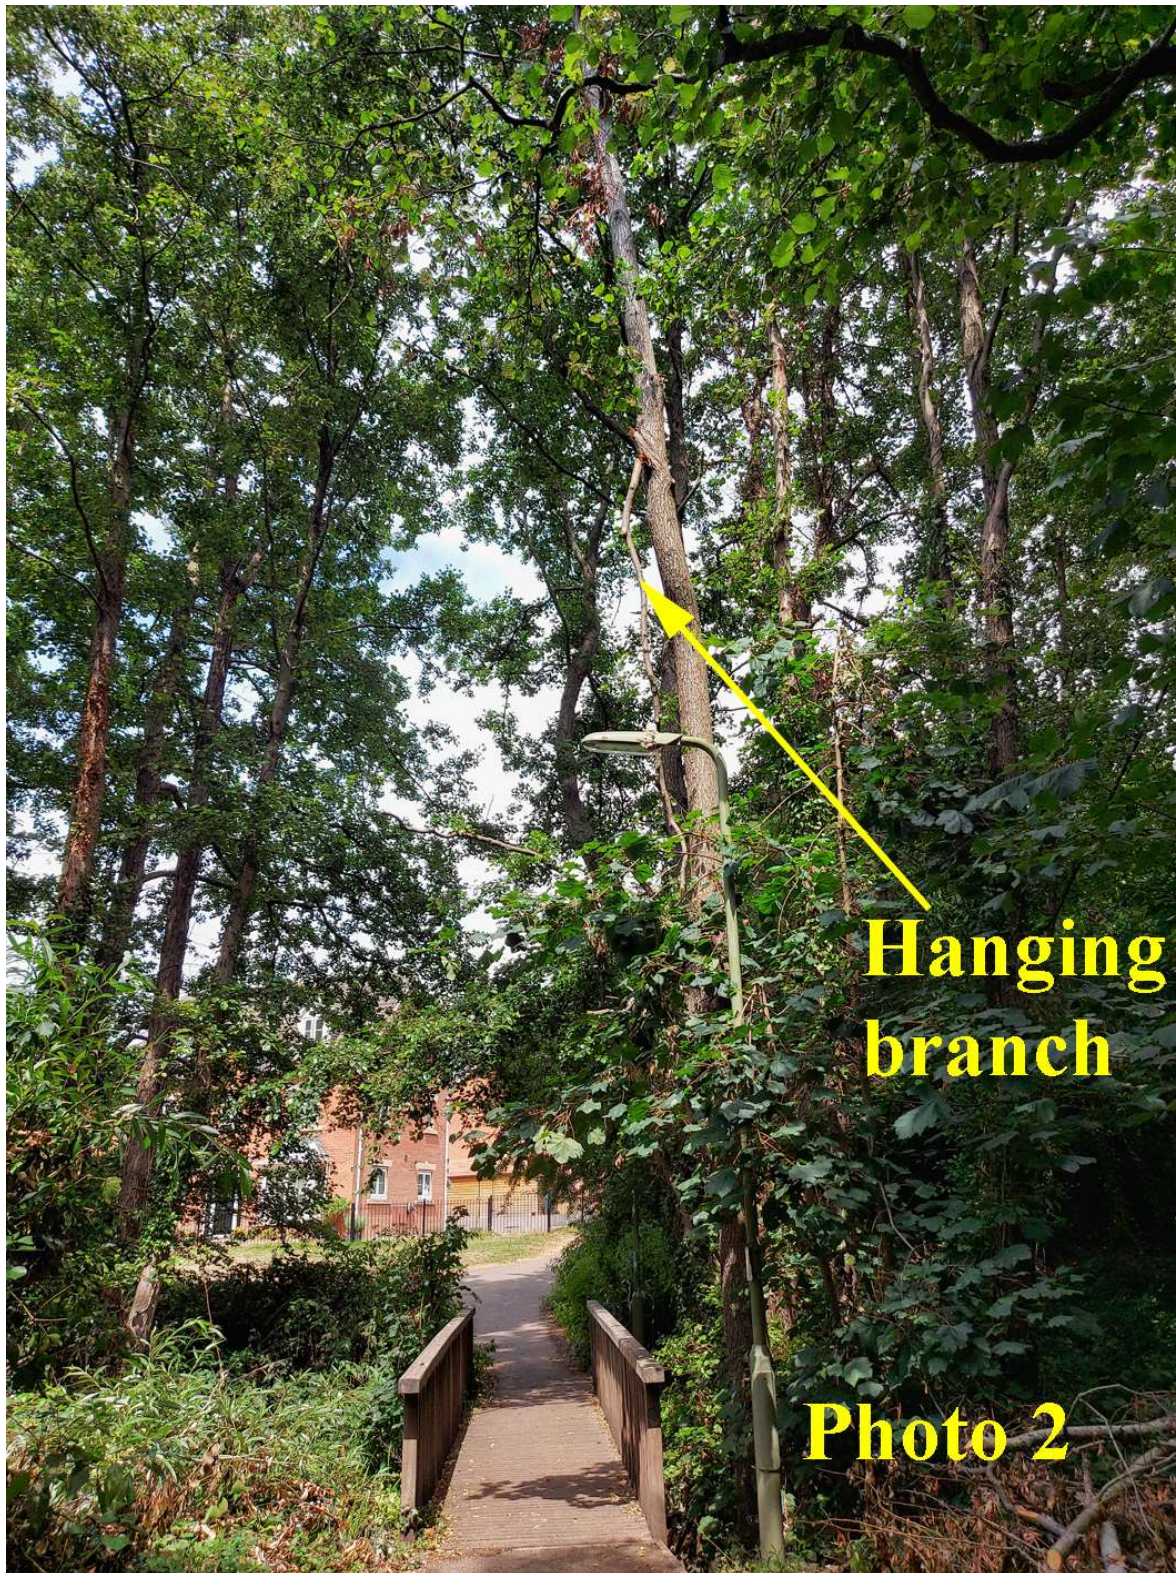
**T2** – Alder, hanging branch over bust footpath bridge. Remove hanging branch. Work to be done within 6 weeks.

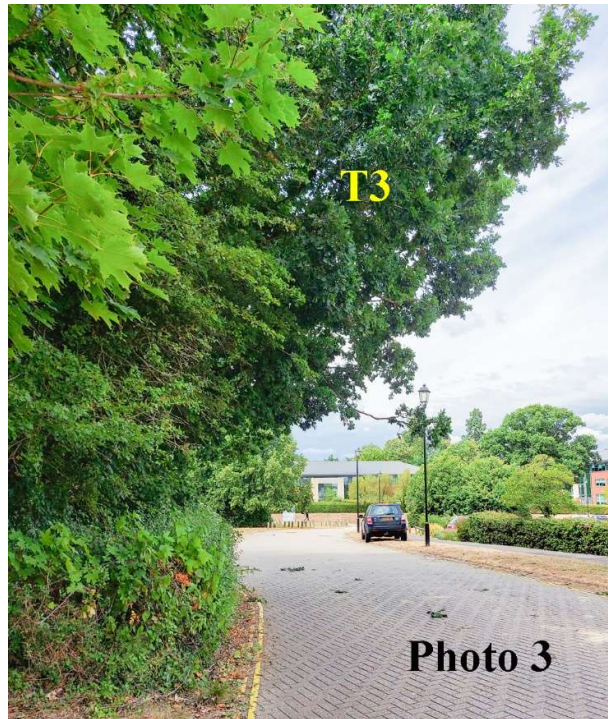
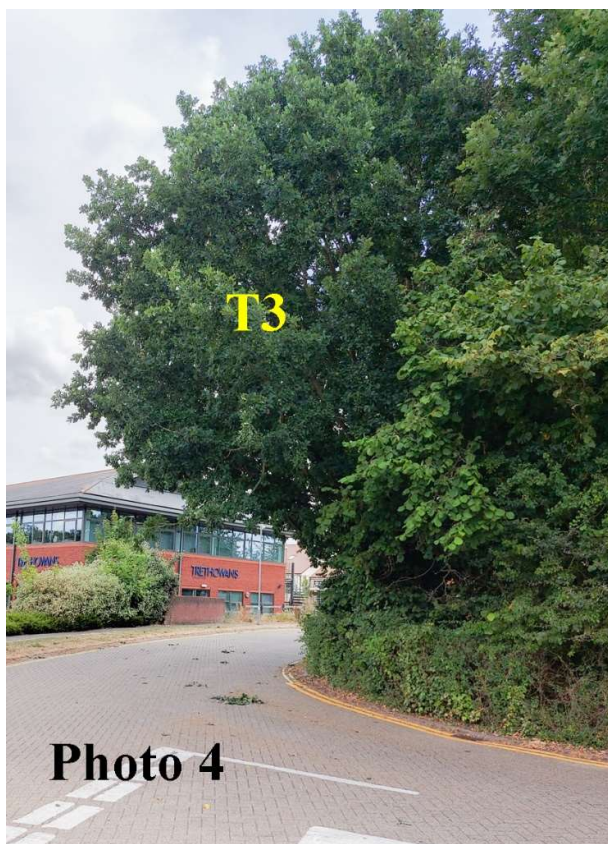
**T3 Oak** – crown lift to 5.2m over road – this canopy has been struck by a vehicle. Work to be done within 6 weeks.

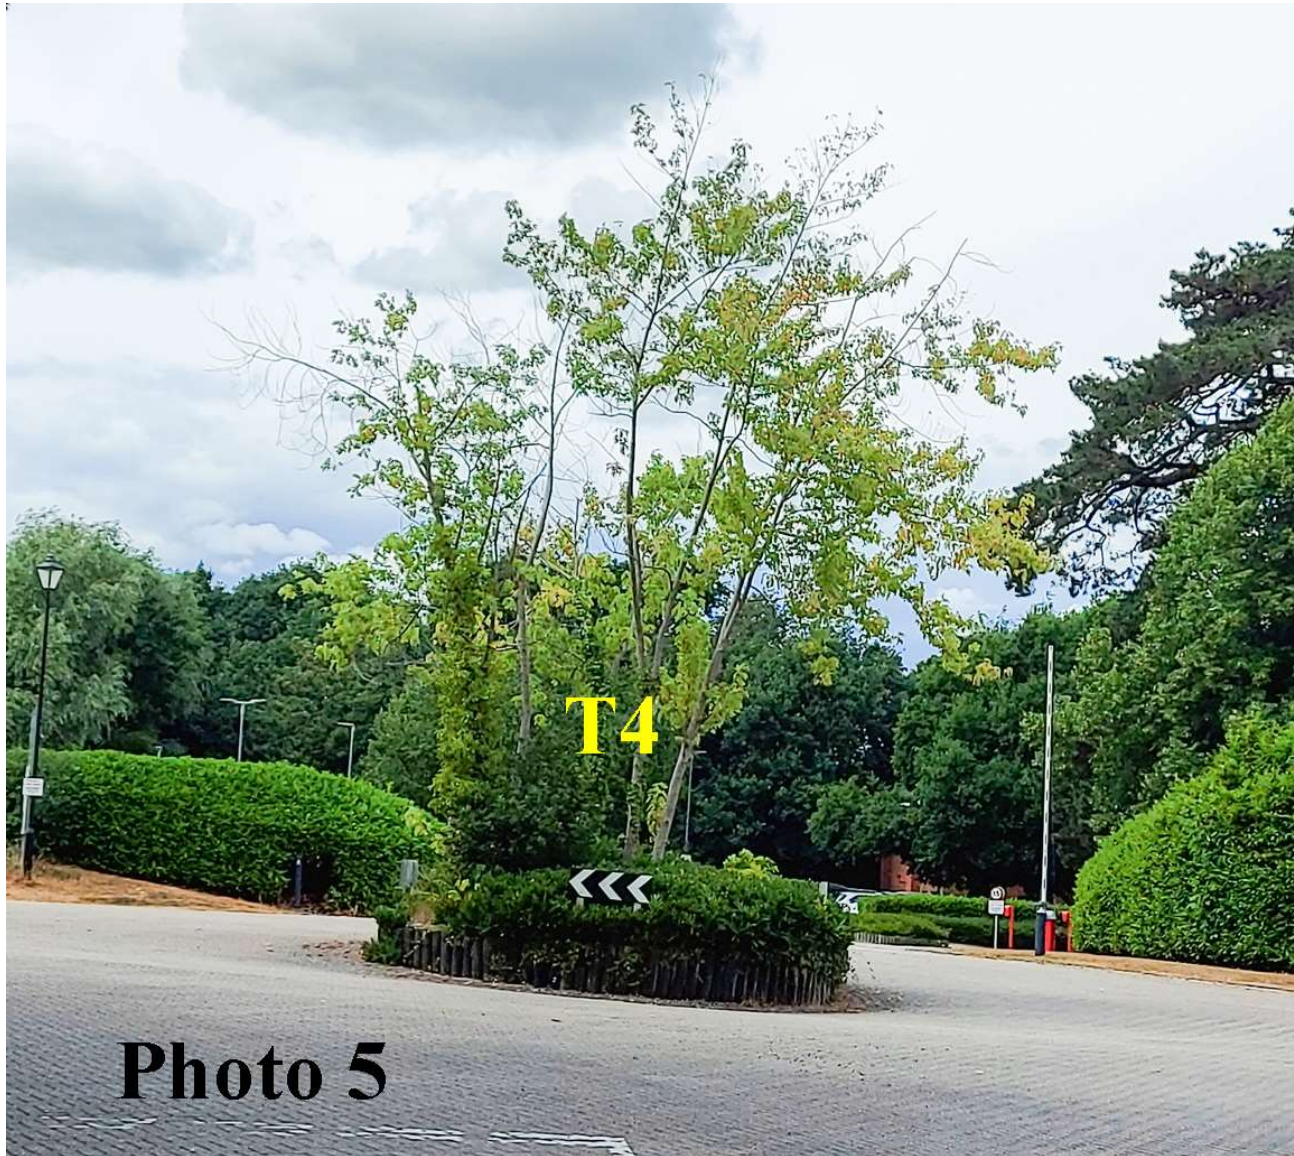
**T4** is a clump of Japanese Maples. These trees have never done well. At the time of inspection, a number of the stems in the clump were showing signs of top and side branch die-back. The minimum recommendation is that the dead wood is removed, however these poor condition trees are in such an important location we suggest that it might be better management to remove them and replace with a more robust feature tree for this visually prominent entrance feature. Work to be done within 6 months.

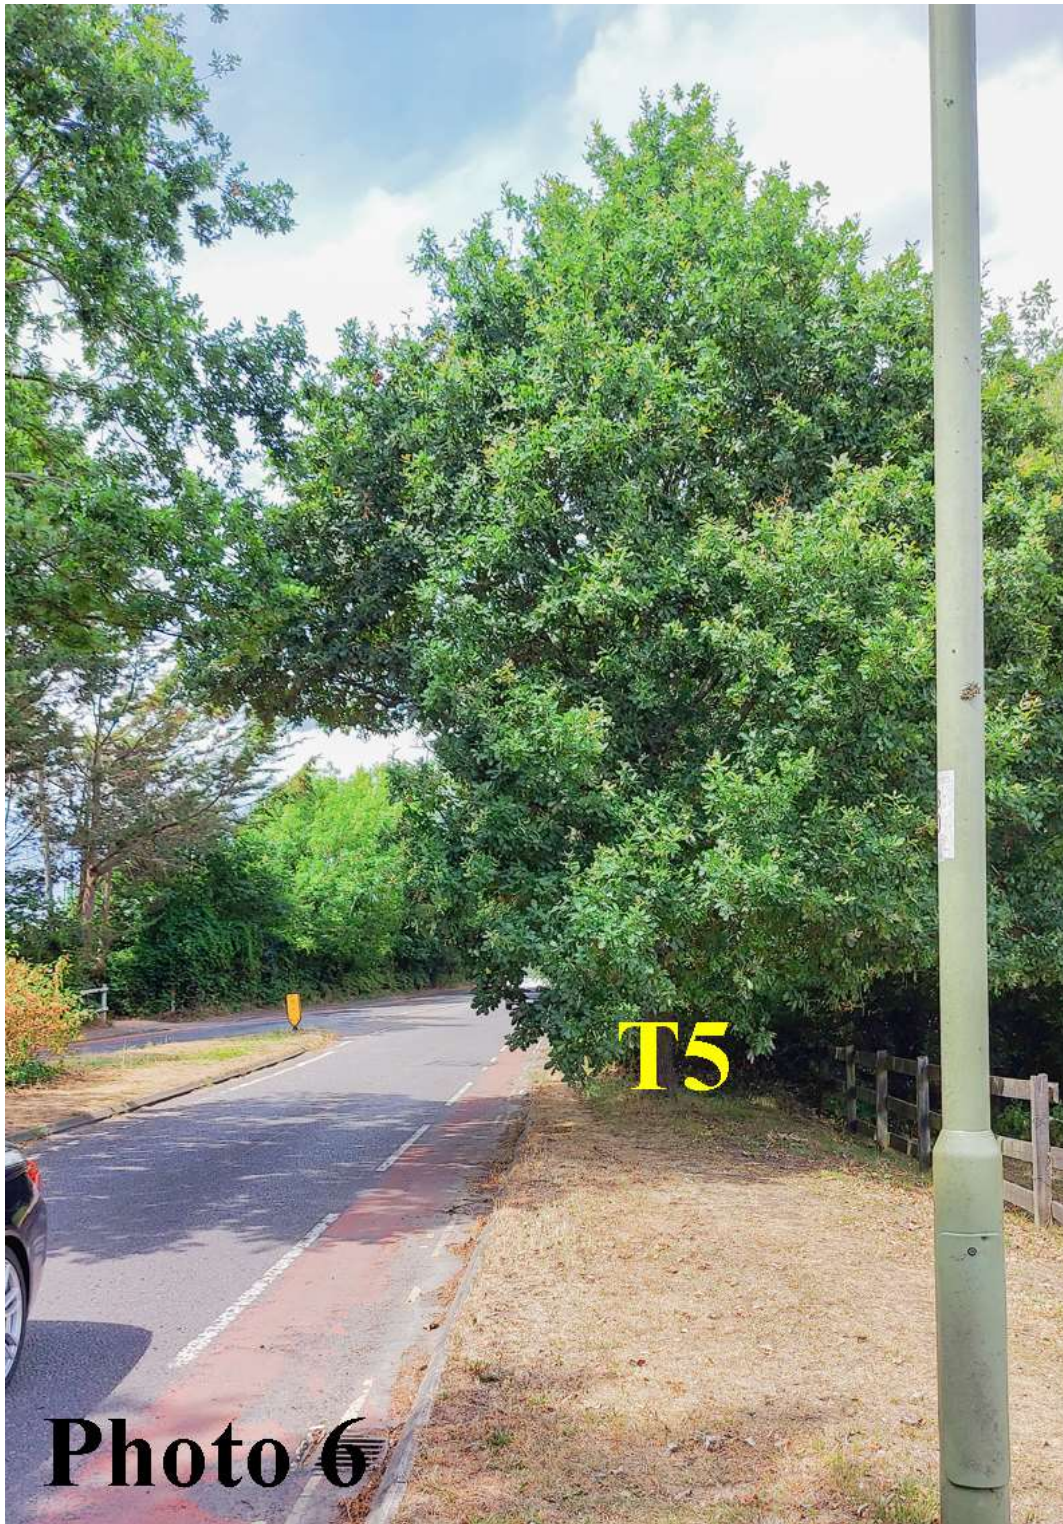
**T5** is an oak the canopy of which is encroaching over the adjacent public highway and cycle way. Crown lift to 5.2m over the carriageway and cut foliage below that height to 1m back from the road edge. Work to be done within 6 weeks. **This is now a serious situation of potential liability.**

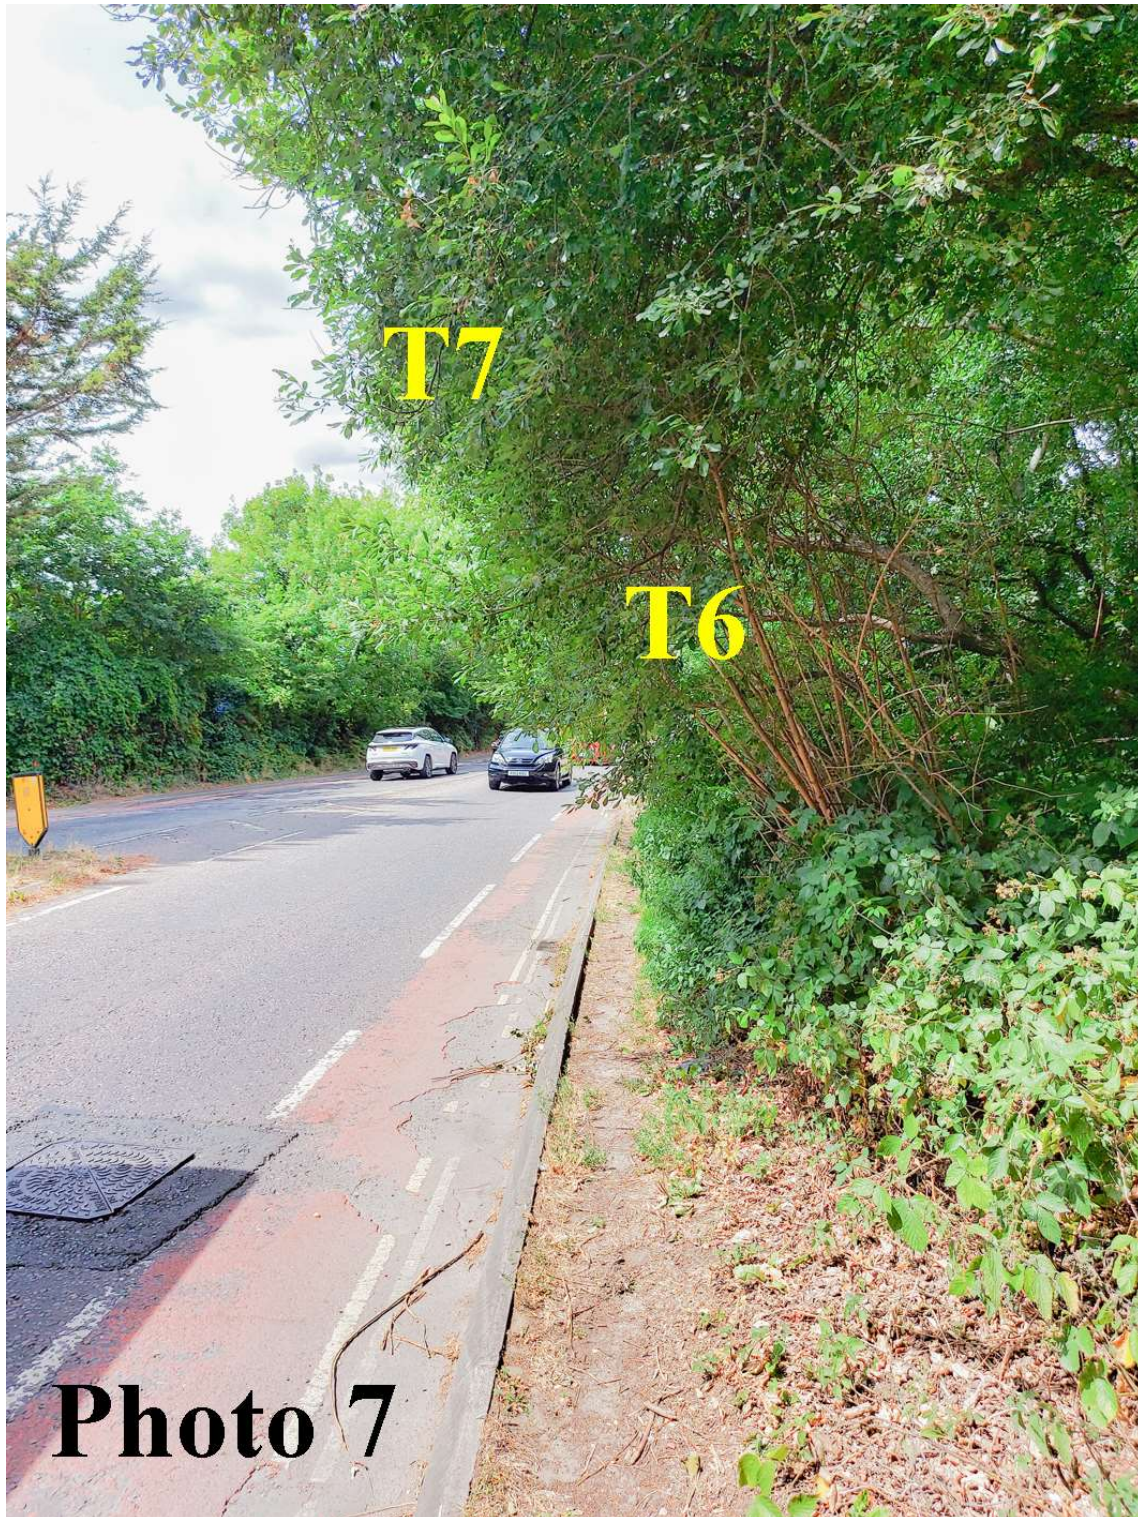
**Photo 7**

**T6 & T7** – are willows the canopies of which are encroaching over the adjacent public highway and cycle way. Crown lift to 5.2m over the carriageway and cut foliage below that height to 1m back from the road edge. Work to be done within 6 weeks. **This is now a serious situation of potential liability.**
