**Project:** 22\_RESI\_08\_24  
**Site:** 1 Portchester Rise, Allbrook, Eastleigh, SO50 4QS  
**Client:** Carl Rivers

| Document Title: | Tree Safety Survey - 3 year time cycle. |
| Project Title: | 1 Portchester Rise, Allbrook, Eastleigh, SO50 4QS |

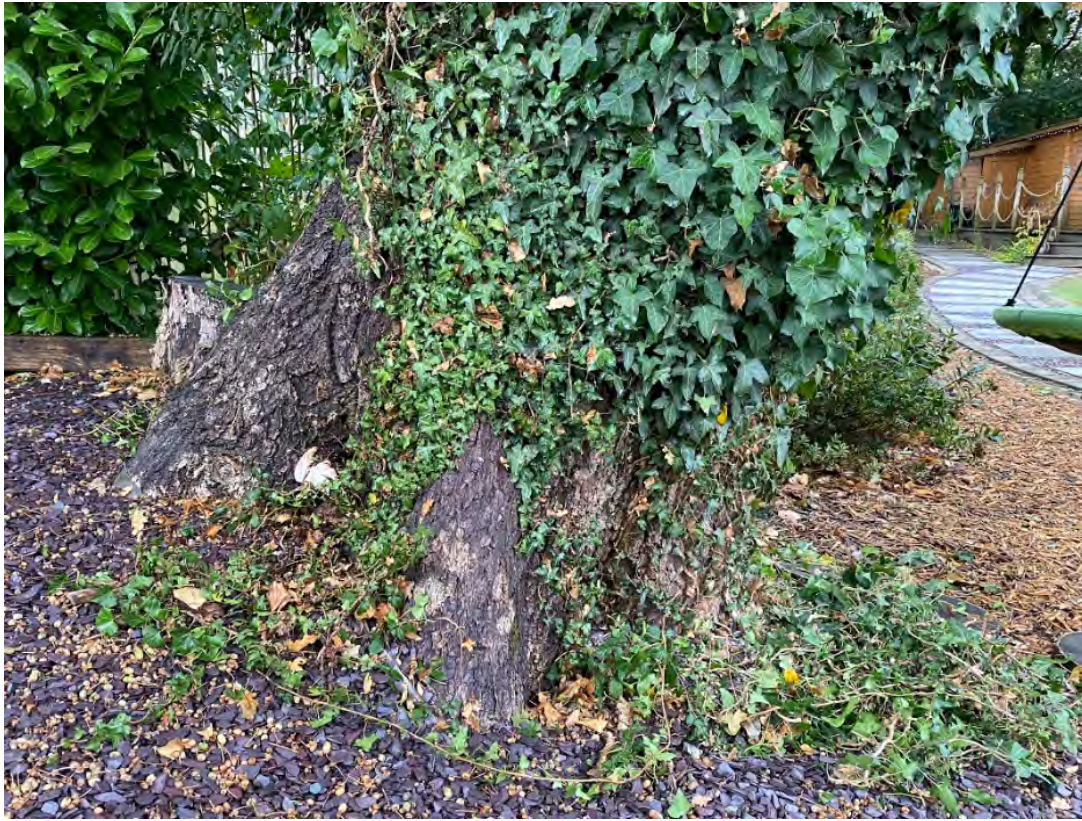
*Photographic plate showing the base of T1 prior to removal of ivy cladding*

- 3.5 T1 is a mature Oak, which was identified as showing signs of decay and fungal fruiting bodies during an added ecology survey by ROAVR. The tree was heavily ivy clad, this was partially removed to reveal a large historic pruning wound to the east at a height of 1.7 metres. The wound is not occluded, and is extensively decayed. Sounding with a mallet suggested column of decay extends from the base of the tree to the wound.

- 4.1 Recommendations for safety works are included within the data tables, with additional recommendations in the paragraphs below.
- 4.2 T1 should be removed as soon as possible, and in any case within 3 months of the date of survey.
- 4.3 T2 should be crown reduced by 2 metres in spread to the west, and the height also reduced by 2 metres.

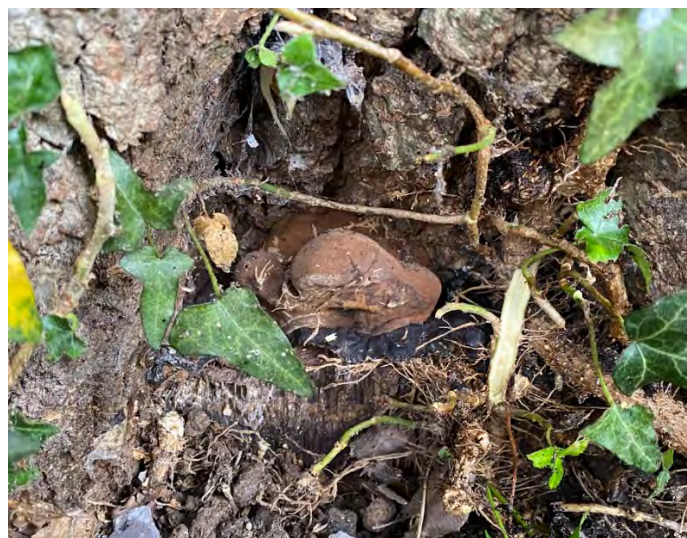
*Photographic plate showing an immature *Ganoderma* fruiting body to the east of T1's stem at ground level, and the remains of a blackened mature fruiting body underneath..*

The fungal fruiting bodies were identified as *Ganoderma applanatum*, and were concentrated around the base of the stem, to the south-west, south-east, and north. The tree was tested using a Resi F400 microdrill, which found extensive decay at the base of the stem, and confirmed the column of decay extending up the stem. The residual wall thickness of wood was between 9 and 11 cm, although much of this remaining wood appears to be degraded. Only the drill taken through the buttress root to the west showed any spike of reaction wood.

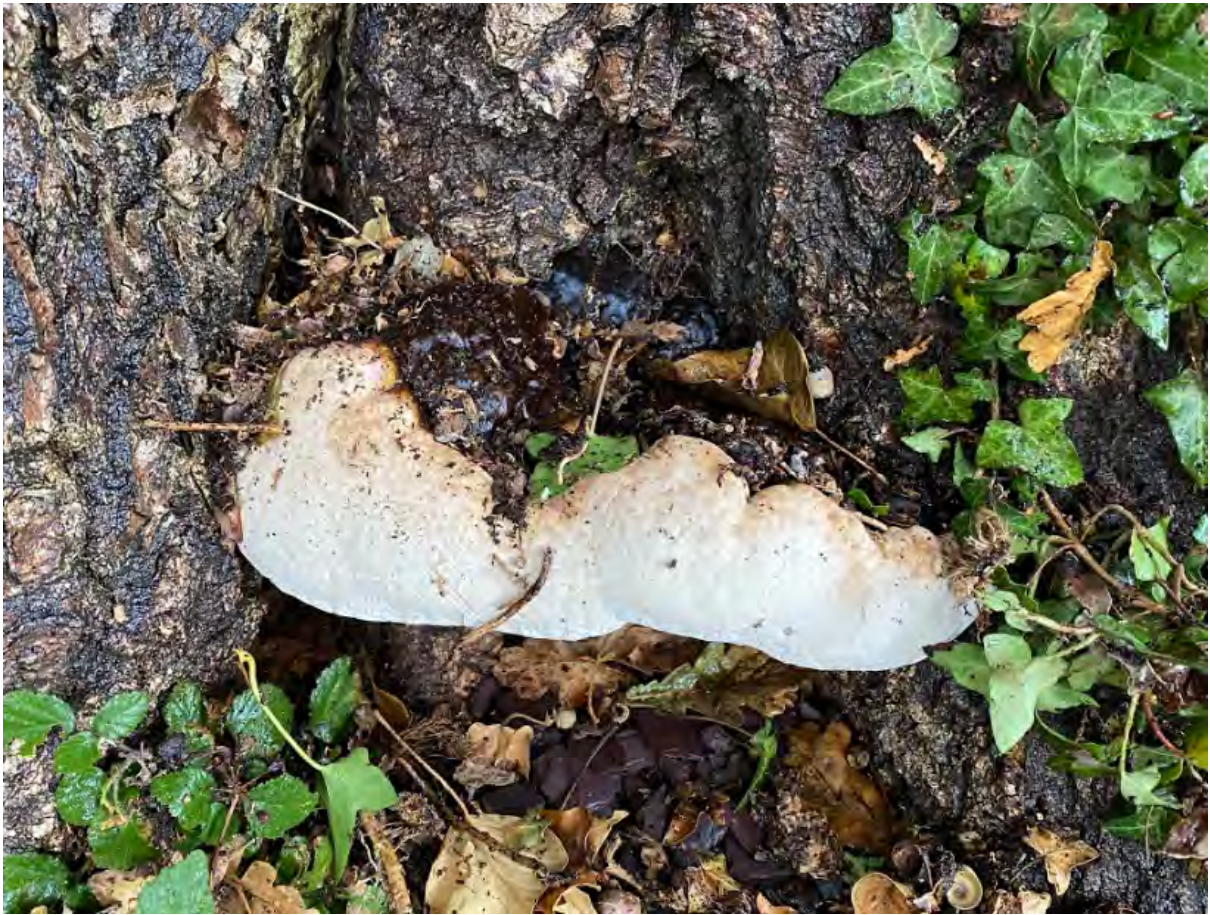
*Photographic plate showing a mature *Ganoderma* fruiting body to the southwest of T1's stem at ground level.*

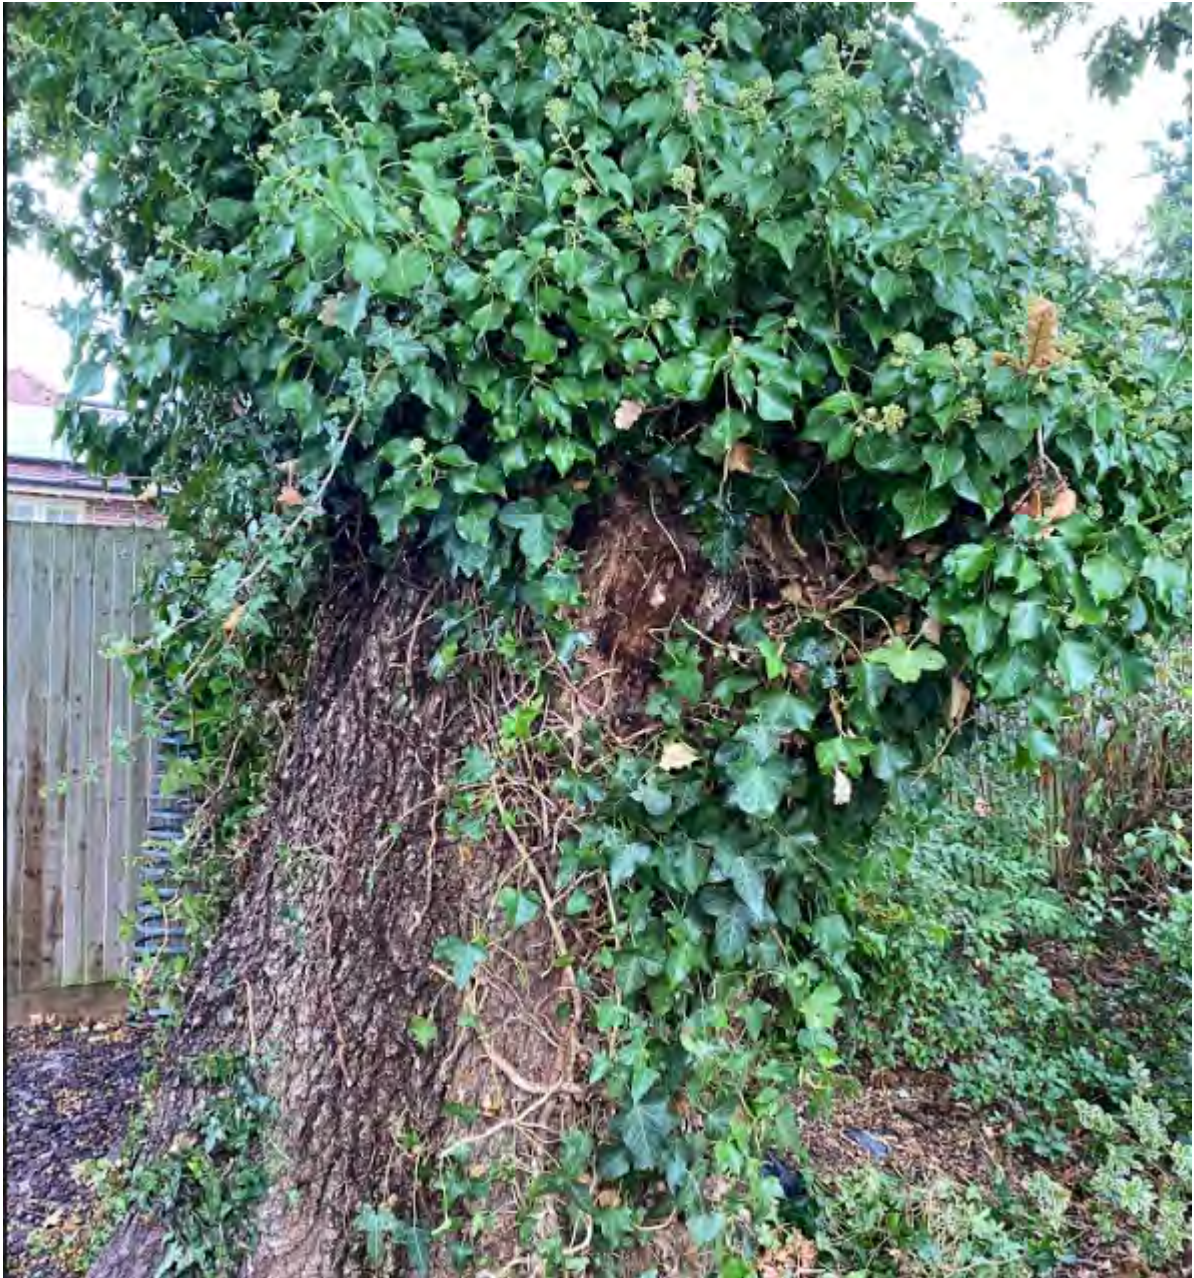
*Photographic plate showing the stem of T1 with the ivy cladding partially removed to reveal a large historic pruning wound to the east.*

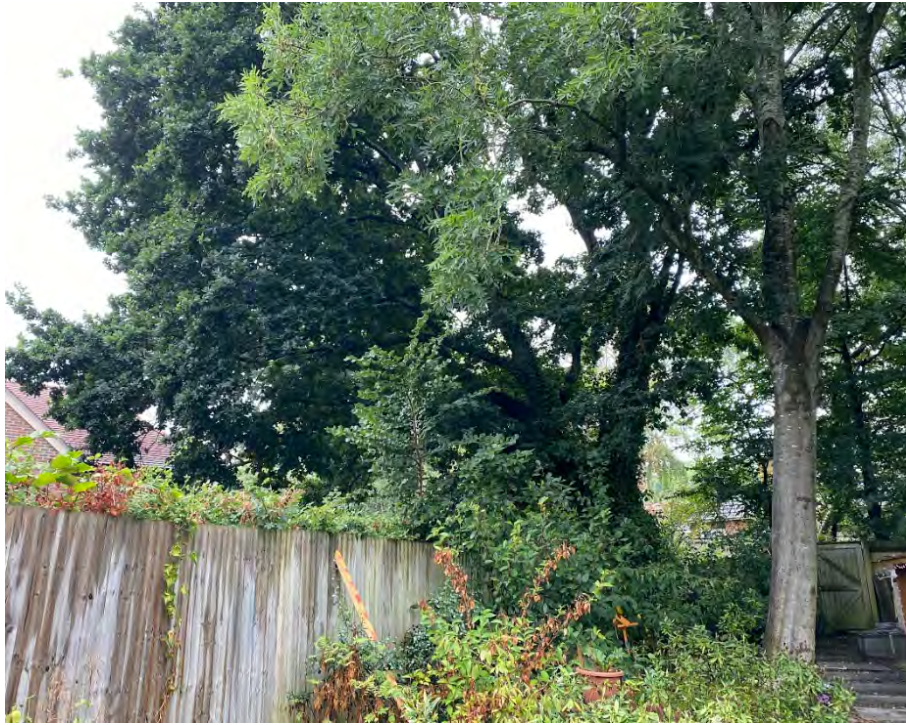
*Photographic plate showing T2, the heavy stem lean to the west, and the overall weighting of the canopy to the west.*

- 3.6 T2 is a mature Oak located towards the rear of the plot, and leans heavily over the boundary to the west. The tree appears to have grown in this form, the lean has not increased significantly in recent times. There are however small cracks in the soil around the buttress roots to the east, and some evidence of mechanical damage and decay to these roots. For this reason it is recommended that the crown spread of the tree to the west be reduced by 2 metres, and the height also reduced by 2 metres.

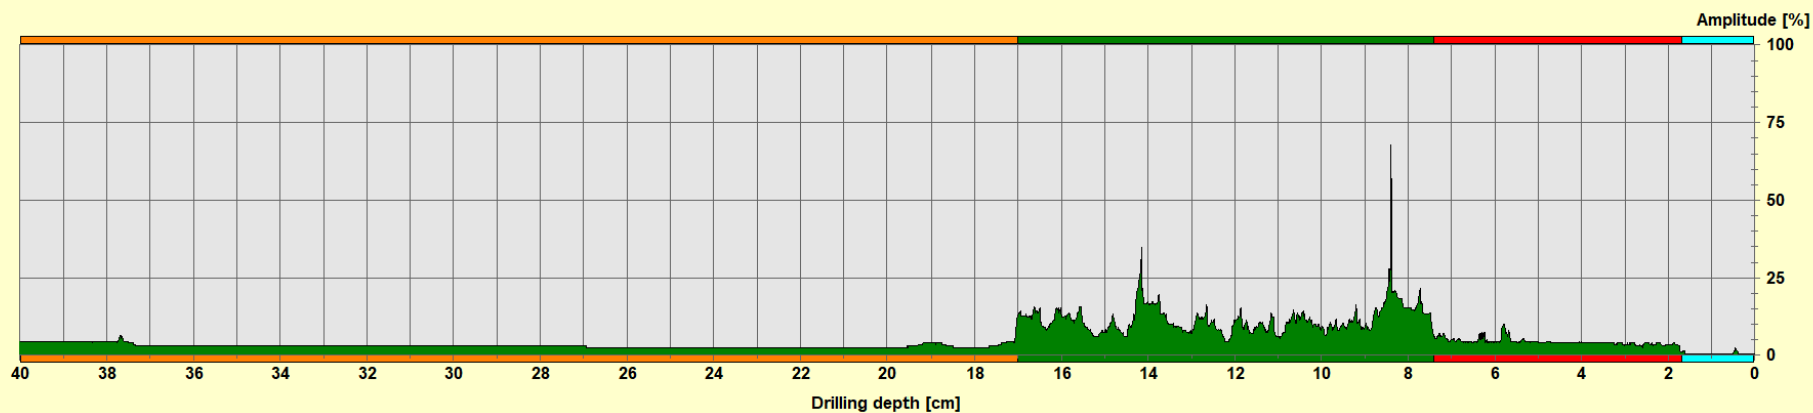
| Measurement no. : | 4 | Tilt : | 54° (1°) | Name : | |

| From 0,0 cm to 1,7 cm : | Pre-engagement |
| From 1,7 cm to 7,4 cm : | Decay |
| From 7,4 cm to 17,0 cm : | Sound Wood |
| From 17,0 cm to 40,0 cm : | Cavity |
