Our Ref.: 18831/LR/Validation Plots 1-50 and 81-93

**Re: Additional Gas Membrane Validation Plots 1-50 and 81-93, Abbey Fruit Farm, Netley, SO31 5FF**

# Gas Membrane Validation Certificate

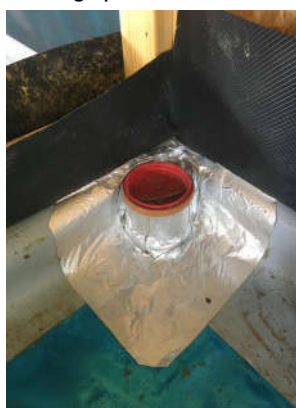
Photograph 4

The floor is to be raised with suitable insulation materials and underfloor heating to the level of the membrane edge and therefore minimize the potential for further damage. No damage or puncture was noted in or on the visible membrane and all corners and joints appeared appropriately and suitably emplaced in line with the appropriate guidance (Photograph 4).

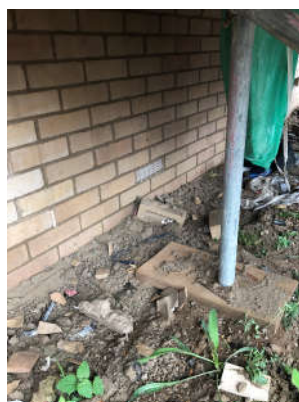
Photograph 1

A suitable membrane has been installed and taped as per recommended guidance and standards and rises from the floor to a level in the outer course of the building above the ventilation course (Photograph 1) and onto any access points at the same level.

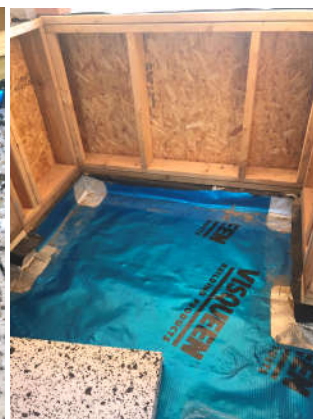
Photograph 4

The ground floor is to be raised with suitable insulation materials to the level of the membrane edge and therefore minimize the potential for further damage. No damage or puncture was noted in or on the visible membrane and all corners and joints appeared appropriately and suitably emplaced in line with the appropriate guidance (Photograph 4).

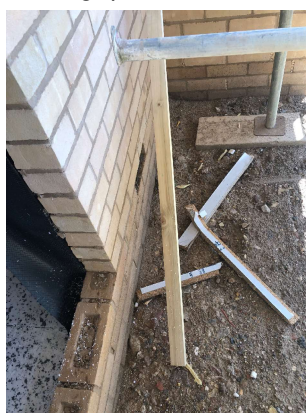
Photograph 1

A suitable membrane has been installed and taped as per recommended guidance and standards and rises from the floor to a level in the outer course of the building above the ventilation course (Photograph 1) and onto any access points at the same level.

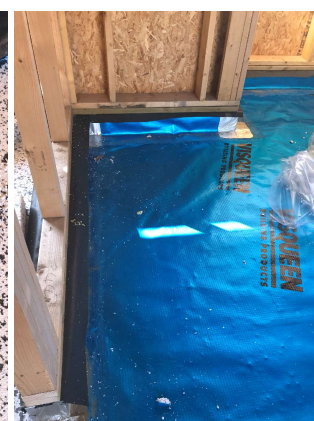
Photograph 4

The ground floor is to be raised with suitable insulation materials to the level of the membrane edge and therefore minimize the potential for further damage. No damage or puncture was noted in or on the visible membrane and all corners and joints appeared appropriately and suitably emplaced in line with the appropriate guidance (Photograph 4).

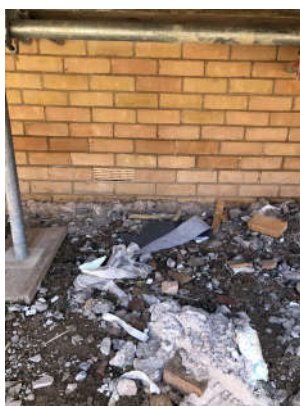
Photograph 1

A suitable membrane has been installed and taped as per recommended guidance and standards and rises from the floor to a level in the outer course of the building above the ventilation course (Photograph 1) and onto any access points at the same level.

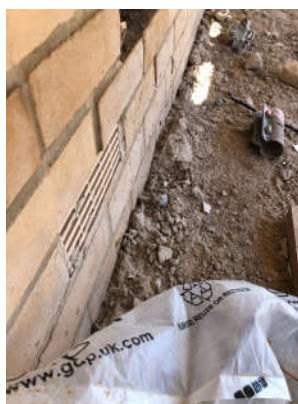
Photograph 1

A suitable membrane has been installed and taped as per recommended guidance and standards and rises from the floor to a level in the outer course of the building above the ventilation course (Photograph 1) and onto any access points at the same level.

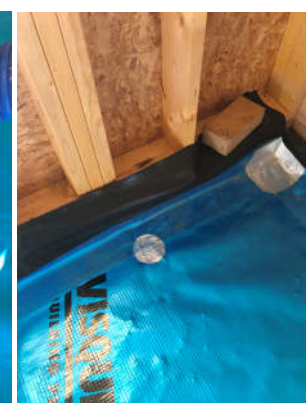
Photograph 4

The ground floor is to be raised with suitable insulation materials to the level of the membrane edge and therefore minimize the potential for further damage. No damage or puncture was noted in or on the visible membrane and all corners and joints appeared appropriately and suitably emplaced in line with the appropriate guidance and appropriately patched if required during installation (Photograph 4).

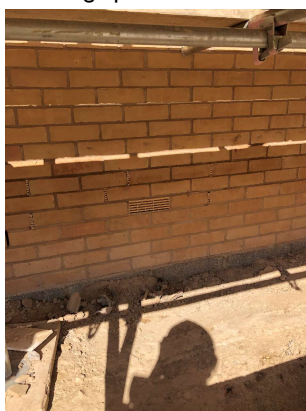
Photograph 1

A suitable membrane has been installed and taped as per recommended guidance and standards and rises from the floor to a level in the outer course of the building above the ventilation course (Photograph 1) and onto any access points at the same level.

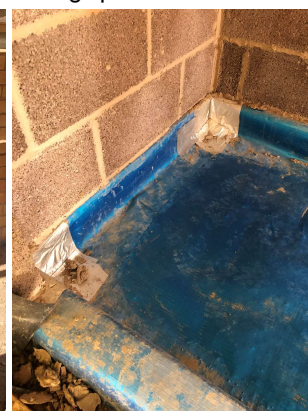
Photograph 2

This has been covered as appropriate and taped in place as required by the manufacturer's guidance and the agreed method statements using hot weld methods to secure the tape and join membranes (Photograph 2). Where required, membrane imperfections or damage have been appropriately covered in a manner consistent with current guidance and appears to be secure and fit for purpose. (Photograph 3).

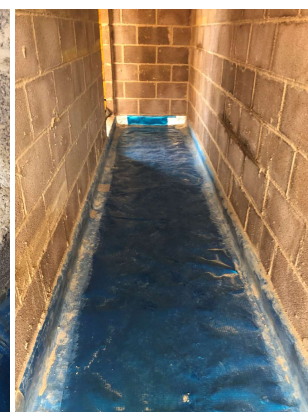
Photograph 4

The floor is to be raised with suitable insulation materials to the level of the membrane edge and therefore minimize the potential for further damage. No damage or puncture was noted in or on the visible membrane and all corners and joints appeared appropriately and suitably emplaced in line with the appropriate guidance (Photograph 4).

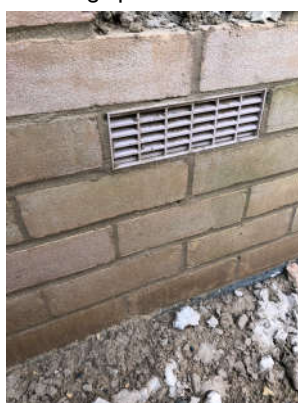
Photograph 1

A suitable membrane has been installed and taped as per recommended guidance and standards and rises from the floor to a level in the outer course of the building above the ventilation course (Photograph 1) and onto any access points at the same level.

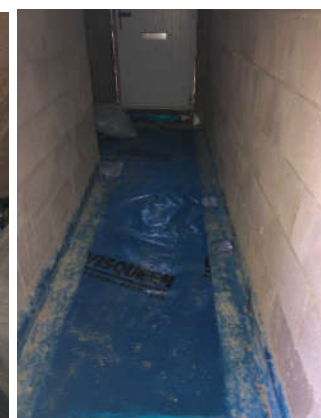
Photograph 4

The floor is to be raised with suitable insulation materials to the level of the membrane edge and therefore minimize the potential for further damage. No damage or puncture was noted in or on the visible membrane and all corners and joints appeared appropriately and suitably emplaced in line with the appropriate guidance (Photograph 4).

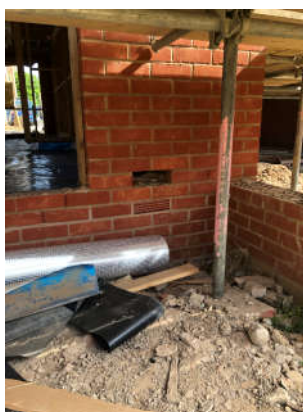
Photograph 1

A suitable membrane has been installed and taped as per recommended guidance and standards and rises from the floor to a level in the outer course of the building above the ventilation course (Photograph 1) and onto any access points at the same level.

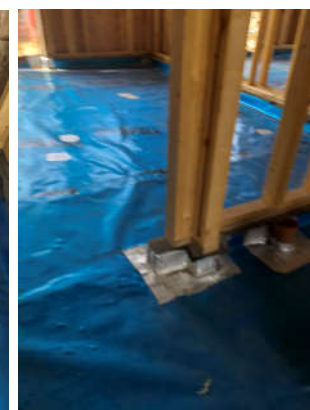
Photograph 4

The ground floor is to be raised with suitable insulation materials to the level of the membrane edge and therefore minimize the potential for further damage. No damage or puncture was noted in or on the visible membrane and all corners and joints appeared appropriately and suitably emplaced in line with the appropriate guidance (Photograph 4).

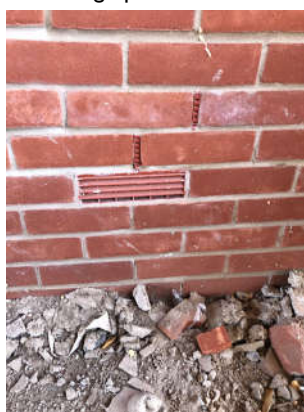
Photograph 1

A suitable membrane has been installed and taped as per recommended guidance and standards and rises from the floor to a level in the outer course of the building above the ventilation course (Photograph 1) and onto any access points at the same level.

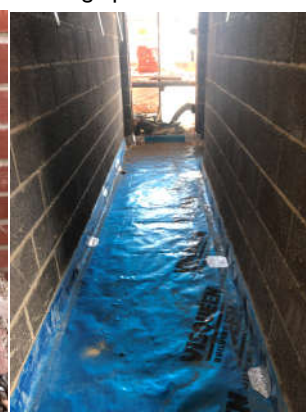
Photograph 2

This has been covered as appropriate and taped in place as required by the manufacturer's guidance and the agreed method statements using hot weld methods to secure the tape and join membranes (Photograph 2). Where required, membrane imperfections or damage have been appropriately covered in a manner consistent with current guidance and appears to be secure and fit for purpose. (Photograph 3).

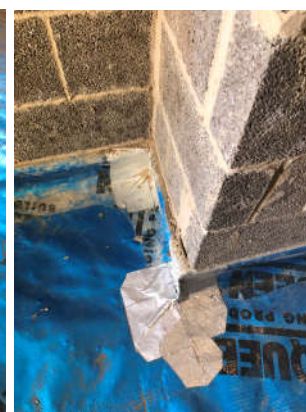
Photograph 4

The floor is to be raised with suitable insulation materials to the level of the membrane edge and therefore minimize the potential for further damage. No damage or puncture was noted in or on the visible membrane and all corners and joints appeared appropriately and suitably emplaced in line with the appropriate guidance (Photograph 4).

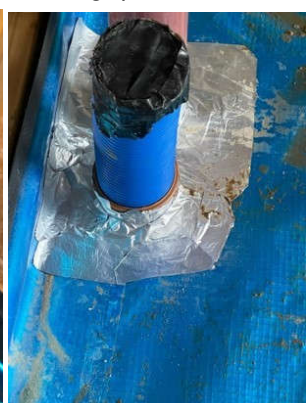
Photograph 4

This has been rectified as of 20<sup>th</sup> December 2021 as evidenced in Photograph 4. The works now appear compliant with provision of precautionary Amber 1 or CS2 levels of gas risk protection and are validated as being suitable and appropriate as such by this inspection, the works to date and the materials used.
