# Tree Risk Assessment Report

**Tree Risk Assessment Report  
Rosewood Cottage, Old Bursledon**

Report reference number: TRA-KC/ROSEWOOD/001

Report date: October 2022

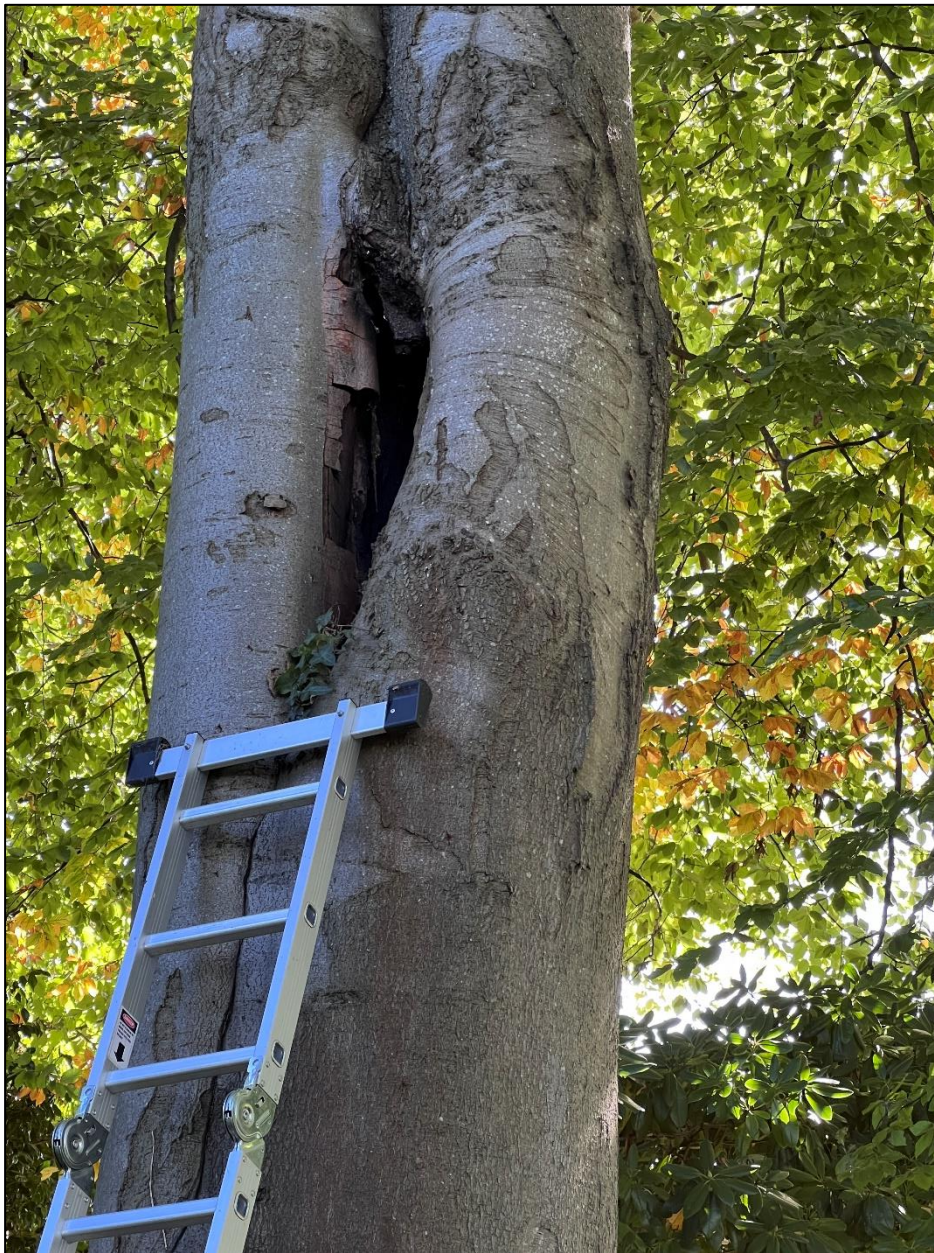
| Tree No | Condition Comments |
|---|---|
| | Cavity on N side from 4m to 5.5m, circa 200mm wide. Good wound wood <sup>6</sup> response to either side of opening. Reaction wood <sup>7</sup> growth around outside of stem in region of cavity. Sounding with mallet indicates sound wound wood. Probing indicates limited extent of hollowing with reasonable residual wall <sup>8</sup> at current time. |

**Photograph one** - view of cavity showing good wound wood on either side of opening and response growth to outer side around stem.

Crown reduce by 3m on S side.  
Max 75mm prune wound diameter.

Reason. To reduce crown extension and weight to dwelling.

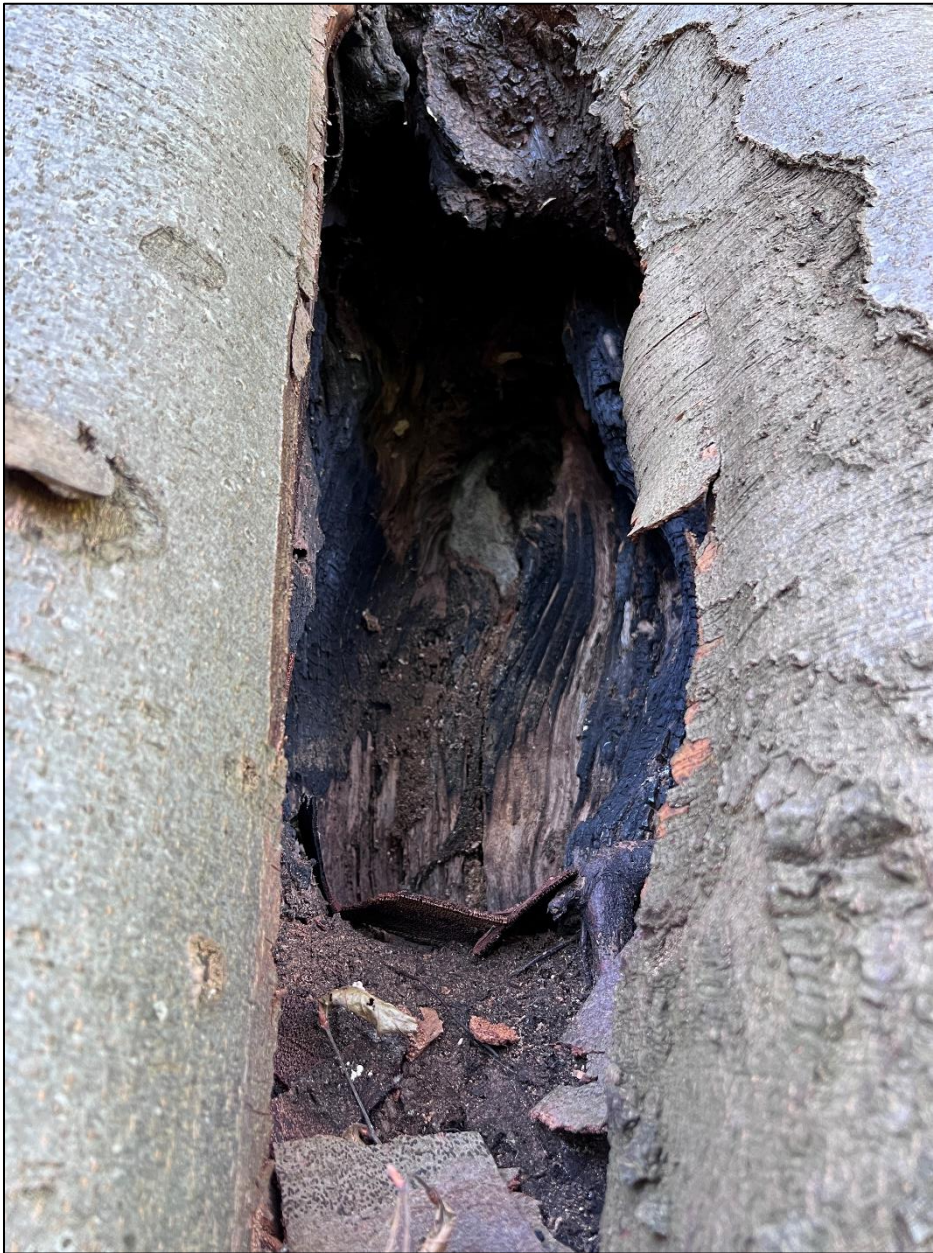
**Photograph two** - showing close up of internal heartwood decay.

- 49 The **review period** for these trees is two year. I consider this prudent in light of, *inter alia*, the target evaluation, size, age and condition of the trees.
- 50 A regular inspection of the tree will inform the timing and effectiveness of future retrenchment pruning and allow monitoring of the condition of the stem cavity.
