## **Arboricultural report**

Pamela Hill

53 Winchester Road, Chandlers Ford, Eastleigh, Hampshire,  
SO53 2GF

9th November 2022

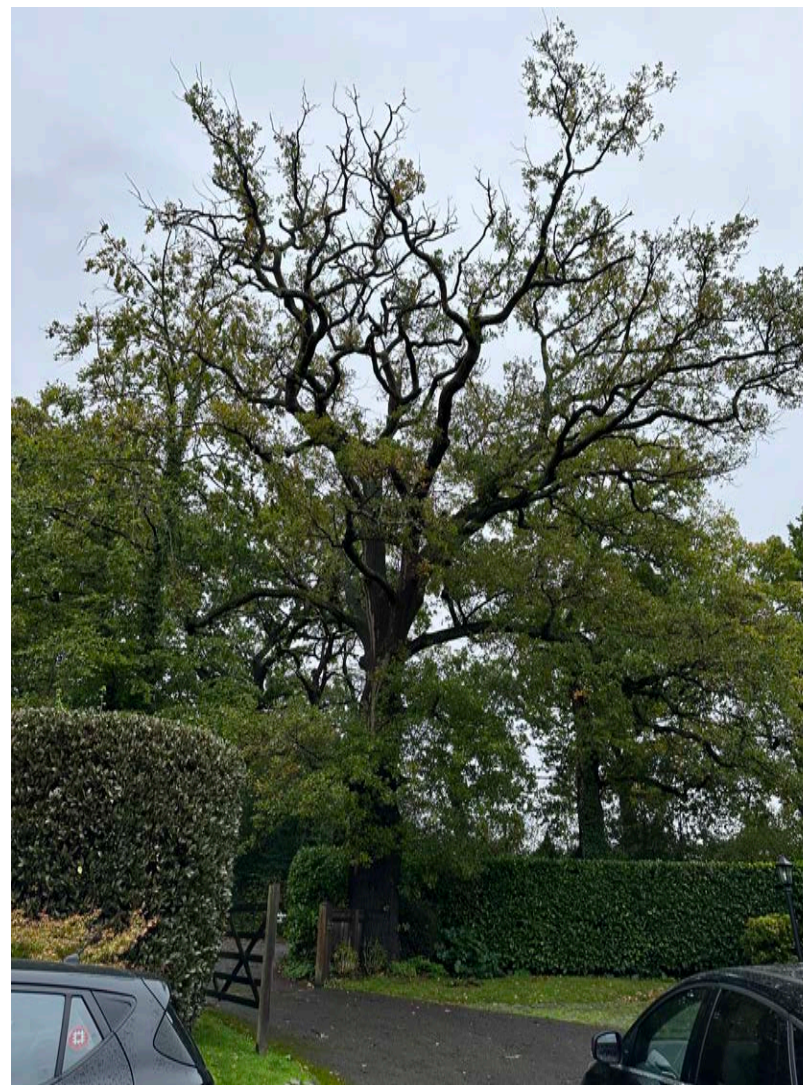
The Oak tree (Figure 1) is located within the front garden of 53 Winchester Road in Chandlers Ford and is located right on the edge of the driveway entrance and adjacent to the public pavement and adjacent to Winchester Road. The property is set to the West downslope from the Oak tree but within falling distance and the canopy extends over the driveway and parking area.

**Figure 1: Oak tree in November 2022 viewed from the West within the property driveway**

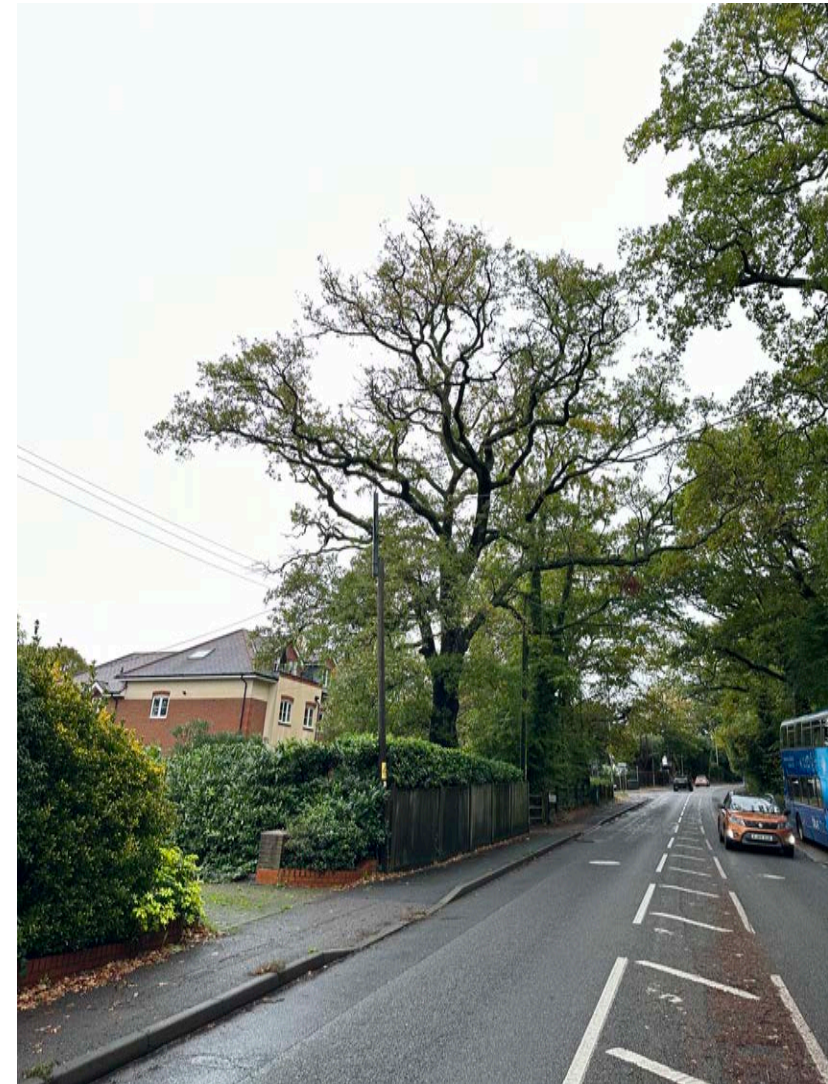
The majority of the canopy of the Oak tree to the East and South East extends over the road of Winchester Road as shown in Figure 3 and the bus stop is actively in use throughout the day also. Therefore the target area around the tree is very high with moderate impact potential and potential for failure of dead or declining branches.

**Figure 3: View of the Oak tree from the South on Winchester Road**

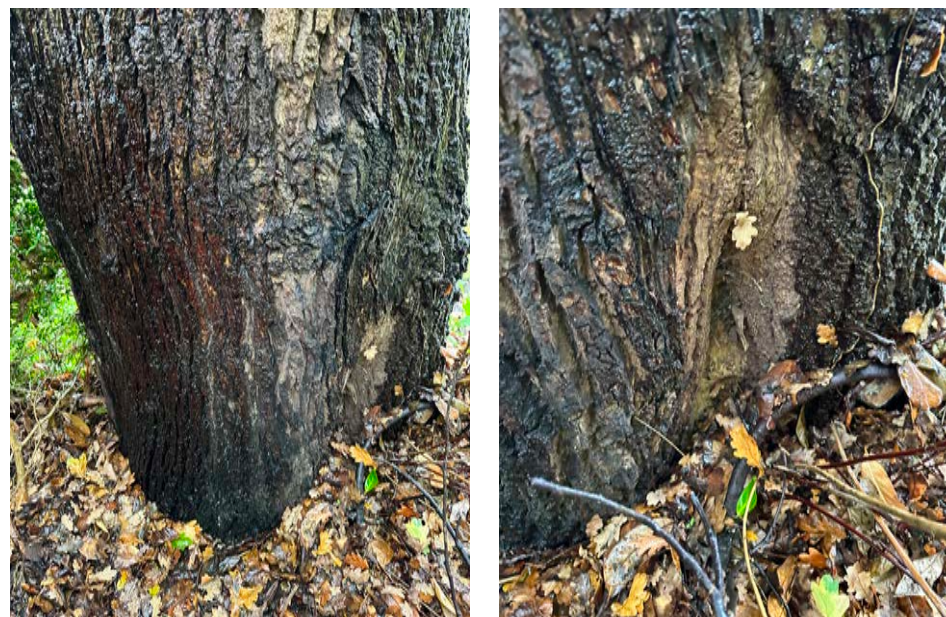
There is bark damage around the lower trunk on the main stem, potentially old impact wounds during the historic construction work on the site. There is bark loss and the edges of the wounds are occluding on the wounds to the North West and West (Figures 4a, 4b and 5). There is bat potential due to open old pruning wounds creating small cavities, holes and crevices on the main trunk and at branch ends (Figure 6). Some of the cavities are wet while others are dry and mainly created as a result of old pruning wounds.

**Figure 4a & 4b: Bark damage to North East of the main trunk**

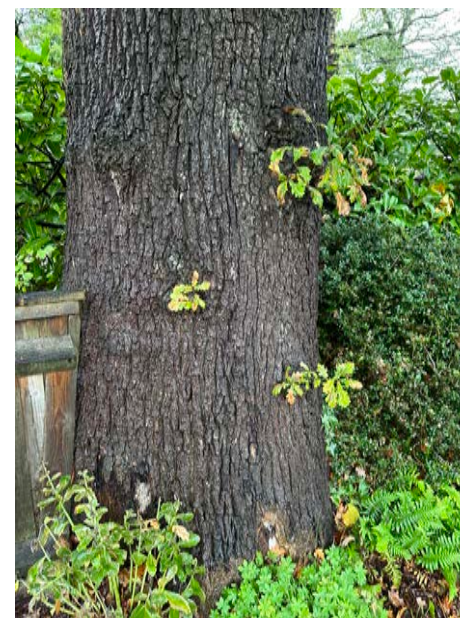
**Figure 5: Bark damage to the South West of main trunk**

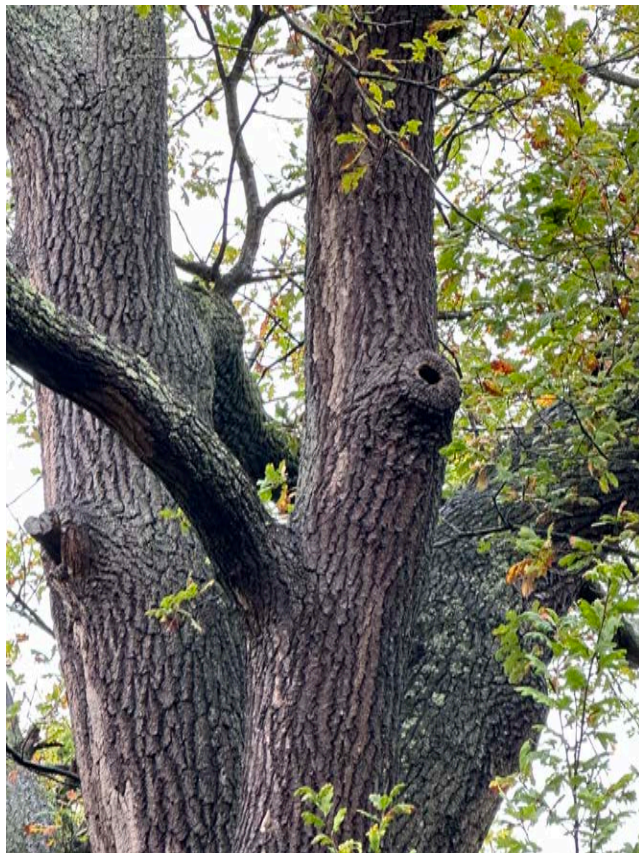
**Figure 6: Cavities and holes and branch stubs**

It is also recommended that appropriate wildlife checks are carried out for bats and nesting birds of cavities and holes within the crown and branches prior to commencing any tree work.

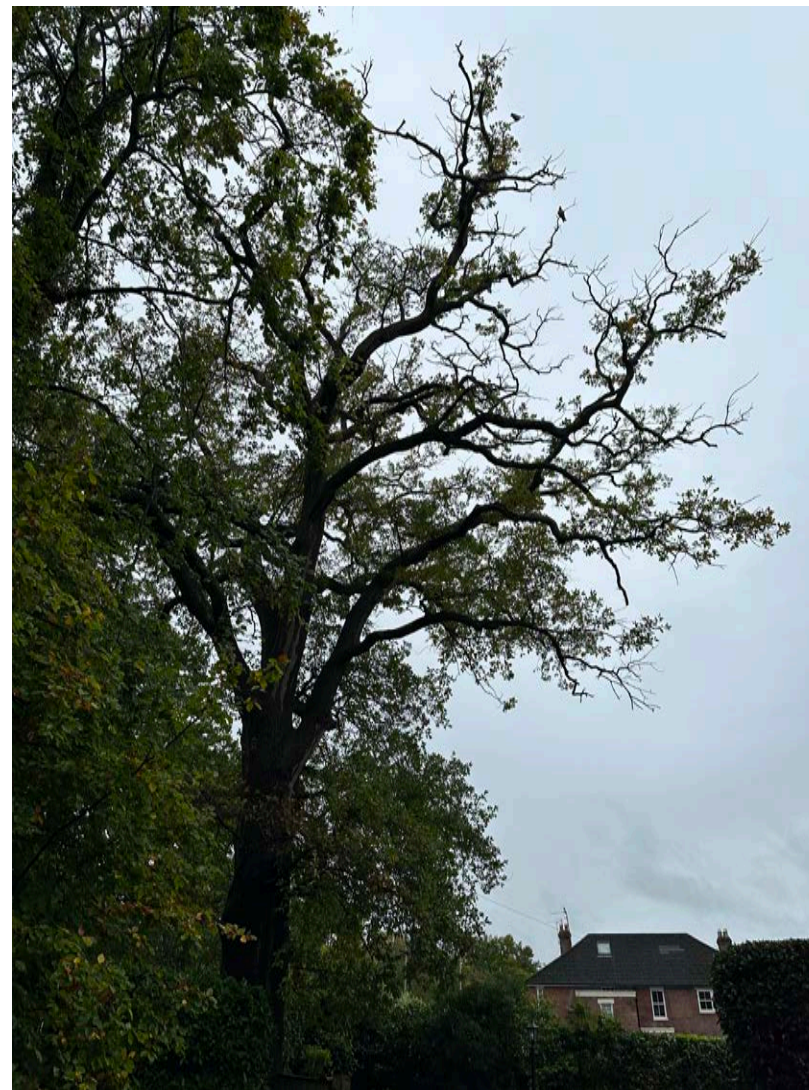
The Oak tree is starting to naturally retrench and there are old branch stubs from previous tree works within the crown. The crown is in decline with major and minor dead wood and branches throughout the crown, particularly to the East, West and North and there are saprophytic fungi on the dead cut branch stub on the lower trunk to the West. The crown is sparse in places with the branch tips dying back and becoming stag head in places.

**Figure 7: Crown decline of the Oak and major deadwood viewed from the North**

The recommendations include the removal of the major dead wood ie dead wood over 50mm in diameter throughout the crown. Particularly in relation to the dead branch over the main driveway entrance to both property locations which is recommended to be reduced as part of the overall crown reduction works back to just beyond the live epicormic growth.

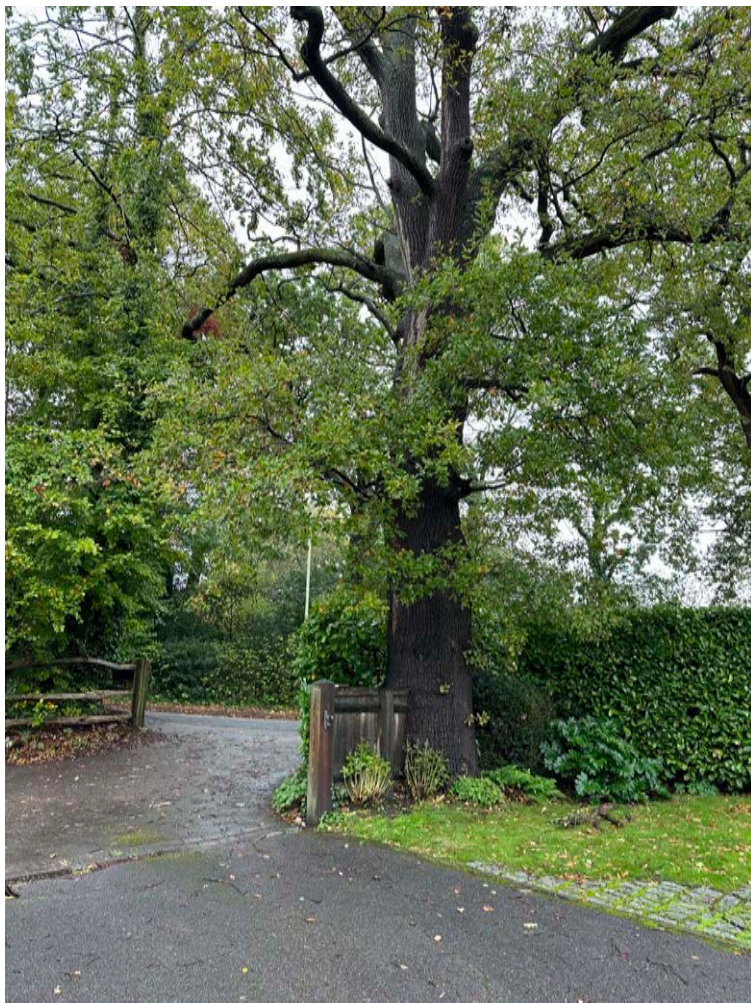
There is a good level of epicormic growth on the lower trunk (Figure 8) and this is also rafting along some of the lower branches. The epicormic growth should be retained to aid with the overall health and condition of the tree.

**Figure 8: Epicormic growth on the main trunk**

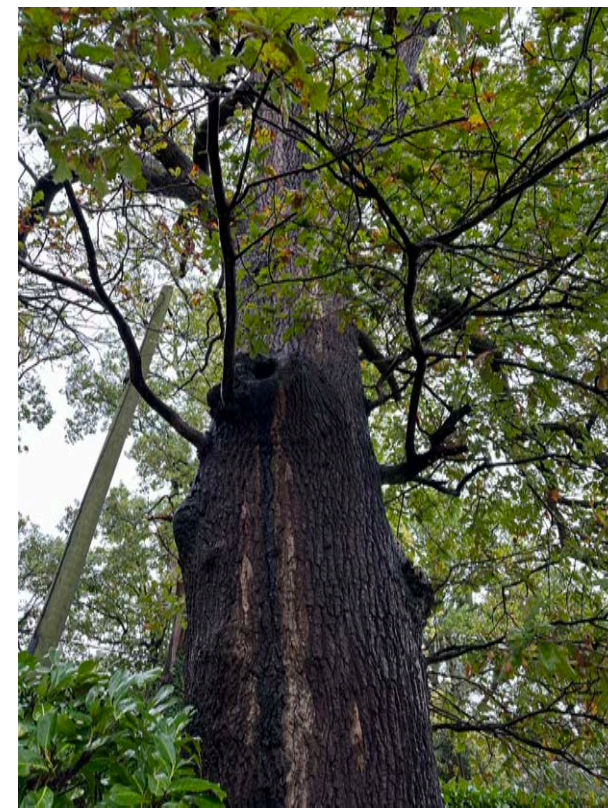
The crown has also historically been crown lifted to remove larger lower branches to the North, East and West but most of these wounds have occluded over fully now (Figure 9).

**Figure 9: Multiple occluded old pruning wounds on lower trunk and an open wet cavity**

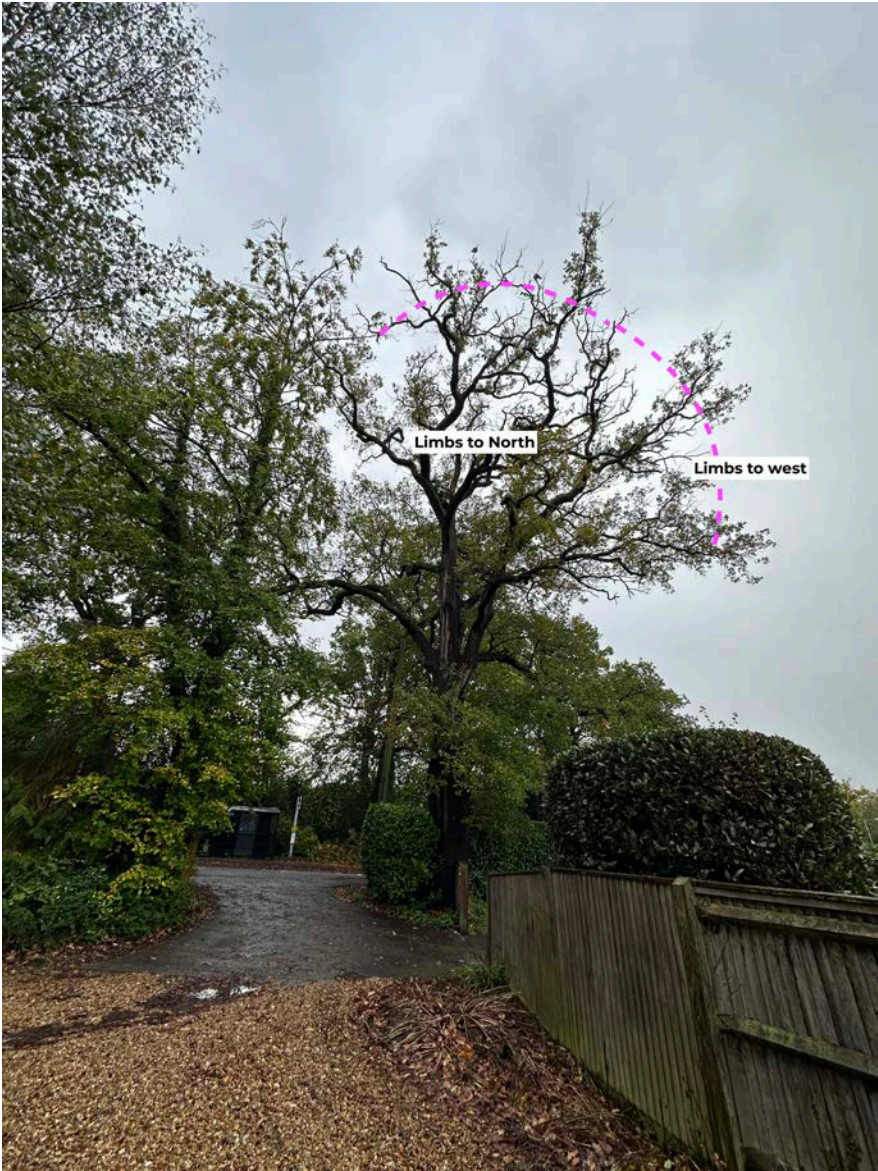
Figure 10: Crown reduction to Northern branches and West

Crown reduction - North - reduce all limbs to the North back by 1 metre to suitable growth points (Figure 10).

West - limbs over the driveway to reduce back by up to 2 metres to suitable growth points (Figures 10 and 13).

Overall height reduction down by up to 2 metres to suitable growth points leaving a 22-metre top height (Figures 10, 12 and 13).

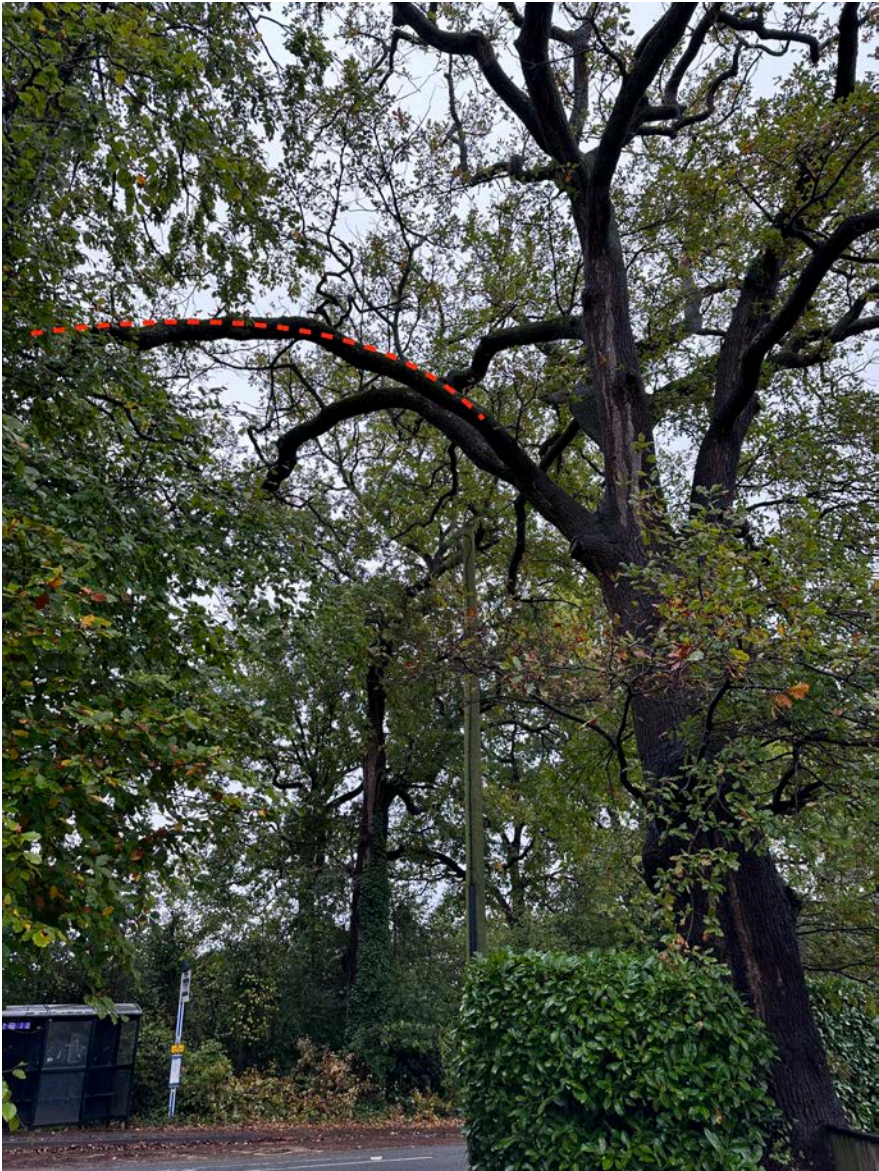
Figure 11: Dead limb reduction to the East over the driveway

East - dead limb over driveway entrance and road to reduce back to 1-metre branch stub beyond the epicormic growth and fork of the main limb. (Figure 11).

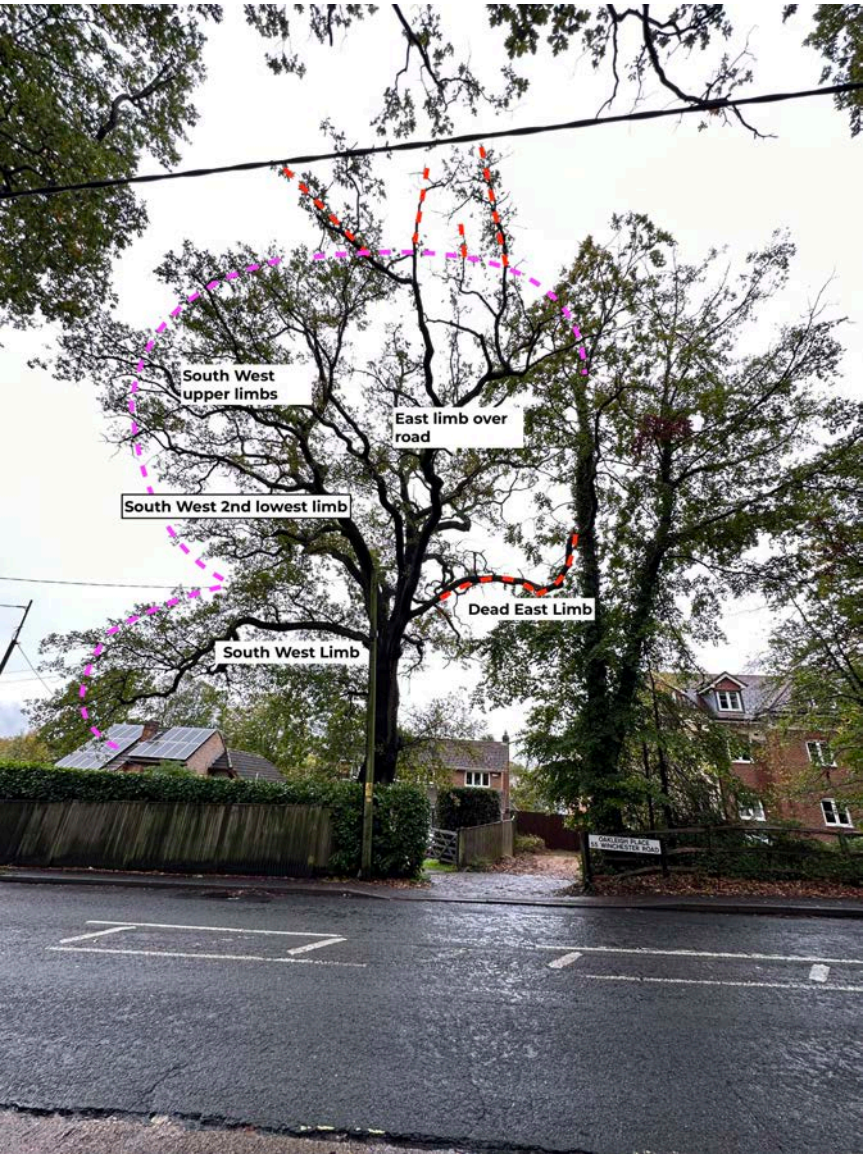
Figure 12: East, South and South West limbs for limb reduction works

East - limb over the road to reduce back by 2 metres in both sections after the fork back to suitable growth points (Figure 12).

South - upper limbs over the road to reduce by 1-2 metres back to suitable growth points (Figure 12).

South West lowest limb running parallel to the hedge in the front garden - reduce end weight and reduce back by 1 metre to suitable growth points (Figure 12).

South West the second lowest limb to reduce back by 1 metre, Figures 12 and 13.

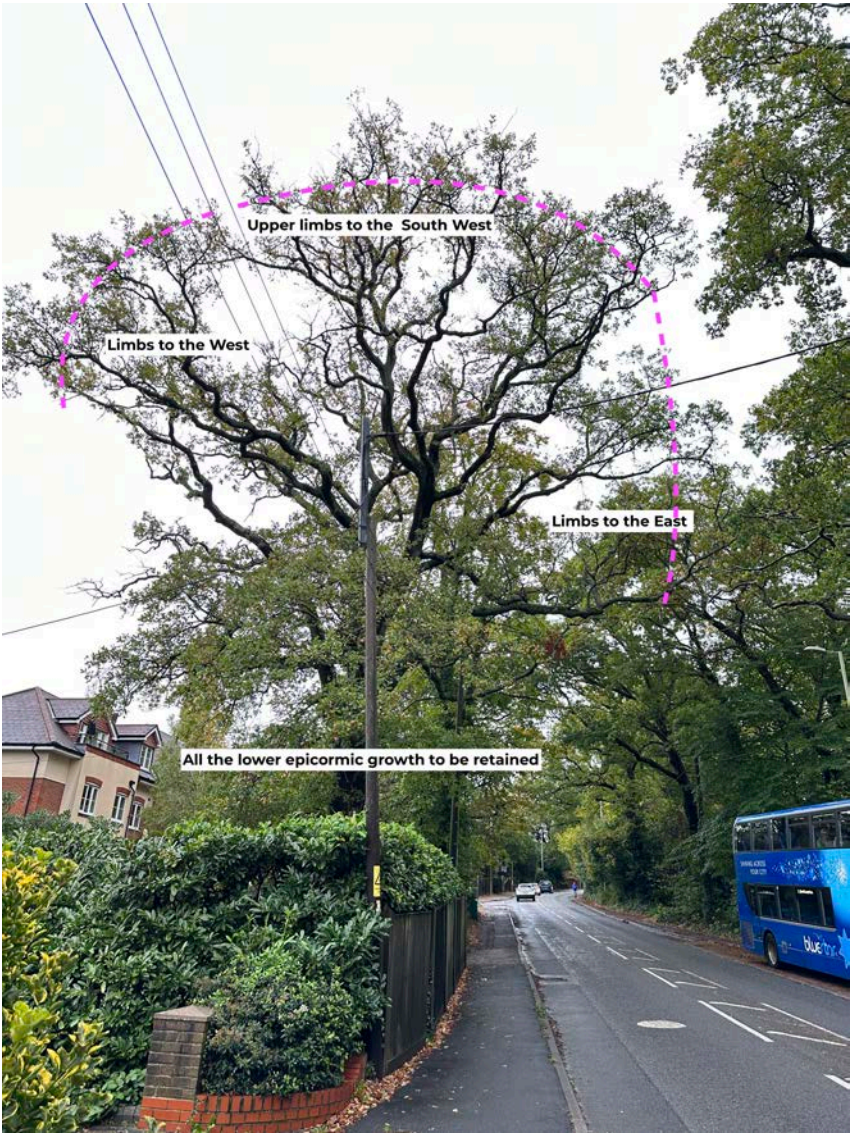
Figure 13: Branch reduction works to the West of the crown over the driveway and parking and overall crown shape

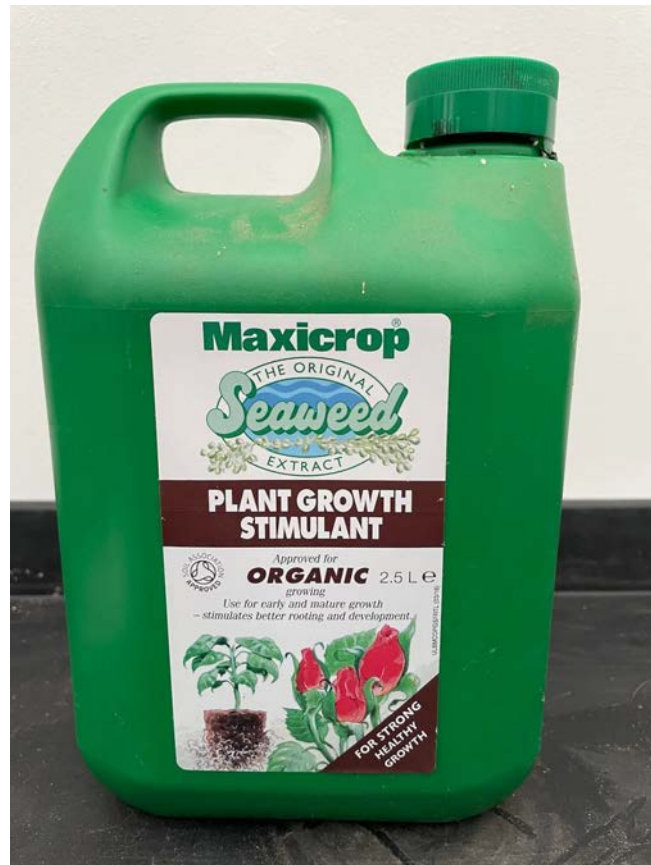
**Figure 14: Liquid nutrient stimulant**

Another recommendation is to provide the Oak tree with a nutrient stimulant or feed (Figure 14 )throughout the summer months weekly with a 20-millilitre solution of organic liquid seaweed fertiliser diluted in 10 litres (2 gallons) of water evenly dispersed around the rooting area of the tree on a weekly basis.
