# Tree Risk Assessment Report

**Fairport House, Lands End Road, Bursledon, SO31 8DN**

Report reference number: TRA-KC/FAIRPORT/001

Report date: November 2022

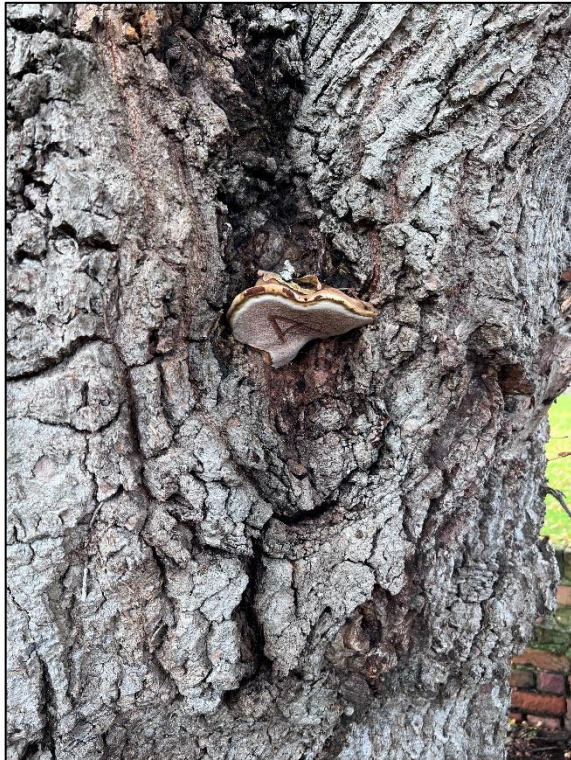
**Photograph one** - small fungal fruiting body of *Ganderma* species on stem

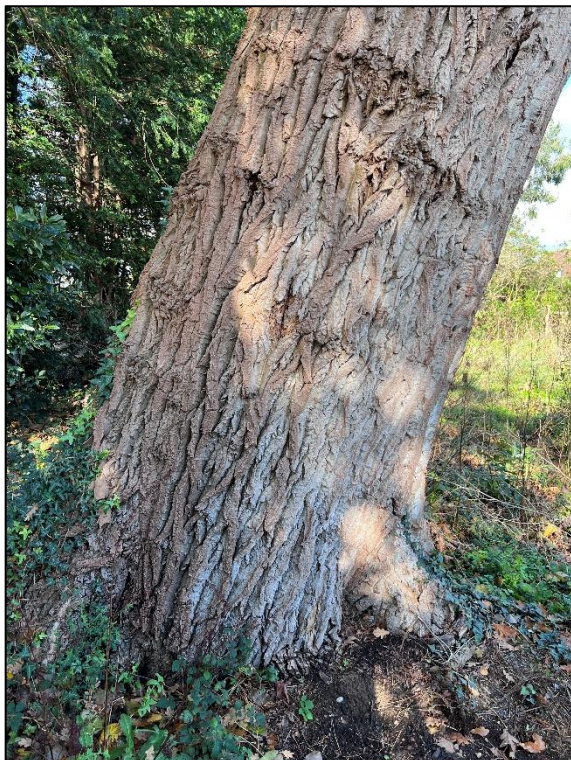
| Tree No | Condition Comments |
|---|---|
| | Part windthrown. |
| Tag No | Upper stem and crown damage by recent wind throw of neighbour to N.<br>Previous failure onto demolished outbuilding; about to commence rebuild. |

**Photograph two** - leaning poplar T2

Fell tree.

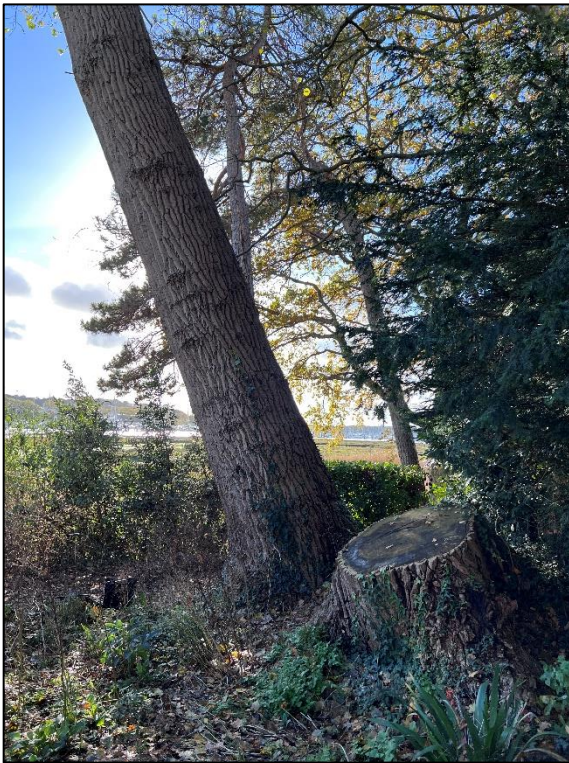
**Photograph three** - T2 from distance showing lean

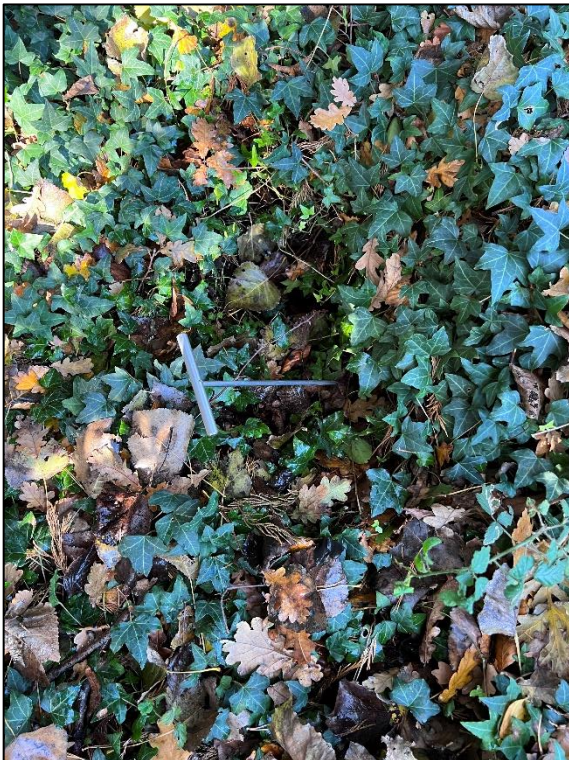
**Photograph four** - showing hole due to movement of root plate

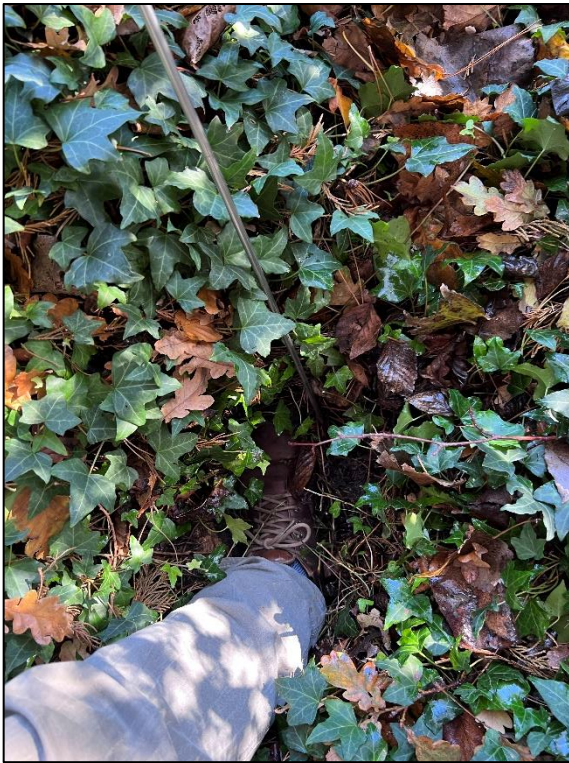
**Photograph five** - hole caused by root plate lift
