**Barn at 148 Church Road, Bishopstoke, EASTLEIGH, SO50 6DS**

## GENERAL STUCTURAL INSPECTION

Barn at  
148 Church Road  
Bishopstoke  
EASTLEIGH  
SO50 6DS

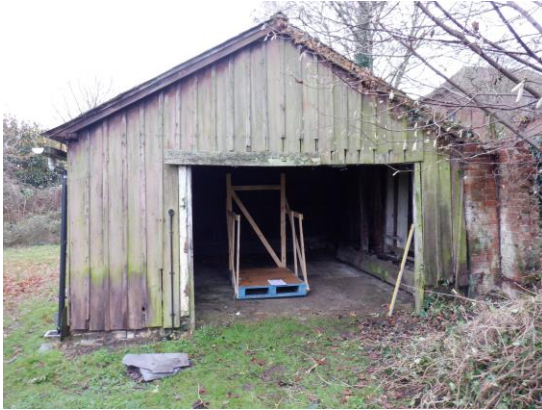
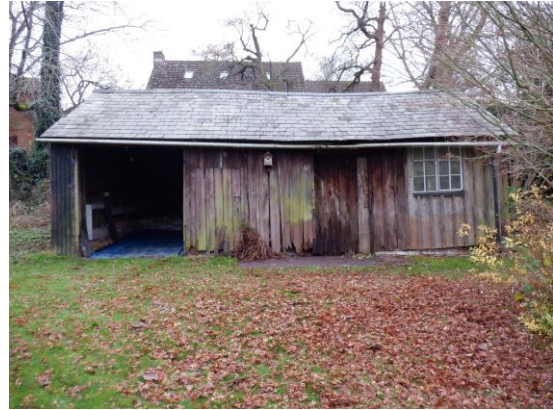
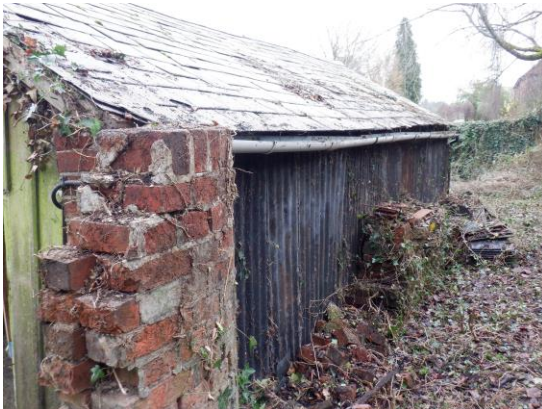
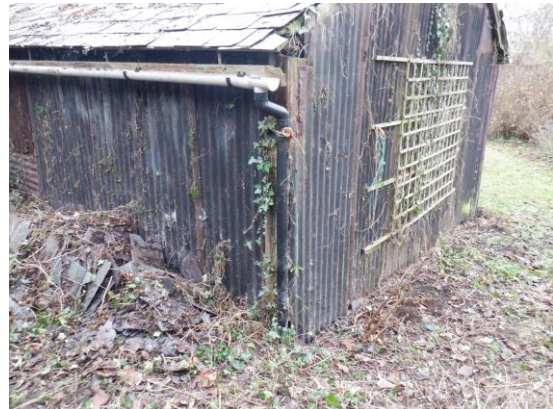
- 3.1** The building construction comprises timber studs built off 9-inch brick walls. The roof comprises timber rafters of varying sizes spanning from eaves to ridge with a single internal tie beam to prevent eaves spread along with the front and rear/internal walls.
- 3.2** The front and left side are clad with vertical timbers, 180 x 20mm with a 10 - 25mm gap between which is covered with a 50 x 15mm cover strip which is chamfers out at the corners. The right side and rear are clad in corrugated steel sheeting. The roof is covered with slates.
- 3.3** The structural walls comprise timber studs of varying sizes and spacings. There have been many alterations to door and window openings, most of which have been boarded over or otherwise blocked off, and there appears to have been numerous repairs to the frame resulting in an assortment of stud types and sizes.

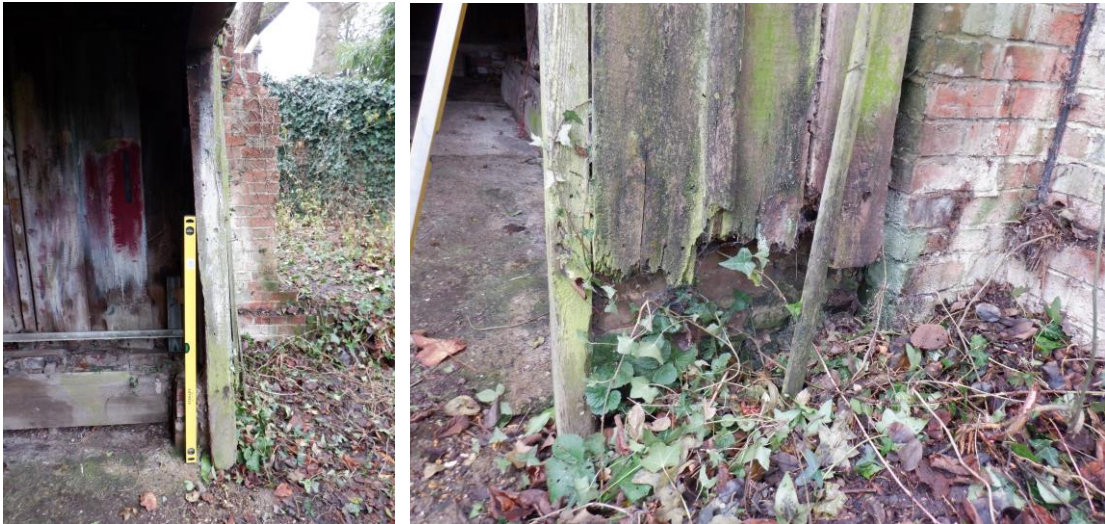
- 3.4** The front wall leans into the building at around 60/1000. To the right side of the opening the cladding is severely decayed at the base.

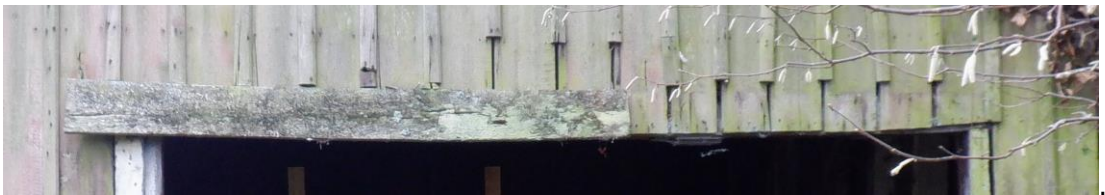
- 3.5** The 100 x 100 timber beam over the 2.8m wide front opening sags an estimated 75 – 100mm

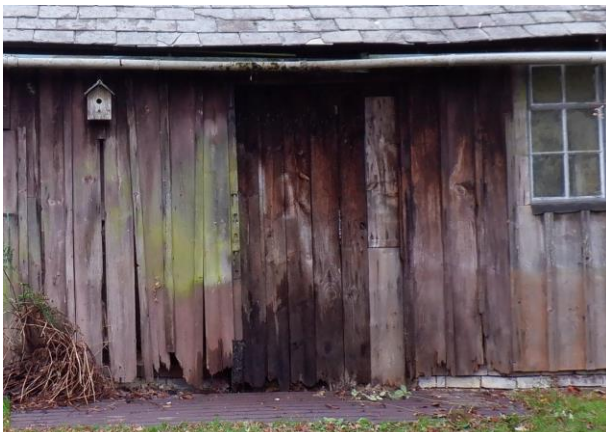
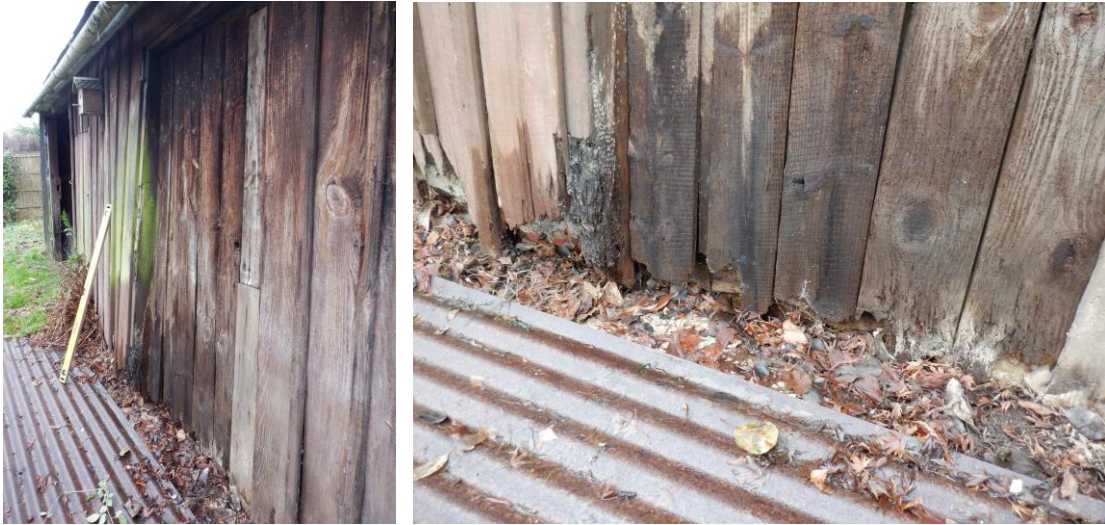
- 3.6** To the left side the eaves sag midway along which appears to have resulted in rainwater from the roof saturating the wall timbers over a long period of time, causing them to decay. There appears to be an old door opening which has been boarded over but the wall appears to have kicked out at the base and now leans into the building at around 100/1000. The timbers are saturated and extensively rotten, particularly towards their bases. The plinth along this side is 1 brick high above slab level.

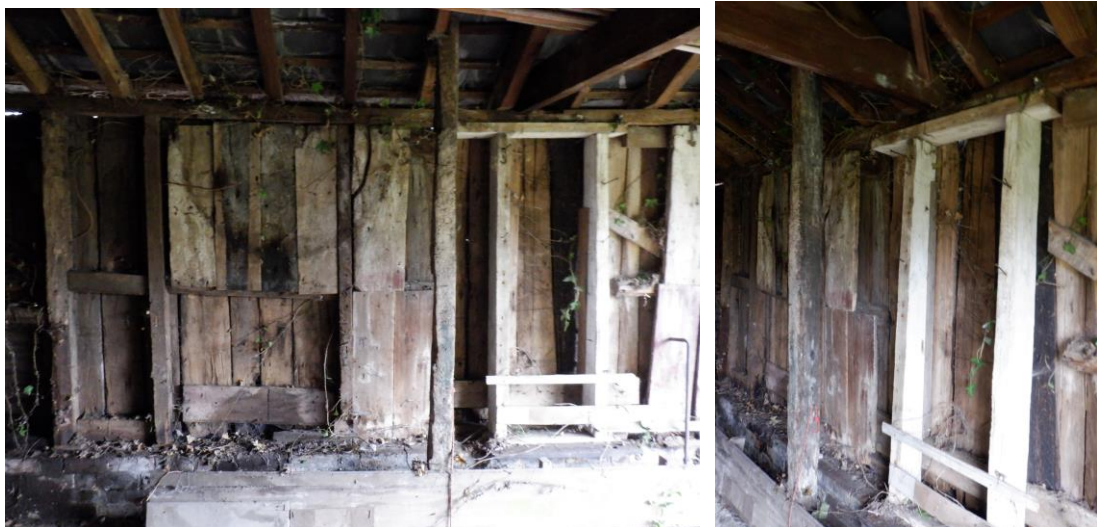
- 3.7** To the right side the brick plinth is 4 bricks high above the slab level. The timber frame here is in very poor condition with extensive repairs and strengthening, including what appear to be props to support what appears to be roof structure and eaves in places. The bases of most timber studs are decayed to greater or lesser degrees.

- 4.2** If the frame were to be repaired, it would also require additional bracing and strengthening to ensure the overall lateral stability of the building. The roof structure would also require additional ties to prevent spreading of the eaves.

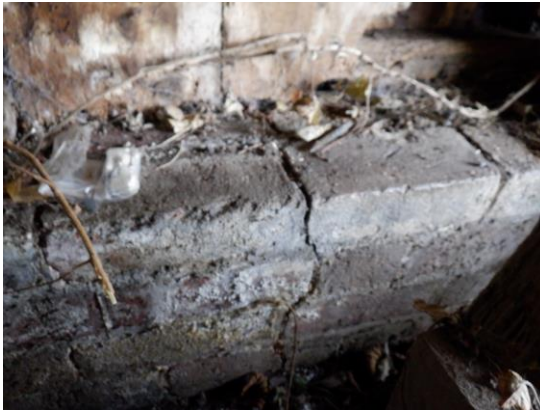
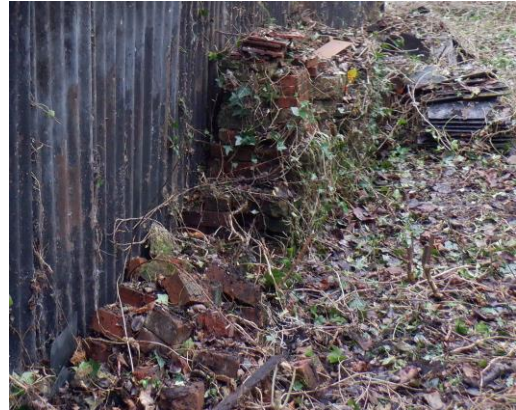
- 3.8** The brick plinth to the right side is cracked. Externally the original timber boarding has been overlaid with corrugated steel sheeting and various bricks and building debris are piled against this area.

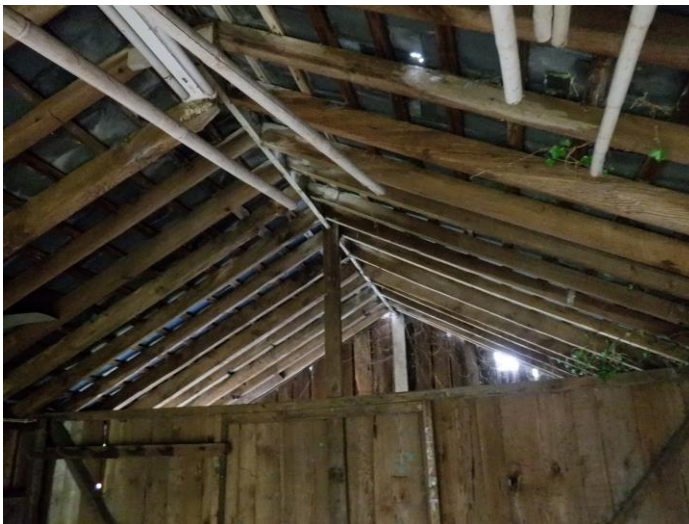
- 3.9** The roof structure comprises rafters of varying sizes (roughly spaced at around 400mm) which span from eaves to ridge. Resistance to eaves spread is provided by the front wall and back wall to the main front of the building as well as the rear wall of the addition, plus there is also one single tie beam approximately 1/3 distance from the front wall. The roof can be seen to be sagging when viewed externally. There is no underfelt and daylight is visible between the slates in places

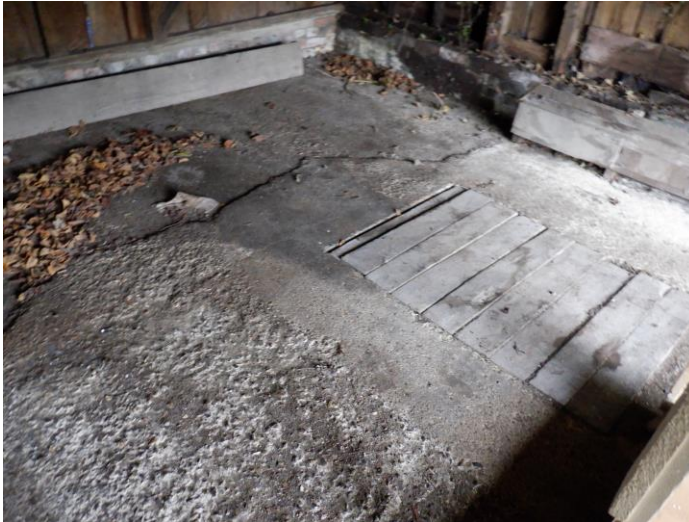
- 3.10** To the main part of the building the floor is of concrete construction. The surface is very uneven and very rough. There is a pit in the centre of the building indicating it has been used for car maintenance.

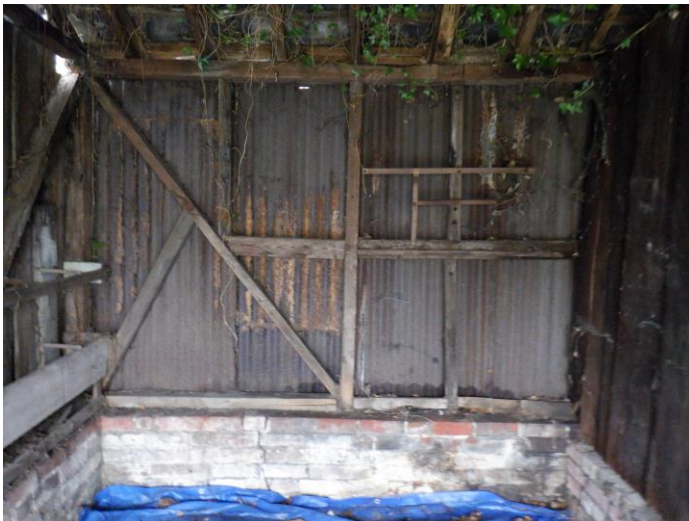
- 3.11** The building appears to have been extended to the rear. The timber framework of this is of lighter weight construction and there is no internal lining to the right side wall, just simply with a single layer of corrugated steel sheeting externally. The brick plinth the right side wall is cracked.

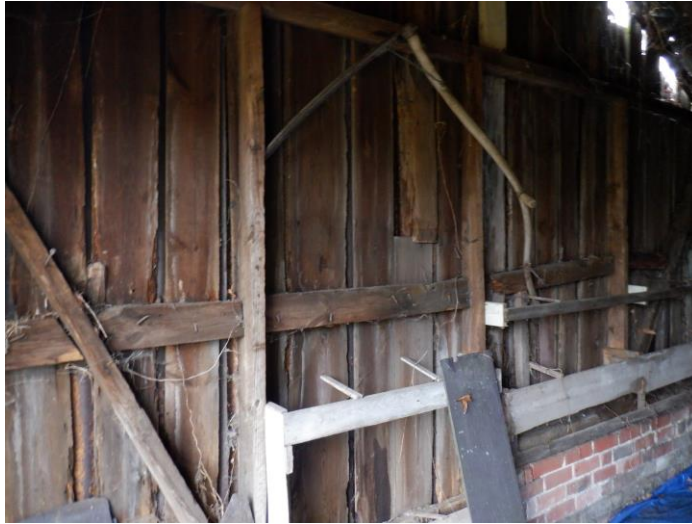
- 3.12** The rear wall has vertical boards internally supported by a light weight timber frame and also has corrugated steel sheets added externally. The rear wall leans to the rear at around 20/1000. This appears to be in keeping with the overall racking of the building to the rear.

- 3.13** All corrugated sheeting is in poor condition and corroding extensively.

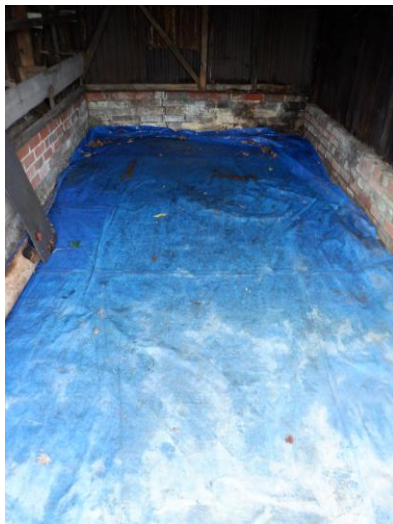
- 3.14** The floor of the rear extension is of brick construction. It was covered with a blue tarpaulin at the time of our inspection to preserve it. It slopes gently down to the left side.
