JOHNSTON TREE  
CONSULTANCY

SALTERNS BOATYARD  
SALTERNS LANE  
BURSELDON  
HAMPSHIRE  
SO31 8DH

DECEMBER 2022

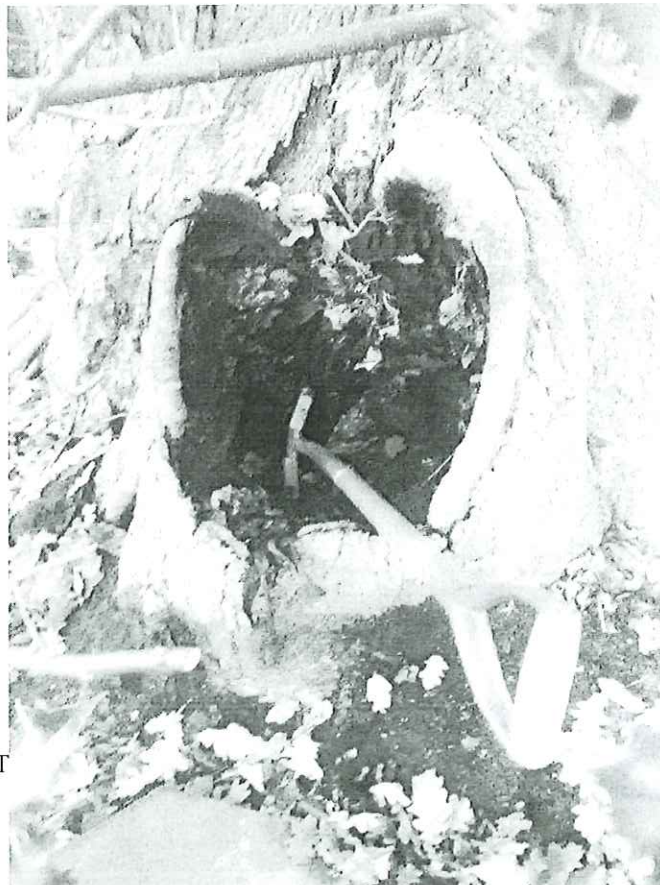
| Tree Number<br>and Species | Height<br>(m) | DBH<br>(mm) | Branch Spread (m) | | | | Age Class | Comments |
|---|---|---|---|---|---|---|---|---|
| T1<br><br>Common Ash<br><br><i>Fraxinus<br/>excelsior</i> | 18 | 1200 | 14 | | 12 | | M | Stem trifurcates at 0.5m, branch unions appeared sound at time of inspection with no obvious defects. Historically a large limb has been lost at ground level leaving a very large cavity. The cavity extends halfway across the base of the trunk of the tree. Die back is evident in the crown, maybe a result of Ash Dieback ( <i>Hymenoscyphus fraxineus</i> ). |

- 6.1 A Visual Tree Assessment (VTA) was undertaken looking at the roots, trunk, branch structure, buds and leaves to aid assessment of general tree health and vitality. The target, failure potential, size of part most likely to fail and site usage are all considered
- 6.2 The frequency of decay related failure is not considered high in this species as stated in Principles of Tree Hazard Assessment and Management. (Lonsdale, David. 1<sup>ed</sup> 1999. The Stationary Office). However, the extent of the decay, its location at the base of the tree, the very large heavy scaffold limbs it is considered that failure is highly likely and damage could be significant.
- 6.3 The area surrounding the cavity was 'tapped' with a nylon hammer to aid determination of the extent of any decay present. It appears the decay extends across half of the width of the truck as well as about 0.5m upwards.

- 7.1 The tree is mature with a sizeable trunk and scaffold limbs. It has significant decay at the base.
- 7.2 Currently the primary 'target' is a cabin, currently undergoing renovation and cannot be moved.
- 7.3 Once the cabin is renovated people will be using the site and although it is acknowledged the usage will be intermittent, the tree is still considered a threat to the safety of people.
- 7.4 If failure occurs the whole tree or at least one of the large scaffold limbs will fail and this could cause considerable damage to property and/or harm to site users.
- 7.5 It is advised that the tree is removed as soon as possible; given this a Notification of Intention will be submitted to Eastleigh Borough Council.

- 5.1 Eastleigh Borough Council (EBC) has verbally confirmed that the tree is not the subject of a Tree Preservation Order. However, the site does fall within the Bursledon Conservation Area. Given this a Notification of Proposed Works will be submitted to EBC for removal of the tree.
