**PRIVATE HARDSTANDING AS  
BUILT APPRAISAL REPORT  
PHASE 9 STONEHAM, EASTLEIGH**

**HIGHWOOD GROUP LIMITED**

NOVEMBER 2022

PROJECT NAME: Phase 9 Stoneham, Eastleigh  
PROJECT NUMBER: 5020063  
DOCUMENT REFERENCE: 5020063-RDG-XX-XX-DOC-C-S22-3008  
DOCUMENT STATUS: S2 – Suitable for Information

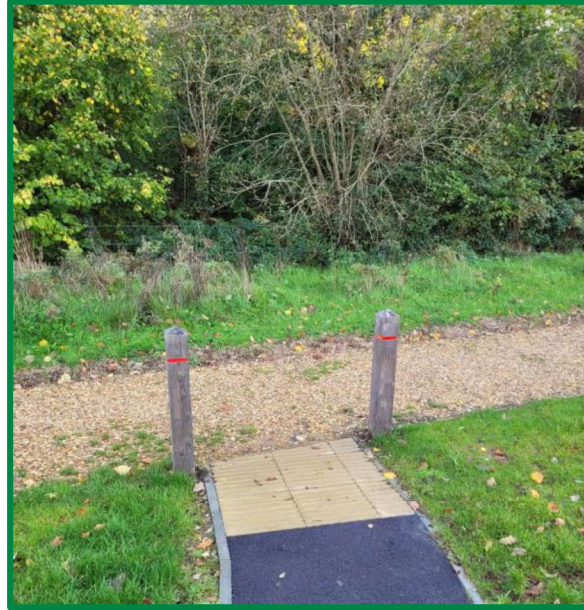
**Photo 58 – View out onto timber/gravel path**

The timber edged gravel footpath to the south of the low-rise housing within the green amenity space was constructed as per the route shown on the Odyssey Layout (see Appendix A and Appendix B). The condition of the path was good and the sides and gravel spread were constructed well.

It was not possible to verify the specification of the timber bollards, however, the bollards were of a robust timber construction with a reflective banding and seemed to be sufficient for their intended use.

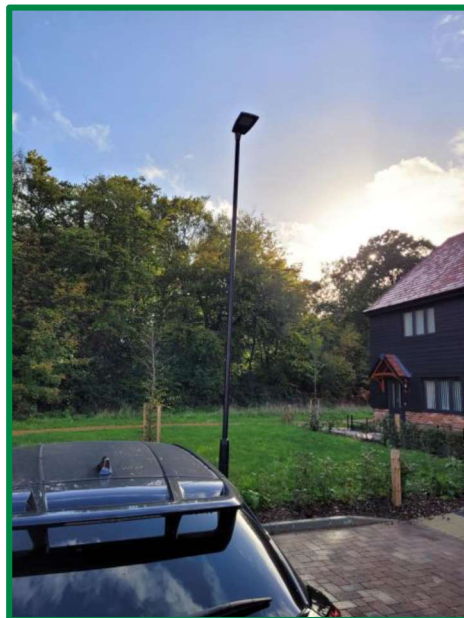
**Photo 51 – Private Lighting Column**

Private lighting columns and illuminated bollards could be seen through the private parking areas, roads and drives although these were not explicitly shown on the supplied plans. The lighting columns seemed to be of a similar specification to the lighting columns in the adopted/adoptable highway and offer a betterment to the unlit lighting arrangement presented in the Construction Make Up Plans (19-308 029-31).

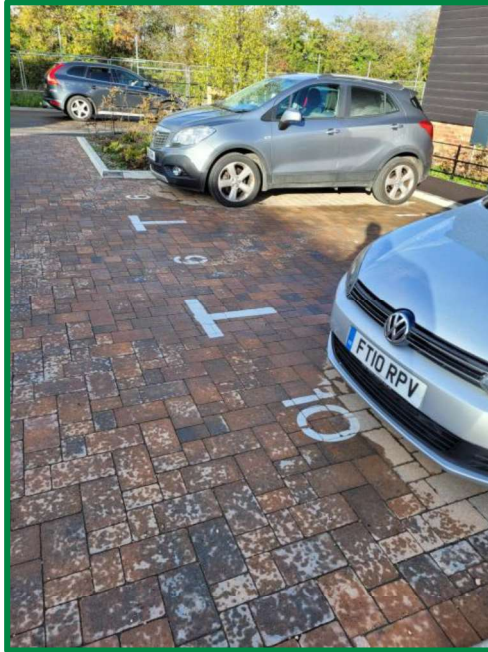
**Photo 55 – Parking Space Numbering**

The numbering of the parking on site was found within the parking space spaces, including visitor locations and locations for local residents to use. The correct quantity of spaces has been provided as per the approved plans. The dimensions of the parking spaces were also consistent with those specified on the approved layout.

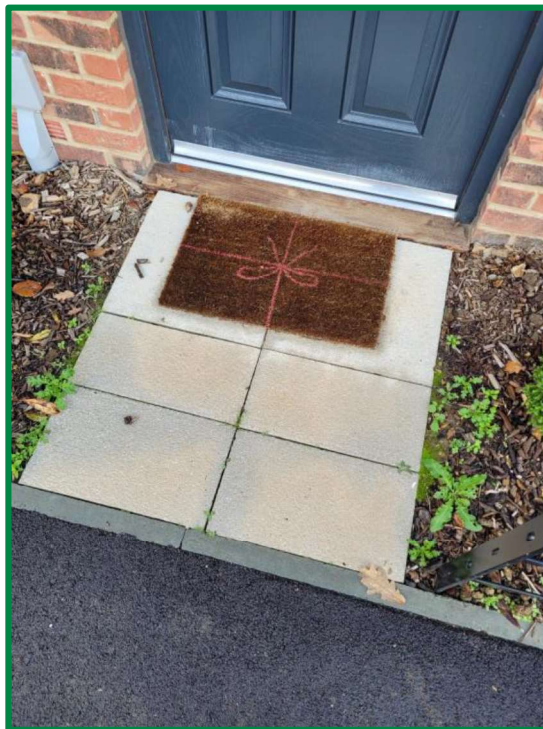
**Photo 49 – Paving Slab Cutting**

Block paving and paving slabs were laid throughout the site in the correctly specified locations and were as per the approved materials. No sign of wear or cracking of private paving was detected during the site visit and all slabs were cut in a clean manner.

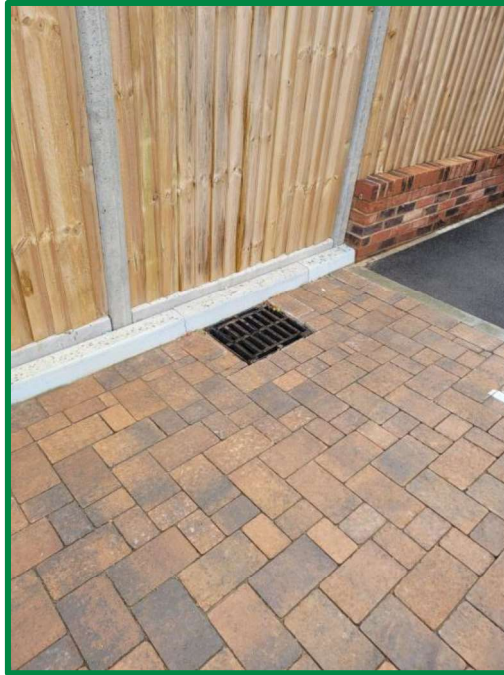
**Photo 41 – Gully Gratings Installed**

The gully gratings installed in the shared surface areas did not appear to be of a pedestrian friendly nature, there is therefore the potential for shoes to get caught in the slots of the grating and for personal items to fall through the slots into the sump below. Although generally the gullies were small in nature it may be prudent to replace the gratings where they are present in close proximity to pedestrian trafficked routes to avoid injury/loss of property.

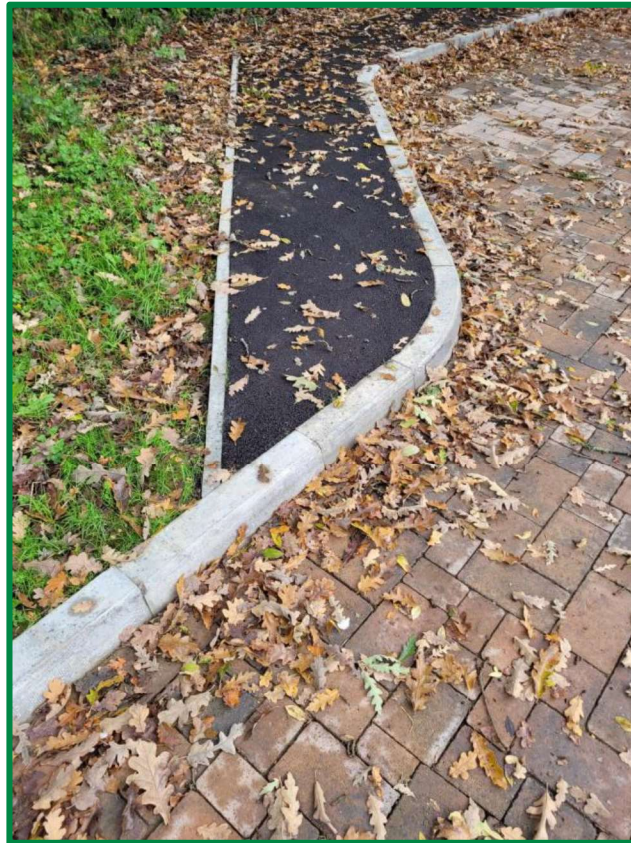
**Photo 32 – Full Height Kerbs Installed**

In some instances, the incorrect kerbs were installed which were not appropriate for the location, however, the difference was of little significance and would not present a hazard to pedestrians and disabled users. Additional edgings were installed in multiple locations against the sides of properties; however, this treatment was not shown on the layout. This actually represents an improvement as it provides the surfacer/groundworker with a clean edge with which to lay asphalt, therefore this does should not be a cause for concern. Some edgings were omitted in areas, for example to the side of plot 5's parking, however, the contribution from these edgings would not have been meaningful and therefore their omission is of little consequence. In some instances, full height kerbs have been specified on the layout, despite these kerbs leading onto pedestrian areas, notably, at the crossing through the woods in front of plot 37 and at the visitor parking in front of plot 34, this could present a trip hazard and consideration should be given to replacing these kerbs with pedestrian friendly alternatives.

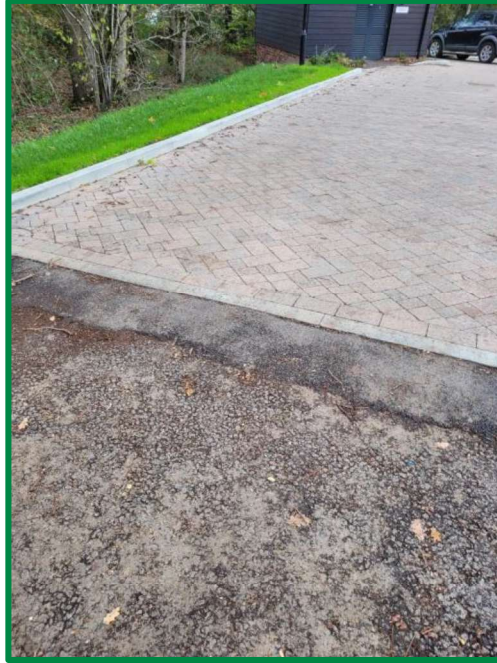
**Photo 17 – Flush Kerb onto Private Hardstanding**

On a number of transitions between adoptable/adopted highway and private drives/roads a flush kerb was present without any intercepting drainage feature, this will encourage highway runoff onto private areas. To remedy this, upstands should be installed with a drainage feature to ensure that runoff is disposed of appropriately.

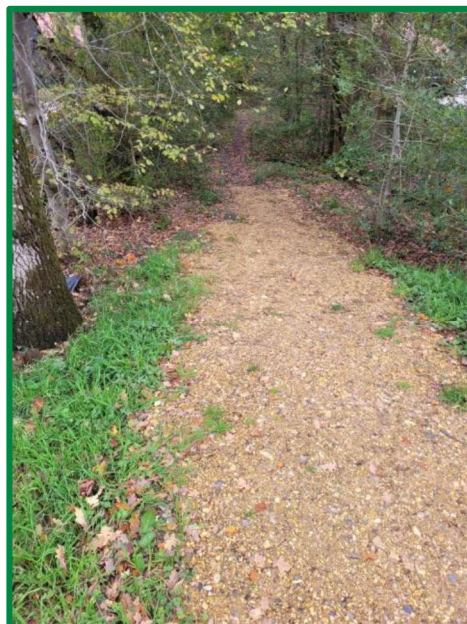
**Photo 26 – Path Passing Through the Woods**

The path passing through the woods on the opposite side of the road to plots 30-38 does not benefit from dropped kerbs. The path through the woods has been laid in a natural gravel finish with a slightly sloping gradient, this should be seen as a vast improvement over the previous arrangement which had unnecessary steps, corduroys and handrails. The new arrangement allows for easy access for cyclists, prams and pedestrians as was observed during the survey.

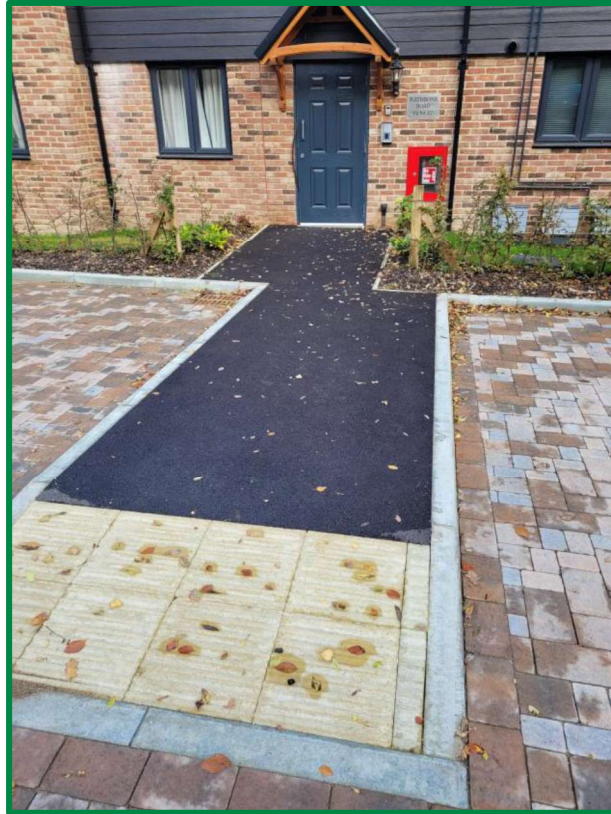
**Photo 4 – Plots 58-65 Rear Access**

The rear access to plots 58-65 differs from the arrangement shown on the layout as the path is wider (1.65m) but contains a small deviation which is not shown on the plans. Although this is the case, the 1.2m wide margin is still maintained at the narrow point and the entrance still meets all grading requirements as per Approved Document M.

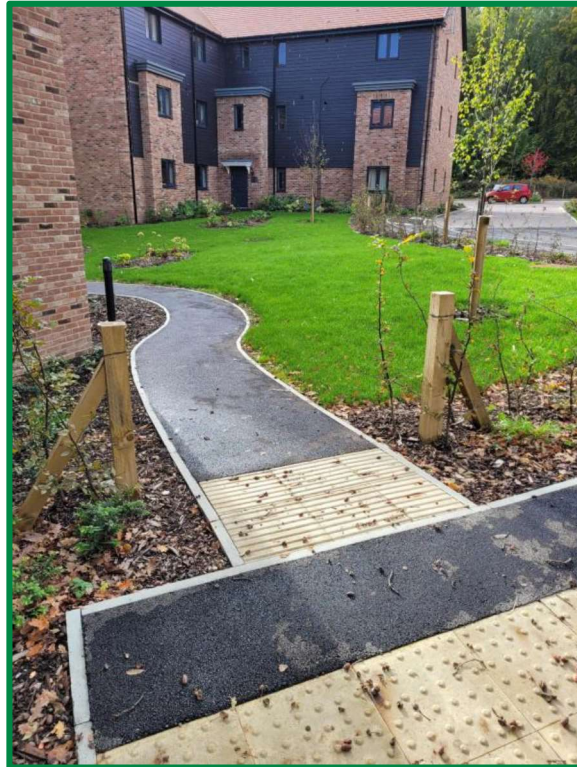
**Photo 13 – Bollards Substituted for Fence Posts**

In one instance bollards were not installed, this is the case in front of plots 30 and 31. In some instances, the bollards have been replaced with fence posts; however, it is understood that this is as per the approved landscaping layout. The fence posts installed work well aesthetically with the adjoining hedges and do not negatively impact the functionality/safety of the street.
