# Ross Consulting

**CLIENT-** Mr and Mrs Youngman

**SITE-** Larkby, Kew Lane, Bursledon

**PROJECT-** Tree Report Based on Recommendations in BS 5837 2012

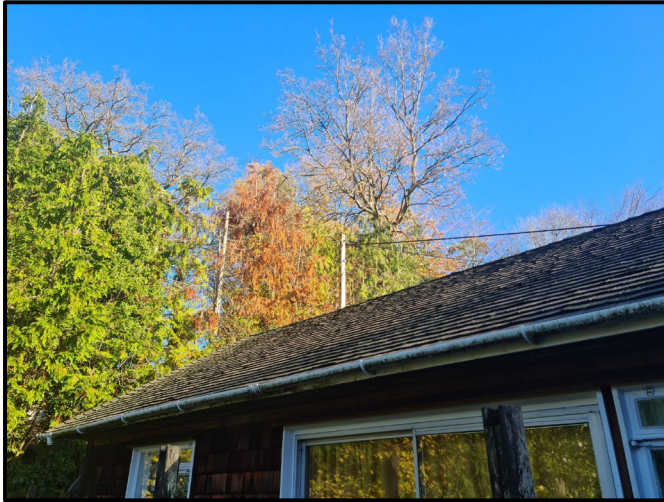
**6.1.4 H4 Lawsons Cypress** – Forming part of the Northern boundary, the hedge has been classified as a B cat feature due to its overall impact although there are a number of dead plants at the Eastern end. The proposed development does impinge on the calculated RPA of the hedge however the Meeuwsen Muldoon Landscape plan 29.09.22 indicates that the existing hedge will be replaced with mixed planting. The consultant is of the opinion that a mixed hedge with some further additions will provide better visual amenity value than the existing hedge.

**Photograph One** – T1 In the background with dead Lawsons Cypress in H4 to the left

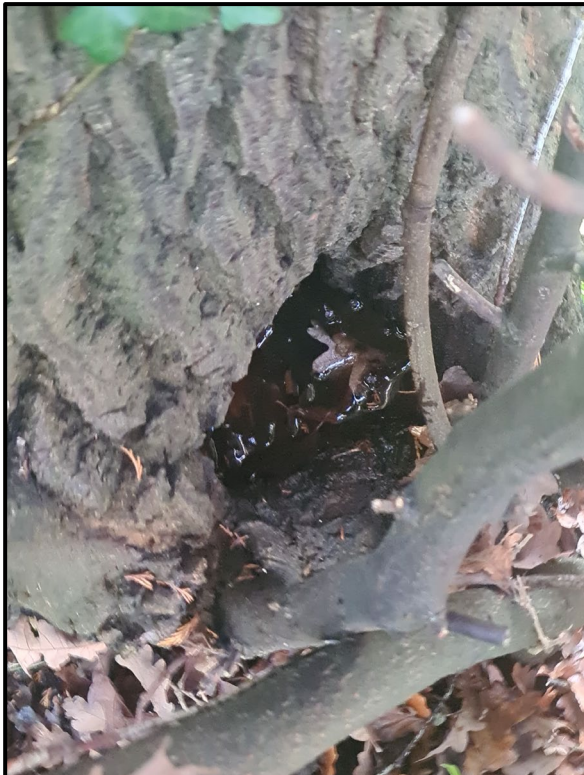
| Tree No | Species | Height (M) | Crown spread (M) | Dia @ 1.5m (mm) | Ht of lowest branch (M) | Age class | Est Cont years | Cat Ret | Condition<br>Physical- P<br>Structural-S<br>Good-G<br>Fair-F<br>Poor - P | RPA M2 | RPA Rad | Observations | Management recommendations |
|---|---|---|---|---|---|---|---|---|---|---|---|---|---|
| T2 | Turkey Oak ( <i>Quercus cerris</i> ) | 18 | Av 12 | 534 | 4 | M | 40> | B | P-F<br>S-F | | | Situated at top of a bank within 3 <sup>rd</sup> party ownership overhanging client's site, unidentified fungi on ground 2 no's toadstools. Cavity present on N side, appears to be a result of historical branch loss many years ago, water and decayed organic matter present, probe shows surface decay only | recommend owner to reinspect |

**Photograph Two** – Cavity at base of T2

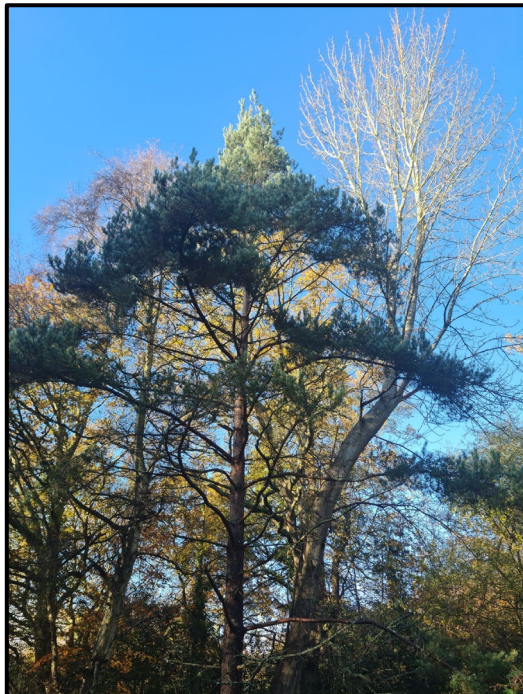
| Tree No | Species | Height (M) | Crown spread (M) | Dia @ 1.5m (mm) | Ht of lowest branch (M) | Age class | Est Cont years | Cat Ret | Condition<br>Physical- P<br>Structural-S<br>Good-G<br>Fair-F<br>Poor - P | RPA M2 | RPA Rad | Observations | Management recommendations |
|---|---|---|---|---|---|---|---|---|---|---|---|---|---|
| T7 | Aspen? ( <i>Populus tremula</i> ) | 20 | N7<br>E8<br>S3<br>W5 | 540 @ 1.3 | 2 | M | 30> | C | P-F<br>S-F | | | Situated in Brambles/scrub, not clear if in ownership of client, growing to North, Tension root visible to S 2m long on surface total Dia 200mm? Lean possible result of storm damage, not able to carry out full inspection | Clear scrub around the root plate and inspect root plate for movement |

**Photograph Four – T6 in the foreground with T7 in the background**

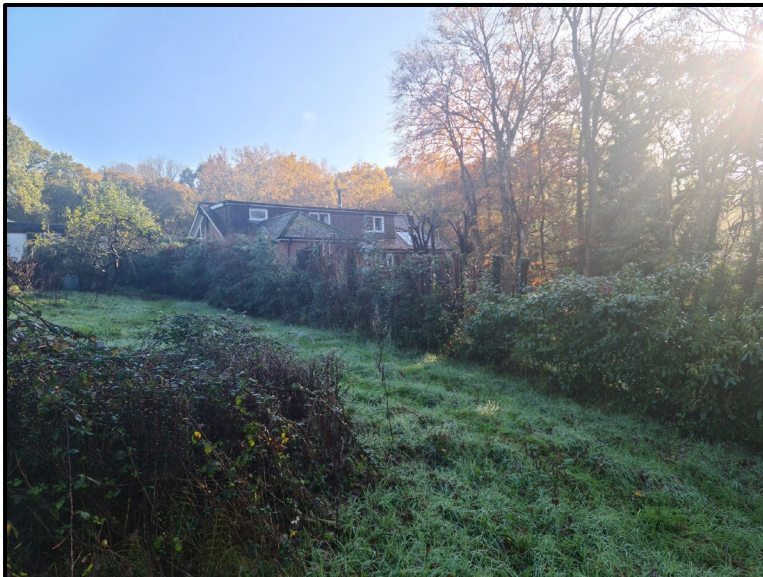
**Photograph Seven – H11a**

- 6.1.9 T9 Goat Willow** – To the South of T8, as above.
- 6.1.10 T10 Apple** – To the North of H11a to be retained, fruit tree pruning required.
- 6.1.11 H11a Laurel/Lawsons Hedge** – Outside the direct influence of proposed development, only necessary work required is the replacement of dead conifers and gapping up of the hedge.

| Tree No | Species | Height (M) | Crown spread (M) | Dia @ 1.5m (mm) | Ht of lowest branch (M) | Age class | Est Cont years | Cat Ret | Condition Physical- P<br>Structural-S<br>Good-G<br>Fair-F<br>Poor - P | RPA M2 | RPA Rad | Observations | Management recommendations |
|---|---|---|---|---|---|---|---|---|---|---|---|---|---|
| H11 a | Lawsons Cypress and Laurel ( <i>Prunus laurocerasus</i> ) | 3m<br>Av | 1.5 | Av 150 | G | MA | 30> | C/B | P-F<br>S-F<br>See Notes | | | Consists of 18m of laurel from West boundary, 17 m of Cypress from laurel to shed includes 6 dead topped conifers | Option 1 – Remove total hedge and replace with semi-mature mixed hedge of yew<br><br>Option 2 Prune and fill up gaps with selected species |

| Tree | Species | Recommendations | Tree | Species | Recommendations |
|---|---|---|---|---|---|
| H11a | Lawsons Cypress and Laurel | <b>Establish Ownership</b><br><b>Option One</b> – Cut back/prune and replace dead conifers<br><b>Option Two</b> – Fell and replace with | H11b | Rhodo, Yew, Beech | Formative pruning to retain and planting up any gaps |

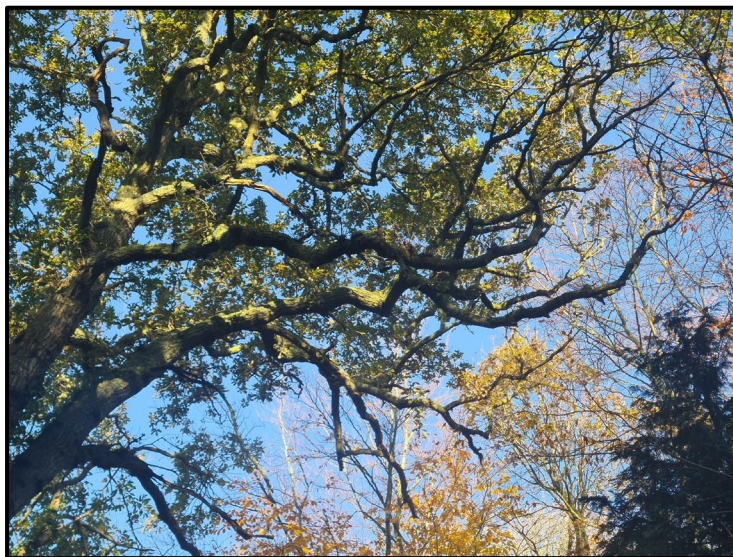
| Tree No | Species | Height (M) | Crown spread (M) | Dia @ 1.5m (mm) | Ht of lowest branch (M) | Age class | Est Cont years | Cat Ret | Condition<br>Physical- P<br>Structural-S<br>Good-G<br>Fair-F<br>Poor - P | RPA M2 | RPA Rad | Observations | Management recommendations |
|---|---|---|---|---|---|---|---|---|---|---|---|---|---|
| T14 | Turkey Oak | 20 | N11.6<br>E13<br>S12<br>W8.6 | 1320 | 2.5 | Near Vet | 30> | B/A | P-F<br>S-F | | | Forks E/W@3m with centre stem, centre forks at 6m with multiple branches. Deadwood present throughout, branch to E over road forks N/ at approx. 7.7m with D/W. Condition of Deadwood not determined | Major deadwood needs removing over the road and moribund partially dead branch to E requires reducing back to live wood. TPO consent required. |

**Photograph Ten** – Deadwood in T14 overhanging road

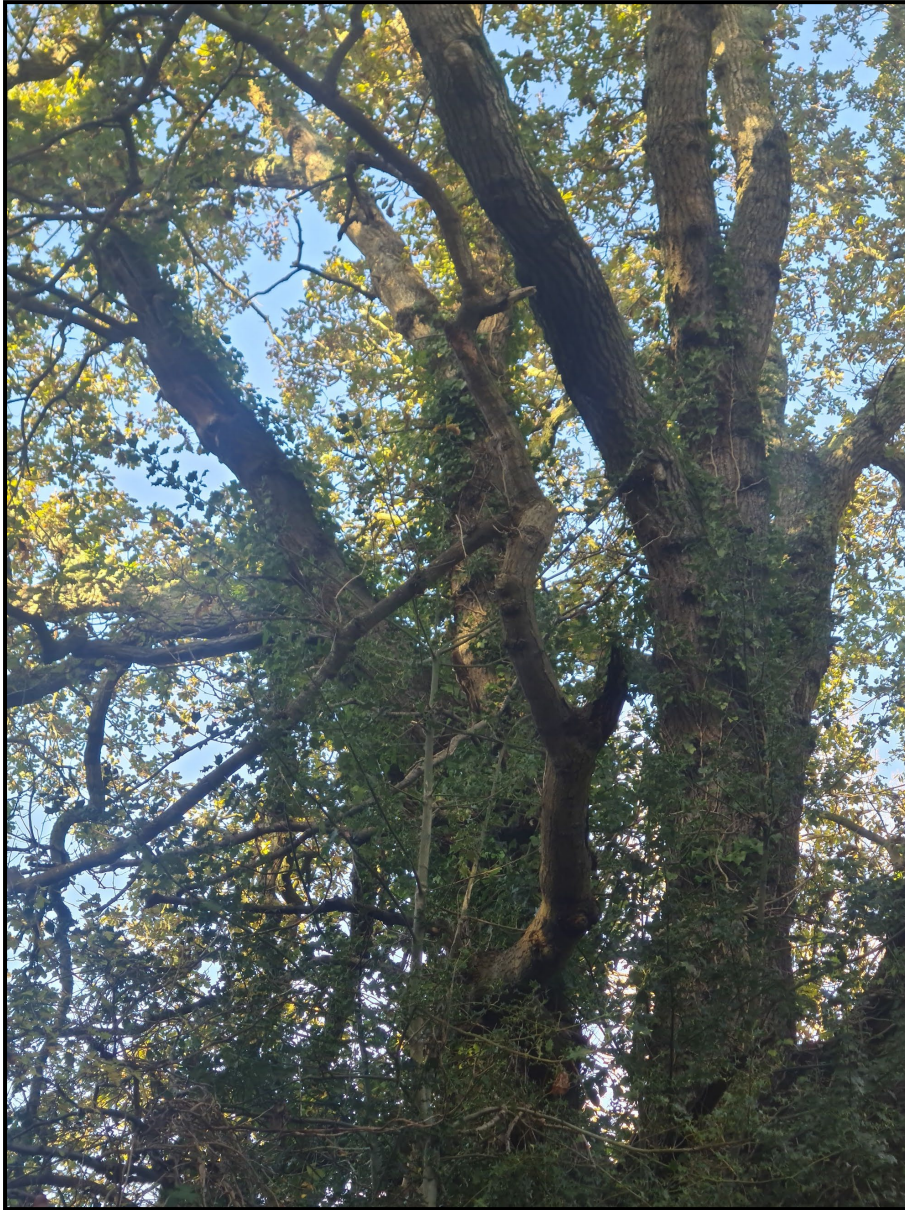
**Photograph Eleven**  
Canopy of T14
