Your ref: **Planning Application /F/22/94046**

Our Ref: **22113-Let1-151222-JB**

**Re: Tree issues at 49 Bishopstoke Road, Bishopstoke, Eastleigh SO50 6BF**

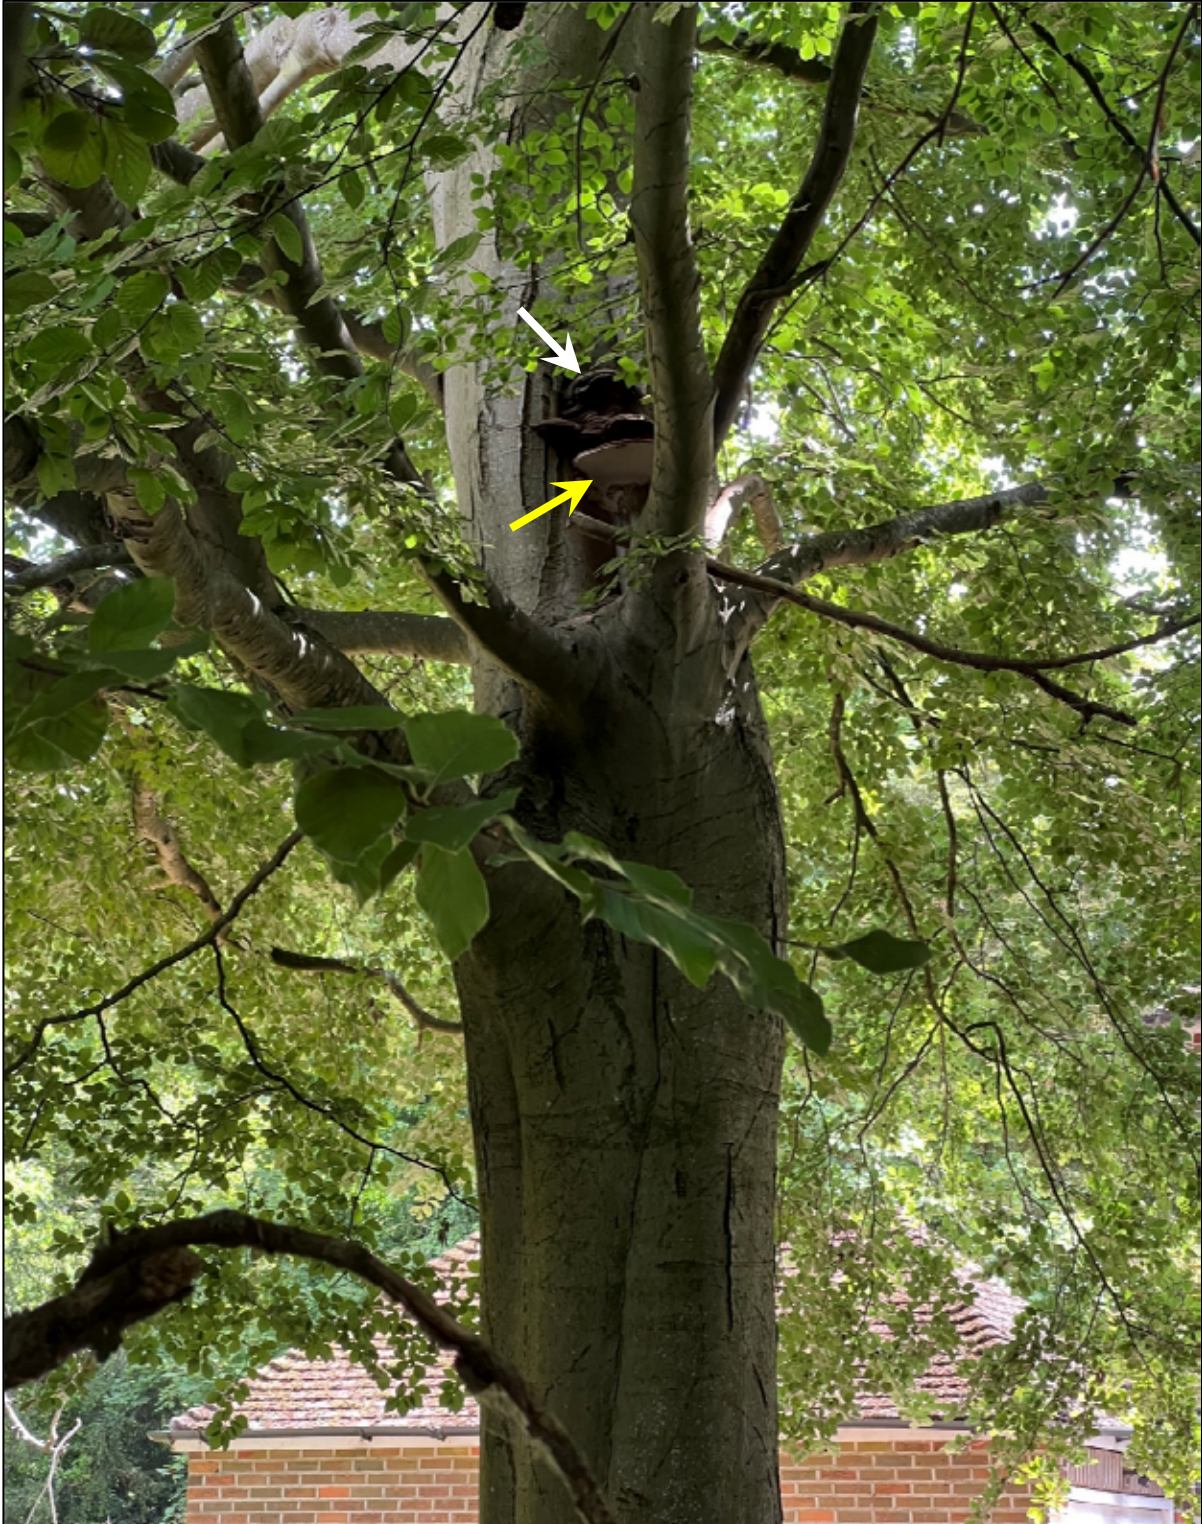
In that context, relating to tree T13, I provide the photographic evidence that we collected on site as Figures 1 and 2 below, showing the cause of our concern relating to the safety of the tree. These images show a large cluster of multiple *Ganoderma* sp fungal brackets on the trunk of T13, which we assess are indications of severe decay and structural instability. This is because our observations shown in the photographs clearly show a large (>30 cm across) active new bracket on the lower side of the cluster, evidenced by its white underside, confirming that it is alive and growing, but also multiple older inactive brackets above it, with some smaller active brackets growing out of those. These old brackets prove that the decay has been present for many years, and the observation that the newest lower bracket is larger than all the others is clear evidence that the decay is progressing and severe. Indeed, when one understands that these brackets are grown from wood digested from within the trunk, then it becomes obvious that there must be extensive and severe decay inside the trunk at this point.

Our assessment of the size of the brackets and the obvious extent of the internal decay is that it cannot be anything other than a severe and deteriorating hazard, creating a reasonably foreseeable risk of harm to the adjacent residential property. As such, it is a high risk because of the adjacent residential use, and clearly falls within the dangerous exception set out in the legislation. Furthermore, this is not a marginal situation where there can be any doubt about the extent of the defect, the existing evidence is compelling and makes it obvious, and it would be both unnecessary, and grossly disproportionate to require further investigation to prove what is obvious. In that context, our advice

**Figure 1:** View of the multiple *Ganoderma* sp fungal brackets on the trunk of T13, showing the newest, largest, and most active bracket with the white underside on the lower side of the cluster (yellow arrow), and the older browner decaying brackets on the upper side of the cluster (white arrow).

In the context of the severity of the decay, we have advised a significant crown reduction, based on the tree having a lot of internal crown foliage, which would provide it with the ability to survive into the longer term, and avoid removing it now. Of course, this is not an ideal solution, but it is a recognised, essential, and viable alternative to premature removal, and becomes necessary to all trees

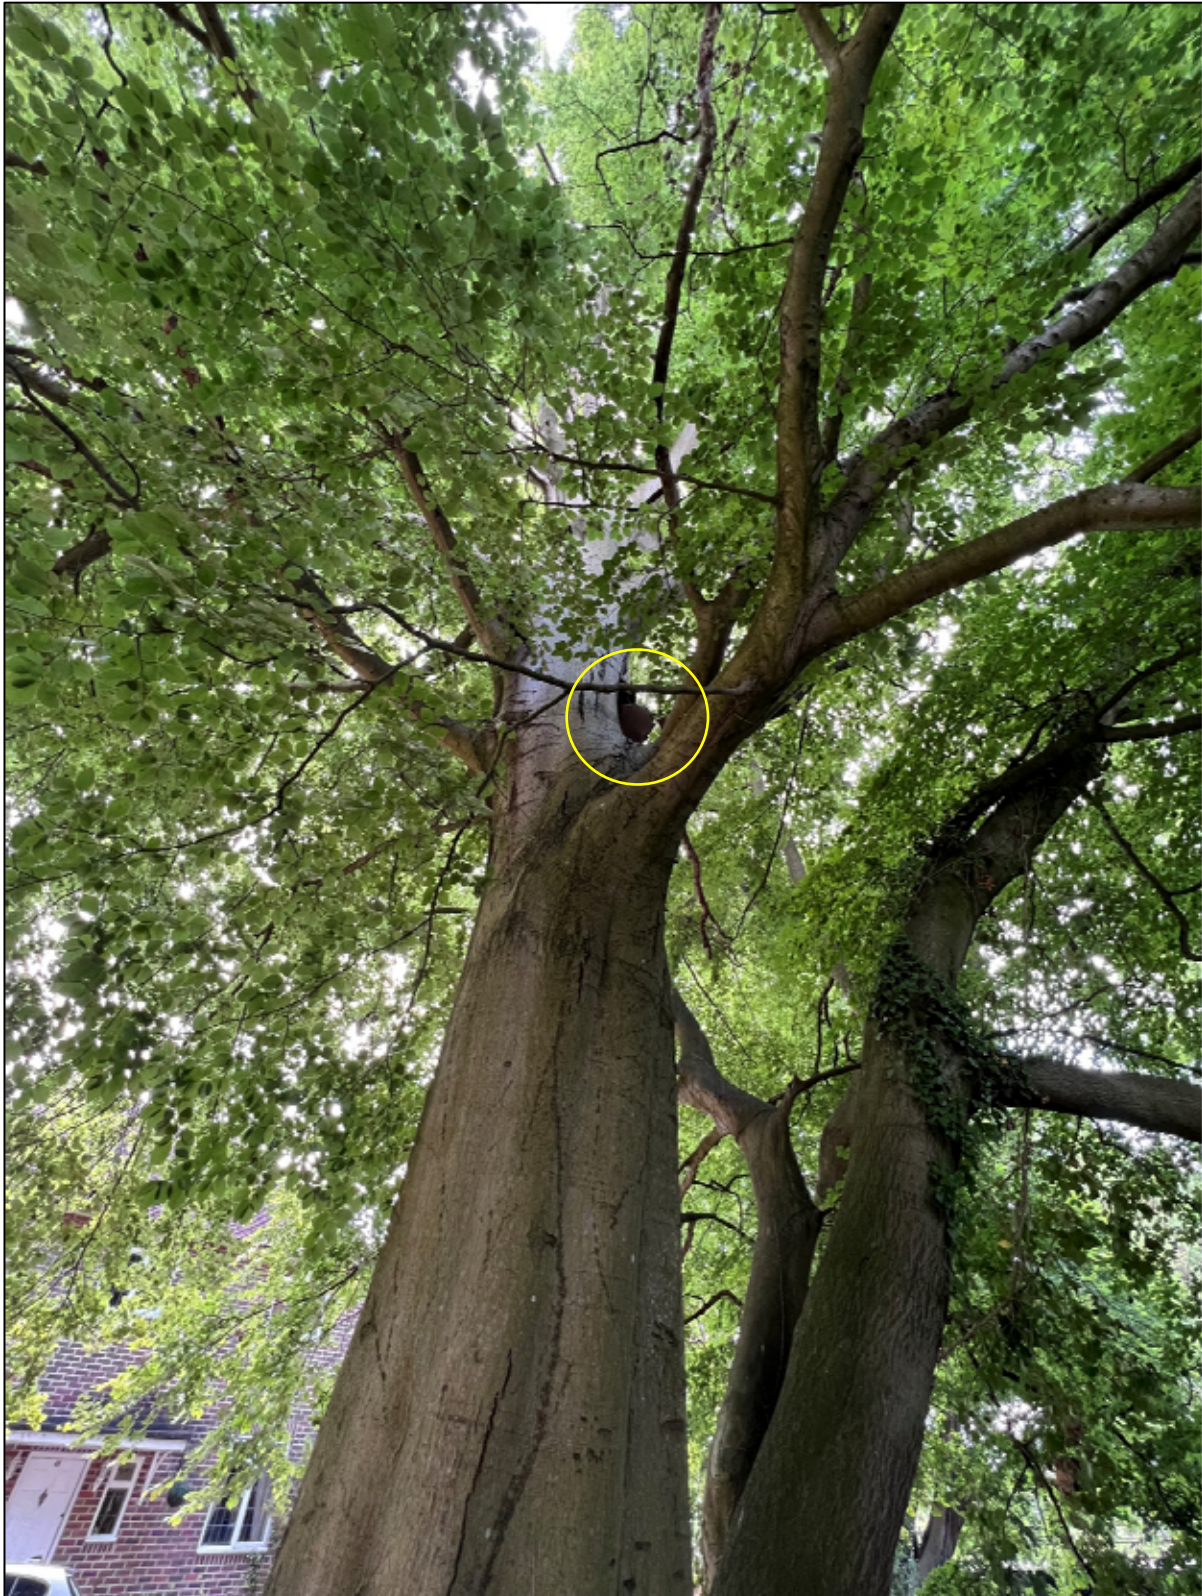
**Figure 2:** More distant view of the multiple *Ganoderma* sp fungal brackets on the trunk of T13 (yellow circle) and the current relationship with the adjacent residential use.

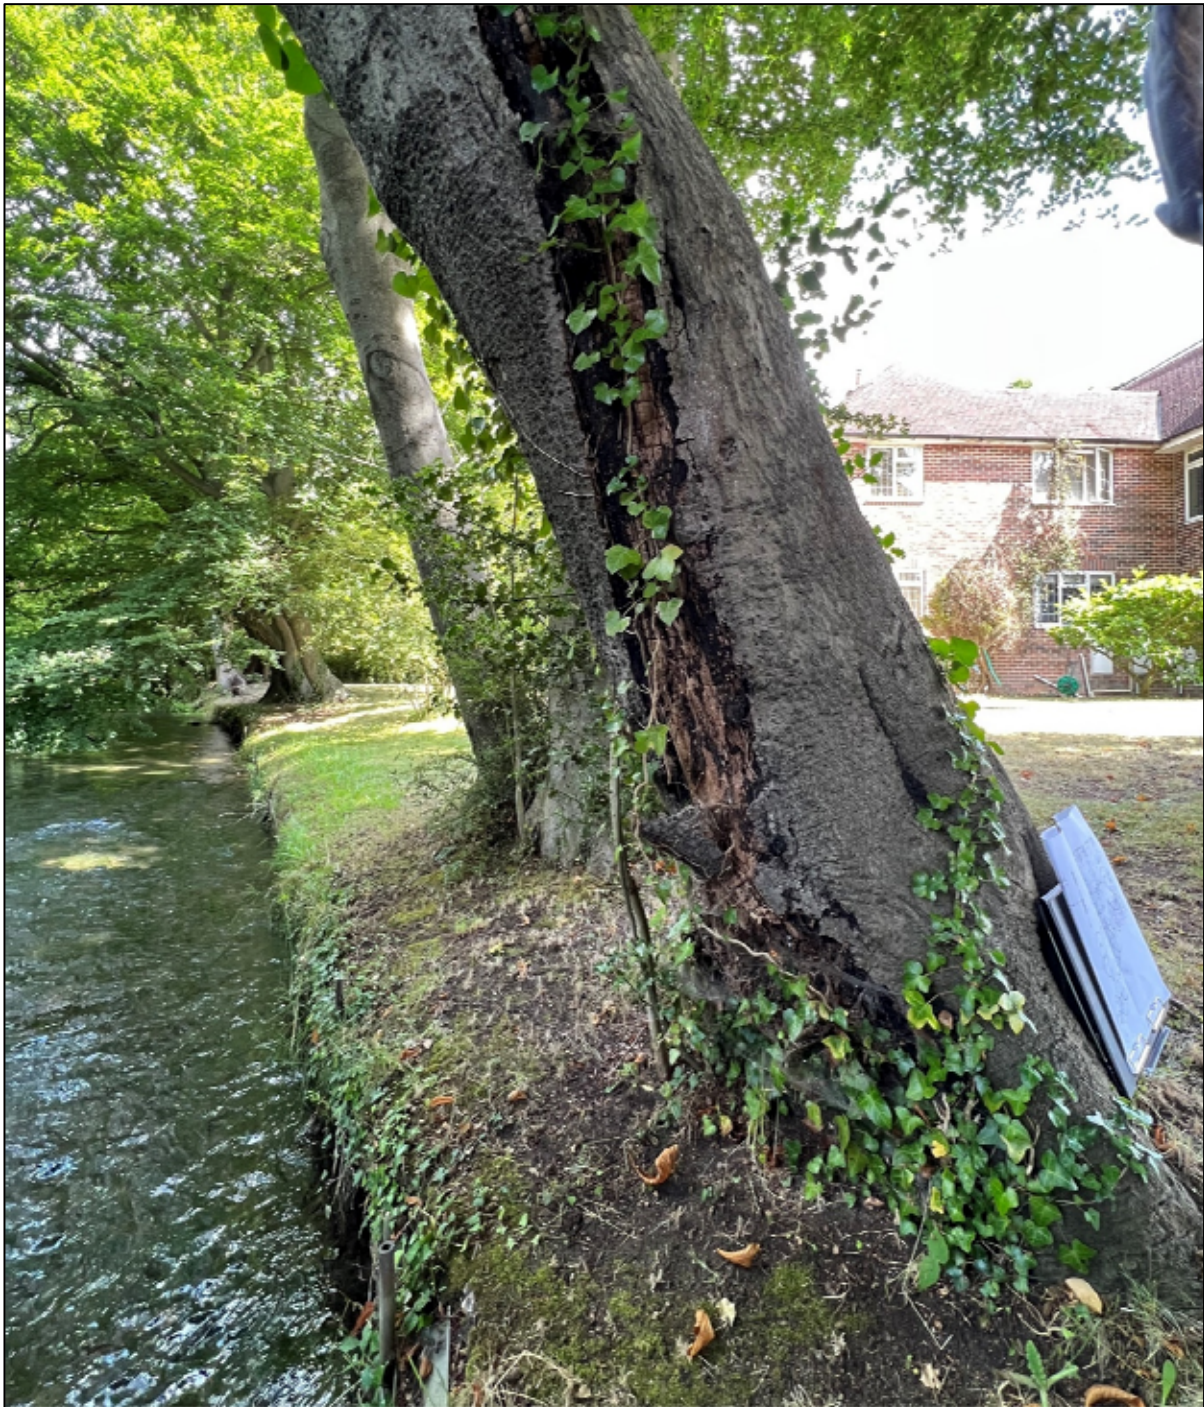
**Figure 3:** An example of other severe defects in the trees within this broad group, that prevents them being retained without significant management works.

As we set out in our report and schedule, there are multiple defects in all these trees, which are so severe that there can be no realistic expectation that they can be retained providing their current visual amenity, and still meet responsible safety management requirements. Indeed, as Figure 3 shows, there is no need to be a tree expert or to pay for sophisticated investigations to appreciate the severity of these defects, it is obvious. Of course, it is unfortunate that such a visually important row of trees is going to have reduced amenity, but the reality is that keeping them as they are and subjecting the adjacent occupants and users of the river to excessive risk is just not acceptable for the duty holders who bear the responsibility for safety. These trees are going to have to be managed, and this planning submission is an opportunity for EBC to agree to responsible works, and secure appropriate replacements for the existing trees once they are gone.
