## Addendum Arboricultural Report

### Subsidence Damage Investigation at:

61 Chalk Hill  
West End  
Southampton  
SO18 3BY

| MWA REF: | SUB210929-9491Rev01 |

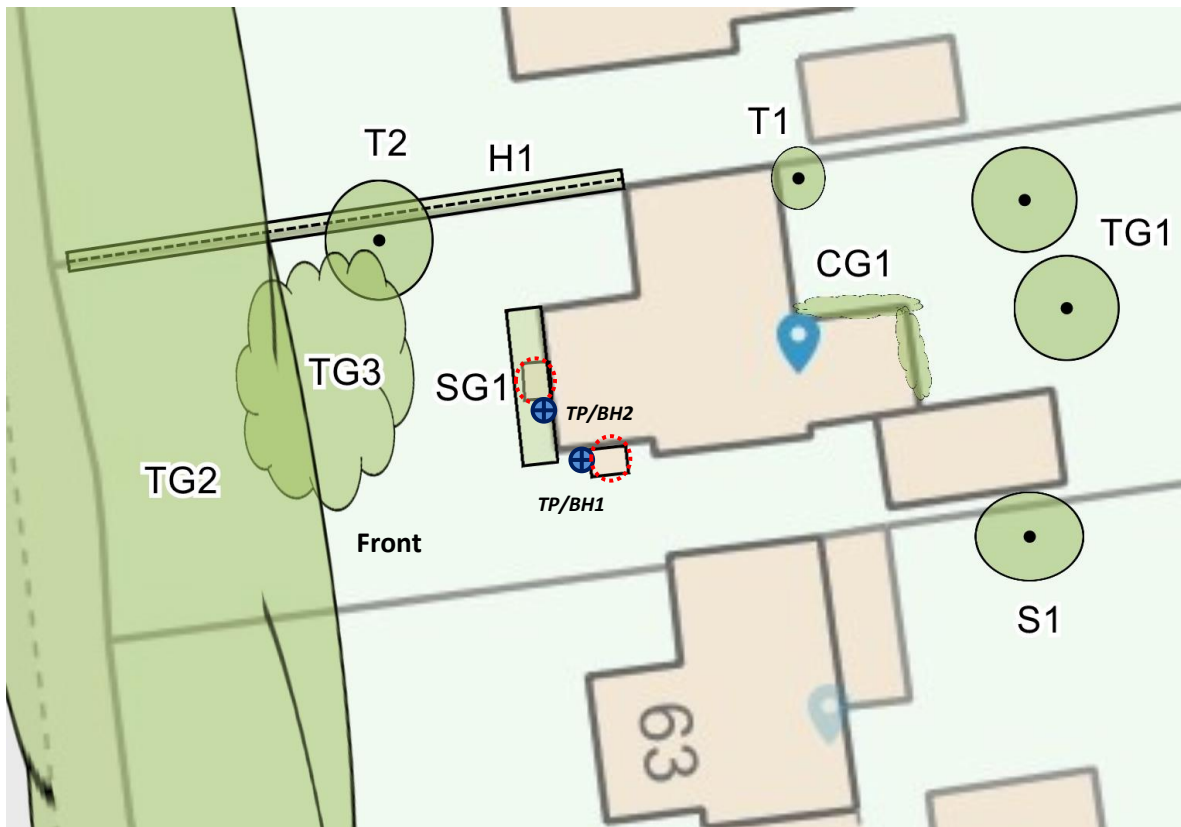
Approximate areas of damage

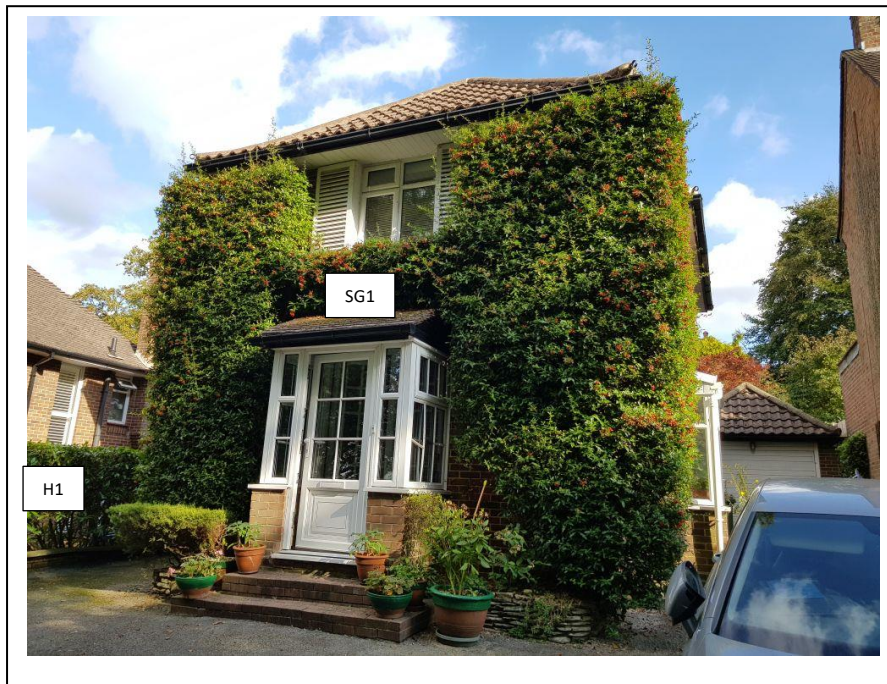
View of front elevation of dwelling

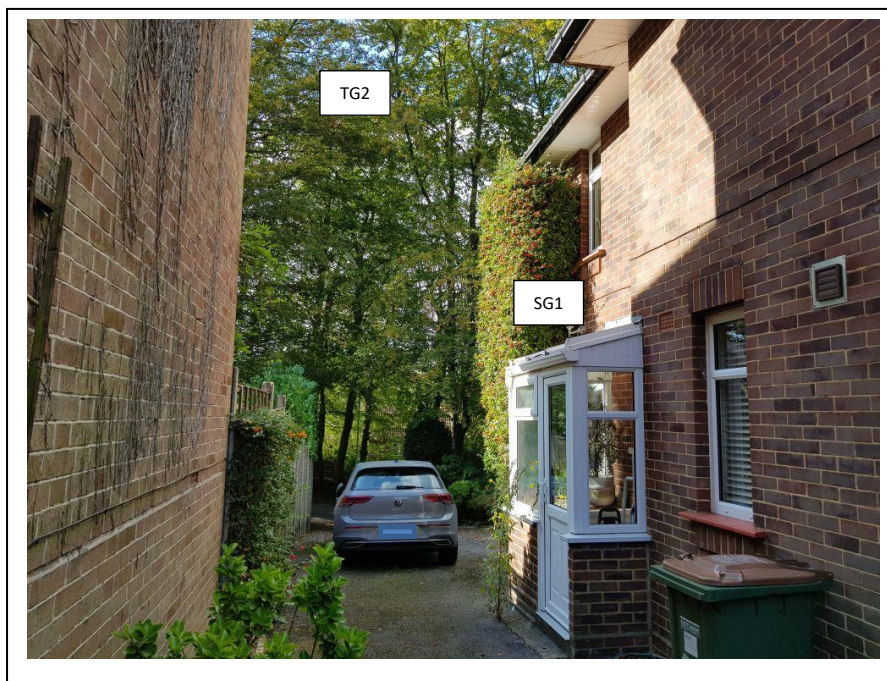
View of right flank of dwelling from rear

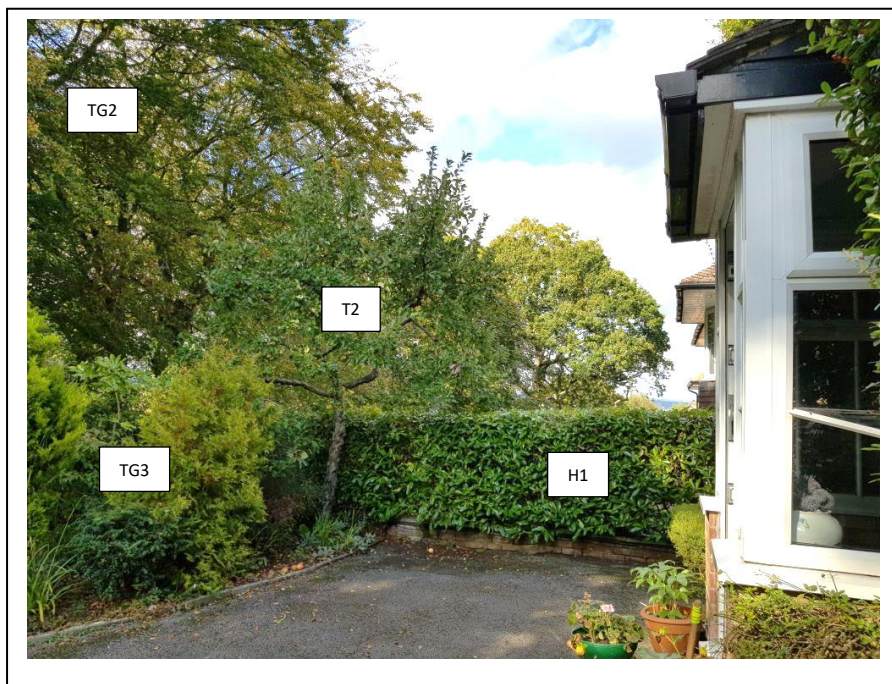
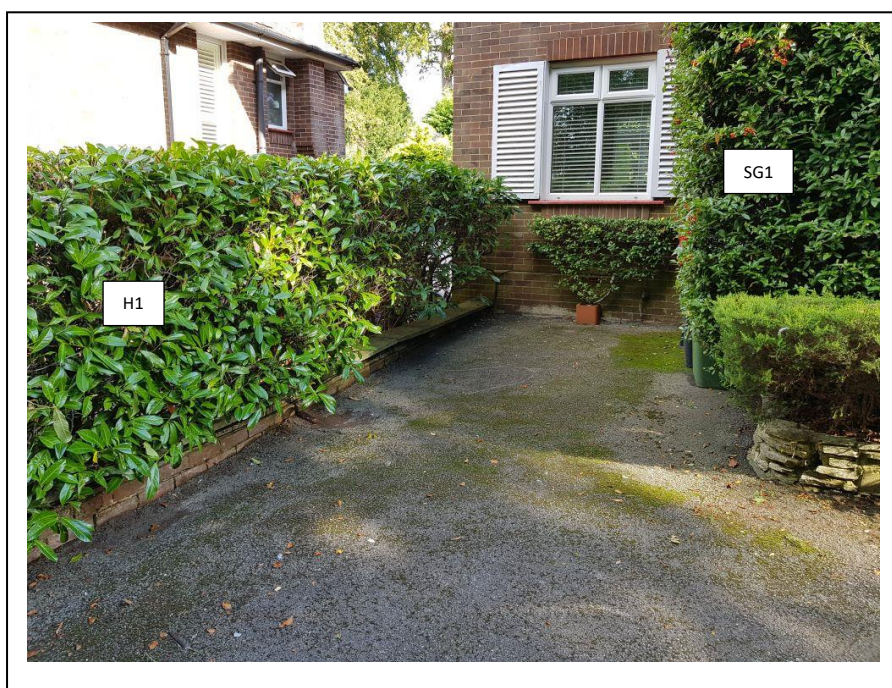
View of vegetation to front left
