## 4 RECOMMENDATIONS

| TPO 413-E – Sweet Chestnut | |

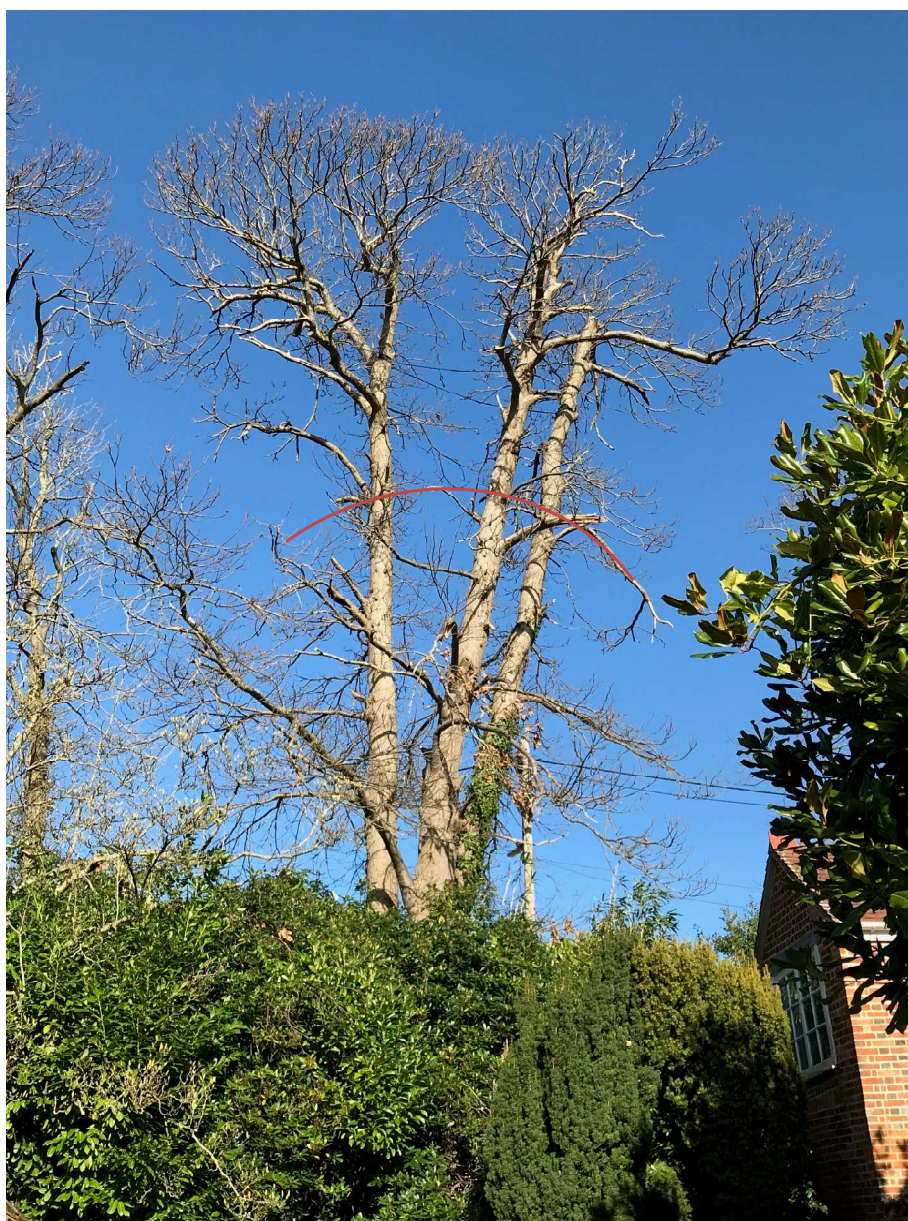
- 4.1 Based on my findings and the trees poor vitality and low amenity value I recommend the following actions:

| TPO 413-E – Sweet Chestnut | |
|---|---|
| Removal of deadwood | Removal of deadwood over 50mm in diameter. |
| Crown reduction | Reduce crown height by 10m (approximately 50%) |
| Line clearance | Remove branches impacting electrical cable back to appropriate growth point. |
