# Tree Inspection and Risk Assessment

12 Alexandra Road

September 2022

| <b>Reference</b> | QU-5611 |

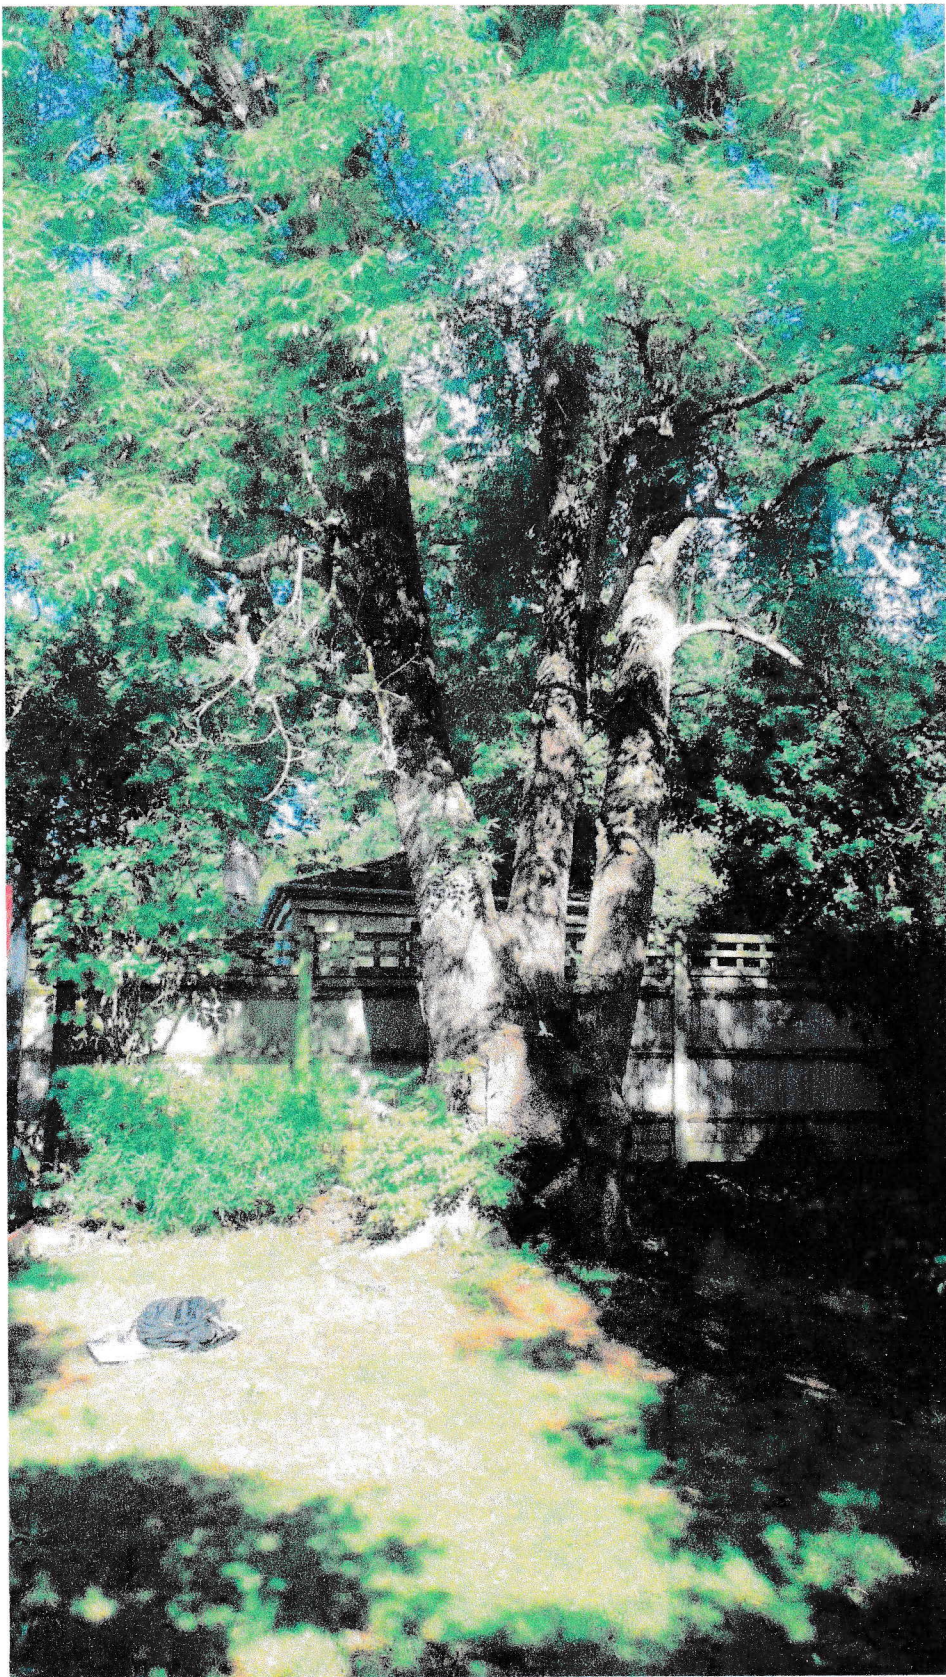
T1 from the east

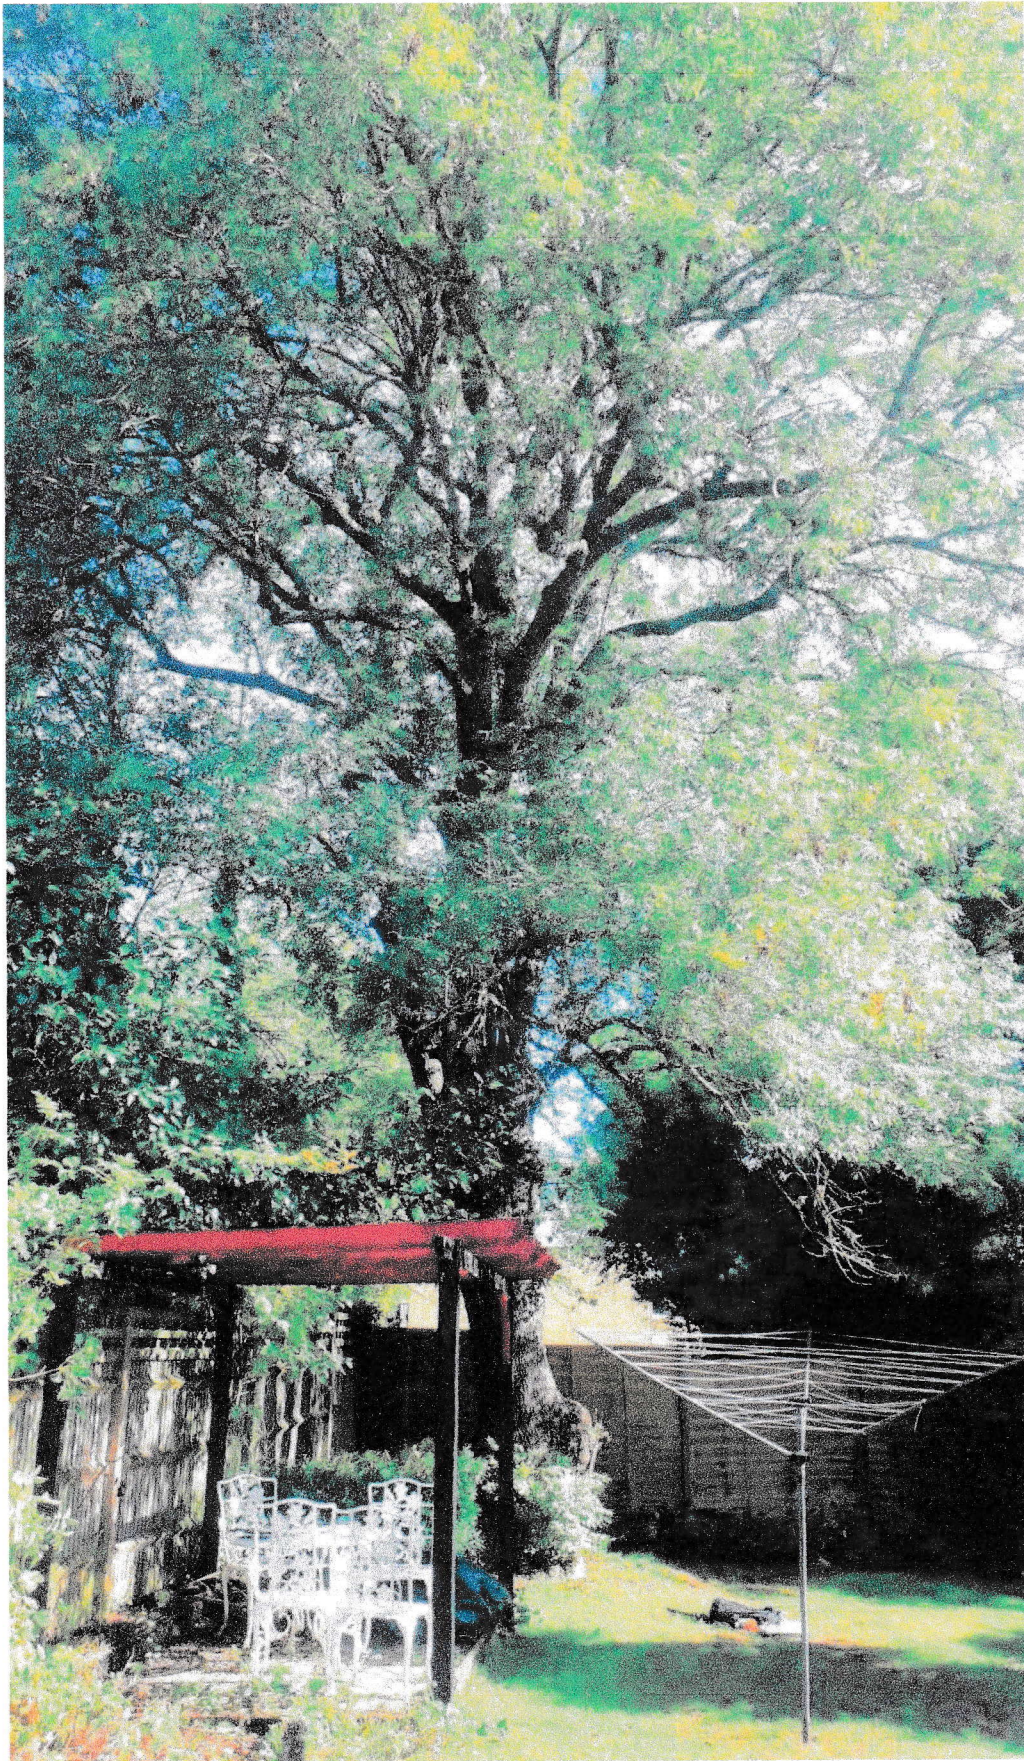
Overall the canopy showed signs of historic deadwood removal and with some localised epicormic growth. The outer canopy is showing signs of localised thinning on the southern aspect which is associated with Ash Die Back.

T1 from the south

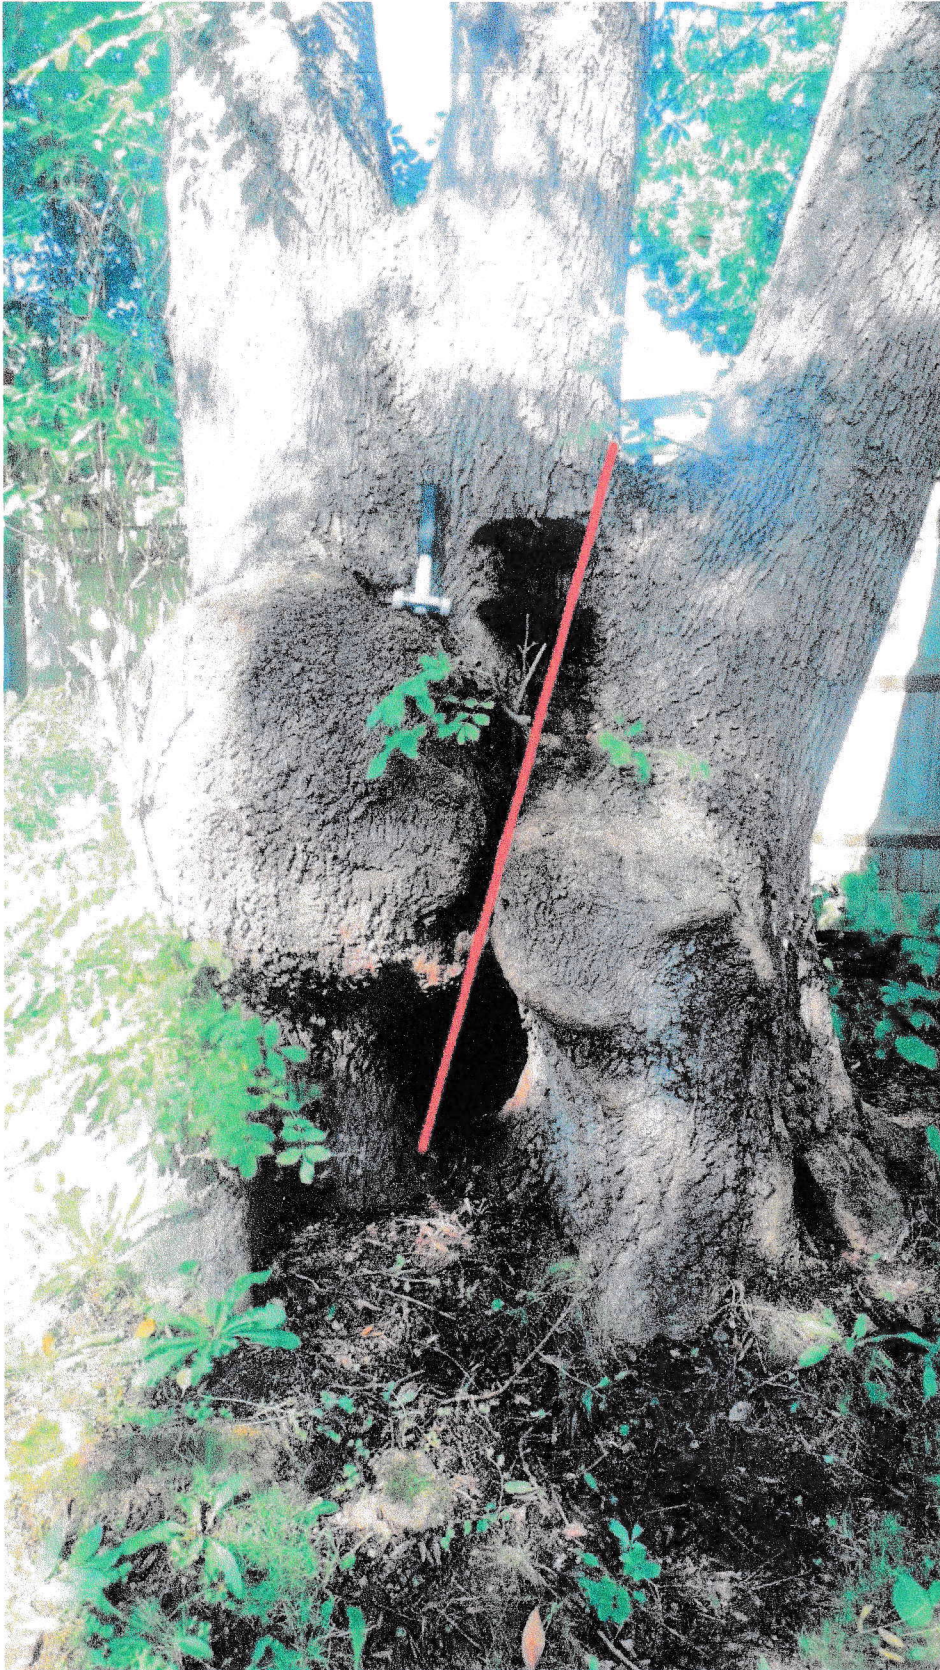
Above this cavity is another unusual cavity between the burr and unusual growth feature. It is approx. 50mm wide and 270mm deep.

This linked cavity feature extends beyond 1.5m from the ground level in the centre of the tree.

Above this cavity feature 2no. *Inonotus hispidus* fungal brackets were visible.

Below these fungal brackets was necrotic bark and associated staining.

These 2 cavity features and the location of the fungal brackets are all linked decay features.

This historic feature is likely the result of several individual decay features which over time have linked and created a significant cavity /void with associated dysfunctional tissue, this has exacerbated potential structural issues.

This species creates a simultaneous white rot form of decay which breaks down the cellulose and lignin in the affected area.

The effect of this fungi is significant and can result in stem or branch failure.

The location of the fungi is also significant as it is just below one of the unions of the triple stem.

However due to the trees triple stem formation, the extent of decay and continuing loss of strength due to *Inonotus hispidus* the risk of a stem failing is high.

Close up of the linked decay feature and *Inonotus hispidus* and the most likely point of failure, represented by the red line.

Given all the issues facing the tree and its location it is recommended to fell the tree and replant with a suitable garden tree.

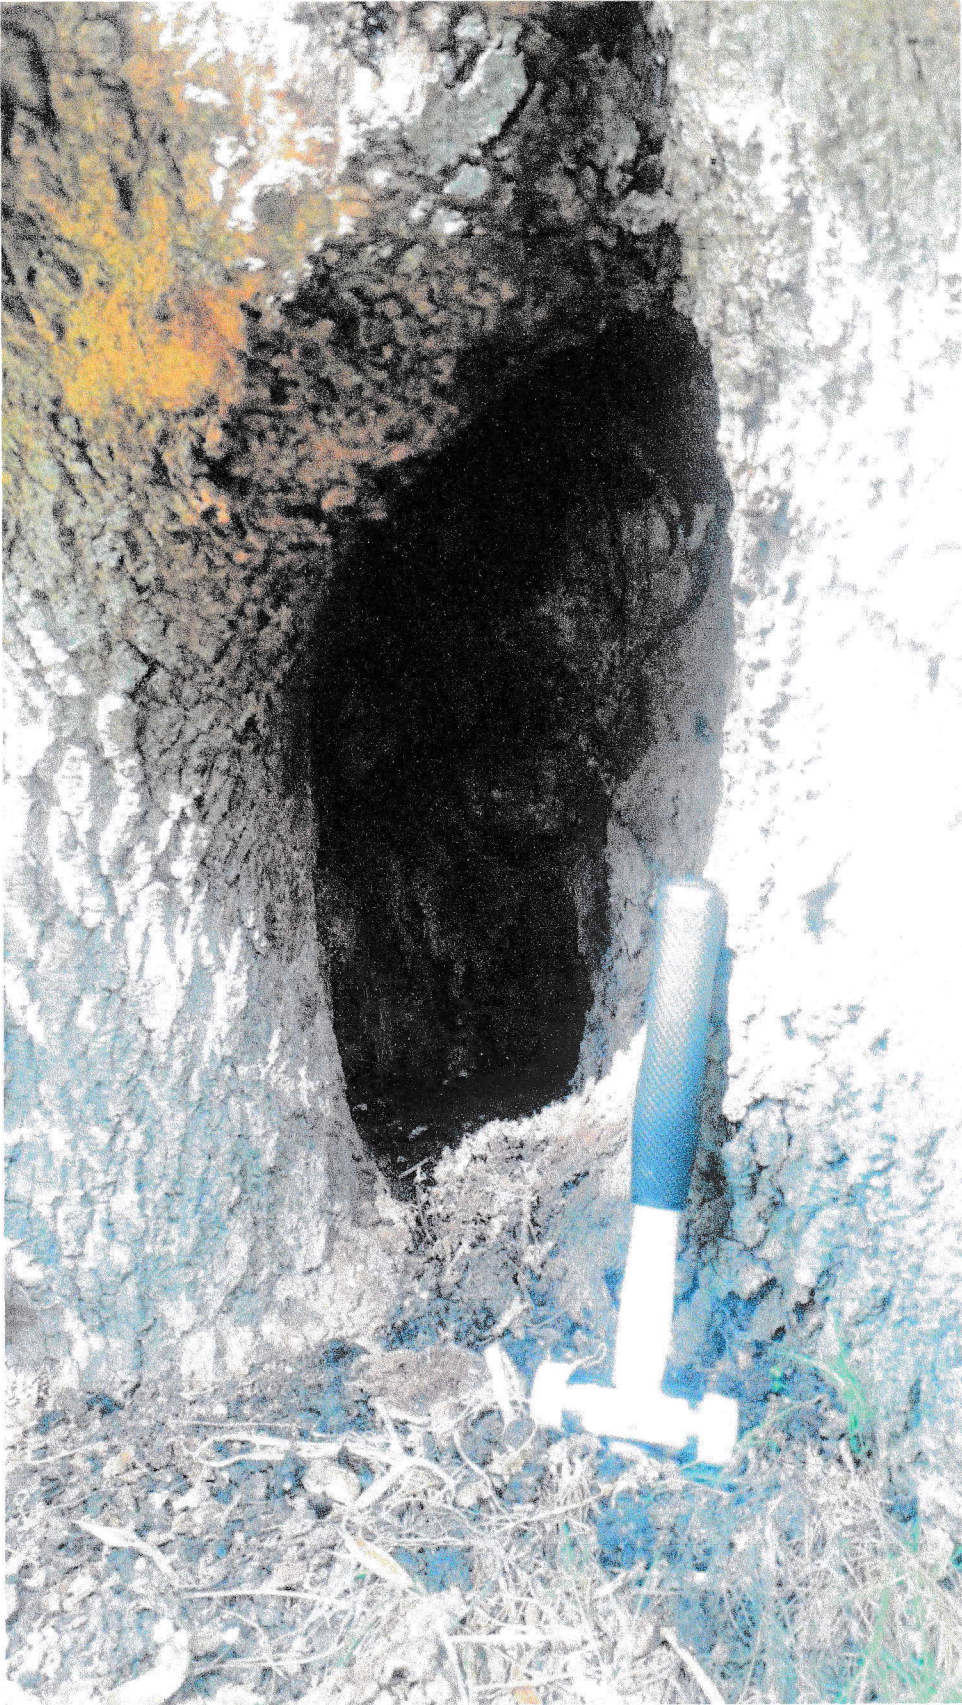
There is a recessed buttress cavity/void from ground level on the eastern side the stem with a 250mm wide opening which is approx. 500mm in height this presented an approximate circular internal void with a 300mm depth to the back wall. There was an area of decay on the back wall, on probing this extended to an extra 300-350mm in depth.

The basal cavity with a sounding hammer for scale.
