**Arboricultural inspection at 23  
Oakwood road, Chandlers Ford,  
Eastleigh, SO53 1LW**

Carried out by Matthew Rowden, Consultant at  
Romsey Tree Surgeons LTD, for Paul Richardson of  
the above address.

Report reference: RTS/23OR/PR/V1

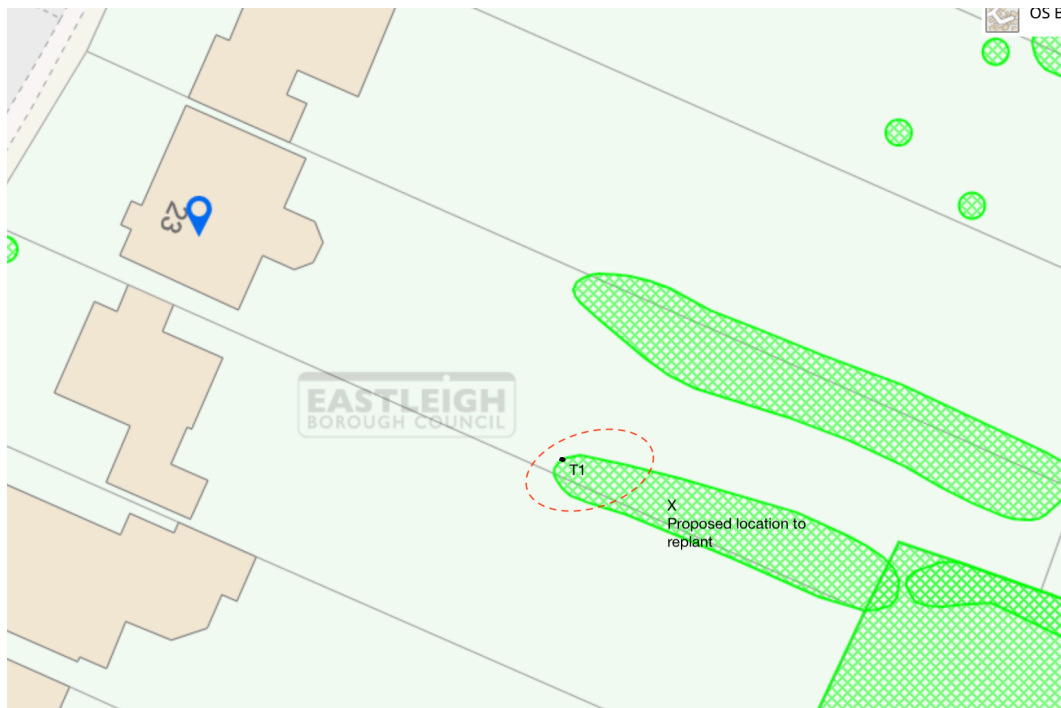
## **Appendix 2: Tree location plan**

- 4. Drawings and documents:** The client has not provided scale plans for the site to aid identification of the tree. A drawing has been obtained from Eastleigh borough council to aid identification. The tree mentioned on the plan shall henceforth be known as T1.
