**Project:** 22\_RESI\_08\_24  
**Site:** 1 Portchester Rise, Allbrook, Eastleigh, SO50 4QS  
**Client:** Carl Rivers

| Document Title: | Tree Safety Survey - 3 year time cycle. |
| Project Title: | 1 Portchester Rise, Allbrook, Eastleigh, SO50 4QS |

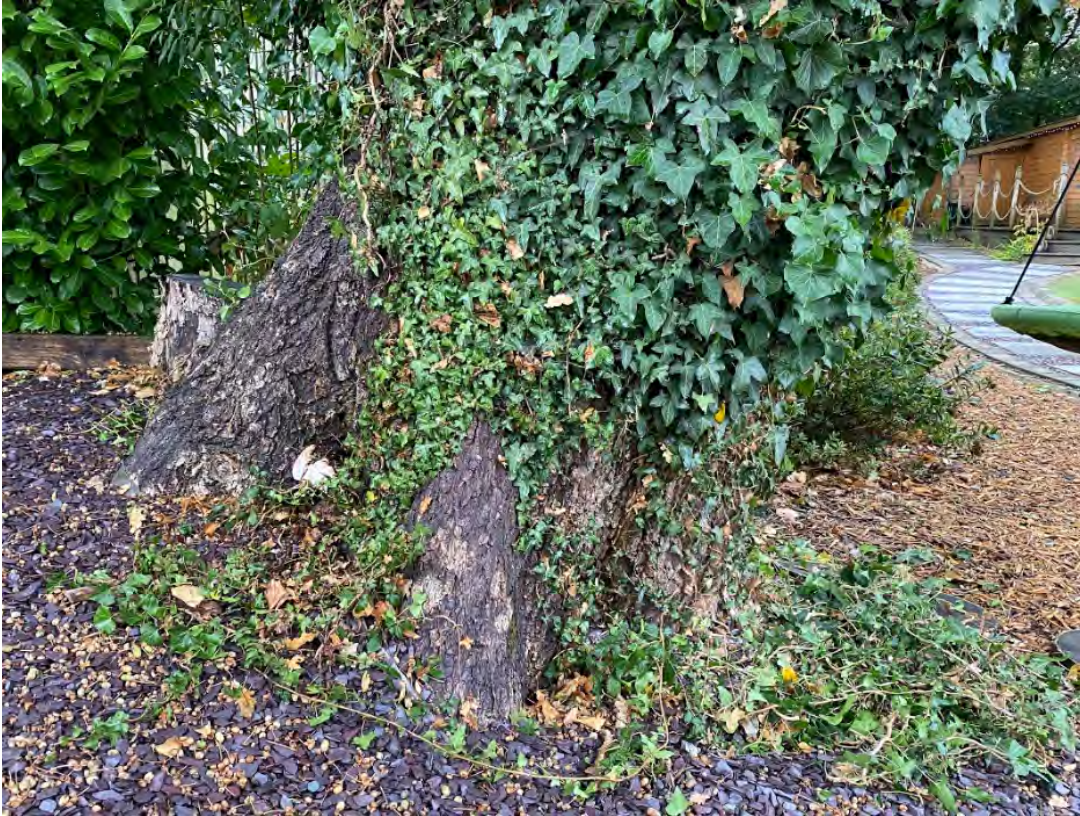
*Photographic plate showing the base of T1 prior to removal of ivy cladding*

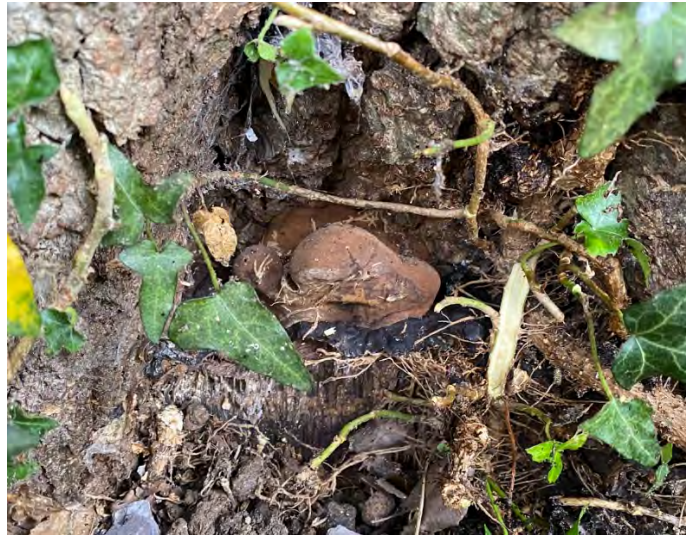
*Photographic plate showing an immature Ganoderma fruiting body to the east of T1's stem at ground level, and the remains of a blackened mature fruiting body underneath..*

The fungal fruiting bodies were identified as *Ganoderma applanatum*, and were concentrated around the base of the stem, to the south-west, south-east, and north. The tree was tested using a Resi F400 microdrill, which found extensive decay at the base of the stem, and confirmed the column of decay extending up the stem. The residual wall thickness of wood was between 9 and 11 cm, although much of this remaining wood appears to be degraded. Only the drill taken through the buttress root to the west showed any spike of reaction wood.

- 4.1 Recommendations for safety works are included within the data tables, with additional recommendations in the paragraphs below.
- 4.2 T1 should be removed as soon as possible, and in any case within 3 months of the date of survey.
- 4.3 T2 should be crown reduced by 2 metres in spread to the west, and the height also reduced by 2 metres.
- 4.4 The recommendation for T1 remains as previously stated.

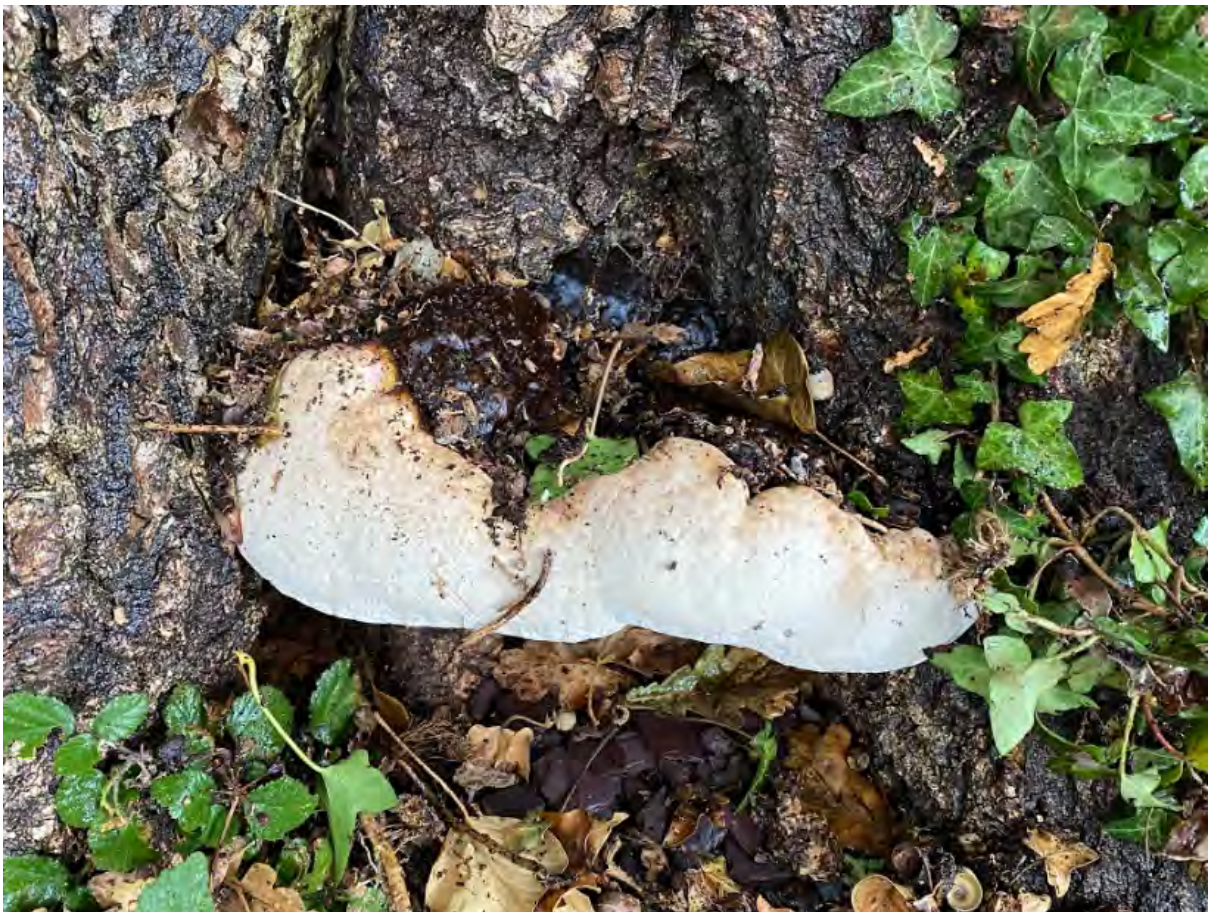
*Photographic plate showing a mature Ganoderma fruiting body to the southwest of T1's stem at ground level.*

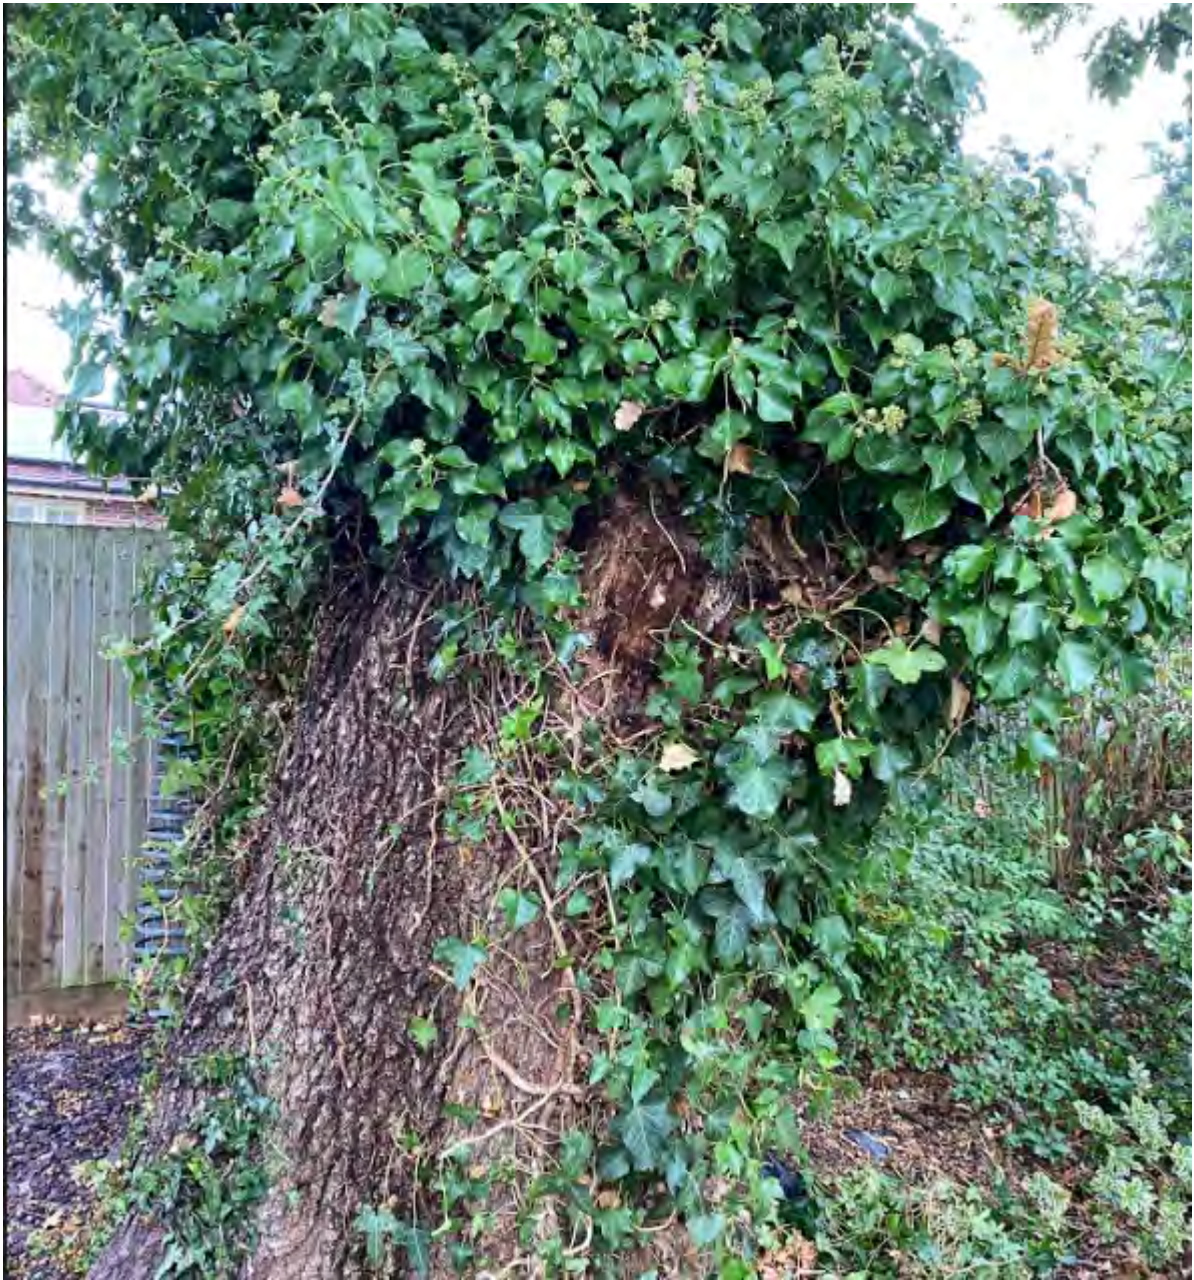
*Photographic plate showing the stem of T1 with the ivy cladding partially removed to reveal a large historic pruning wound to the east.*

- 3.5 T1 is a mature Oak, which was identified as showing signs of decay and fungal fruiting bodies during an added ecology survey by ROAVR. The tree was heavily ivy clad, this was partially removed to reveal a large historic pruning wound to the east at a height of 1.7 metres. The wound is not occluded, and is extensively decayed. Sounding with a mallet suggested column of decay extends from the base of the tree to the wound.

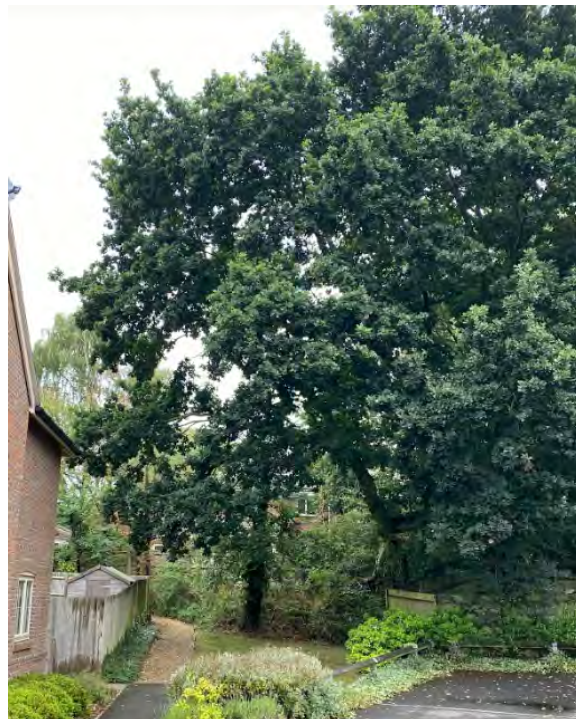
*Photographic plate showing the crown of T2 encroaching on an adjacent dwelling.*

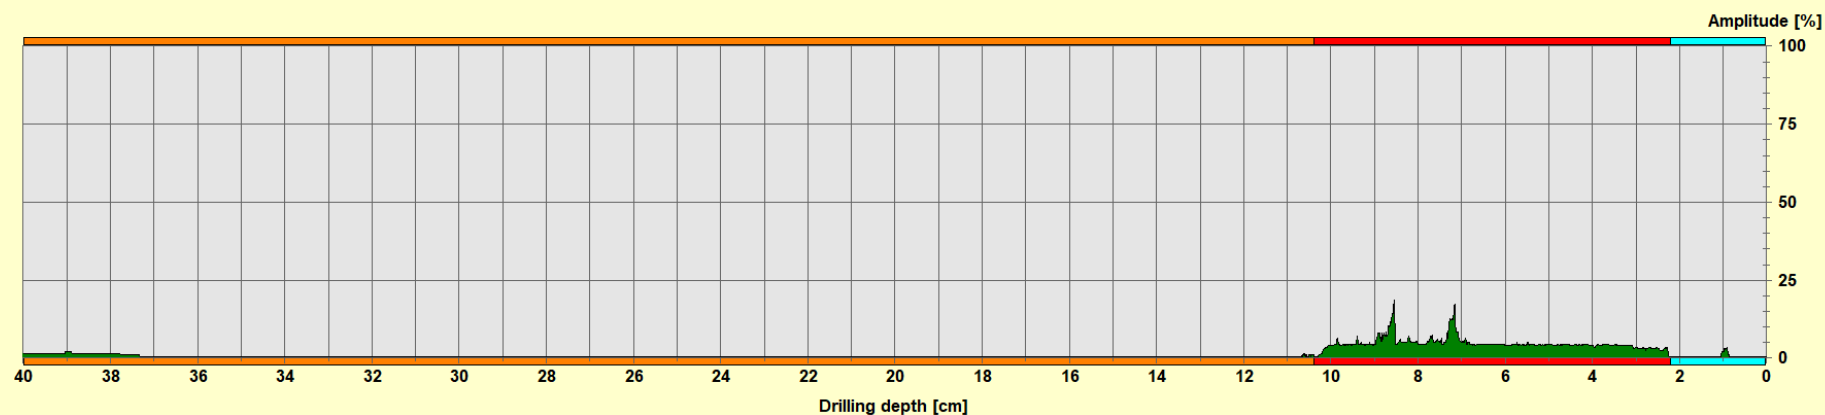
| Measurement no. : | 1 | Tilt : | 76° (1°) | Name : | |

| From 2,2 cm to 10,4 cm : | Decay |
| From 10,4 cm to 40,0 cm : | Cavity |

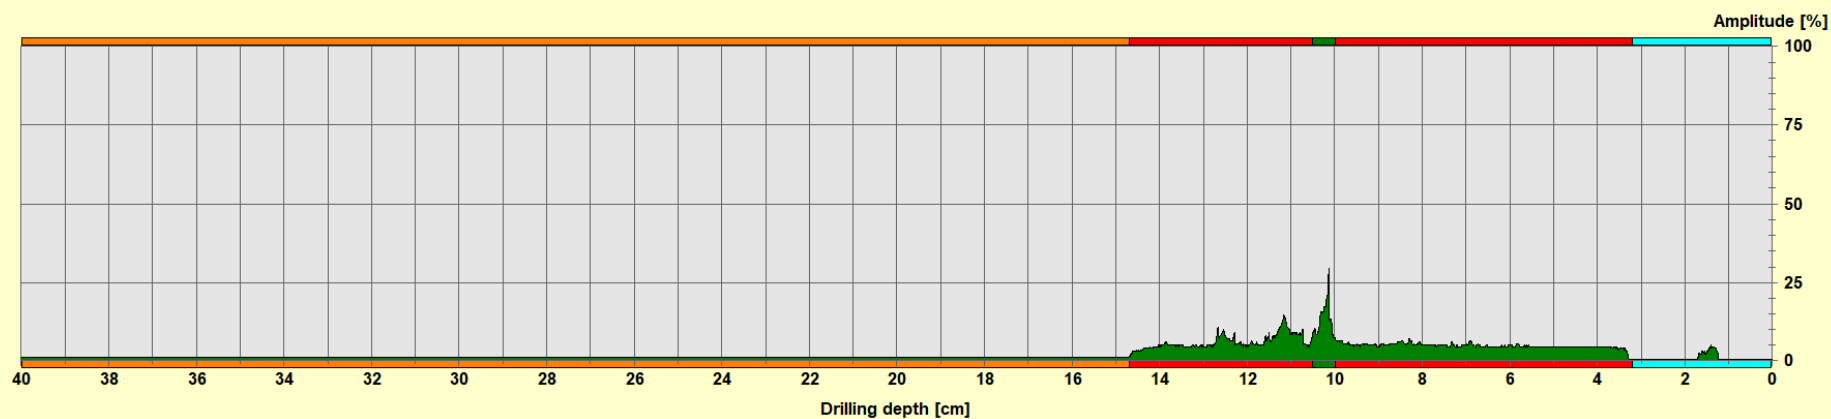
| Measurement no. : 2 | Tilt : 76° (1°) | Name : |

| From 3,2 cm to 10,0 cm : | Decay |
| From 10,5 cm to 14,7 cm : | Decay |
| From 14,7 cm to 40,0 cm : | Cavity |

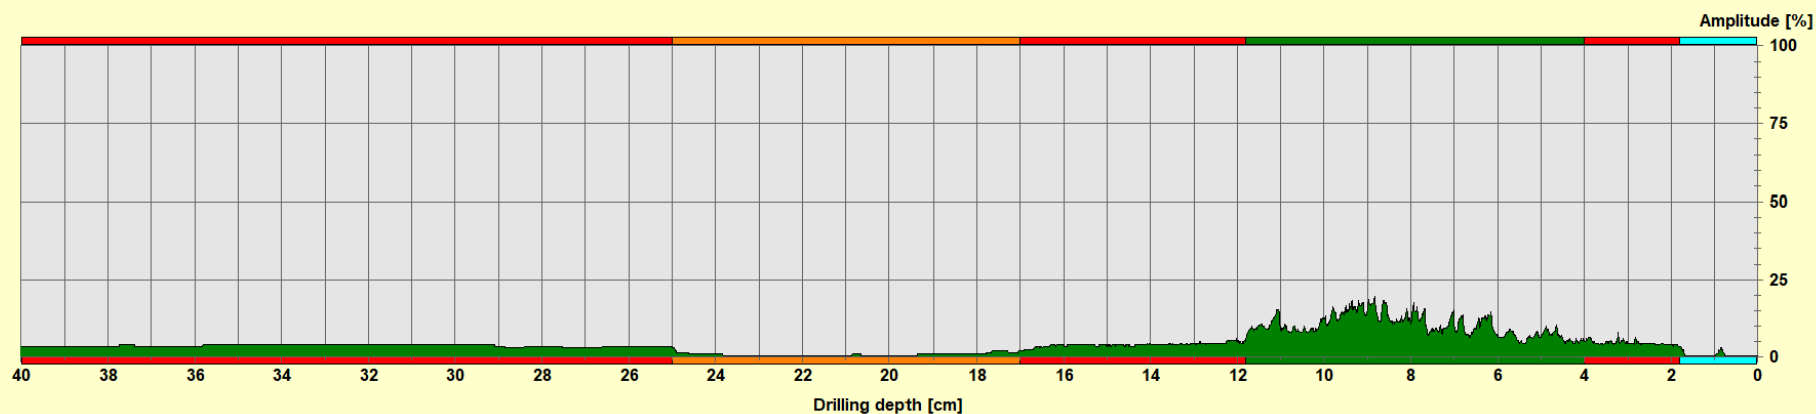
| Measurement no. : | 3 | Tilt : | 58° (1°) | Name : | |

| From 1,8 cm to 4,0 cm : | Decay |
| From 11,8 cm to 17,0 cm : | Decay |
| From 17,0 cm to 25,0 cm : | Cavity |
| From 25,0 cm to 40,0 cm : | Decay |

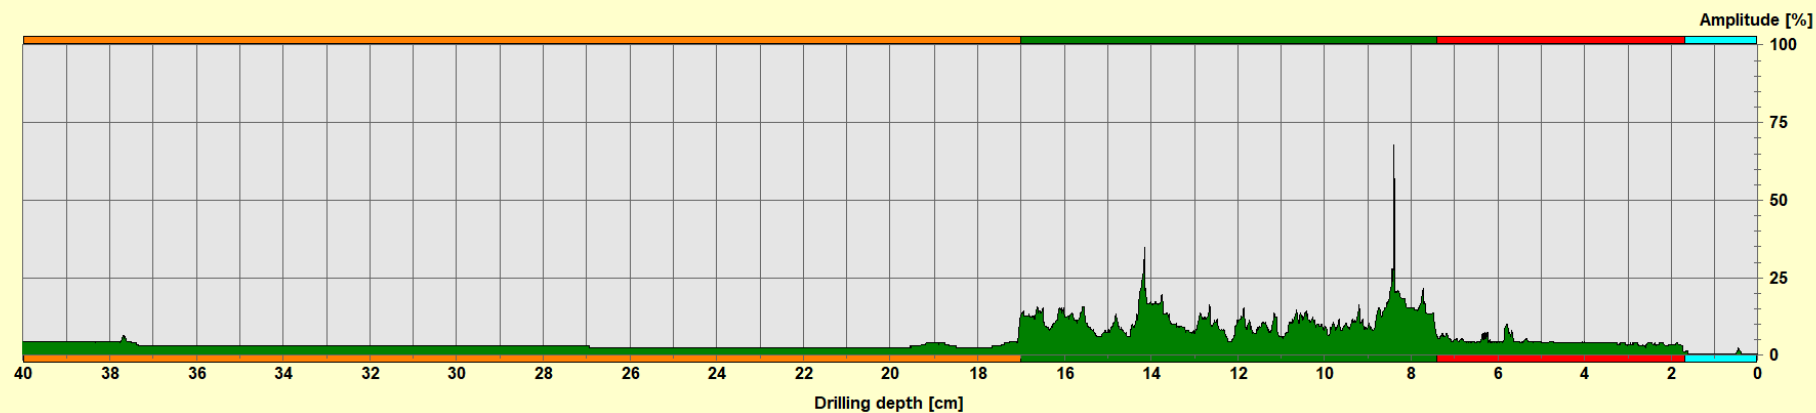
| Measurement no. : | 4 | Tilt : | 54° (1°) | Name : | |

| From 1,7 cm to 7,4 cm : | Decay |
| From 17,0 cm to 40,0 cm : | Cavity |

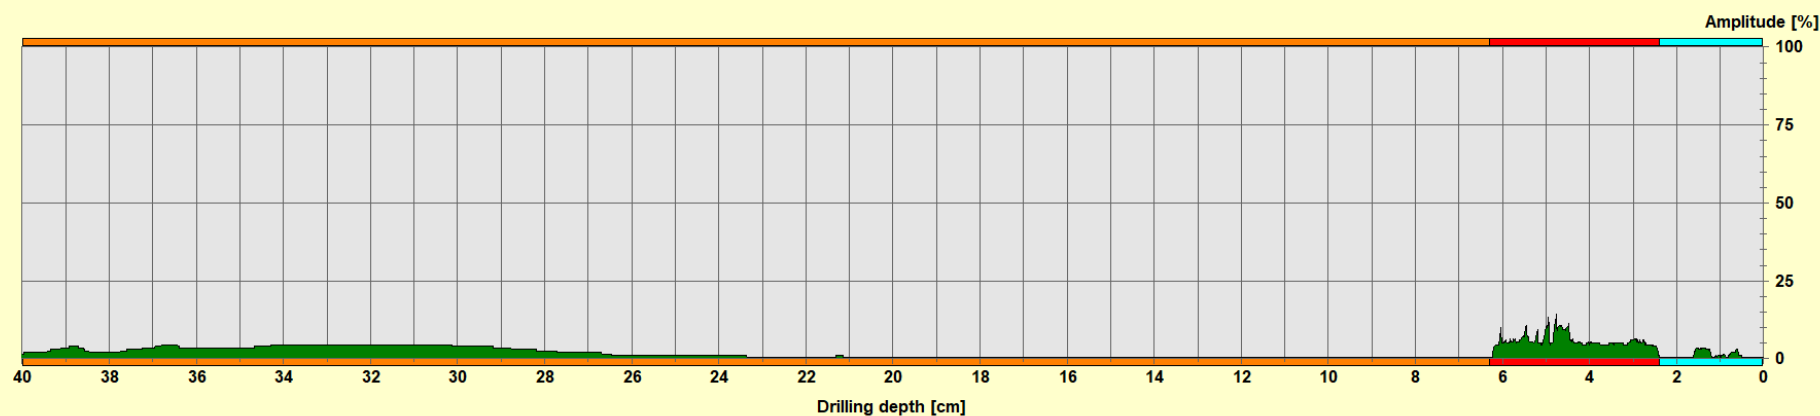
| Measurement no. : | 6 | Tilt : | 90° (1°) | Name : | |

| From 2,4 cm to 6,3 cm : | Decay |
| From 6,3 cm to 40,0 cm : | Cavity |

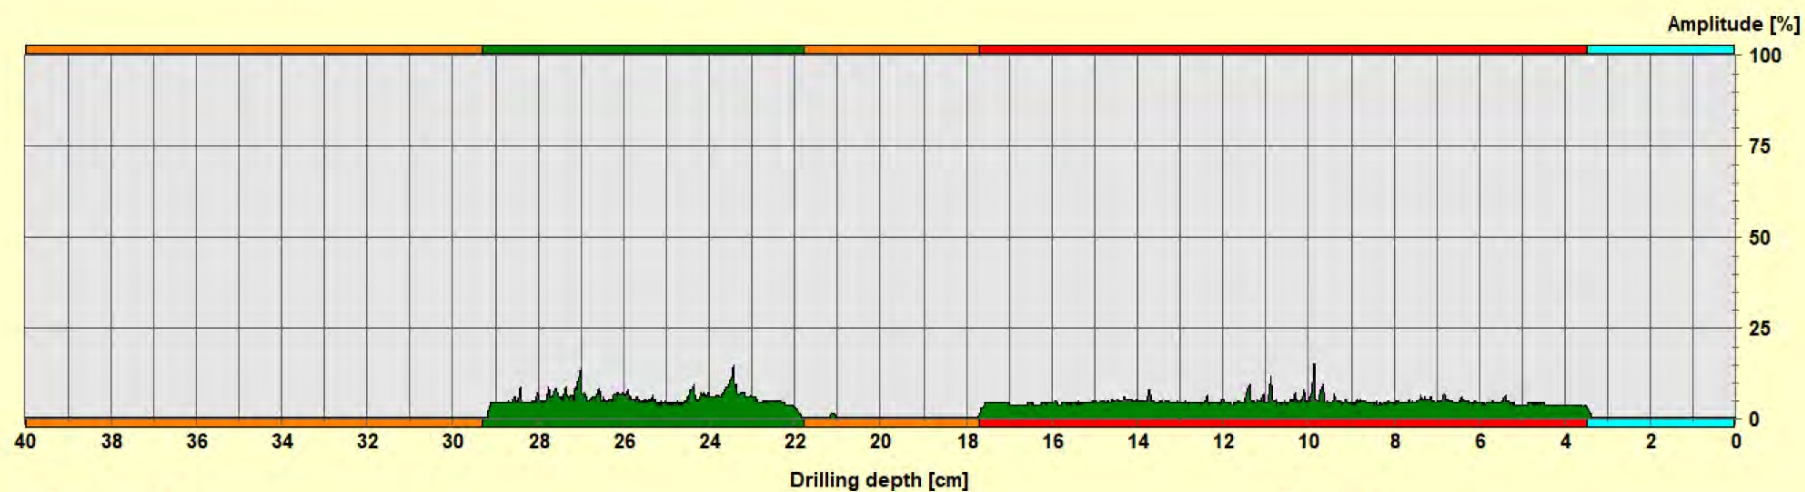
| Measurement no. : | 12 | Tilt : | 77° (1°) | Name : | P Haine |

| From 3,5 cm to 17,7 cm : | Decay |
| From 17,7 cm to 21,8 cm : | Cavity |
| From 29,3 cm to 40,0 cm : | Cavity |

Drill into buttress root. Some sound wood at around 10 cm, but the majority of this section is significantly degraded.

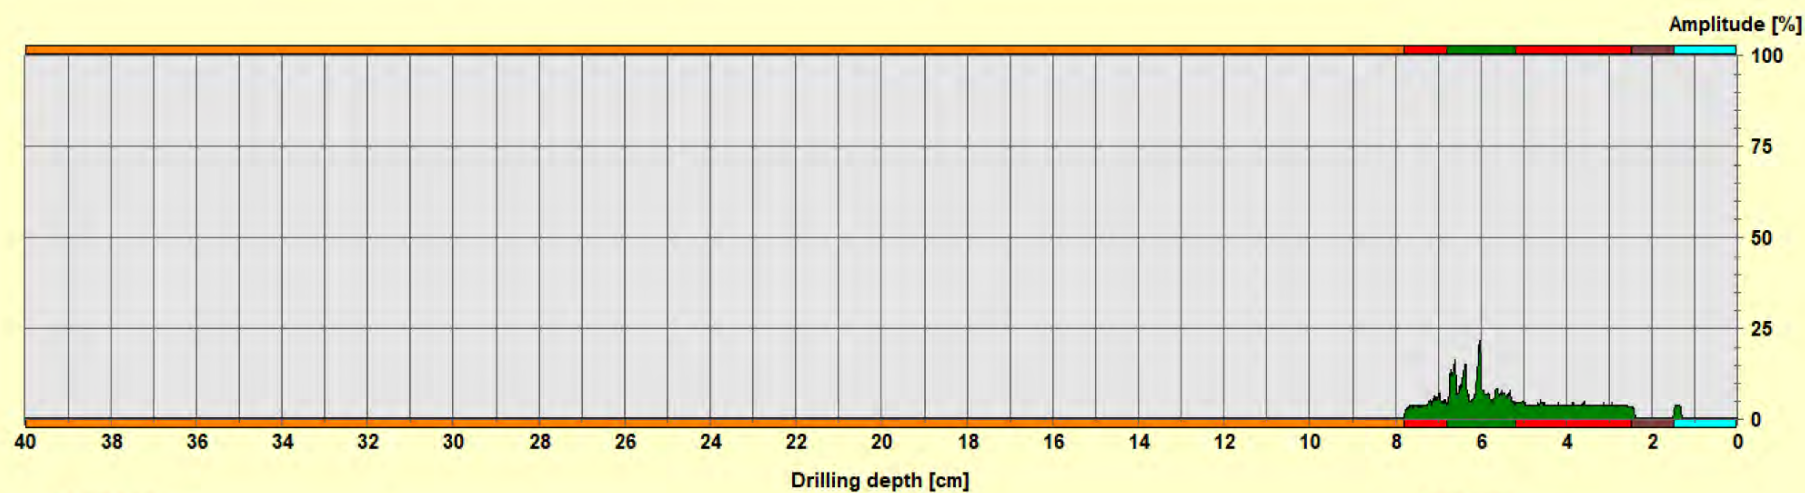
| Measurement no. : | 13 | Tilt : | 75° (1°) | Name : | P Haine |

| | From 2,5 cm to 5,2 cm : | Decay |
| | From 7,8 cm to 40,0 cm : | Cavity |

Between buttress roots. (20 cm.)

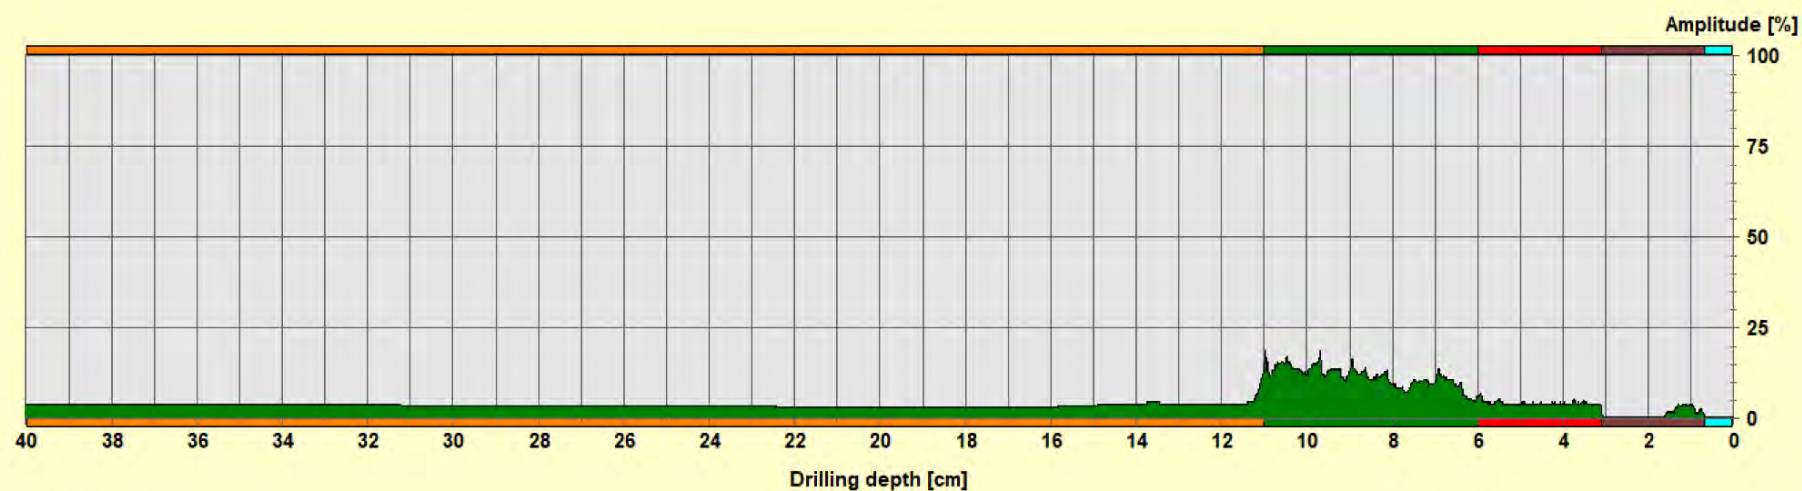
| Measurement no. : | 14 | Tilt : | 81° (1°) | Name : | P Haine |

| From 3,1 cm to 6,0 cm : | Decay |
| From 11,0 cm to 40,0 cm : | Cavity |

Between buttresses. (40cm)
