**VISUAL TREE ASSESSMENT REPORT  
(VTA)**

**RUNNYMEDE ESTATE,  
RUNNYMEDE, WEST END,  
SOUTHAMPTON**

**NAPIER MANAGEMENT SERVICES LTD**

**Report Number: MB230104**

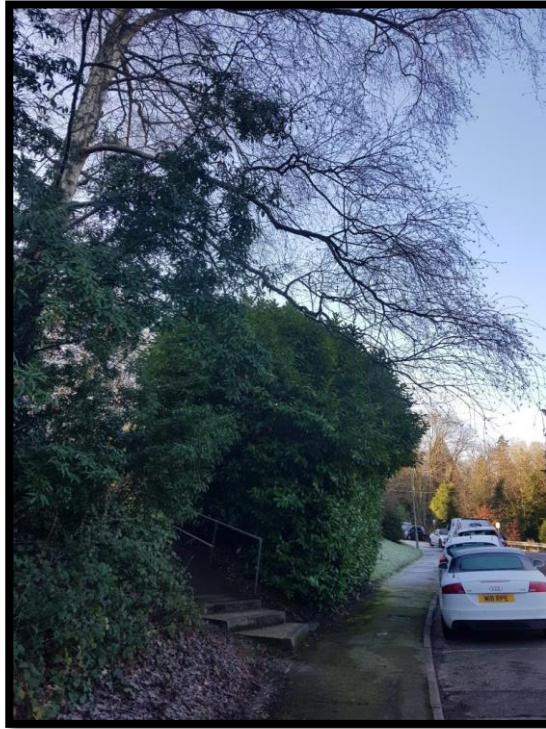
**4.1.2** Tree number 5 was observed to be growing adjacent to the highway and footway of Runnymede with low hanging branches. See Plate 3.

**Plate 3: Tree number 5 whips vehicles beneath the branches.**

Trees and vegetation that overhang the highway should be crown-lifted to at least 5.2 m to allow safe passage of high sided vehicles as well as being cut back sufficiently from the edge of the carriageway to allow clearance for wing mirrors. Trees and vegetation that overhang footways and footpaths should be crown-lifted to at least 2.5 m and cut back to ensure the footpath/way is at least 1.2 m in width. This is to allow safe passage for all footpath/way users including wheelchairs, mobility scooters, etc.

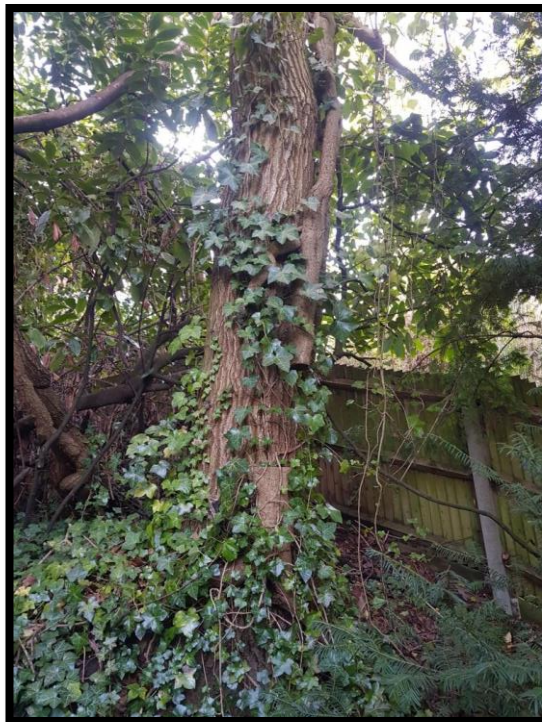
**4.1.3** The understorey vegetation of the trees surveyed are suppressed and stunted due to the canopy cover. In addition, the Cherry Laurel remains a concern as it has not been managed or maintained which is becoming overgrown and reducing the garden space. It is strongly advised to begin eradication of the non-native species of Cherry Laurel as this plant can overshadow the ground flora and encroach onto the garden space causing excessive shade. See Plate 4.

**Plate 4: Non-native Cherry Laurel.**
