## **Appendices 1-4 to Statement on behalf of the Appellant (Trees)**

Land adjacent to Braeside House, 49 Bishopstoke Road, Bishopstoke, Eastleigh, Southampton, Hampshire SO50 6BF

## Arboricultural impact appraisal and method statement

Land adjacent to Braeside House, 49 Bishopstoke Road, Bishopstoke, Eastleigh,  
Southampton, Hampshire SO50 6BF

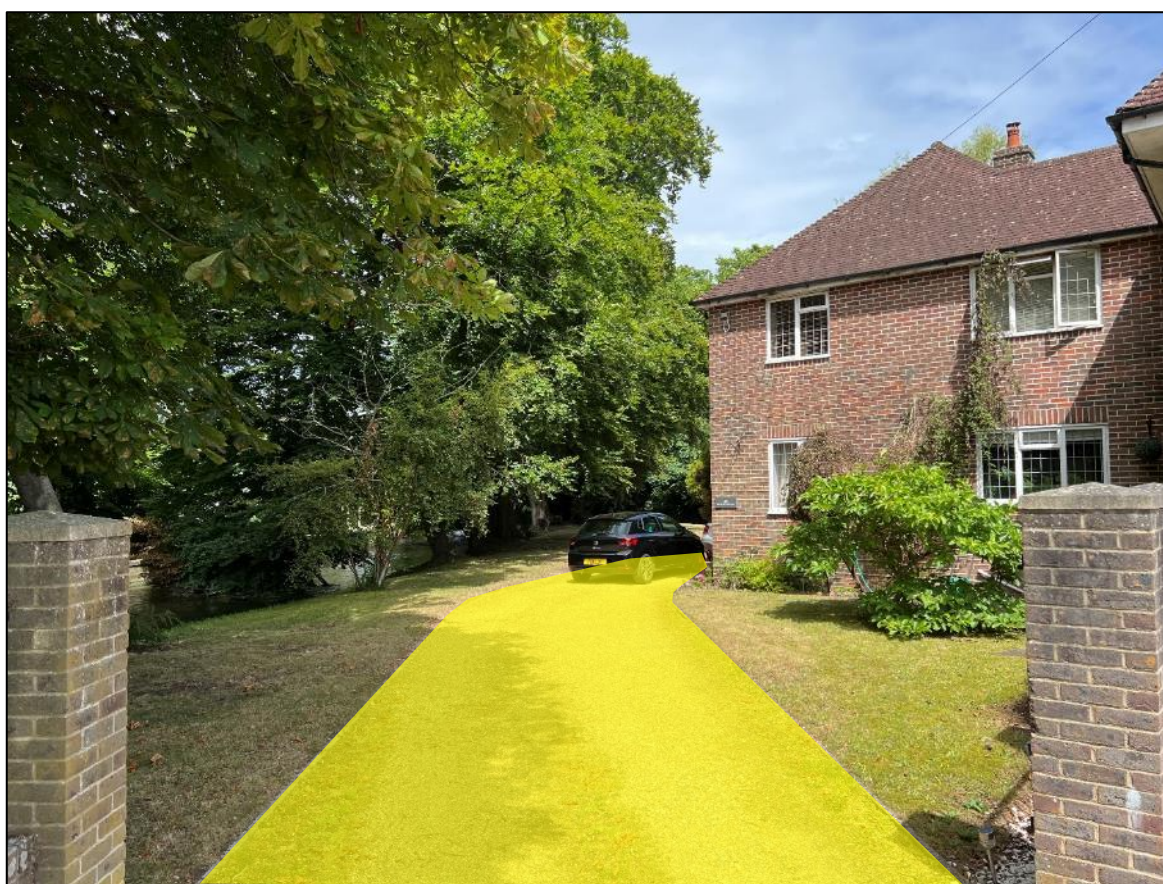
**Photo 1:** Showing the existing gravelled driveway highlighted by the yellow annotation, looking northwest, that will need to be upgraded prior to the development activity. The yellow annotation corresponds to the precautionary area on the tree protection plan, and the protective fencing will run either side of the driveway to protect the exposed ground from the development activities.

In summary, if the guidance set out in SGN 7 *Excavating in RPAs* and SGN 9 *Installing/upgrading surfacing in RPAs* is observed, we believe that the proposed works can be implemented without any long-term detrimental impact on tree health, and therefore local character. All new surfacing must be installed before any development works to prevent damage to the RPAs from the various activities.

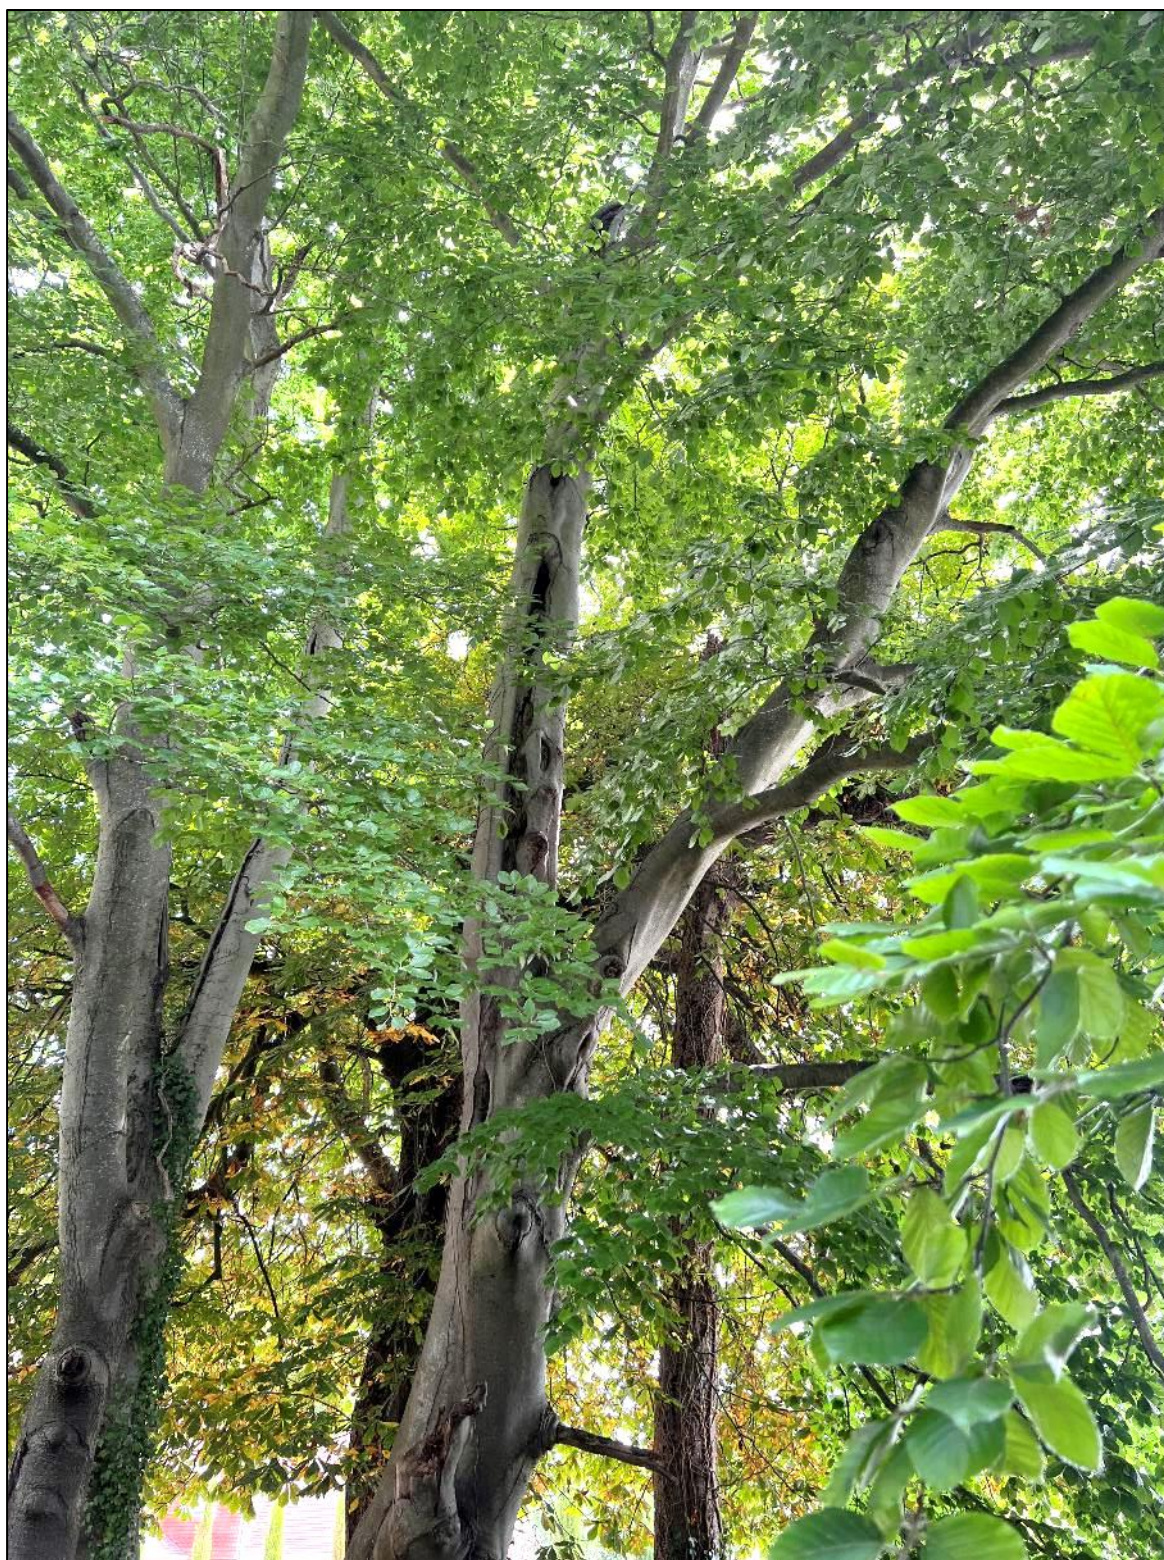
| Tree No | Species | Height (m) | Diameter (cm)<br>@ 1.5 m | Maturity | Low<br>Branches | Category | Notes | Tree Works | RPA<br>Radius<br>(m) |
|---|---|---|---|---|---|---|---|---|---|
| T3 | Beech | 18 | 90* | Mature | | C | River directly west, localised stem decay at<br>base, storm damage, significant stem decay<br>and hollowing of upper stem west, heavily<br>imbalanced and asymmetric canopy | Crown reduce the height by<br>about 4 m, the southerly<br>canopy extent by about 2–3 m,<br>and the westerly canopy<br>extent by about 3–4 m. The<br>resulting height of the tree<br>should be about 14 m, and the<br>canopy extents about 3 m<br>north, 1 m east, 3 m south,<br>and 3 m west. | 10.8 |

**Photo A3.1:** Showing the significant stem decay in T3 looking east, with cavity openings orientated west. Whilst the tree is subject to TPO, its structural condition is so poor that it will need management works soon if it is to be retained in the short term, and so it has been categorised as low value category C and should not be considered a constraint on the development.

Trees T3, T4, T8, and T13 are in poor structural condition and will need to be pruned if they are to be retained in the short term. These works will have an obvious impact on their visual amenity in the immediate vicinity in the short term, simply due to the extent of the pruning required. However, without the works, the trees will likely begin to fail soon, and so they are justified irrespective of the development.

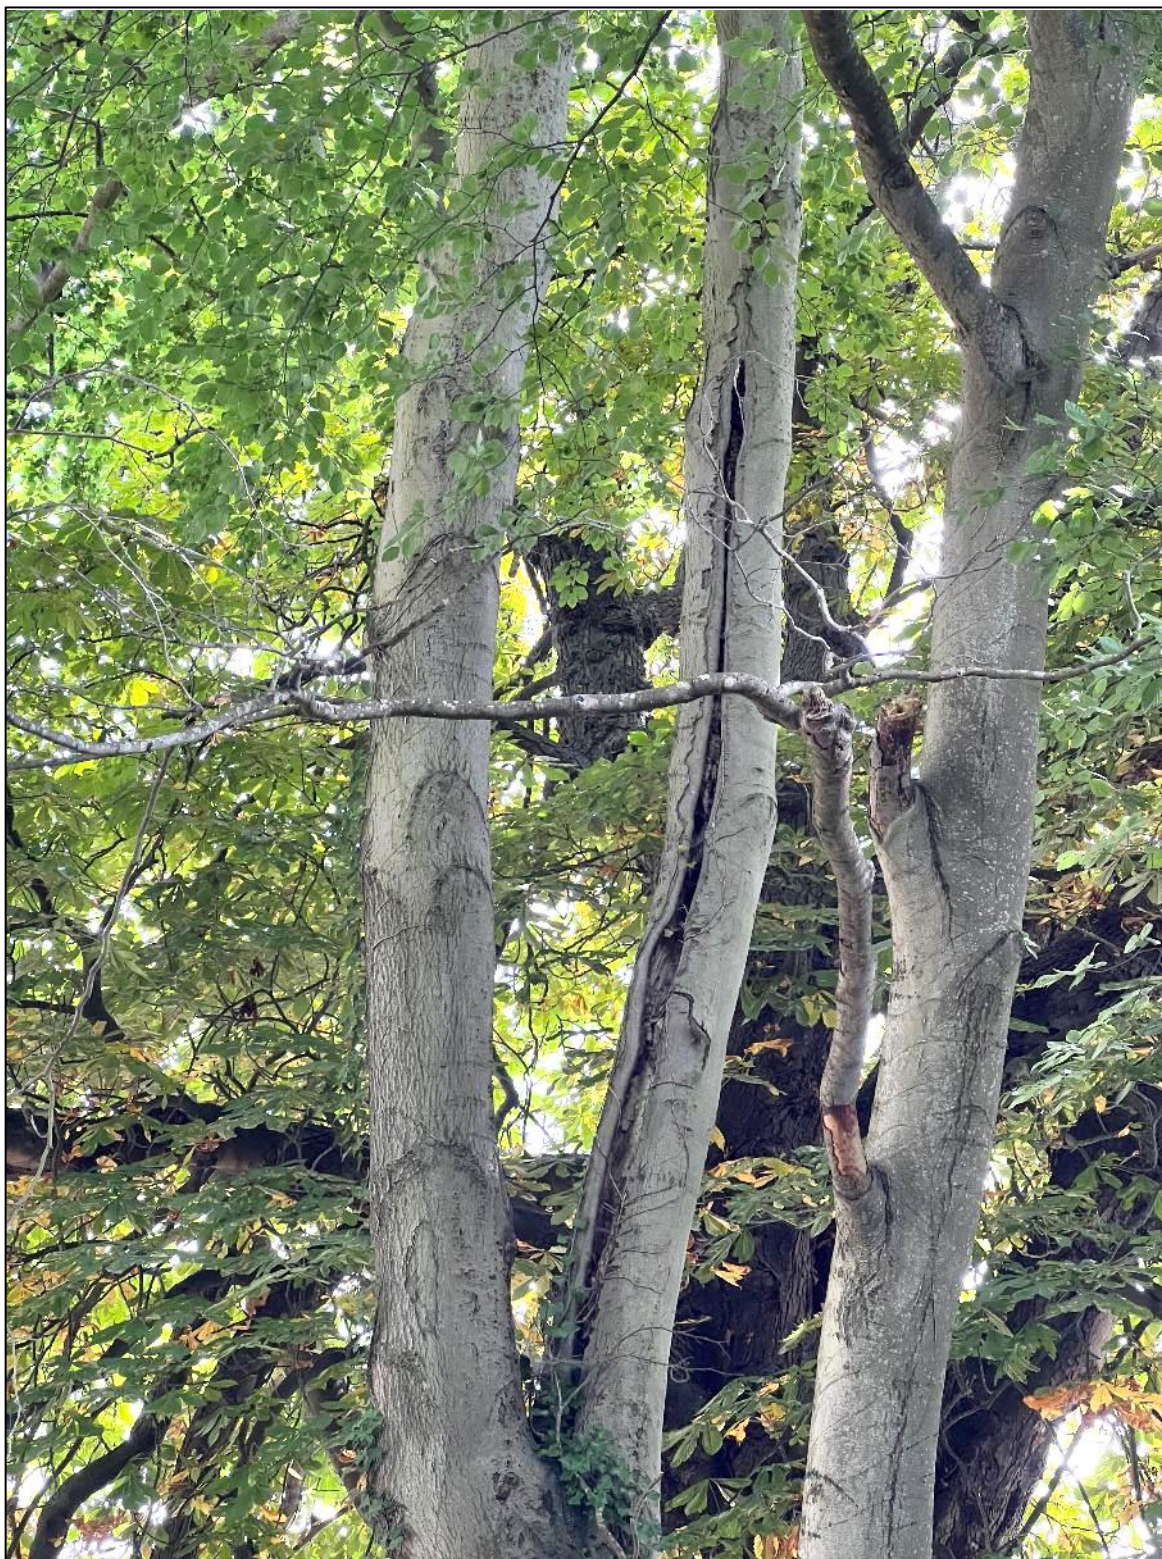
| Tree No | Species | Height (m) | Diameter (cm)<br>@ 1.5 m | Maturity | Low<br>Branches | Category | Notes | Tree Works | RPA<br>Radius<br>(m) |
|---|---|---|---|---|---|---|---|---|---|
| T4 | Beech | 18 | 60* | Mature | | C | River directly west, stem cavity at 0.5 m<br>south with decaying fungal fruiting bodies<br>within (possibly <i>Kretzschmaria deusta</i> ), co-<br>dominant stems at 5 m with significant decay<br>in both stems above | Crown reduce the height by<br>about 4 m, the northerly<br>canopy extent by about 1–2 m,<br>and the westerly canopy<br>extent by about 3–4 m. The<br>resulting height of the tree<br>should be about 14 m, and the<br>canopy extents about 3 m<br>north, 4 m east, 3 m south,<br>and 4 m west. | 7.2 |

**Photo A3.2:** Showing the significant stem decay and hollowing in T4 looking east, with cavity openings orientated west. Whilst the tree is subject to TPO, its structural condition is so poor that it will need management works soon if it is to be retained in the short term, and so it has been categorised as low value category C, and should not be considered a constraint on the development.

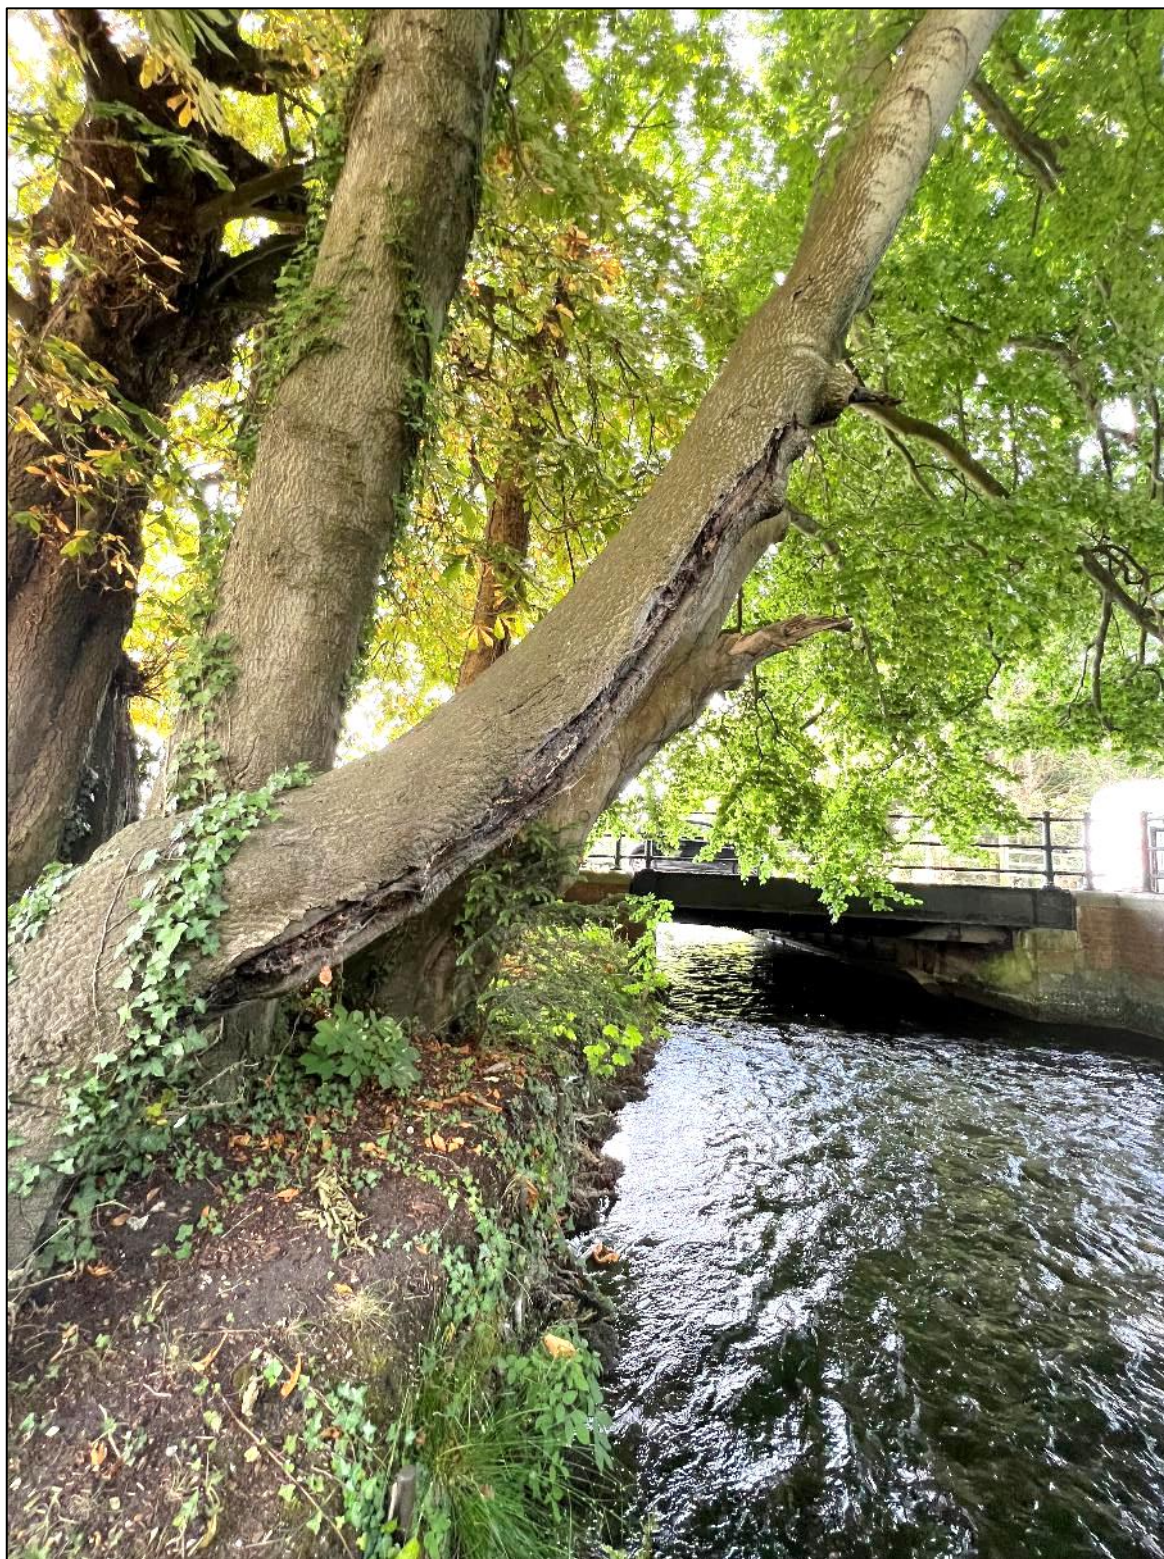
| Tree No | Species | Height (m) | Diameter (cm)<br>@ 1.5 m | Maturity | Low<br>Branches | Category | Notes | Tree Works | RPA<br>Radius<br>(m) |
|---|---|---|---|---|---|---|---|---|---|
| T5 | Beech | 16 | 60 | Mature | | U | River directly west, significant stem decay, heavily imbalanced | Reduce the height of the tree to about 6 m to create a standing stump for habitat. Reduce any lateral branches that remain after the height reduction to leave 1 m stubs. | |

**Photo A3.3:** Showing the significant stem decay in T5 looking south, with the cavity opening orientated west. Whilst the tree is subject to TPO, its condition is so poor that works are needed to address increasing levels of risk, and so it has been categorised as category U.

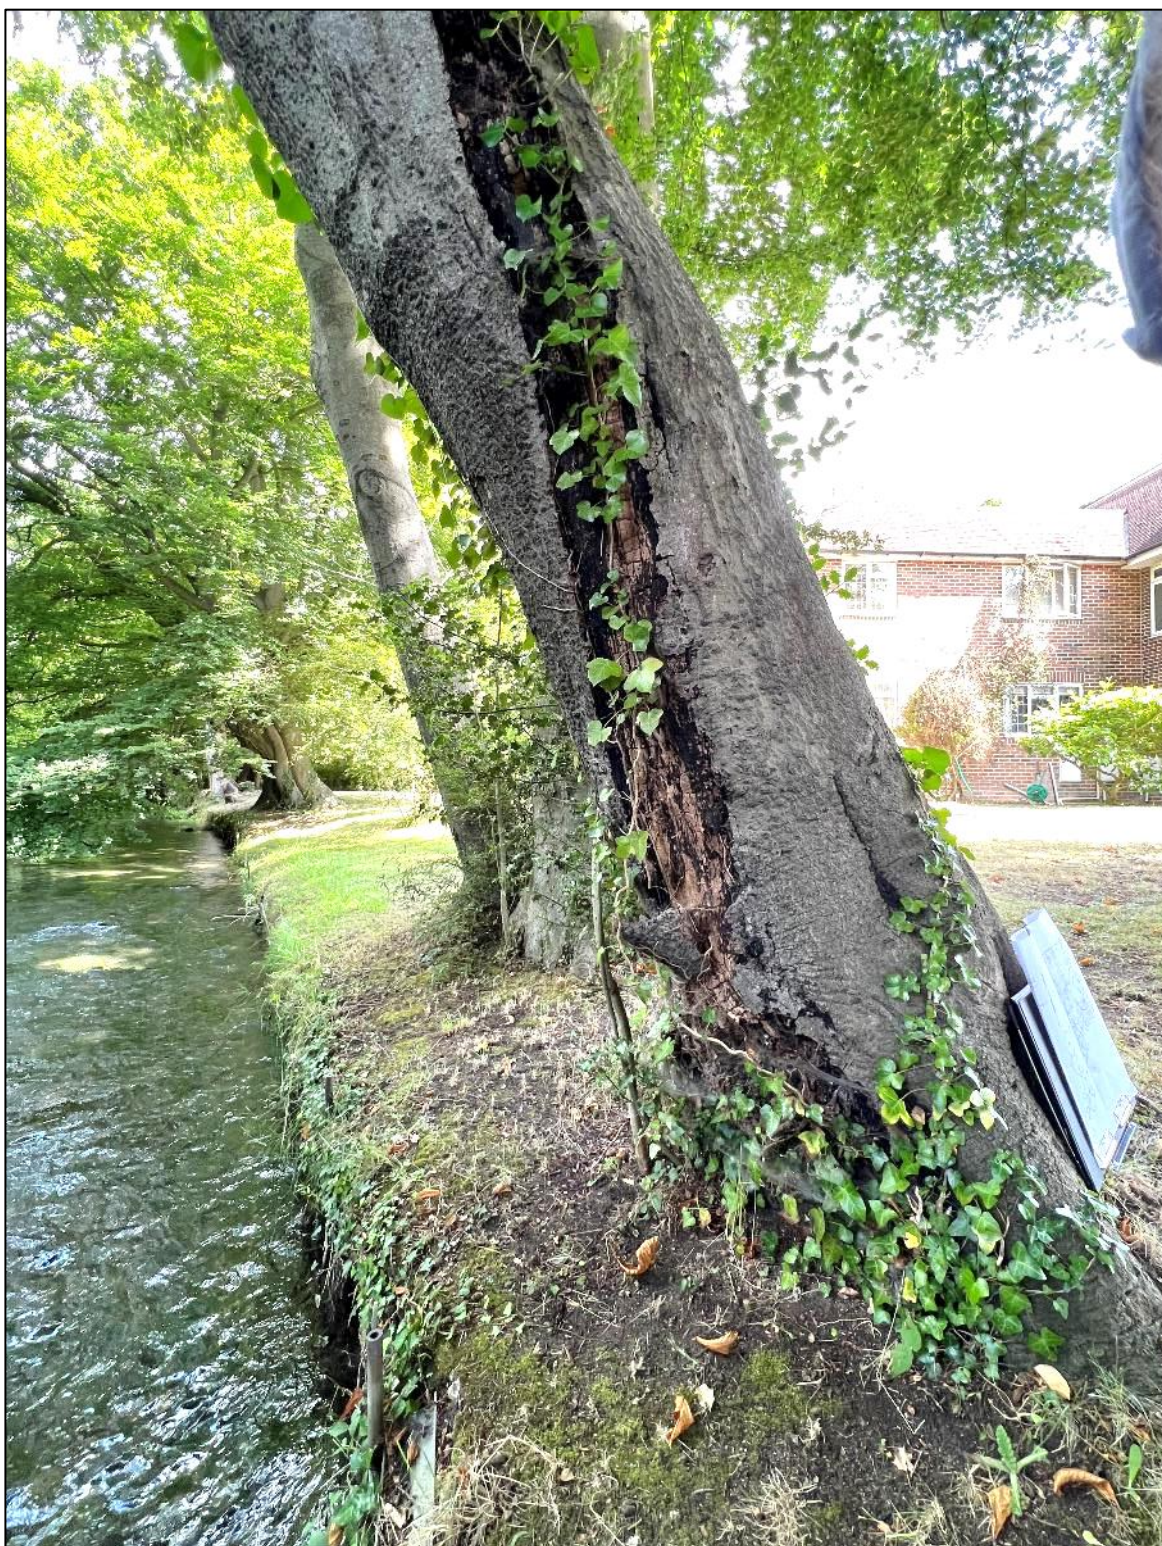
| Tree No | Species | Height (m) | Diameter (cm)<br>@ 1.5 m | Maturity | Low<br>Branches | Category | Notes | Tree Works | RPA<br>Radius<br>(m) |
|---|---|---|---|---|---|---|---|---|---|
| T6 | Beech | 20 | 60 | Mature | | U | River directly west, significant stem decay from base up to about 8 m with multiple fungal fruiting bodies of <i>Kretzschmaria deusta</i> within cavity, heavily imbalanced | Reduce the height of the tree to about 6 m to create a standing stump for habitat. Reduce any lateral branches that remain after the height reduction to leave 1 m stubs. | |

**Photo A3.4:** Showing the significant stem decay in T6 with multiple fungal fruiting bodies of *Kretzschmaria deusta* within looking north, with the cavity opening orientated southwest. Whilst the tree is subject to TPO, its condition is so poor that works are needed to address increasing levels of risk, and so it has been categorised as category U.

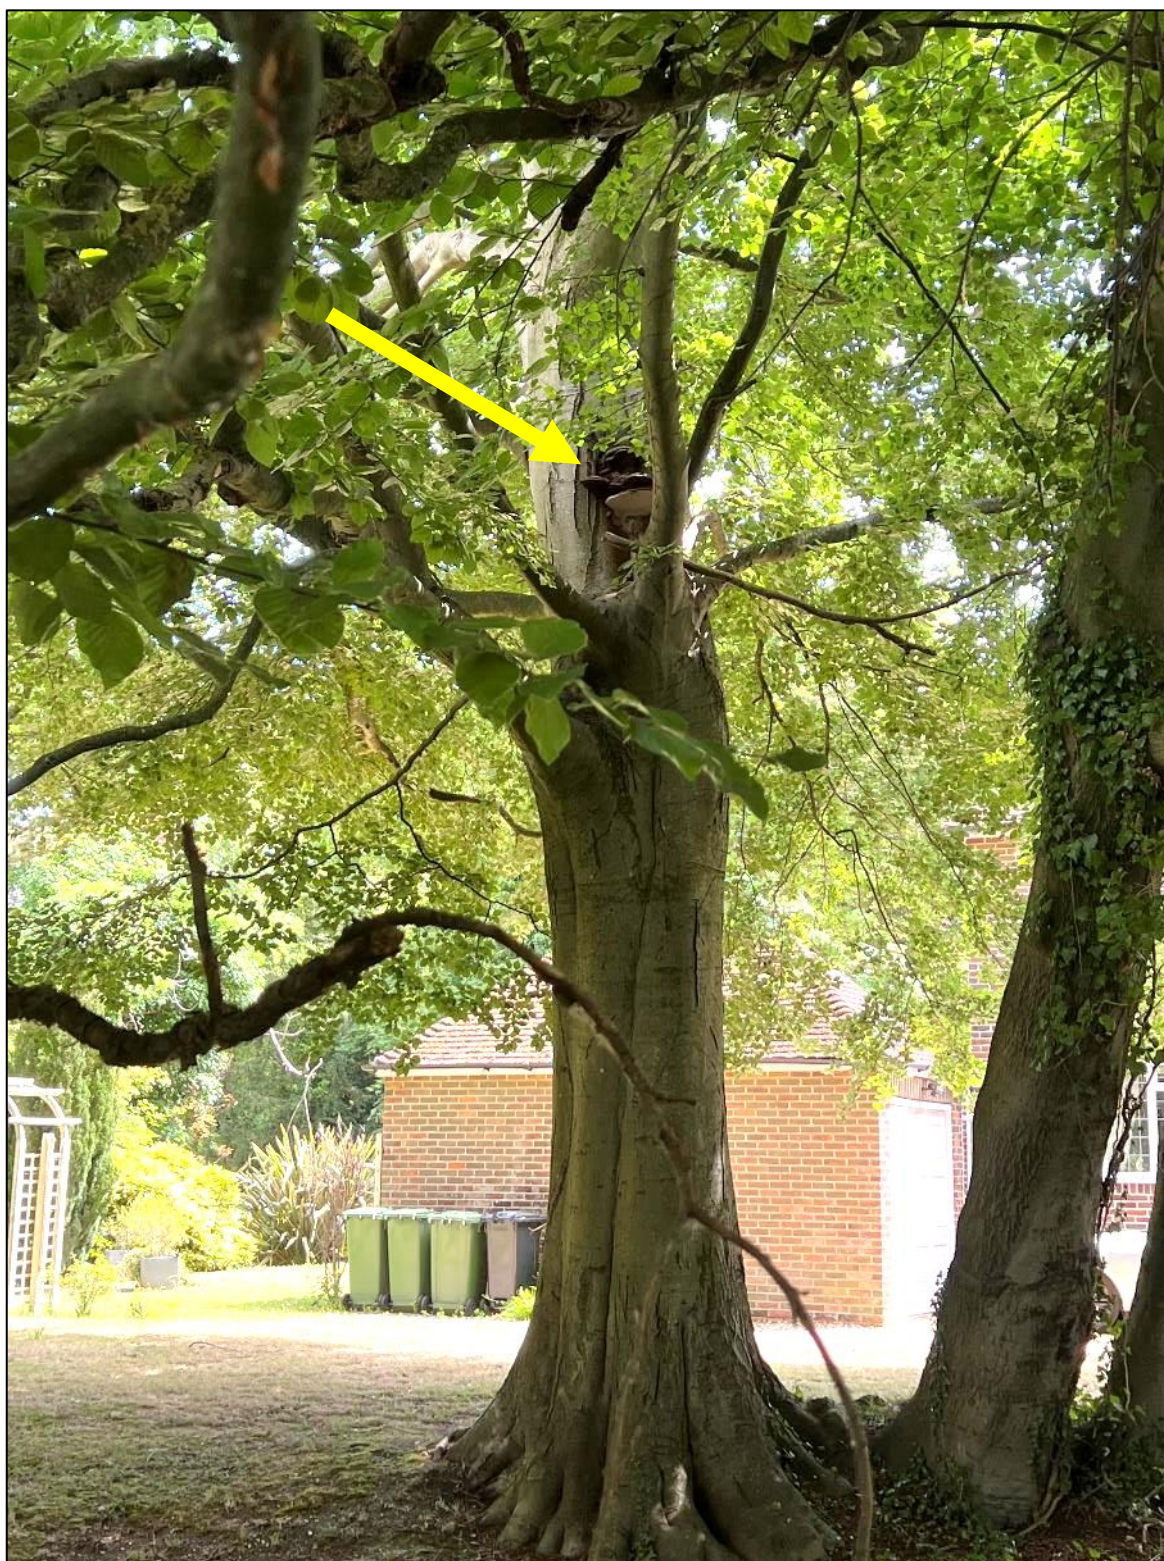
**Photo A3.5:** Showing the multiple layered *Ganoderma* sp fungal fruiting bodies at about 4 m on the westerly side of the main stem, highlighted by the yellow arrow, with significant internal decay likely. Whilst the tree is subject to a TPO, it will need management works soon if it is to be retained in the short term, and so it has been categorised as low value category C, and should not be considered a constraint on the development.

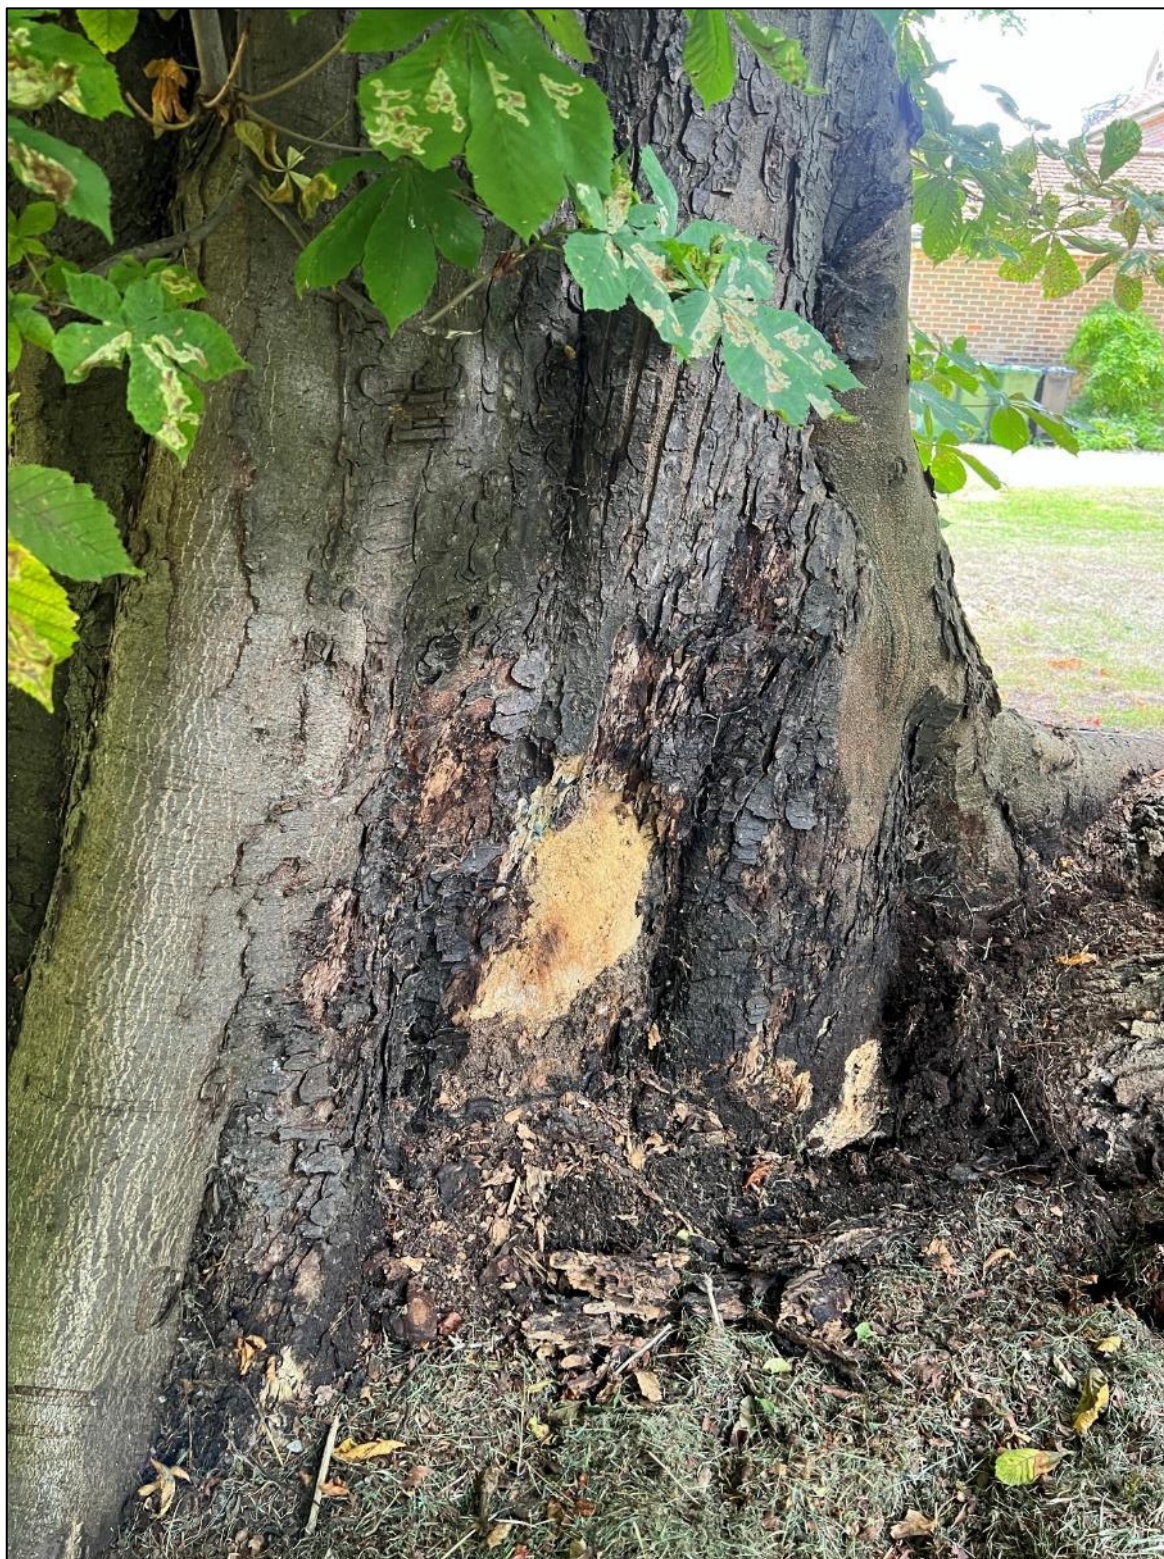
| Tree No | Species | Height (m) | Diameter (cm)<br>@ 1.5 m | Maturity | Low<br>Branches | Category | Notes | Tree Works | RPA<br>Radius<br>(m) |
|---|---|---|---|---|---|---|---|---|---|
| T15 | Horse chestnut | 25 | 125* | Over<br>mature | | U | River directly west, significant basal decay and hollowing up to at least 3 m with <i>Ganoderma</i> sp fungal fruiting bodies within | Reduce the height of the tree to about 6 m to create a standing stump for habitat. Reduce any lateral branches that remain after the height reduction to leave 1 m stubs. | |

**Photo A3.6:** Showing the significant basal decay and area of wood softening on the westerly side of T15. There is also a large cavity opening at the base orientated north, with several *Ganoderma* sp fungal fruiting bodies within, shown in Photo A3.6. Whilst the tree is subject to TPO, its condition is so poor that works are needed to address increasing levels of risk, and so it has been categorised as category U.

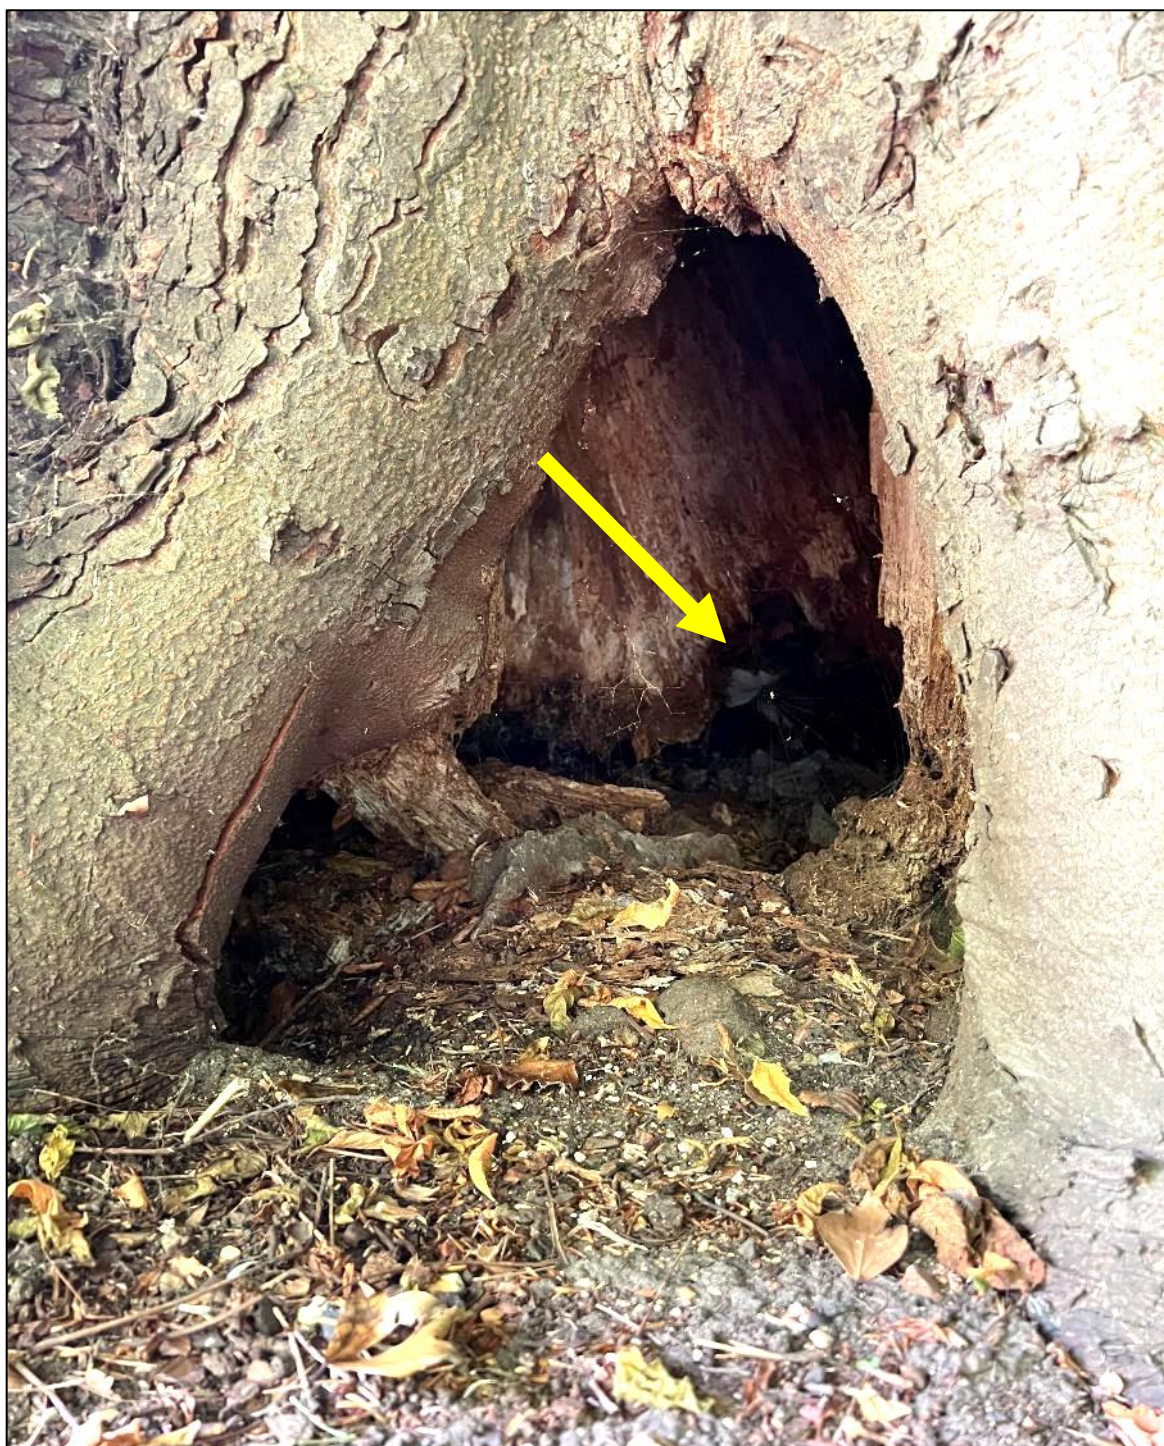
**Photo A3.7:** Showing the large cavity at the base of T15, orientated north, with significant decay and hollowing, and the *Ganoderma* sp fungal fruiting bodies within highlighted by the yellow arrow. Whilst the tree is subject to TPO, its condition is so poor that works are needed to address increasing levels of risk, and so it has been categorised as category U.
