**Storm Drainage, Site Inspection  
& Verification Report**

**Hamble Wood  
Heath House Lane,  
Hedge End**

**SMA Ref: 6351/Inspect**

# Site Inspection Record 1.

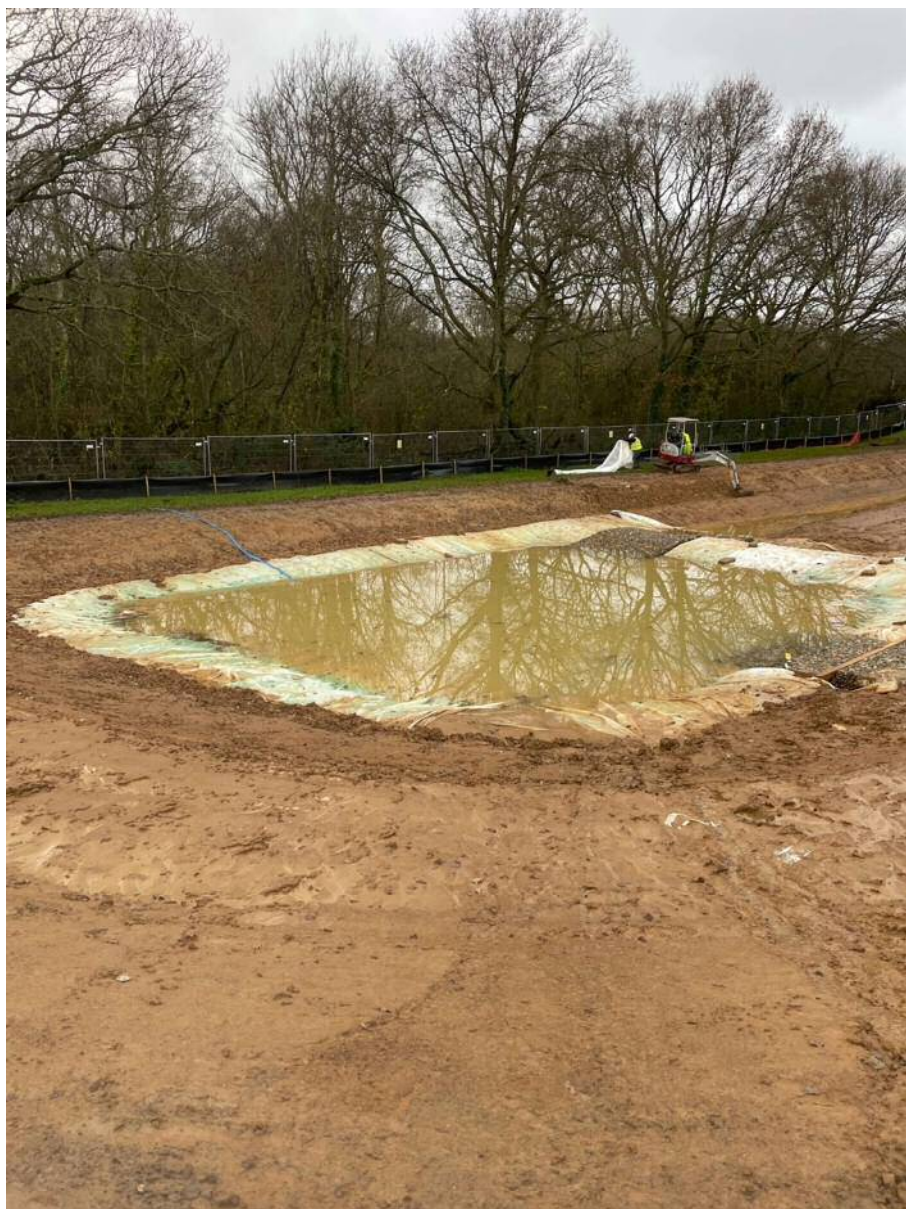
Photograph 1 : pond stilling upper basin installation, view south west

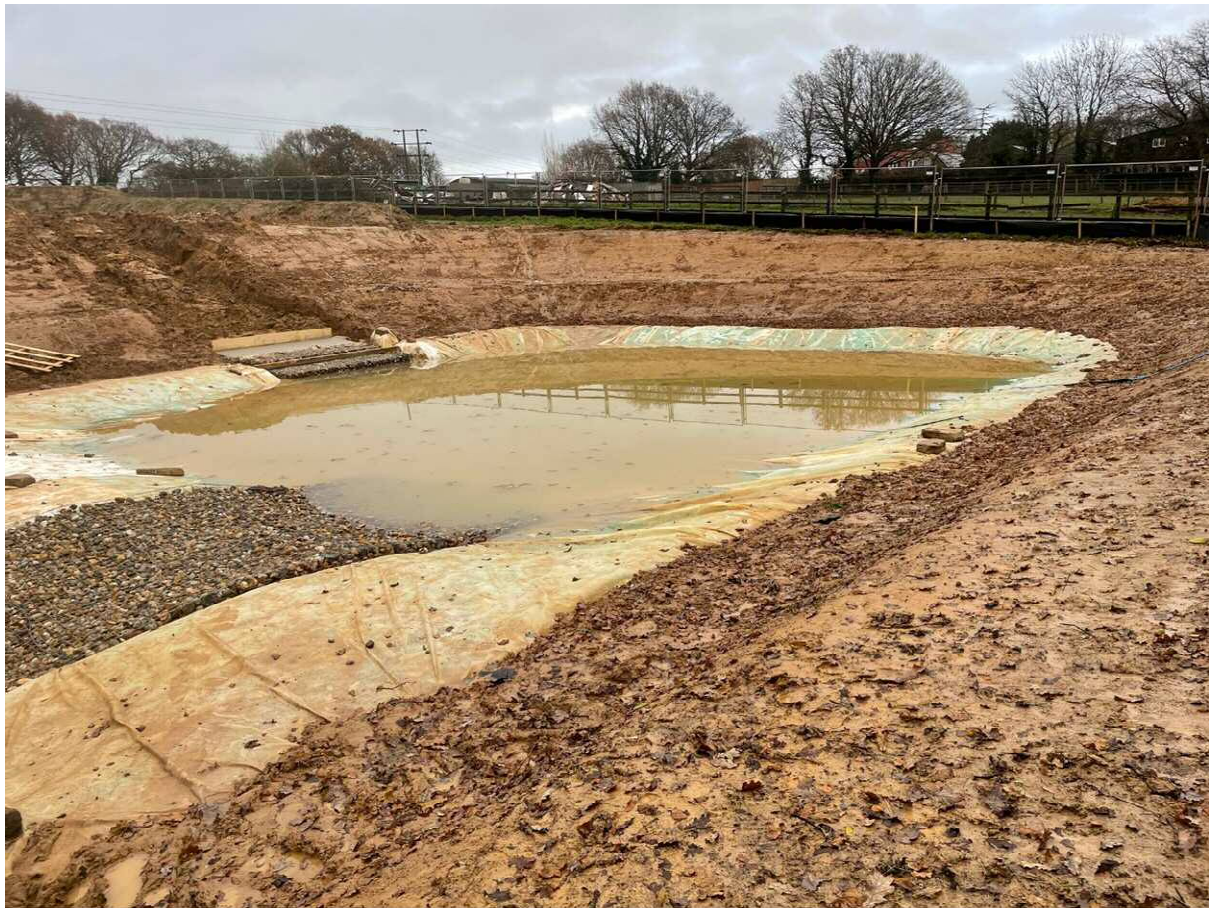
Query raised on the pond liner which was only partially visible during the inspection due to the geotextile fabric protection installed over.

Query later confirmed that the pond liner was not as per approved drawing and a heavy duty EDPM pond liner was not used

Photograph 2 : Pond looking north east, outfall matting visible as in the liner within the geotextile

The pond liner is therefore condemned, and must be replaced with the approved EDPM liner.

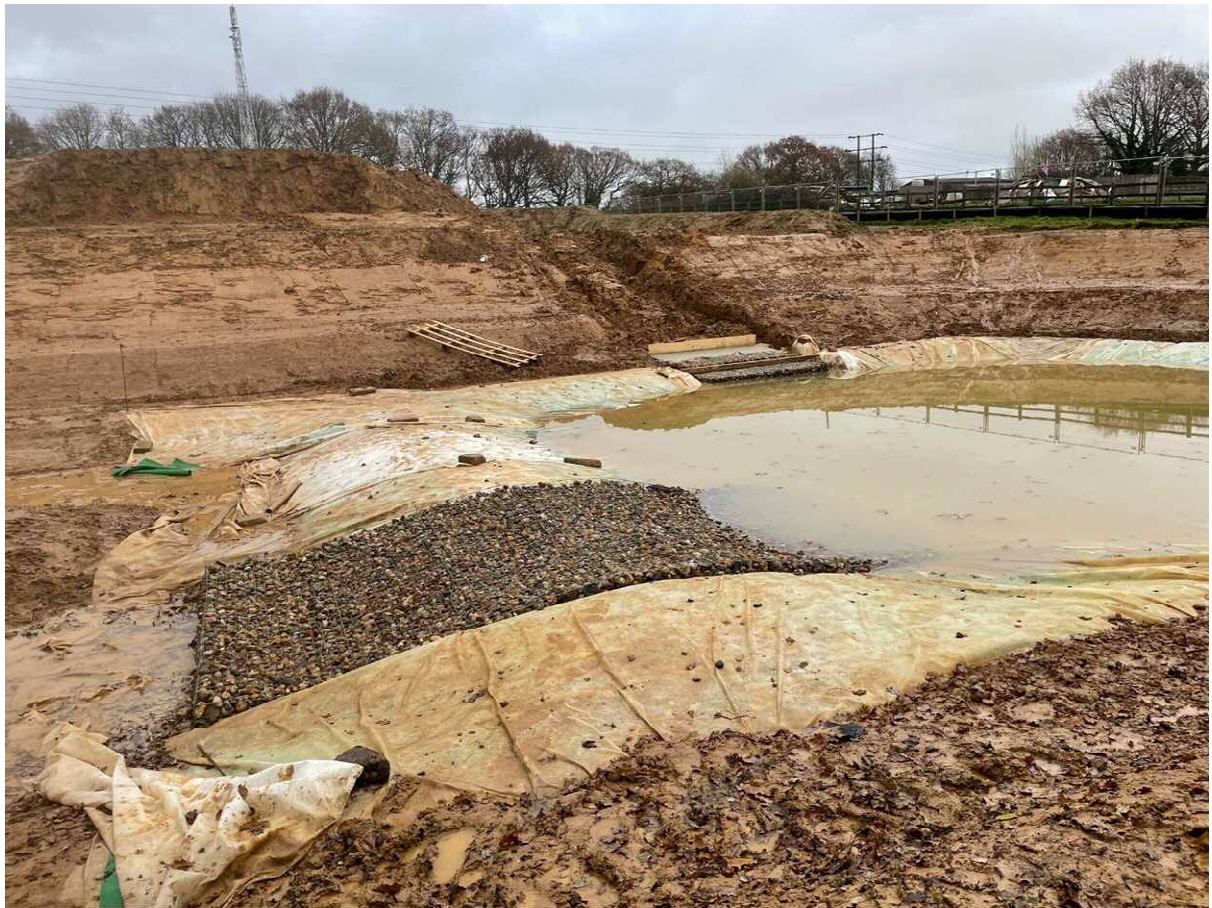
Photograph 3 : Pond looking north, transition weir to foreground

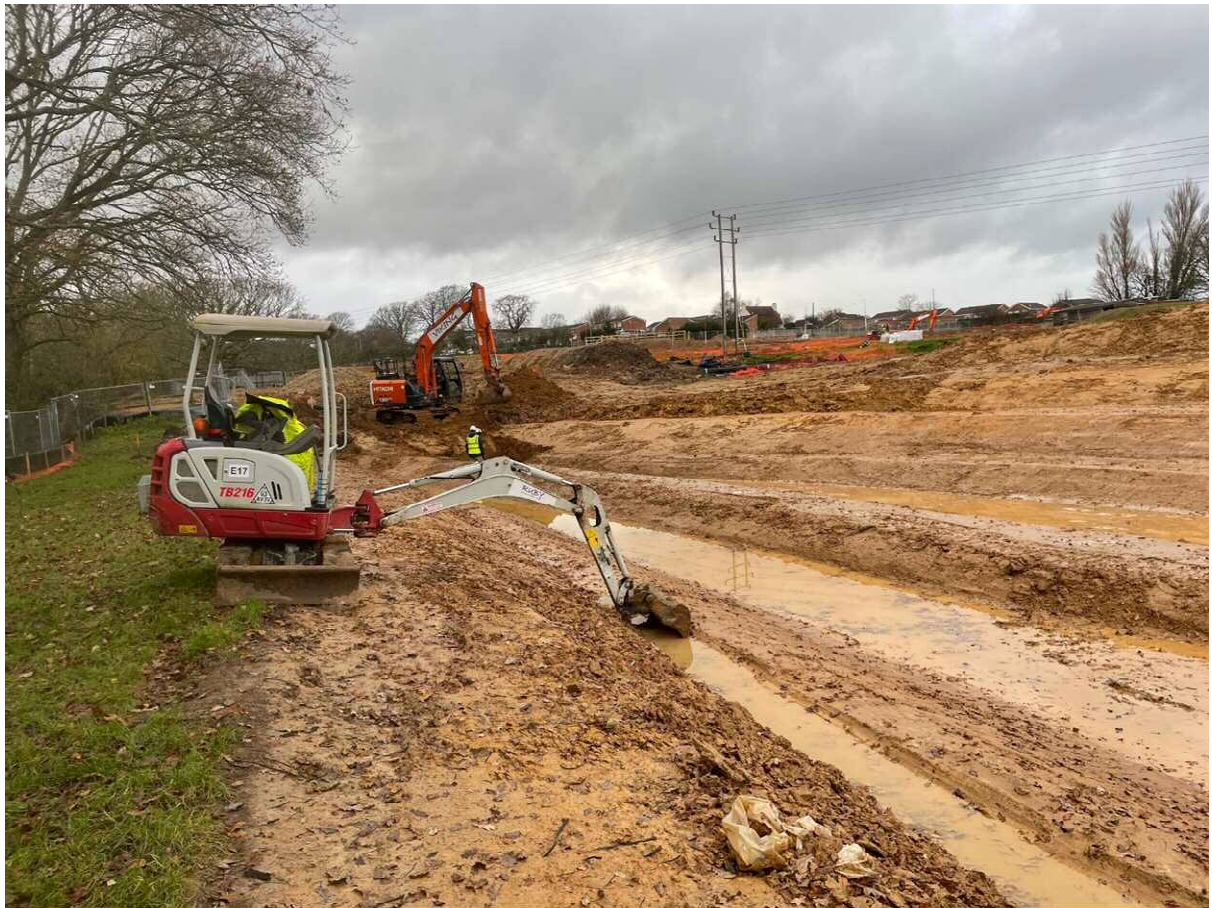
Photograph 4 : Excavation of the pond channel system, view west

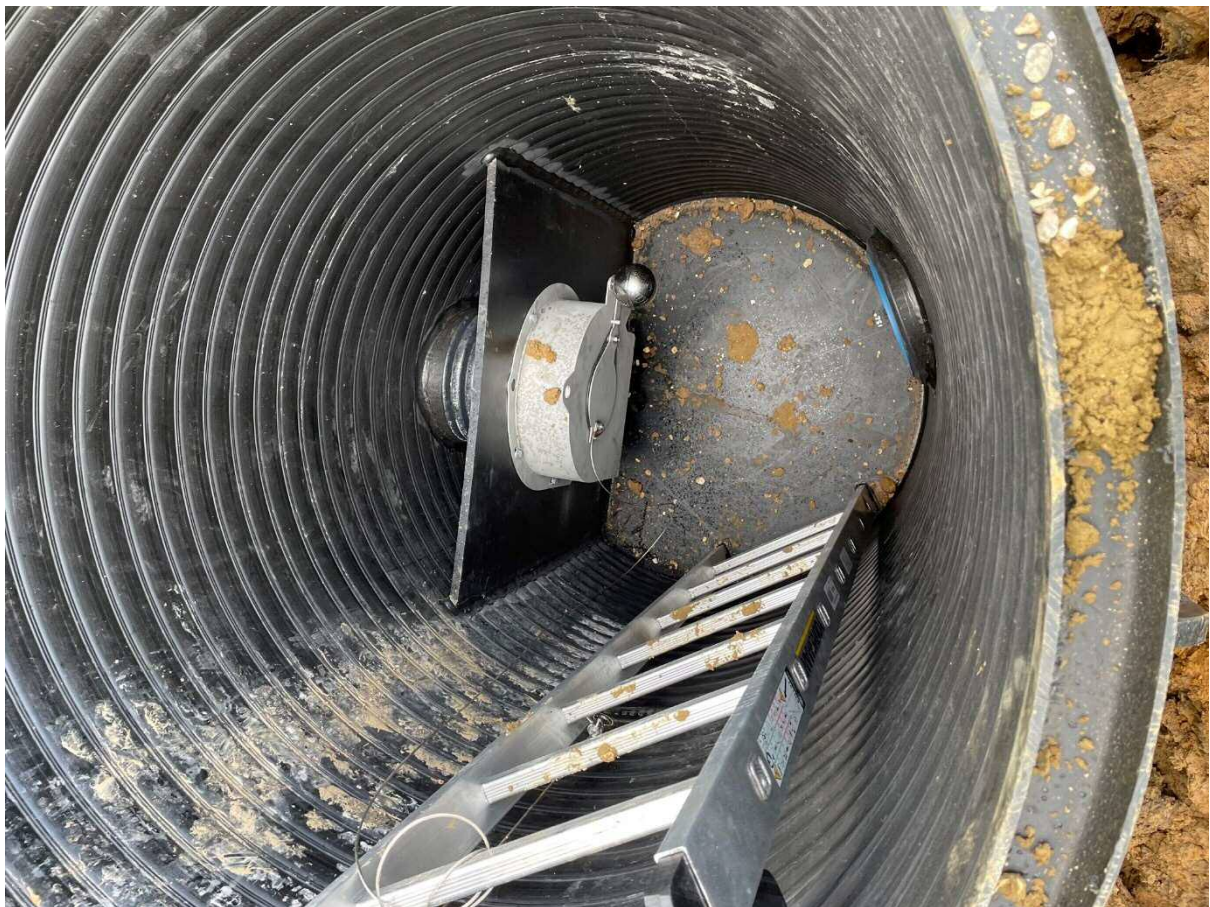
Photograph 1: Control Chamber during installation, hydrobrake control feature visible

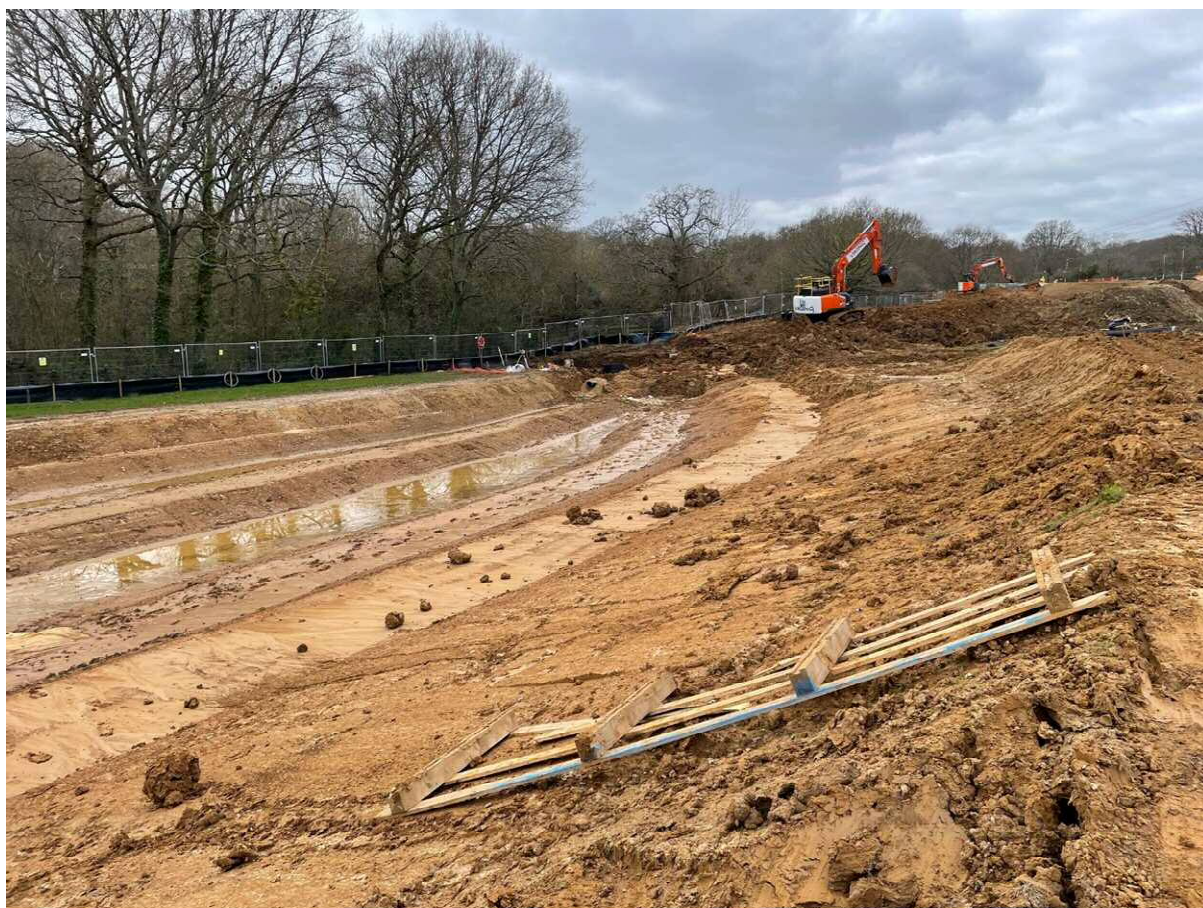
Photograph 2, pond looking west

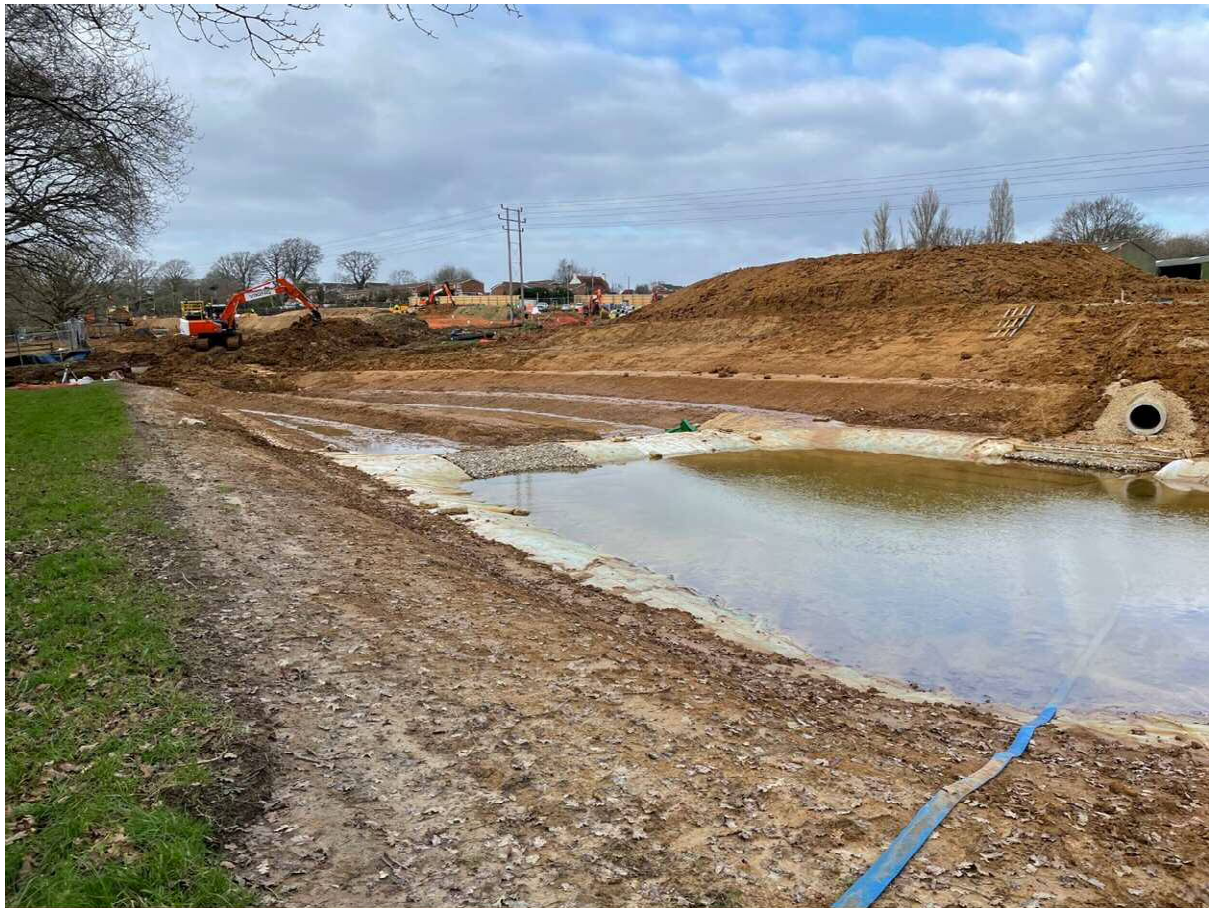
Photograph 3: pond looking north, outfall and pond liner visible

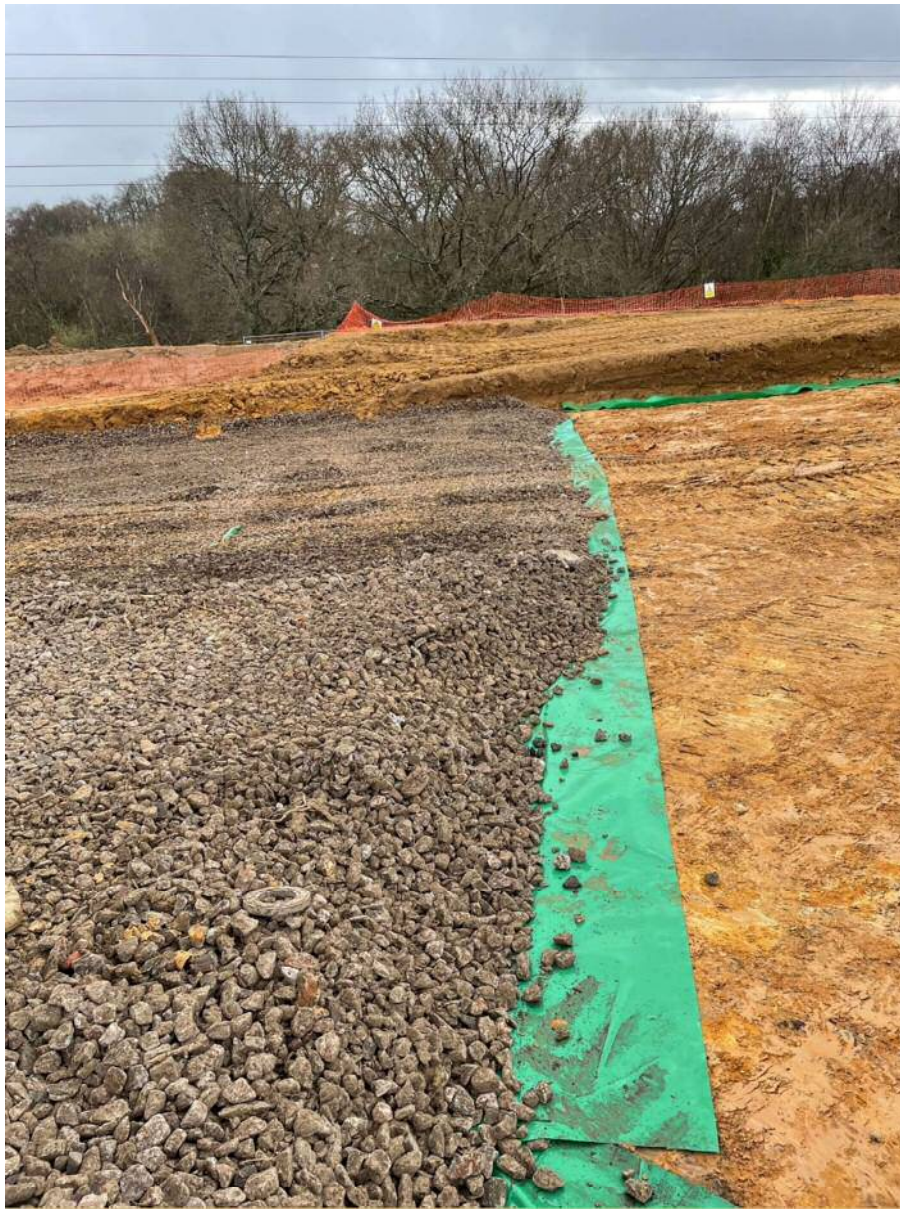
Photograph 4 : Early installation of the porous paving, liner and 'no fines' stone material recorded

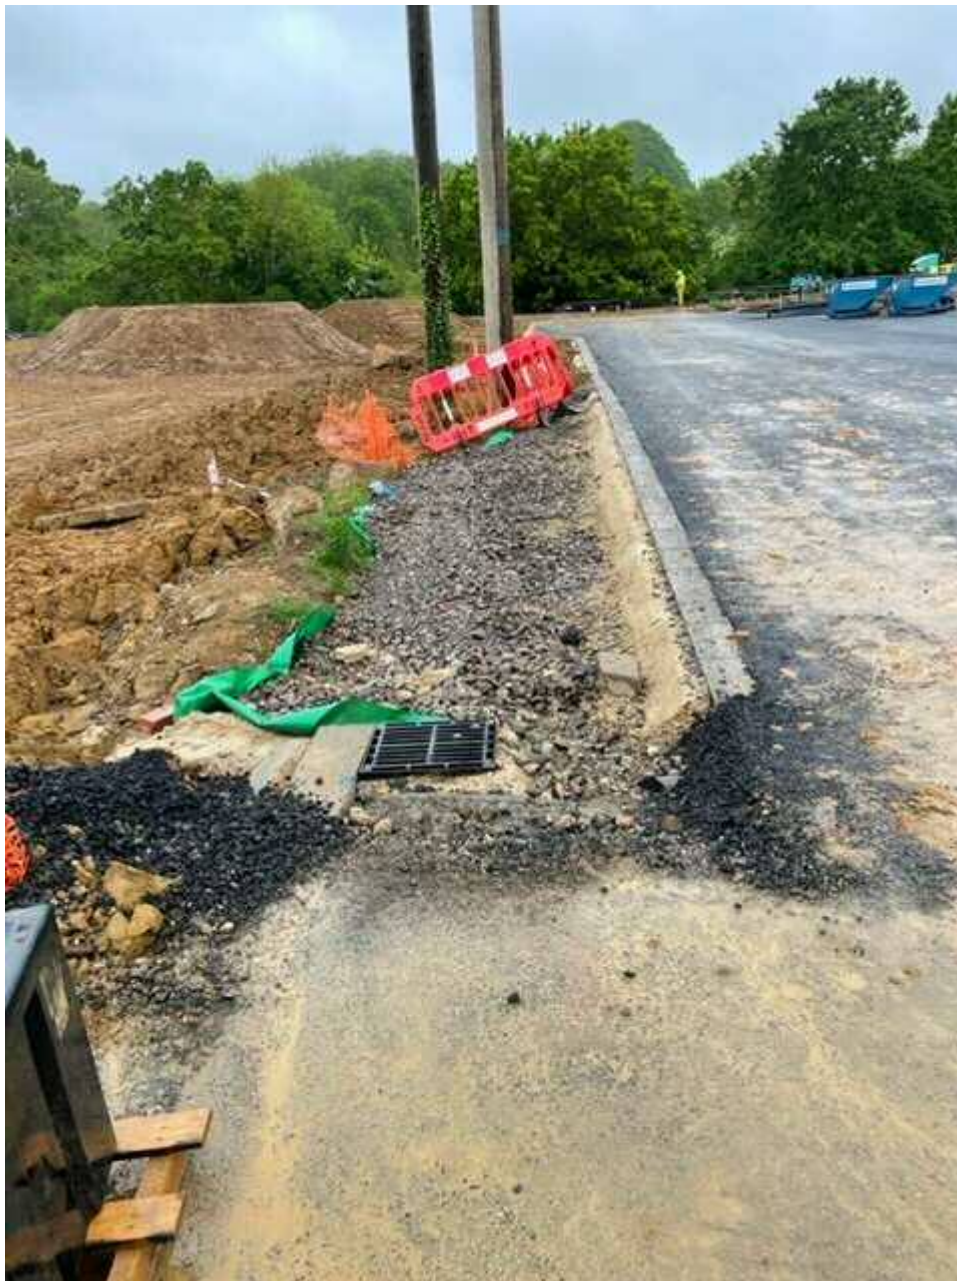
Photograph 1: Porous private road, note liner and no fines stone infill, temporary macadam open graded material laid over as construction running surface

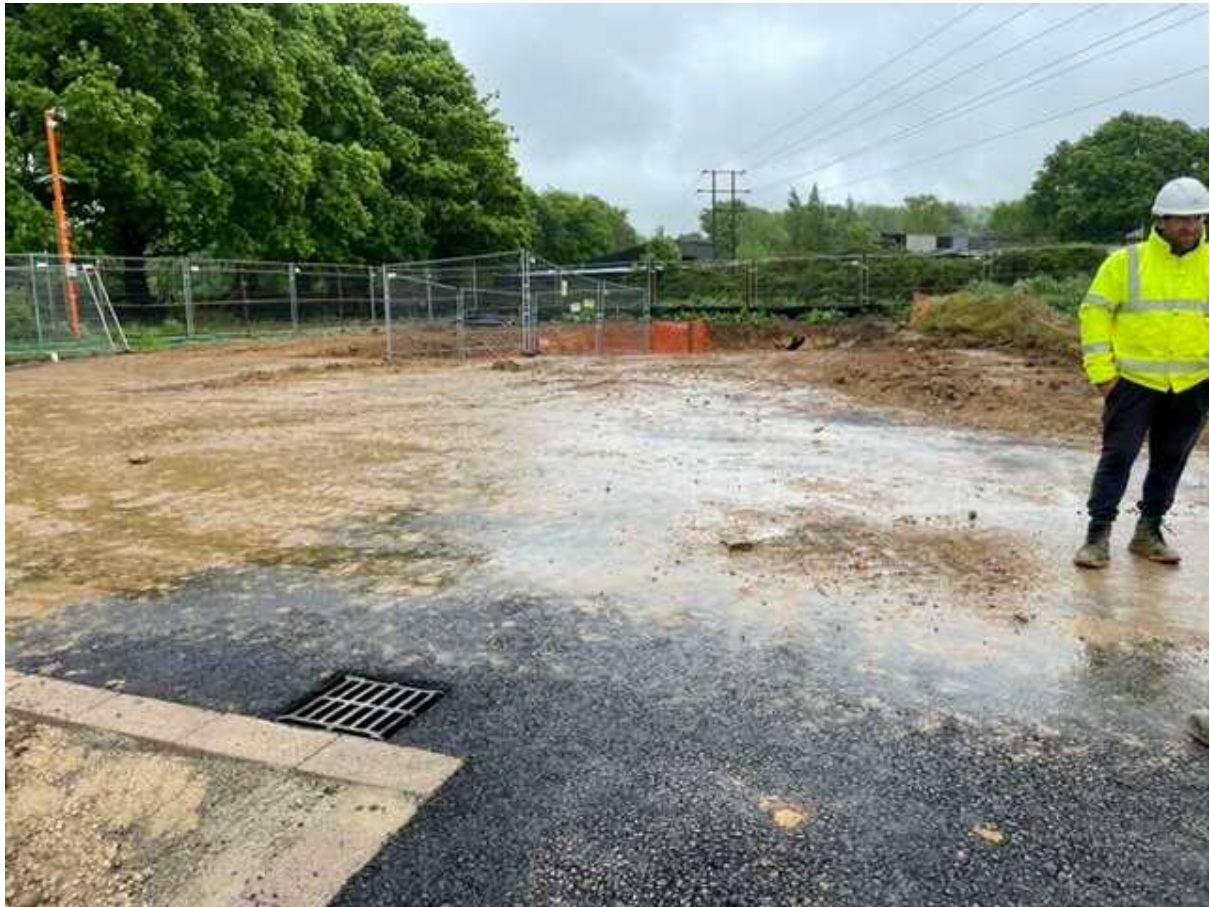
Photograph 2, Macadam surface over porous paving

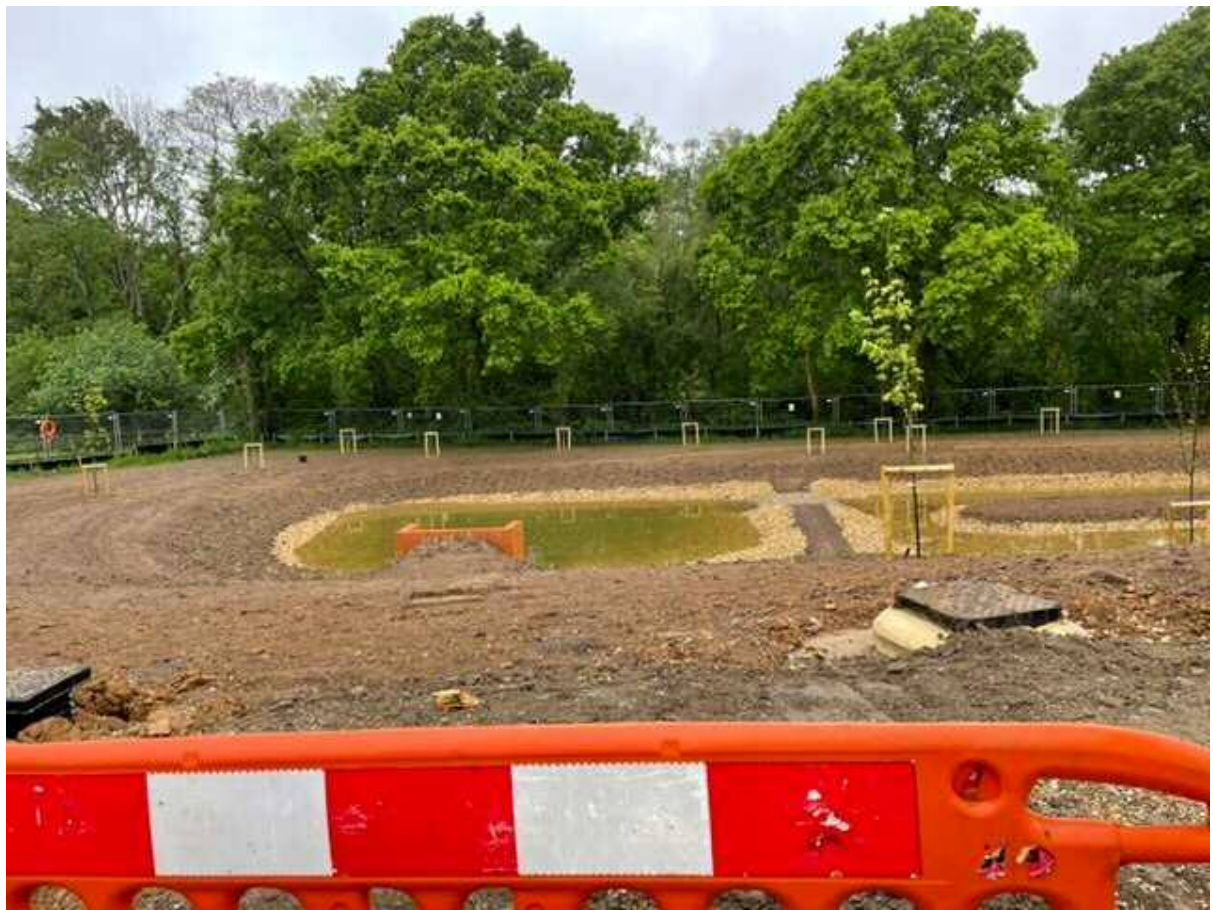
Photograph 3: pond looking south, finished masonry outfall and mattress visible

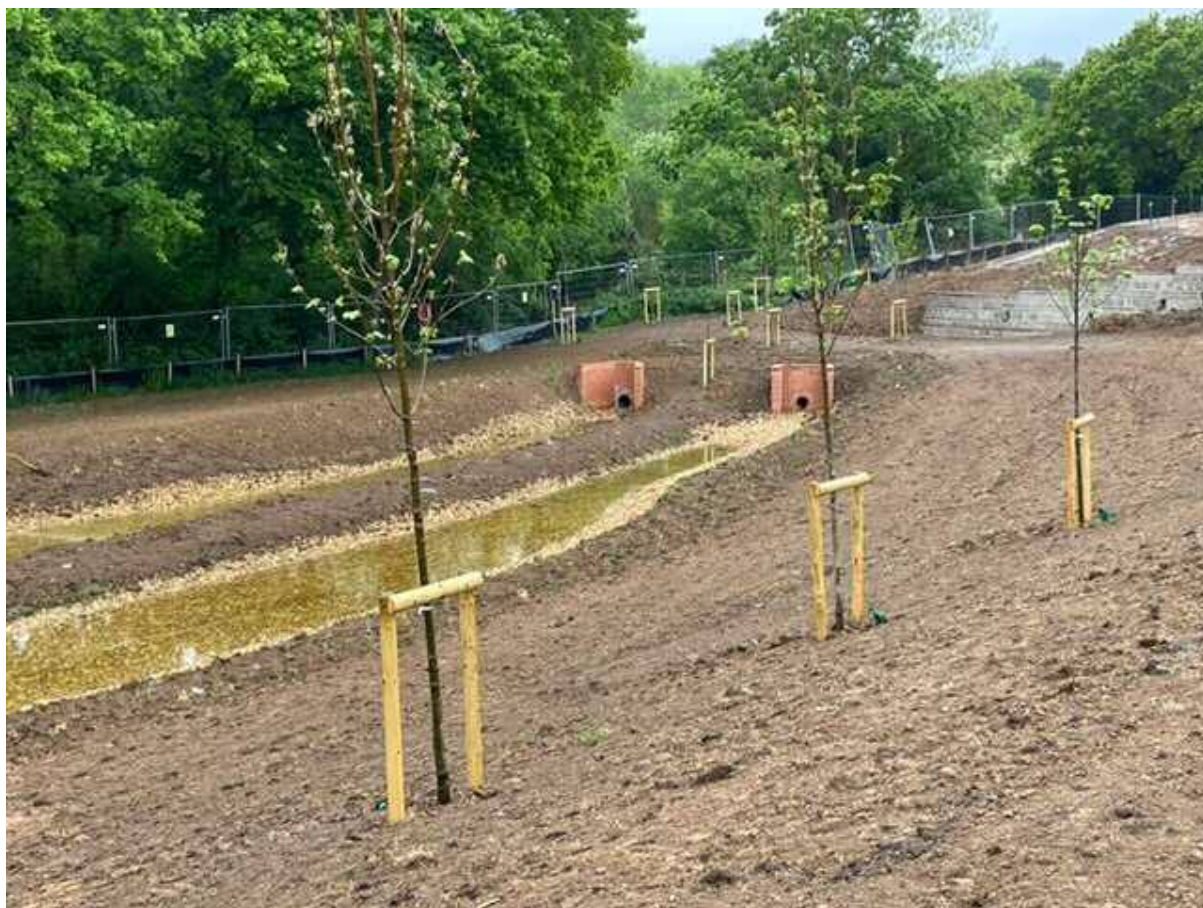
Photograph 4 : pond looking south west, tree planting to banks installed, masonry headwalls to channel system visible

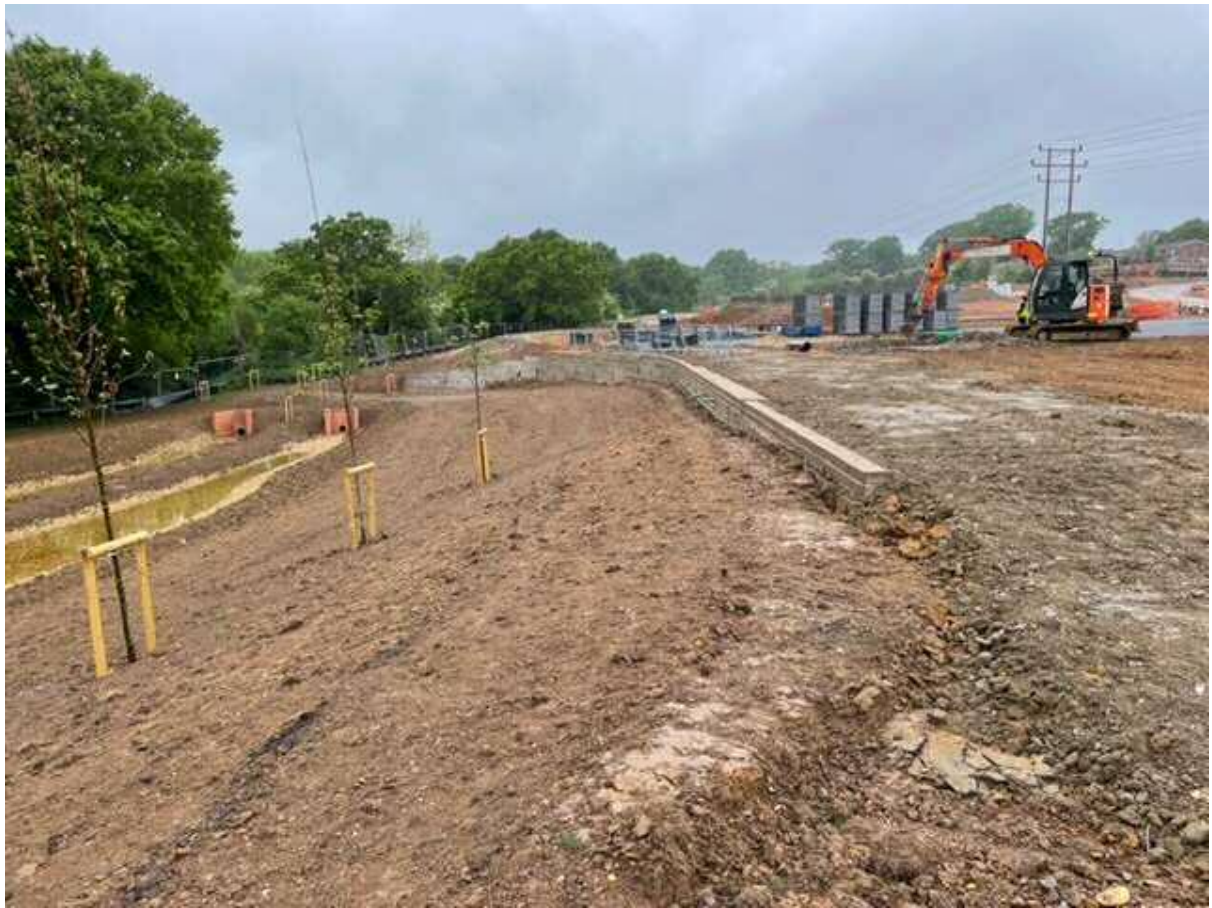
Photograph 5 : pond looking, tree planting to banks installed, upper wall also installed to serve perimeter footpath

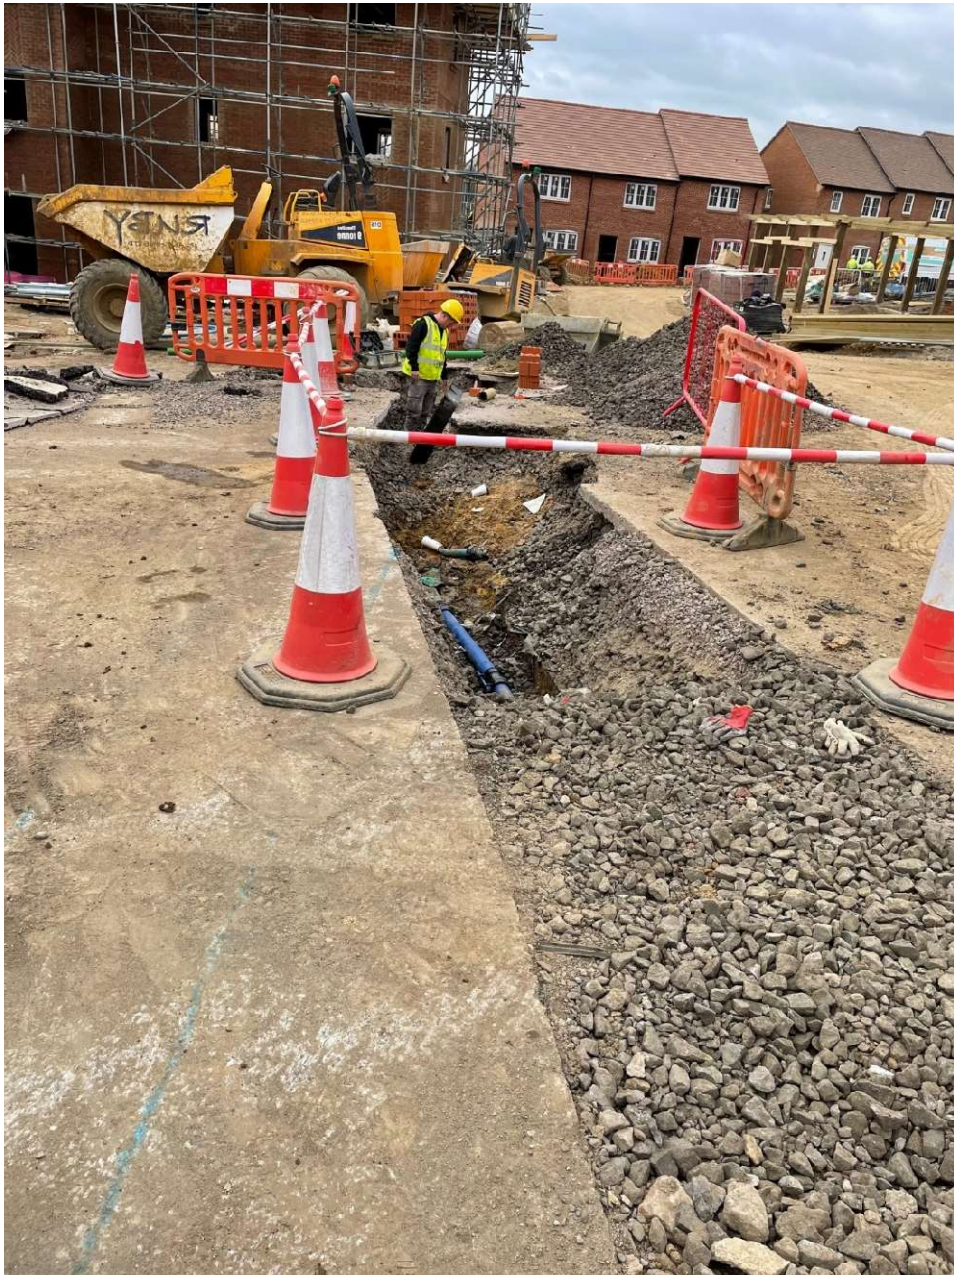
Photograph 1: Porous private road, currently excavated to expose and divert a potable water main. The porous stone, (Type 3 no fines material) was clearly noted in the excavated material confirming the porous paving was constructed correctly and in accordance with the approved plans.

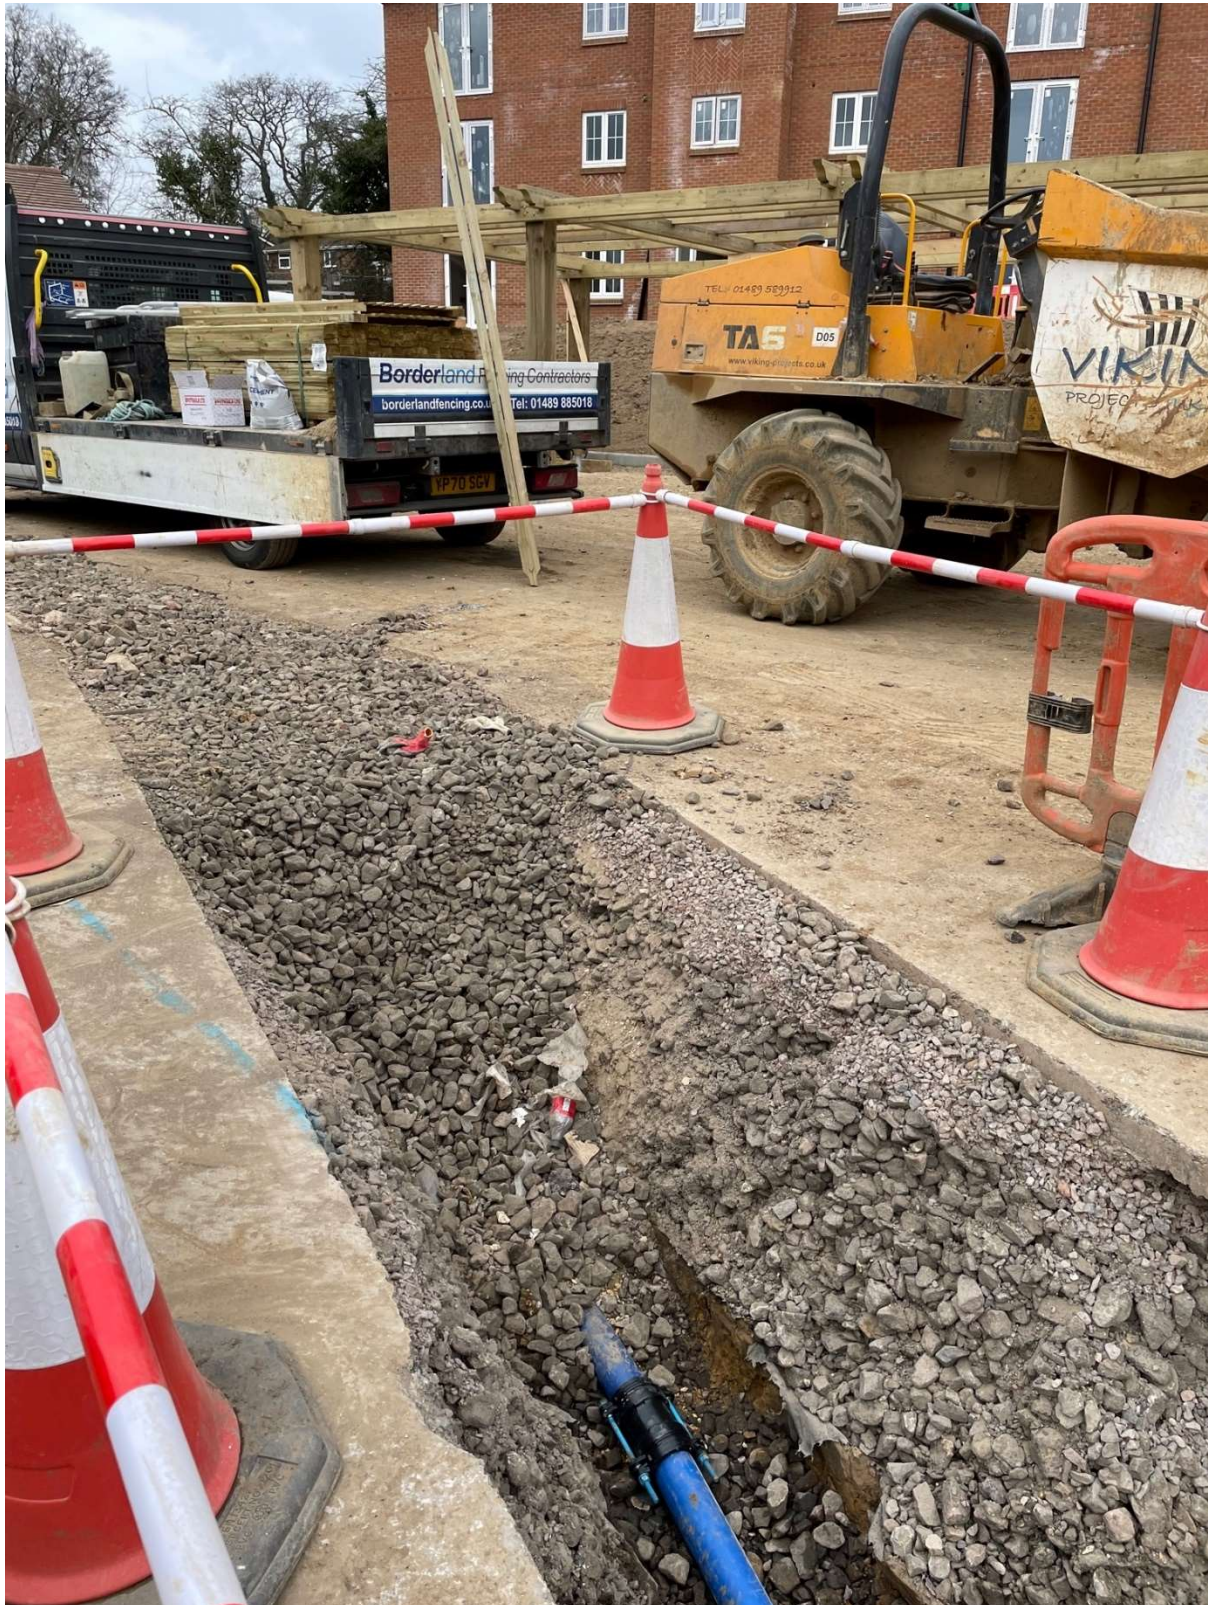
Photograph 2, Porous paving, excavated for potable water diversion

Note the presence of the liner at the base of the porous paving

| <p><b>Queries / Requests for Information</b></p> <p>A sweeping regime is important to ensure the performance of the porous during the construction period and the open graded macadam material</p> <p>The contractor was reminded of the need to adequately tape and joint the porous paving membrane once the water main works have completed to ensure that the porous maintains the installed tanking</p> | |

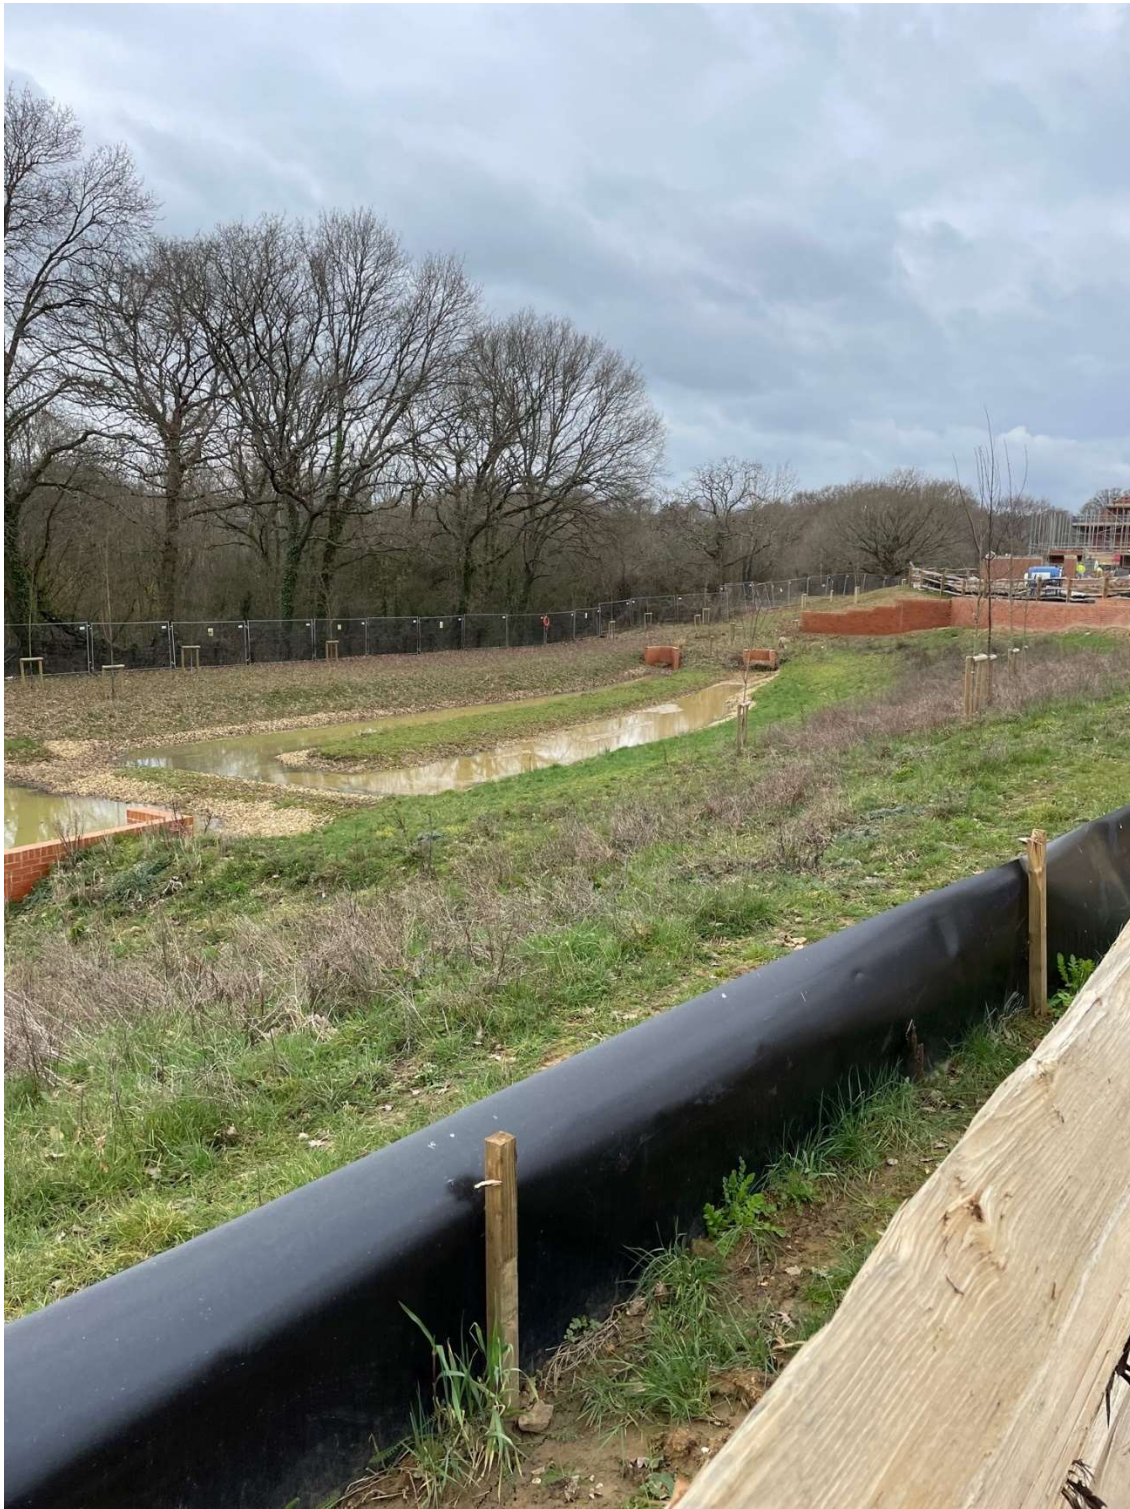
Photograph 3: pond looking south, finished masonry outfall and landscaping visible

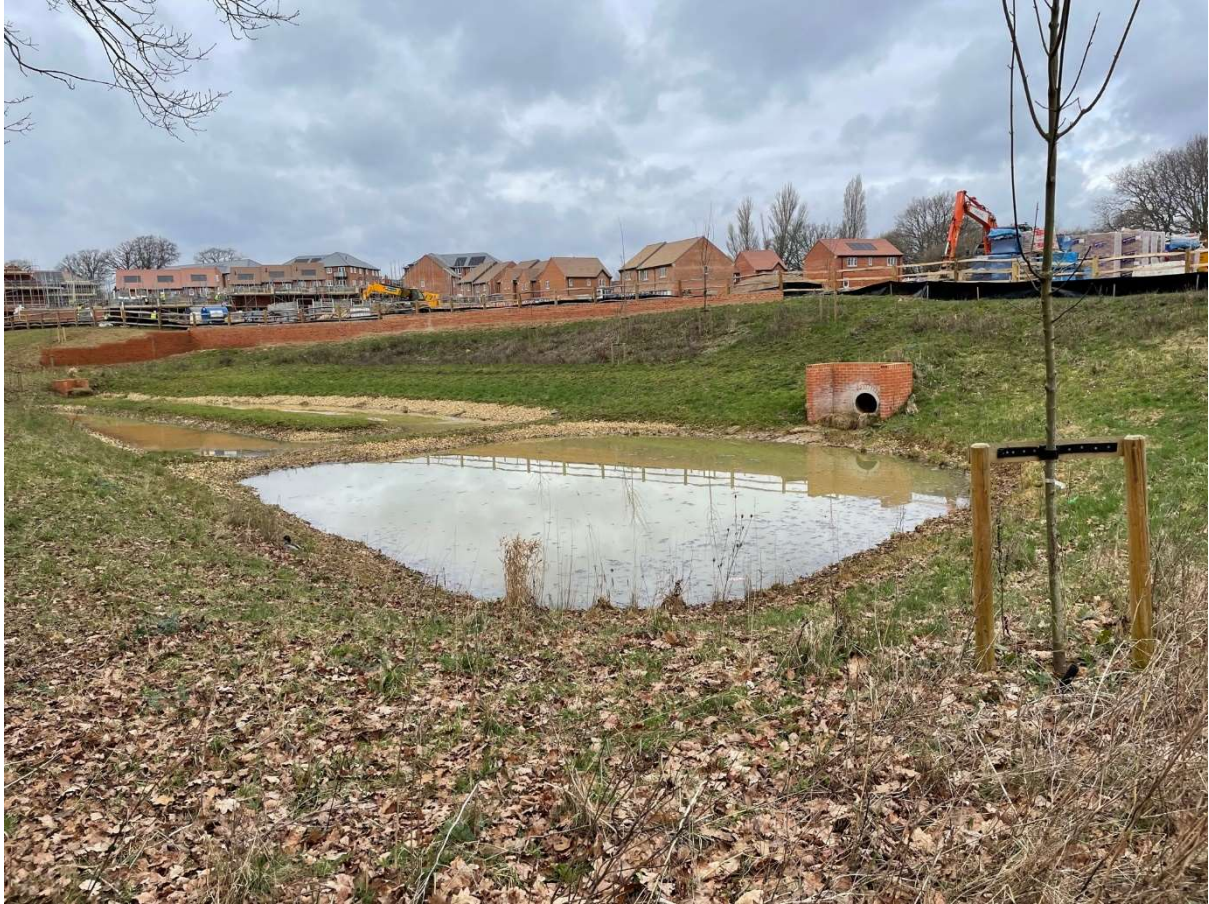
Photograph 4 : pond looking north, tree planting and landscaping clearly visible. Note the masonry outfall requires a safety grill

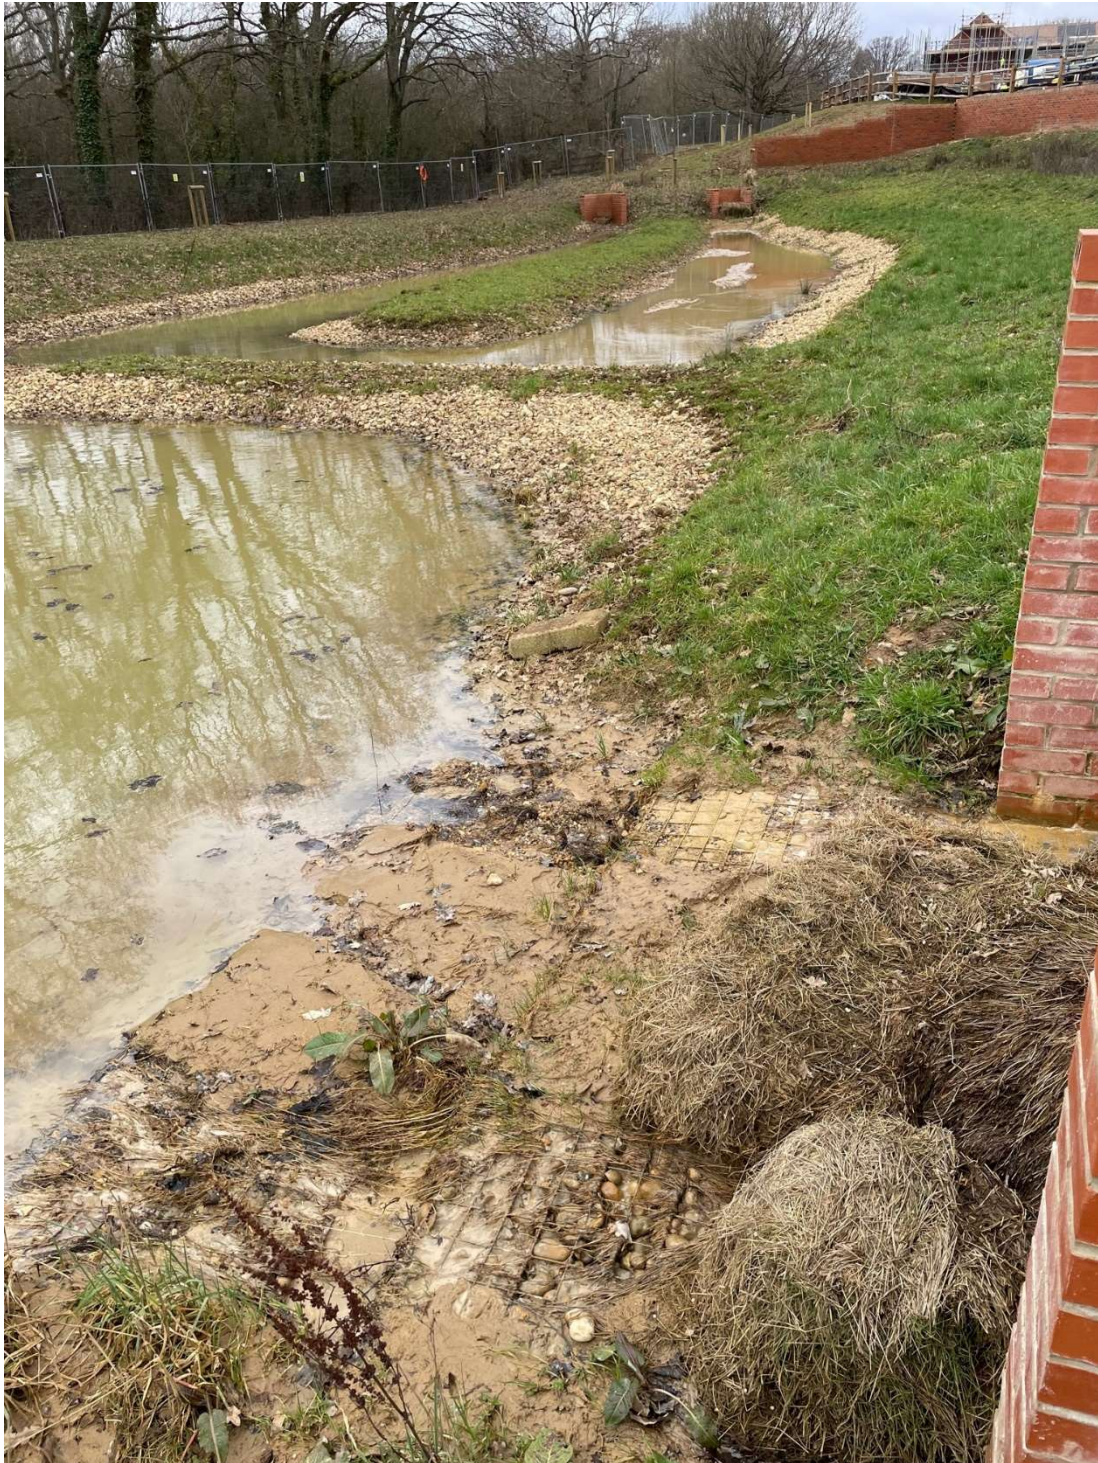
Photograph 5 : pond closer view of the pond outfall, noting the straw bales used as a temporary silt control, suggest these are replaced and maintained during the construction works
