# Arboricultural Appraisal Report

## Subsidence Damage Investigation at:

39 Lakewood Road  
Chandler's Ford  
Eastleigh  
SO53 1EU

| REPORT DATE: | 12/12/2022 |

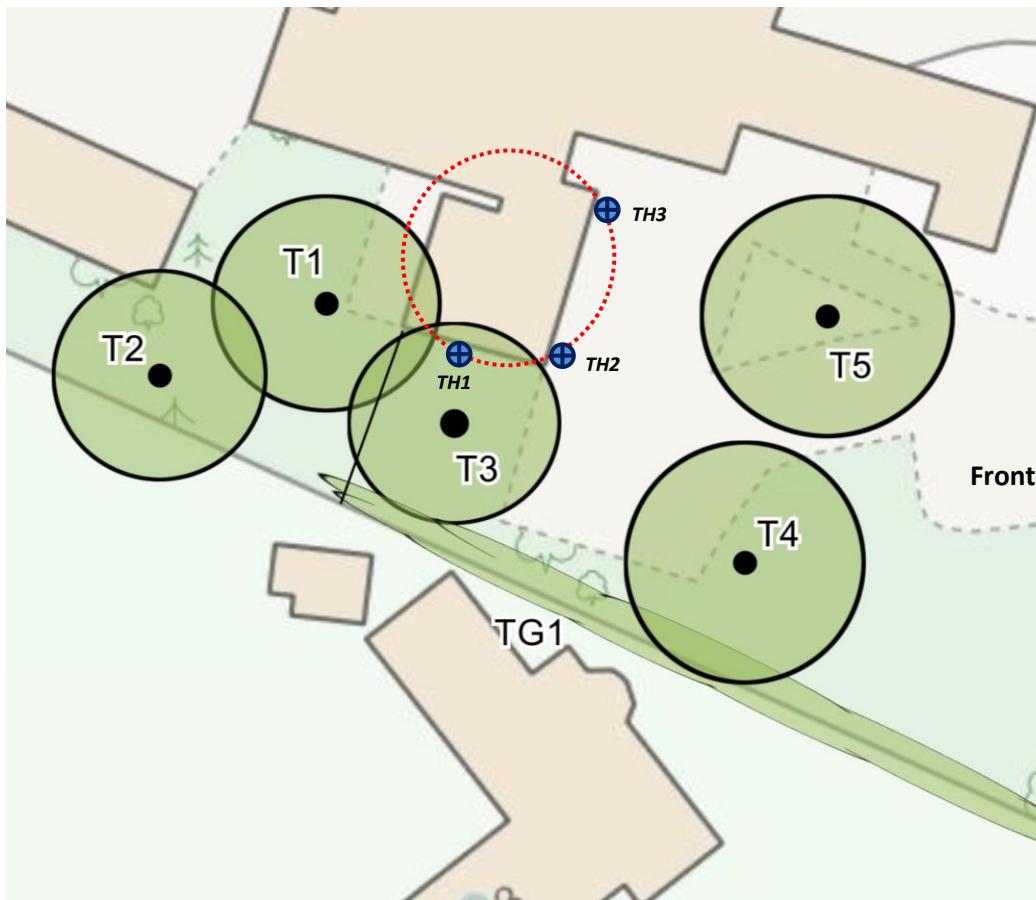
Approximate areas of damage

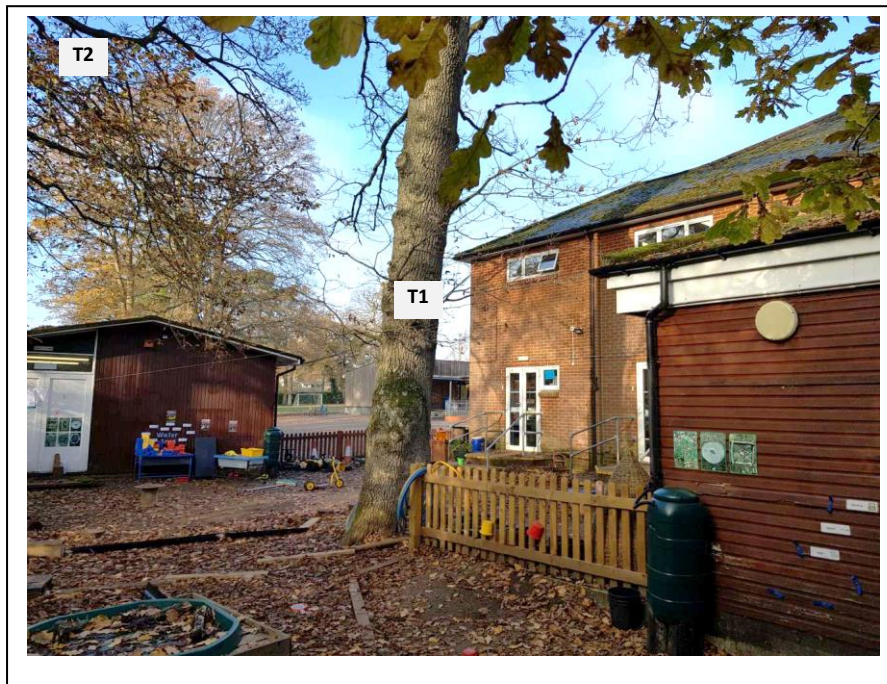
Roots were observed to a depth of 1150mm bgl in TH1 and recovered samples have been positively identified (using anatomical analysis) as *Quercus spp.*, the origin of which will be T1 or T3, confirming their influence on the soils below the foundations.

Based on the technical reports currently available, engineering opinion and our own site assessment we conclude the damage is consistent with shrinkage of the clay subsoil related to moisture abstraction by vegetation. Having considered the information currently available, it is our opinion that T1 and T3 are the principal cause of or are materially contributing to the current subsidence damage.

| Tree No. | Species | Ht. (m) | Dia. (mm) | Crown Spread (m) | Dist. to building (m) | Age Classification | Ownership |
|---|---|---|---|---|---|---|---|
| T1 | Oak | 20 * | 650 * | 14 * | 4.5 | Older than extension(s) | Policy Holder |
| Management history | | Subject to past management/pruning - appears regularly pruned. | | | | | |

View of base of T1

If an arboricultural solution is to be implemented to mitigate the influence of the implicated trees/vegetation we recommend that T1 and T3 are removed.

| Tree No. | Species | Ht. (m) | Dia. (mm) | Crown Spread (m) | Dist. to building (m) | Age Classification | Ownership |
|---|---|---|---|---|---|---|---|
| Recommendation | | Remove (fell) to near ground level. Owner to physically remove any regrowth (no chemical treatment due to translocation risk). | | | | | |

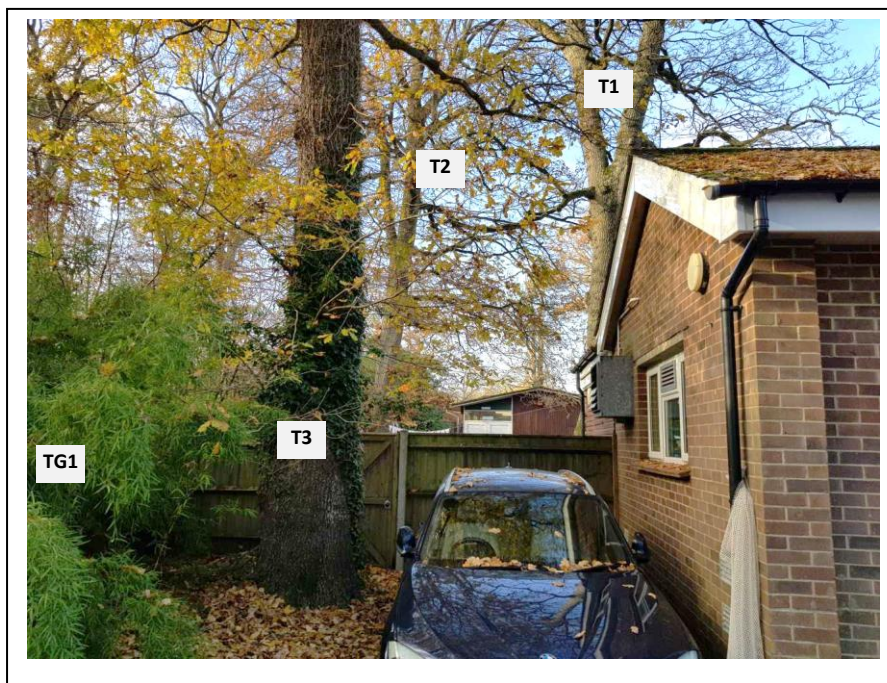
Roots were observed to a depth of 600mm bgl in TH2 and recovered samples have been positively identified (using anatomical analysis) as *Quercus spp.*, the origin of which will be T3, confirming its influence on the soils below the foundations.

| Tree No. | Species | Ht. (m) | Dia. (mm) | Crown Spread (m) | Dist. to building (m) | Age Classification | Ownership |
|---|---|---|---|---|---|---|---|
| T3 | English Oak | 21 | 890 | 12 * | 3.5 | Older than extension(s) | Policy Holder |
| Management history | | Subject to past management/pruning - appears regularly pruned. | | | | | |

View of base of T3

| Tree No. | Species | Ht. (m) | Dia. (mm) | Crown Spread (m) | Dist. to building (m) | Age Classification | Ownership |
|---|---|---|---|---|---|---|---|
| Recommendation | | Remove (fell) to near ground level. Owner to physically remove any regrowth (no chemical treatment due to translocation risk). | | | | | |

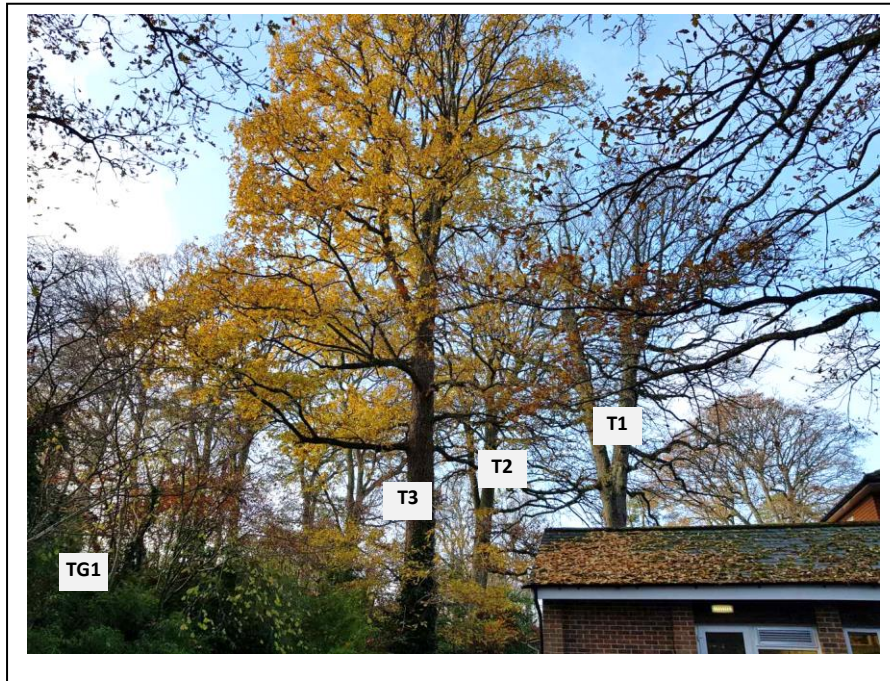
We note that some of the trees have been subject to crown reduction in the past but those works would not have removed sufficient leaf volume to be significant in respect to subsidence.

Consideration has been given to pruning alone as a means of mitigating the vegetative influence, however in this case, this is not considered to offer a viable long-term solution due to the proximity of the responsible vegetation.

View of crown of T1 and T3

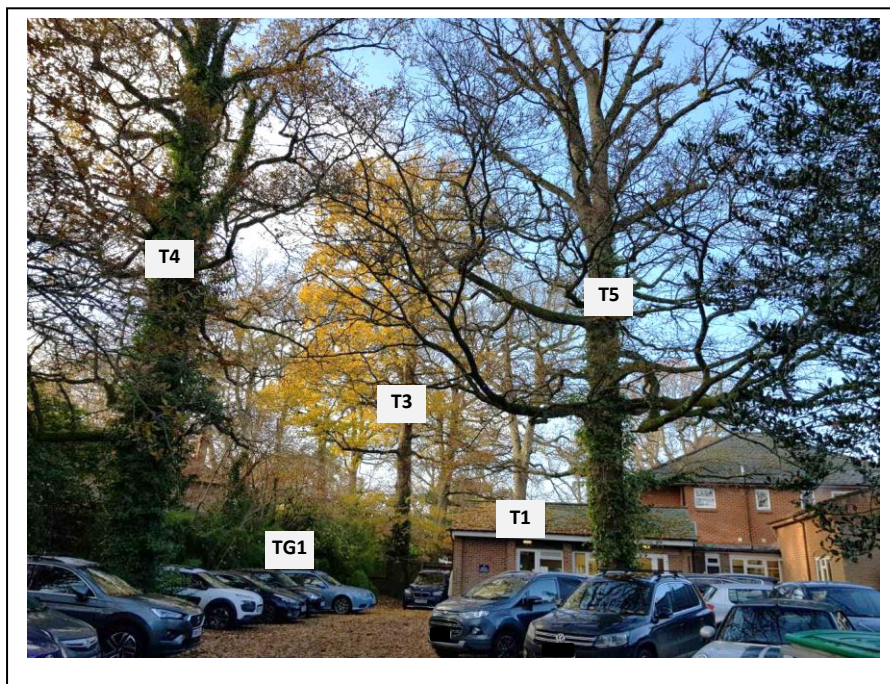
The area affected is a single storey element used as a kitchen, attached to a two-storey building to the right. Internal and external cracking was present but has been temporarily repaired to ensure a hygienic food preparation area. It was first noticed in the summer of 2022.

View of kitchen from front
