# Site Investigation Report

140472.1.1.BSI

Auger were commissioned by Quadra to undertake a site investigation and CCTV inspection of the underground drainage within the area of concern (AOC) at the property.

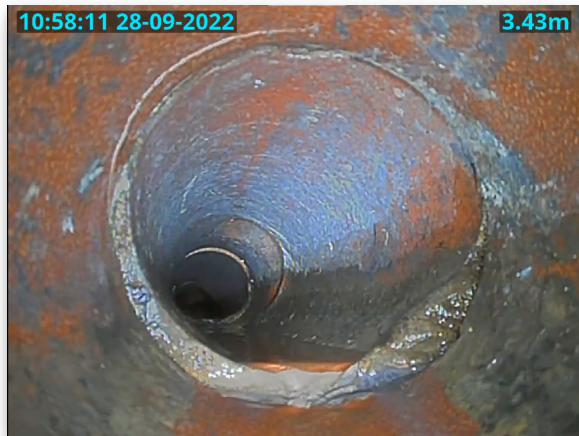
Our survey of line 3 revealed joint displacements and cracking (see Fig 4.1). However, these defects were noted to be outside the area of concern.

The above mentioned defects to the below ground drainage system have been caused by ground movement.

Fig 4.1: Line 3 Joint Displacements and Cracking

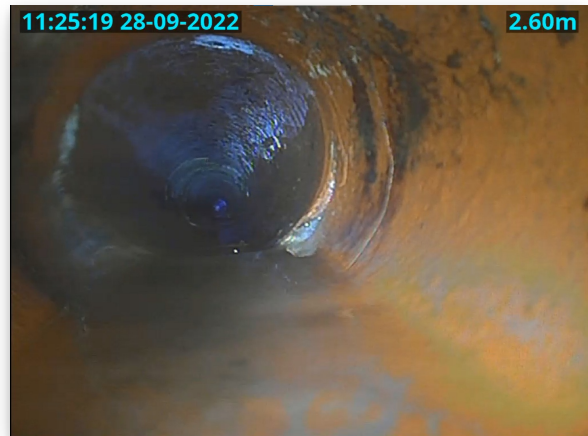
Our survey of line 4 revealed joint displacements and cracking (see Fig 4.2). However, these defects were noted to be outside the area of concern.

Fig 4.2: Line 4 Joint Displacement and Cracking

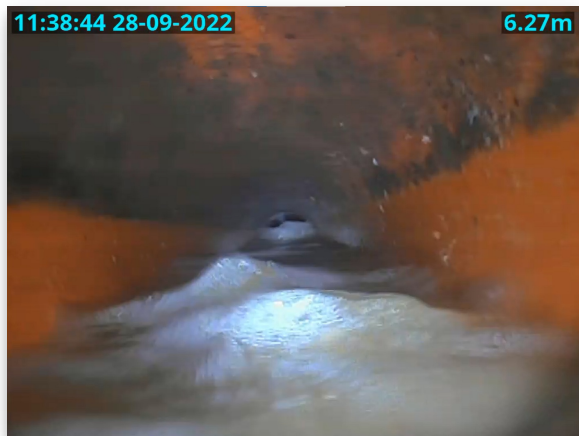
Our survey of line 7 revealed bellied pipework causing slight water retention (see Fig 4.3). However, this defect is not allowing an escape of water.

Fig 4.3: Line 7 Water Retention

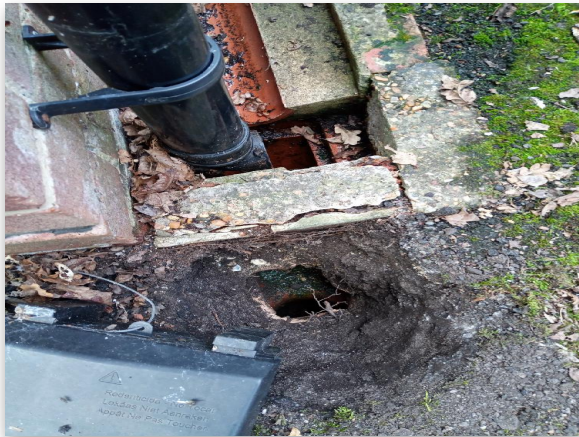
We were unable to complete a full CCTV survey of line 8 due to silt/debris in the pipework. We performed an excavation to access the pipework downstream of the gully which was also revealed to be heavily silted up (see Fig 5.1). We performed high pressure water jetting in order to clear the line which was unsuccessful.

Fig 5.1: RWG1 Break in point

| Refer Back to Client | <p>It is recommended that the following repairs are carried out to prevent an escape of water from the system:</p> <p><b>Line 8</b><br/>Excavate and replace RWG1 and install new 3m of 100mm pipework directly downstream to MH1 at a depth no greater than 1.0m through tarmac. This will required breaking through wall of MH1 to make a new connection.</p> <p>The surface will be temporarily reinstated with cold lay tarmac to leave the area safe and tidy. A specialist contractor will be required to reinstate the hot lay tarmac which would incur additional costs.</p> <p>A specialist will also be required to alter the above ground pipework, including the guttering, in order to redirect all rain water into this new gully. This is the most cost effective option. The alternative, more costly option, would be to excavate and further investigate downstream of RWG1 and RWG2 which likely lead to failed soakaways.</p> <p><b>Please Note:</b><br/>Auger have not allowed or will not be held responsible for any alteration or modification to the above ground drainage following the removal of the existing gully and reinstatement of a new gully. The customer must ensure that the above ground drainage correctly expels into the gully pot and avoids overcrowding the gully with numerous downpipes which could lead to the gully overflowing.</p> <p>We would like to note that the gully we are proposing to replace has a large concrete surround. When installing the new gully Auger will install a type 3 gully at ground level with a smaller surround. We would therefore like to make the customer aware that the newly installed gully will aesthetically differ from the current arrangement.</p> <p>It should be noted that our drainage survey revealed defects which were outside the area of concern. We would therefore recommend that the customer opens a separate claim for accidental damage to underground services as these works would not be covered as part of a subsidence claim.</p> <p>We will now refer the claim back to the client in order to progress the claim.</p> |

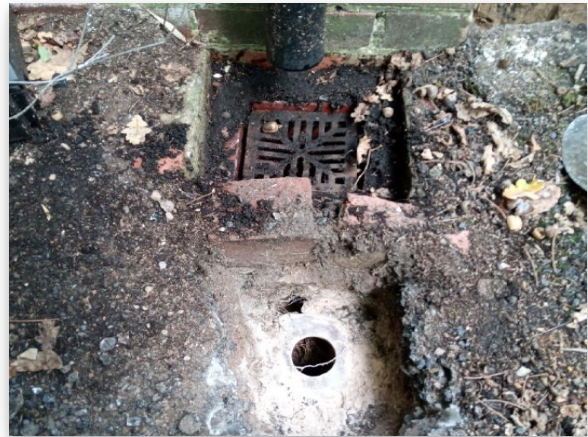
We were unable to complete a full CCTV survey of line 9 due to silt/debris in the pipework. We performed an excavation to access the pipework downstream of the gully which was also revealed to be heavily silted up (see Fig 5.2). We performed high pressure water jetting in order to clear the line which was unsuccessful.

Fig 5.2: RWG2 Break in point

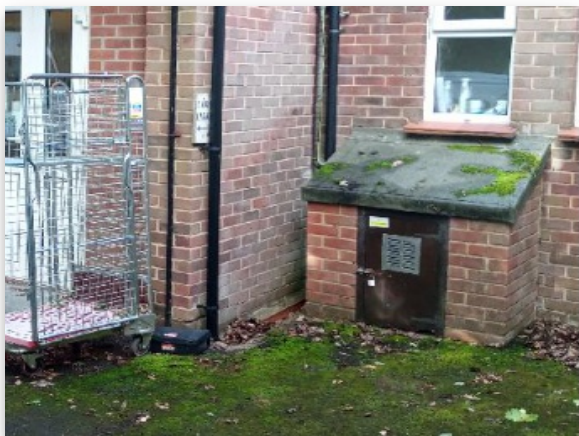
TH3 was moved to front elevation on same corner because of a gas mains box and drainage within originally proposed area (Fig 5.3). TH3 was completed to the required depth and the requested soil and root samples were collected whilst on site.

Fig 5.3: TH3 Proposed location
