## **Land to the Northwest of Boorley Green, SO32 2BX (Phase RM1)**

### **DISCHARGE OF CONDITIONS**

ACD have been instructed to produce a technote to address condition 22 of planning application X/21/91994, and condition 8 of planning application X/19/84943, which both relate to confirmation of implementation of tree protection measures onsite.

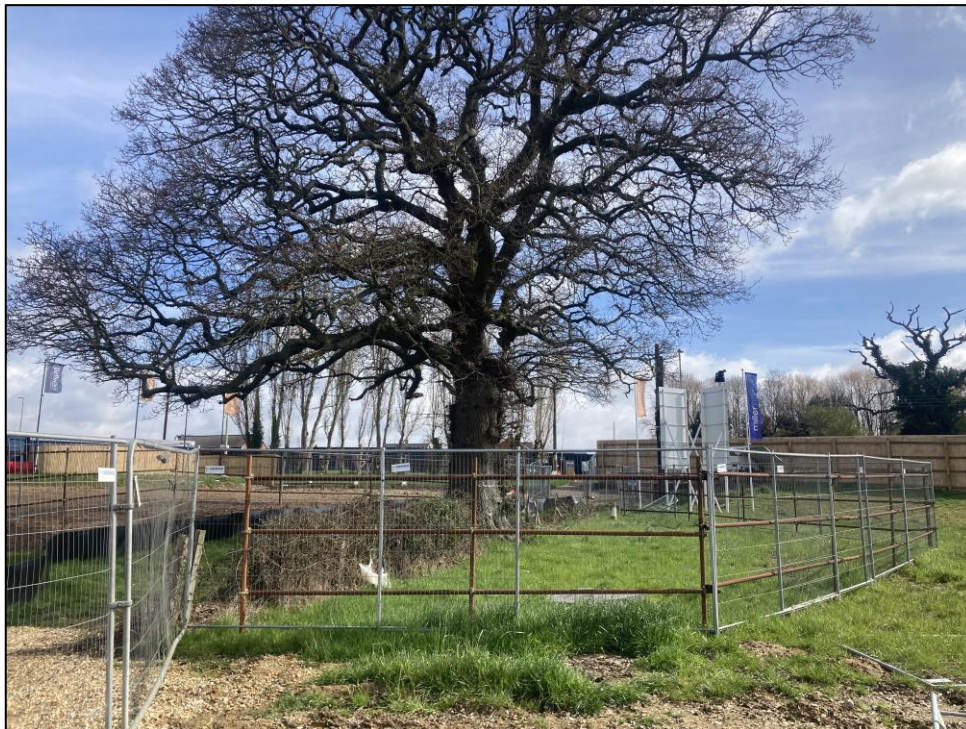
*Figure 1: Photo showing tree protection fencing surrounding tree T19 - 'A' Category Oak*

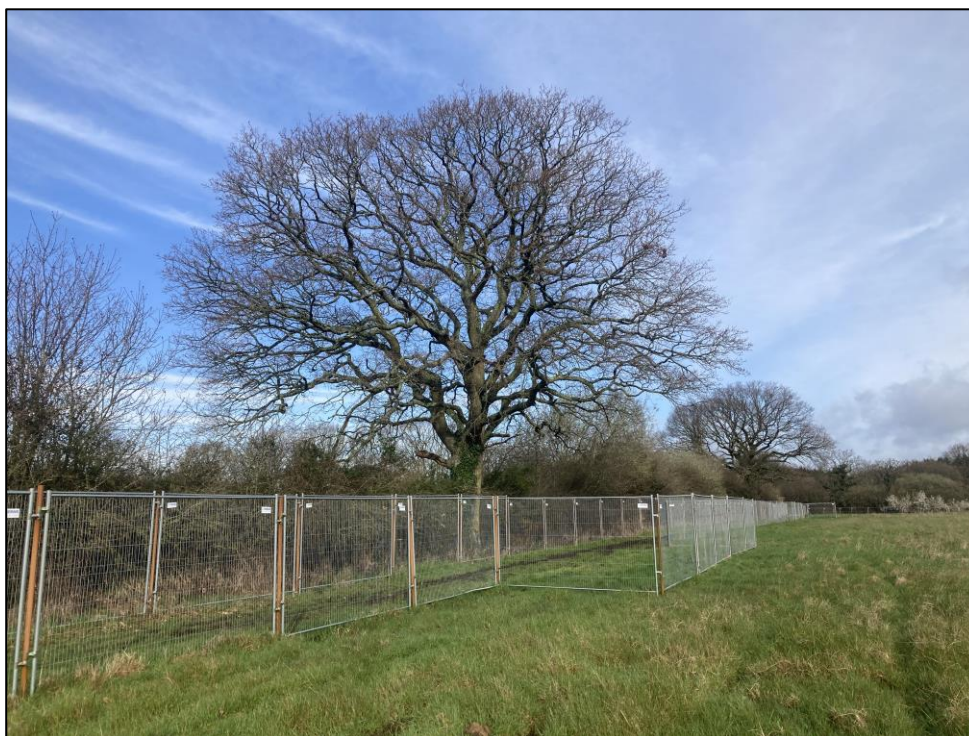
*Figure 2: Photo showing tree protection fencing surrounding tree T15 & T16 - 'A' Category Oaks and T17 – 'B' category Oak*

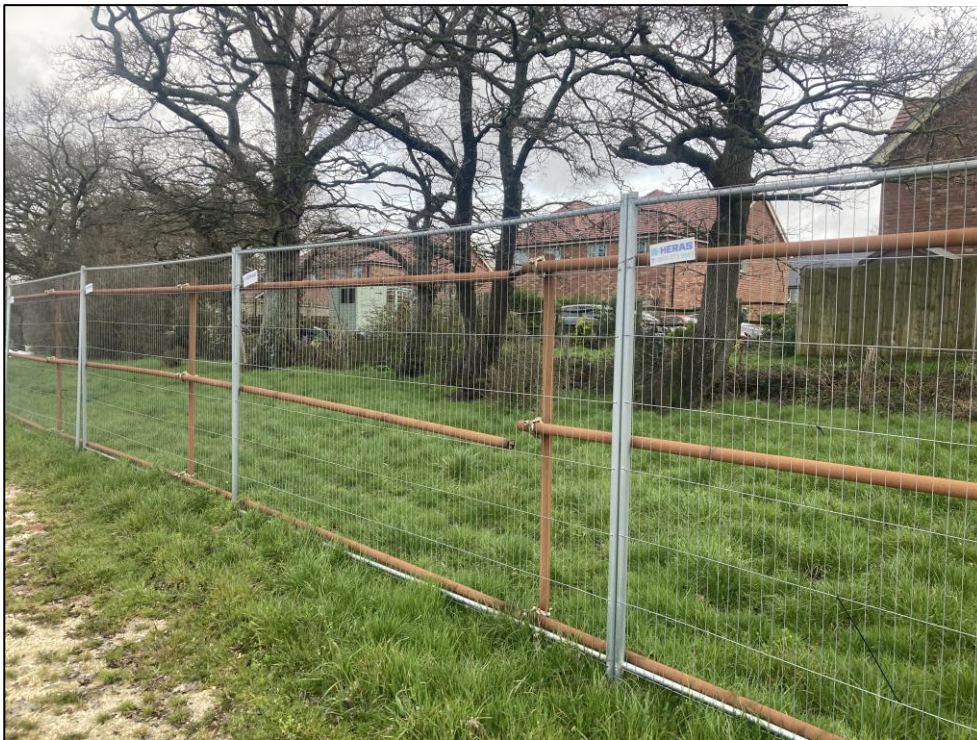
*Figure 3: Photo Showing TPF erected to the West of G24 on the Eastern boundary of the site*

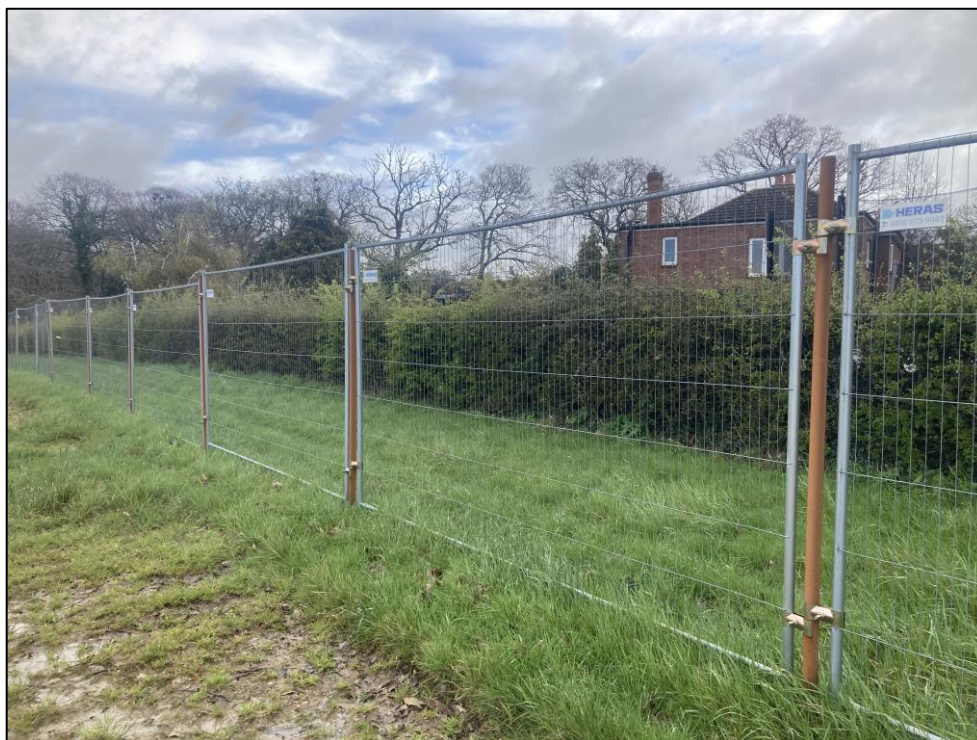
*Figure 4: Photo showing TPF to the West of H10 on the Eastern boundary of the site*

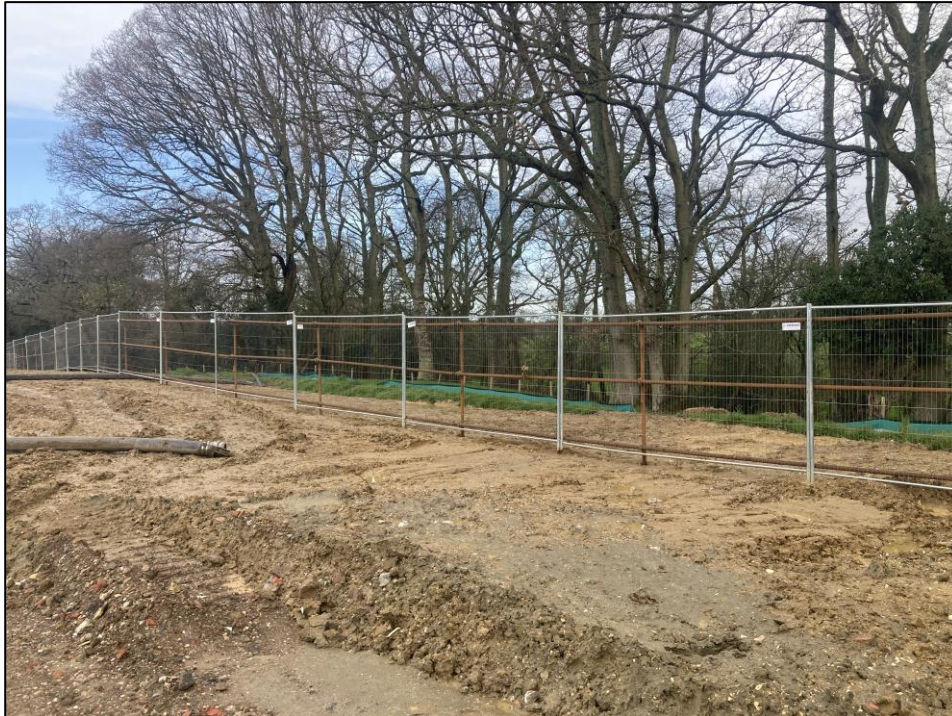
*Figure 5: Photo showing TPF to the South of G26 along the Northern boundary of the site*

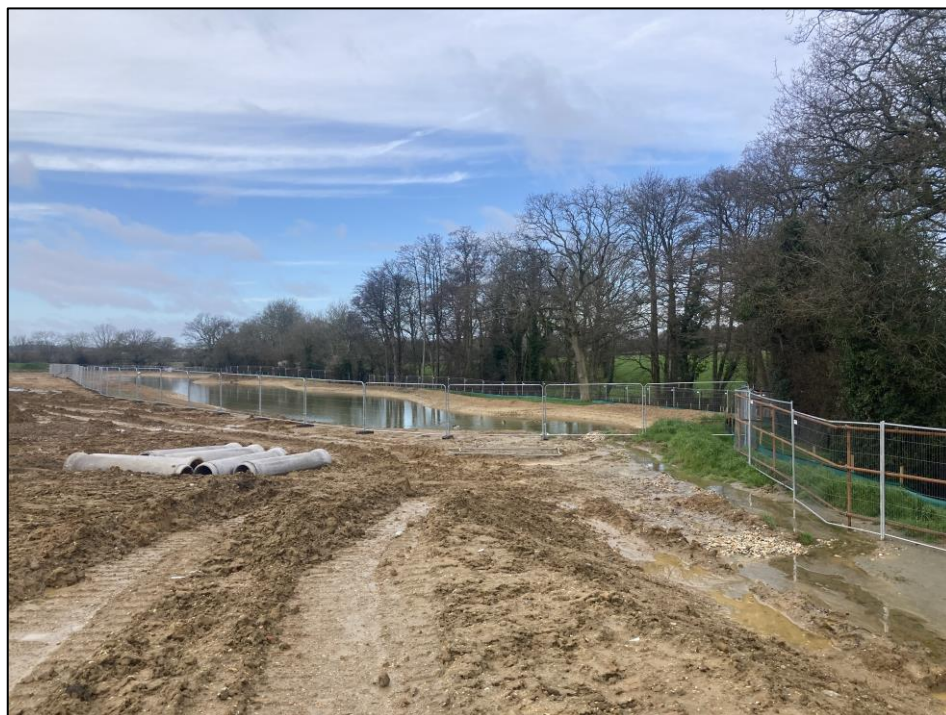
*Figure 6: Photo showing TPF to the South of G27 along the Northern boundary of the site*

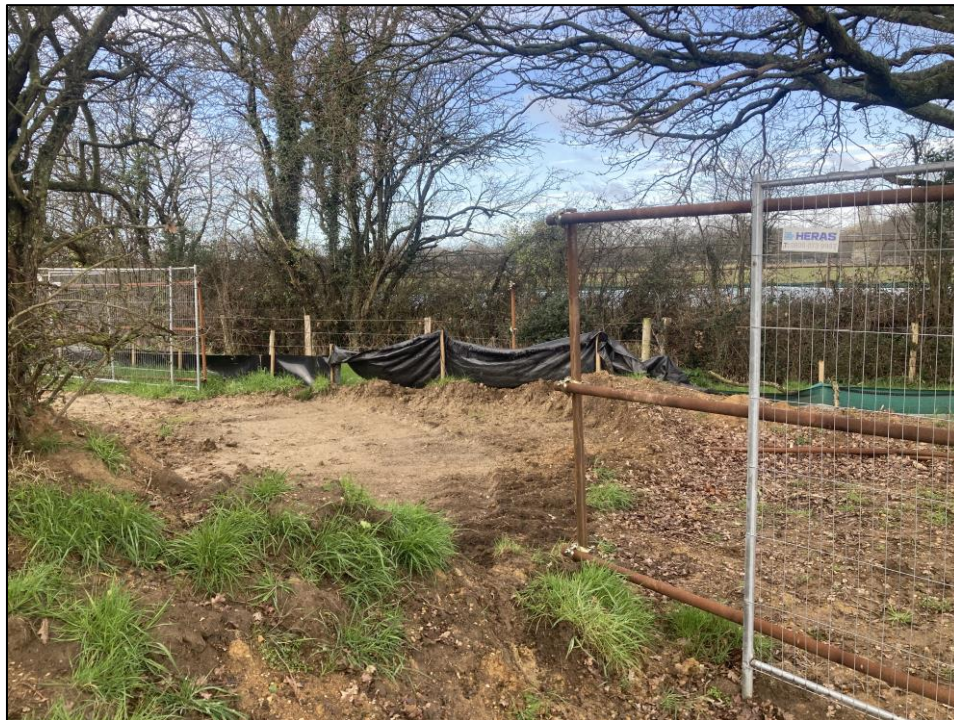
During the site visit, x2 areas of fencing were found to require amendment, however, subsequent photos supplied in May 2023 following these recommendations confirm that these rectifications have been conducted and therefore Tree Protection Fencing is now considered adequate and in line with the approved drawings.

*Figure 7: Section of missing fencing to the South of large Oak within G16*

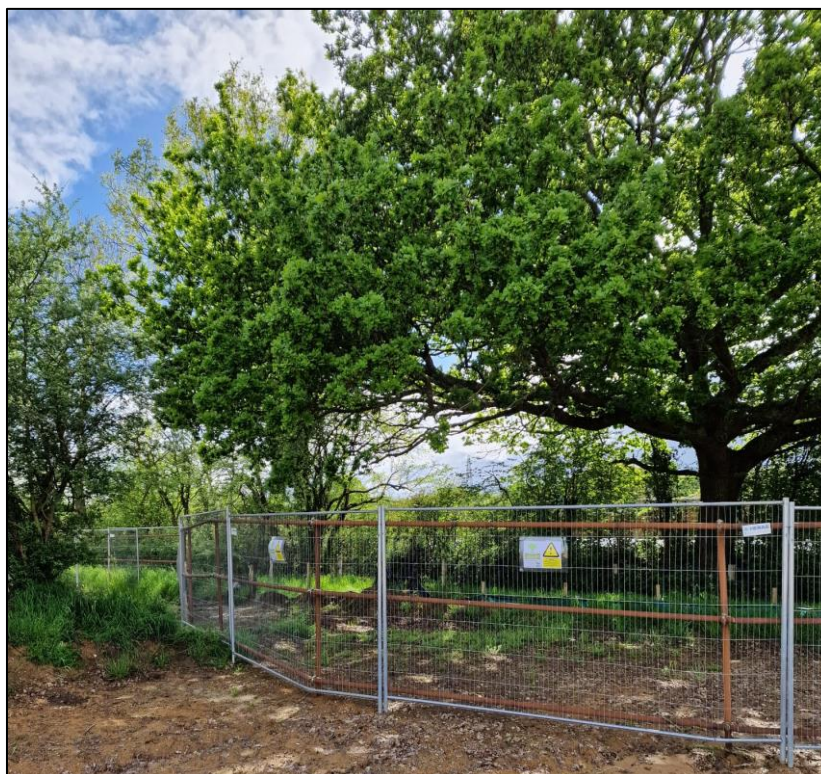
*Figure 8: Subsequent confirmation of rectification of TPF for G16*

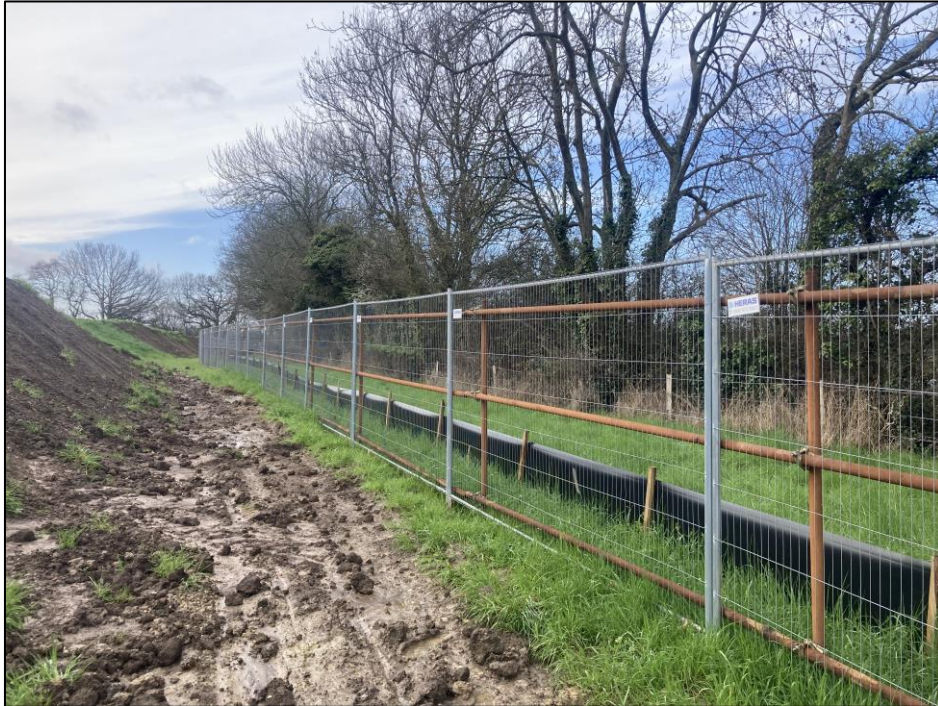
*Figure 9: Photo Showing fencing along the West of G16*

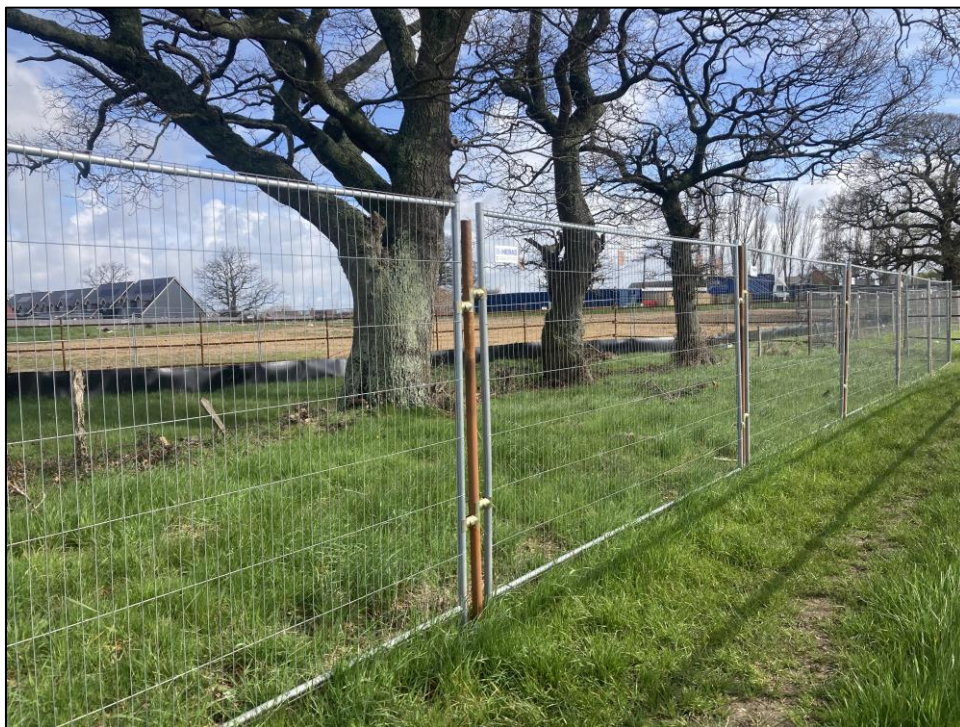
*Figure 10: Phot showing TPF surrounding G14*

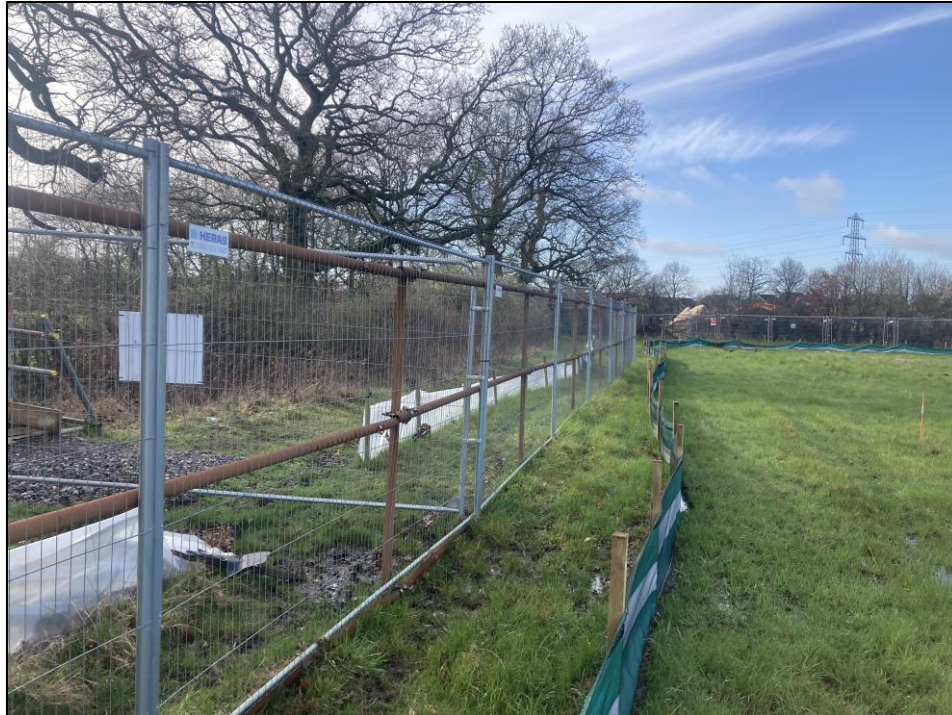
*Figure 11: Photo showing TPF to the East of G12 & T8*

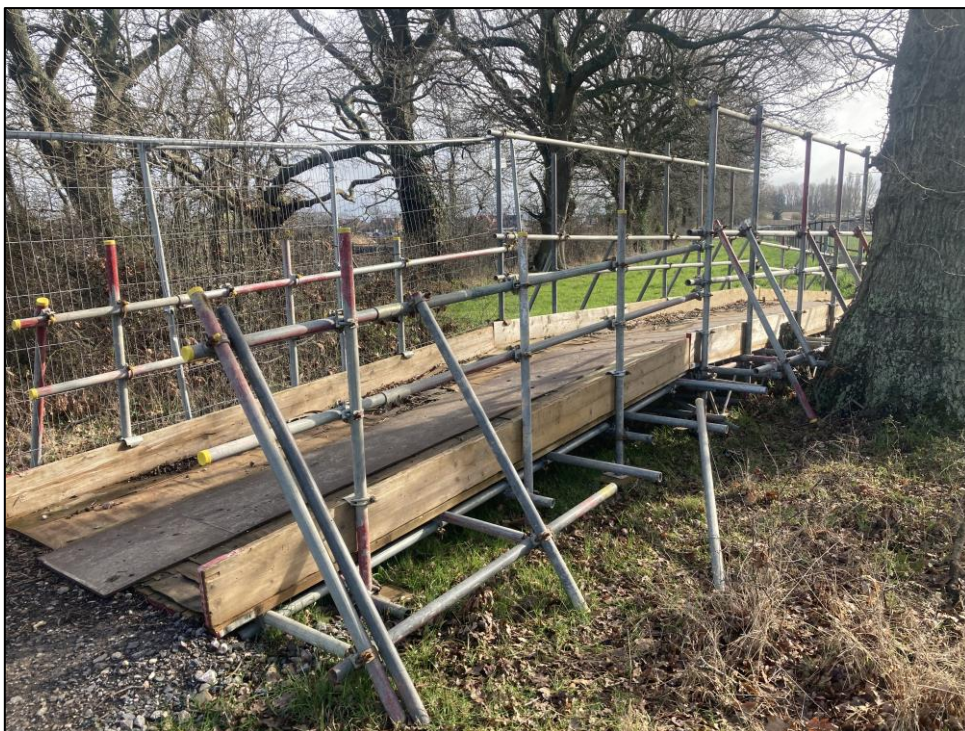
*Figure 12: No-dig pedestrian bridge along the Public Right of Way that runs through the RPA of G12*

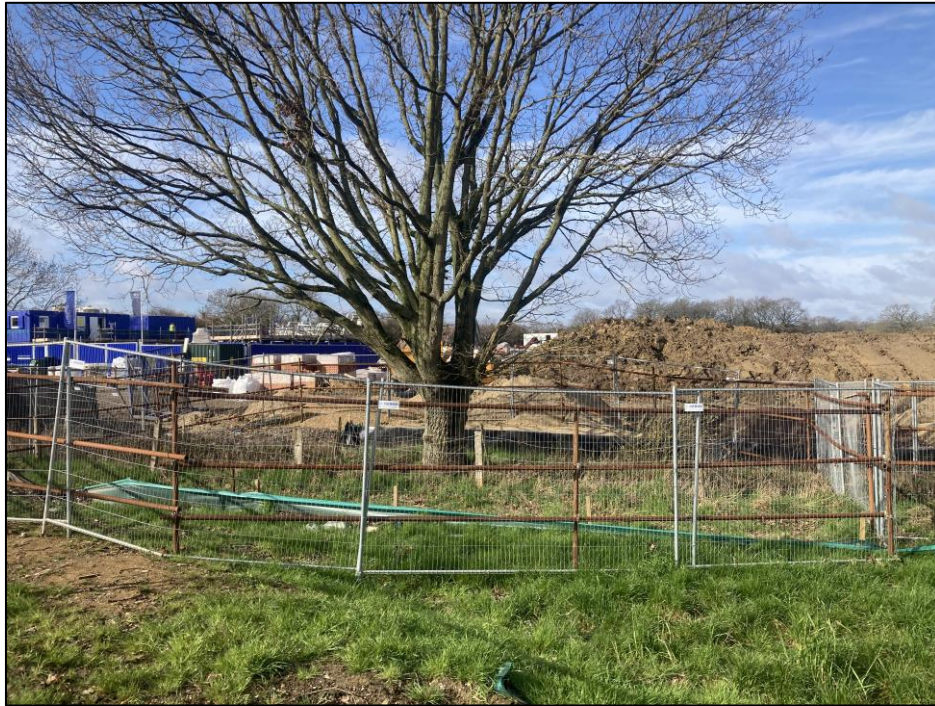
*Figure 13: Photo Showing TPF around T7*

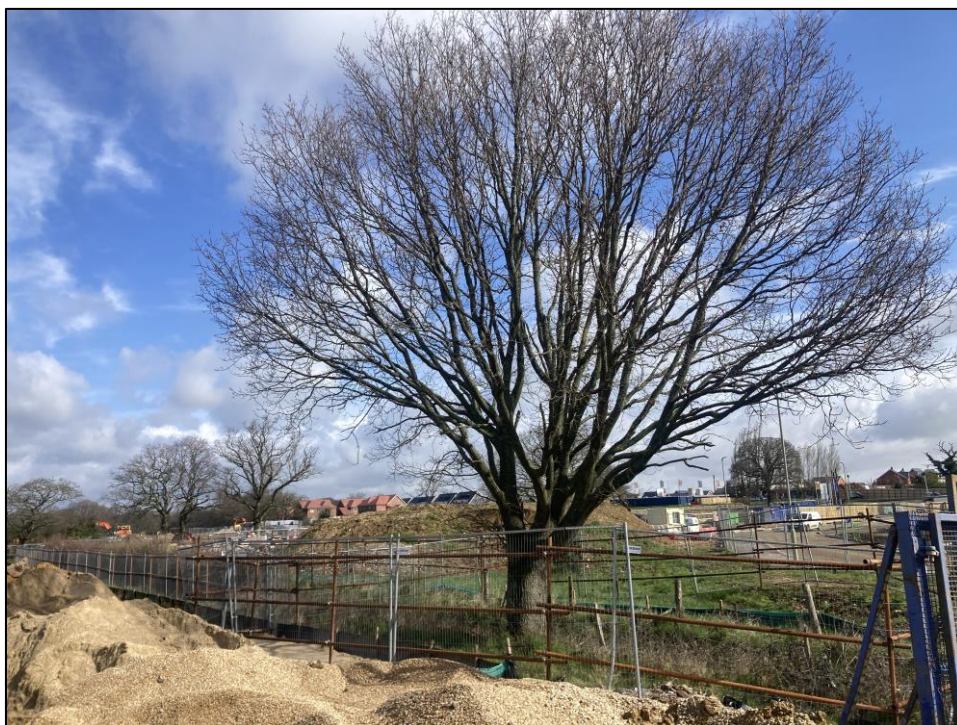
*Figure 14: Photo Showing TPF around T7*

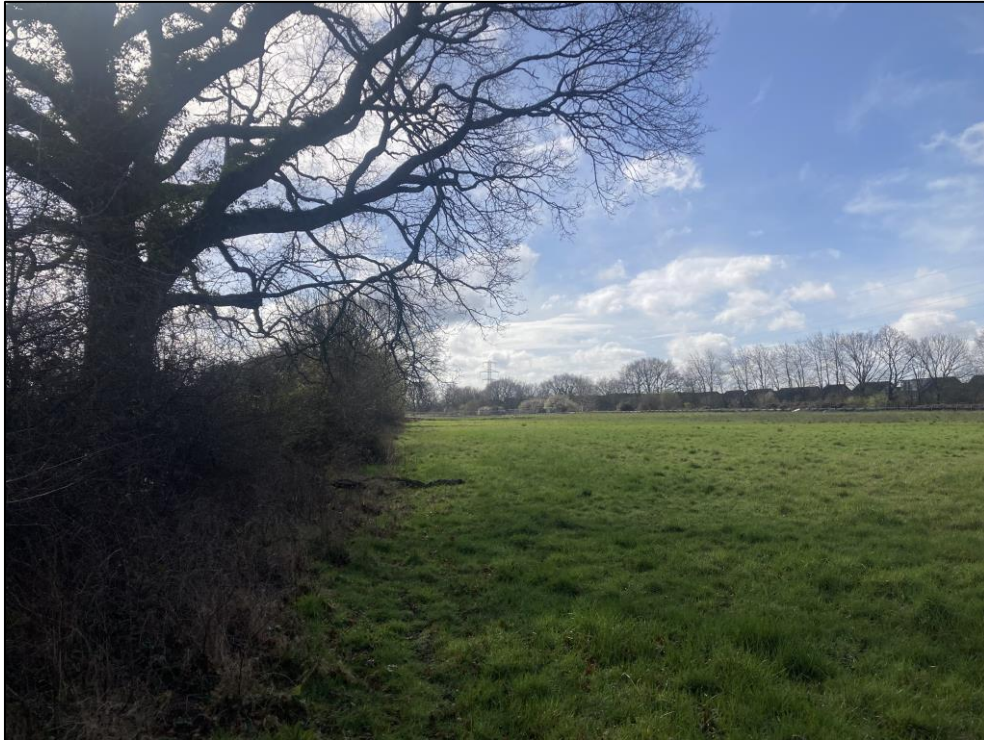
*Figure 1: Photo showing lack of TPF surrounding T15*

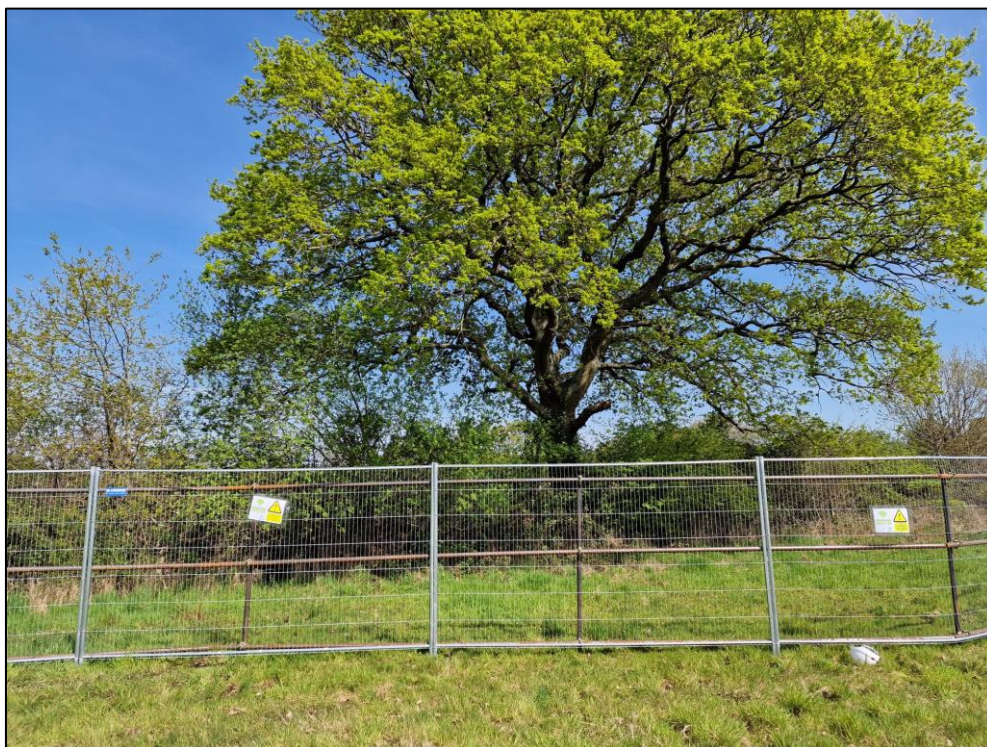
*Figure 2: subsequent confirmation of rectification of TPF surrounding T15*
