## **Road Safety Audit Stage 1**

**Derby Road**

**Eastleigh**

Report Title            Derby Road, Eastleigh Road Safety Audit Stage 1

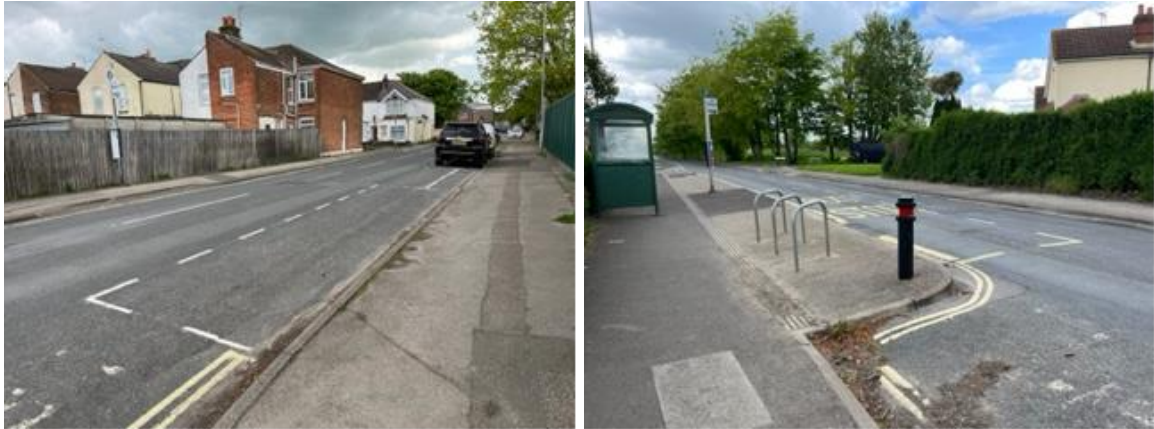
**Summary:** Lack of visibility could lead to side impact collisions or rear end shunts.

No visibility splays have been provided for assessment at the Access Road junction with Derby Road, where there is concern that parking and the bus stop may restrict visibility – see figures 1&2 overleaf, however, it is recognised that this is an existing situation. Insufficient visibility could lead to side impact collisions or rear end shunt collisions.

Figures 1 & 2 Potential obstructions to the visibility splays.

It is recommended that the parking bay to the east of the access should be reduced in length to aid visibility.

| <p><b>3.3.1 PROBLEM</b></p> <p><b>Location:</b> Access Road junction with Derby Road.</p> <p><b>Summary:</b> Lack of visibility could lead to side impact collisions or rear end shunts.</p> <p>No visibility splays have been provided for assessment at the Access Road junction with Derby Road, where there is concern that parking and the bus stop may restrict visibility – see figures 1&amp;2, if, however, it is recognised that this is an existing situation. Insufficient visibility could lead to side impact collisions or rear end shunt collisions.</p> | It is recommended that the parking bay to the east of the access should be reduced in length to aid visibility. | <p>No visibility splays were provided at the access of the Service Road with Derby Road as this junction is an existing vehicle crossover which does not have a record of accidents despite both the on-street parking and bus stop already being in situ. Based on the low traffic generation of the proposals it is considered that this would not result in a severe highway safety concern in accordance with the NPPF.</p> <p>Furthermore, Manual for Streets and Manual for Streets 2 both state that parking is considered a temporary obstacle which should not cause safety concerns in practice as vehicles would tend to nudge out until they have the clear visibility. The build out to the west of the access further enforces this point and ensures vehicles would not be waiting in the highway.</p> | | |
