## Toynbee Road and Romsey Close, Eastleigh

### Flood Risk & Drainage Technical Note

| <b>Project No.</b> | 1373 |
| <b>Revision</b> | C |

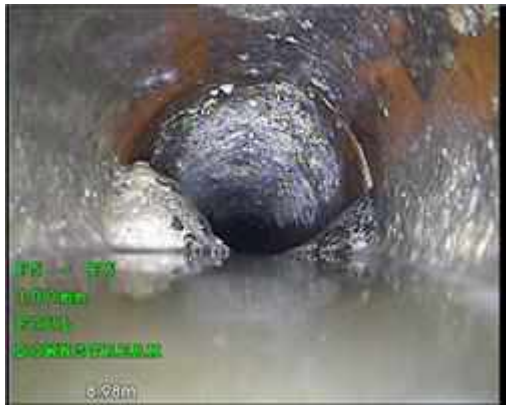
| Pos | Video Ref | Code | Description | Image |
|---|---|---|---|---|
| 09.00m | 0:01:38 | DEE | Attached deposits, encrustation from 03 o'clock to 10 o'clock: 40% Cross sectional area loss - Severity 3 | <p>Image Provided - Ref: 4_7</p> |

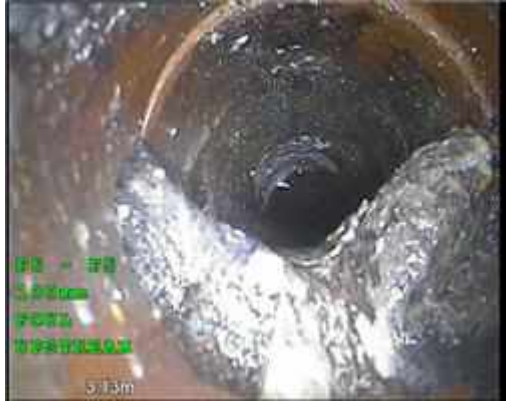
| Pos | Video Ref | Code | Description | Image |
|---|---|---|---|---|
| 03.13m | 0:00:30 | DEE | Attached deposits, encrustation from 02 o'clock to 09 o'clock: 40% Cross sectional area loss - Severity 3 | Image Provided - Ref: 5_3<br> |

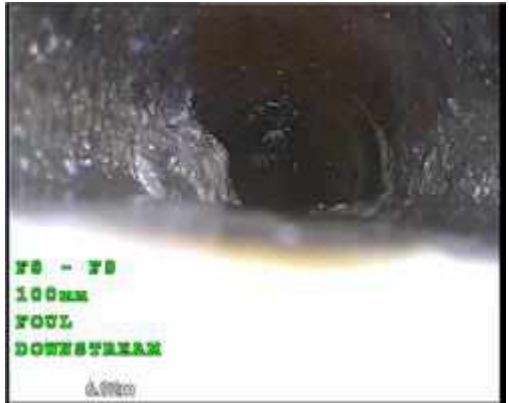
| Pos | Video Ref | Code | Description | Image |
|---|---|---|---|---|
| 06.90m | 0:01:19 | DEE | Attached deposits, encrustation from 03 o'clock to 10 o'clock: 30% Cross sectional area loss - Severity 3 | <p>Image Provided - Ref: 8_7</p> |

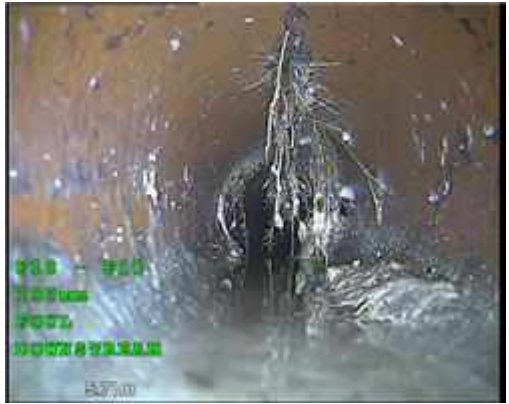
| Pos | Video Ref | Code | Description | Image |
|---|---|---|---|---|
| 05.70m | 0:00:54 | FL | Fracture longitudinal at 12 o'clock - Severity 3 | Image Provided - Ref: 10_3<br> |
| 05.70m | 0:00:54 | R | Roots - Severity 3<br>ROOT MASS | |
| 05.70m | 0:00:57 | DES | Settled deposits fine: 10% Cross sectional area loss - Severity 3 | |

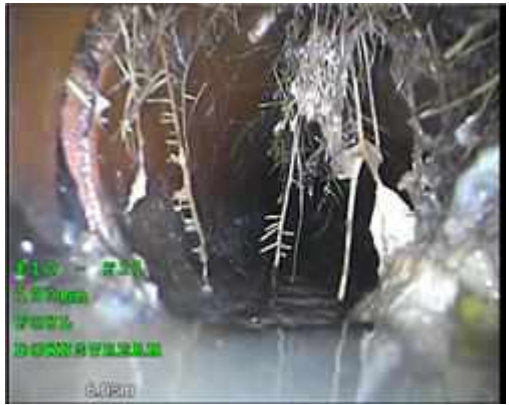
| Pos | Video Ref | Code | Description | Image |
|---|---|---|---|---|
| 06.00m | 0:00:58 | RJ | Roots at joint - Severity 3<br>FINE ROOTS AT JOINT | Image Provided - Ref: 10_6<br> |

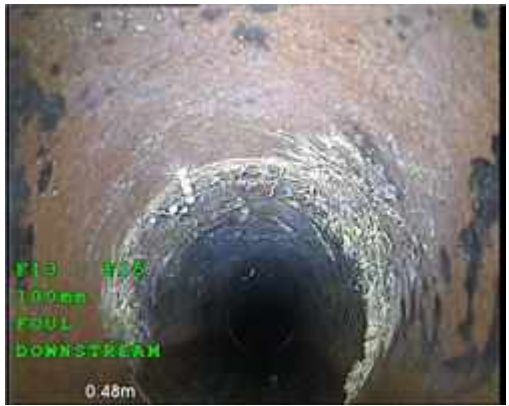
| Pos | Video Ref | Code | Description | Image |
|---|---|---|---|---|
| 00.48m | 0:00:04 | R | Roots - Severity 3<br>FINE ROOTS | Image Provided - Ref: 4_3<br> |

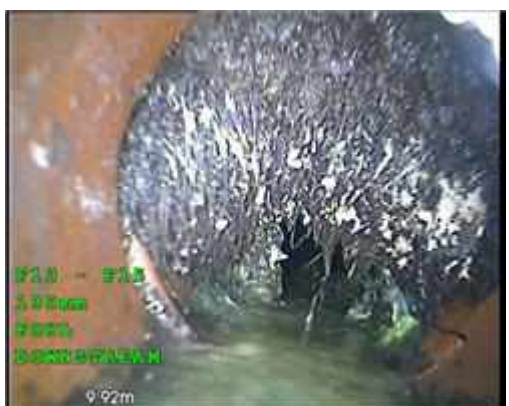
| Pos | Video Ref | Code | Description | Image |
|---|---|---|---|---|
| 09.92m | 0:01:32 | R | Roots - Severity 3<br>MASS ROOTS AT JOINT | Image Provided - Ref: 4_5<br> |

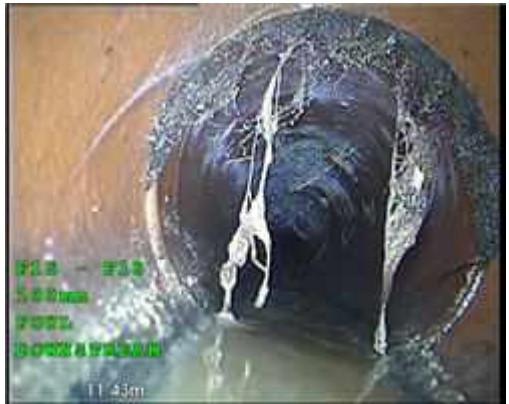
| Pos | Video Ref | Code | Description | Image |
|---|---|---|---|---|
| 11.43m | 0:01:40 | RJ | Roots at joint - Severity 3<br>MASS ROOTS AT JOINT | <p>Image Provided - Ref: 6_5</p> |

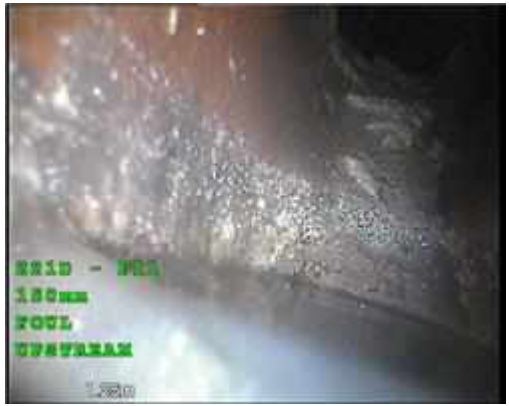
| Pos | Video Ref | Code | Description | Image |
|---|---|---|---|---|
| 01.42m | 0:00:29 | REM | General remark<br>RUNNING TRAP | <p>Image Provided - Ref: 7_5</p> |

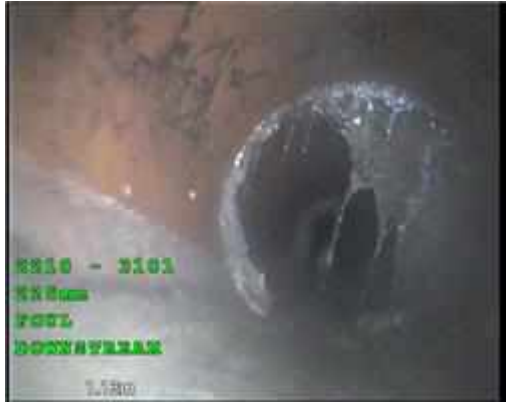
| Pos | Video Ref | Code | Description | Image |
|---|---|---|---|---|
| 01.20m | 0:00:07 | RJ | Roots at joint - Severity 3<br>MASS ROOTS AT JOINT | Image Provided - Ref: 9_4<br> |

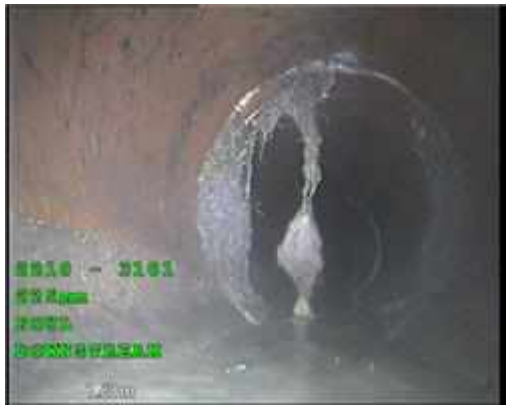
| Pos | Video Ref | Code | Description | Image |
|---|---|---|---|---|
| 01.60m | 0:00:11 | RJ | Roots at joint - Severity 3<br>MASS ROOTS AT JOINT | Image Provided - Ref: 9_5<br> |
