# ARBORICULTURAL ASSESSMENT REPORT

Woodlands, Hungerford, Bursledon, Southampton, SO31 8DF

PRI Ref: 261189

Survey Date: 18/05/2023

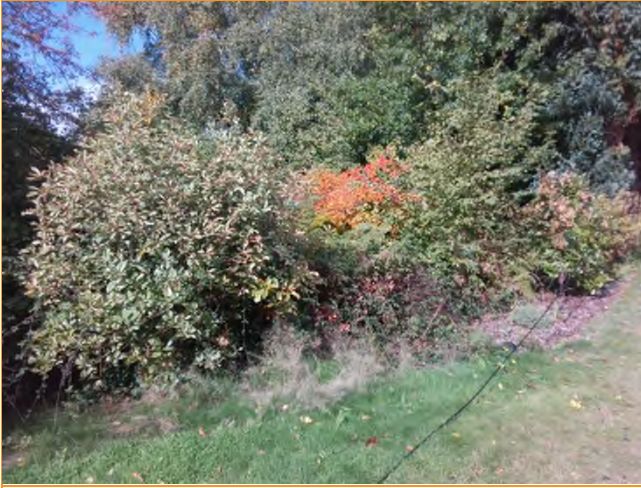
| Tree No | Common Name | Age Class | Condition | Height (m) | Crown Spread (m) | Stem diam. (mm) | Dist to bldg. (m) | Roots Implicated | Pruning history | Recommendation | Tree work constraints | Notes | Owner address | Owner |
|---|---|---|---|---|---|---|---|---|---|---|---|---|---|---|
| SG1 | Mixed species shrubs | Mature | Fair | 2.1 | 2 | 30 | 4.7 | N | Managed as a shrub group. | No work required. | | Group comprised of Photinia, Bay Laurel, Hazel and Dogwood. | Woodlands<br>Hungerford<br>Bursledon<br>Southampton<br>SO31 8DF | PH |

| SG1 - Mixed species shrubs (Oct 2022) | T1 - Oak (English) (Oct 2022) |

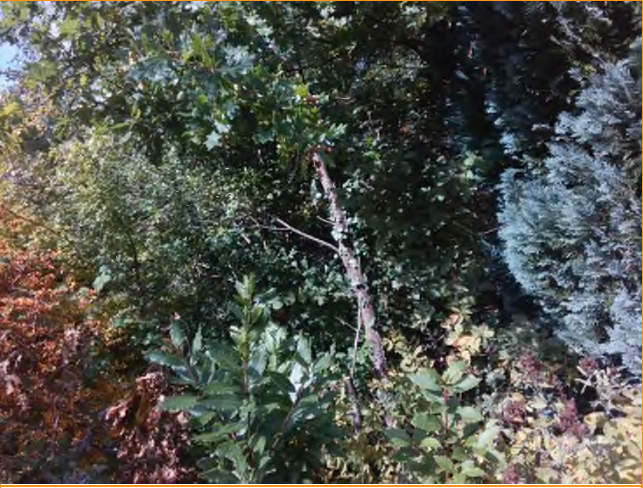
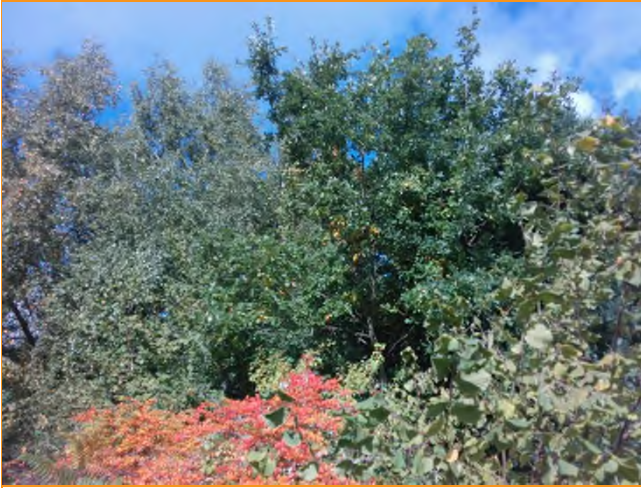
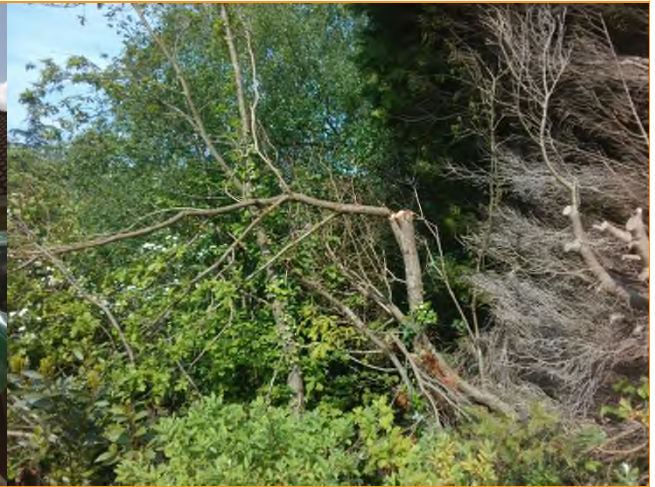
| Tree No | Common Name | Age Class | Condition | Height (m) | Crown Spread (m) | Stem diam. (mm) | Dist to bldg. (m) | Roots Implicated | Pruning history | Recommendation | Tree work constraints | Notes | Owner address | Owner |
|---|---|---|---|---|---|---|---|---|---|---|---|---|---|---|
| T1 | Oak (English) | Semi-Mature | Poor | 2.6 | 0 | 70 | 4.4 | Y | Subject to recent management.<br>North stem reduced in height by half. | No work required. | | | Woodlands<br>Hungerford<br>Bursledon<br>Southampton<br>SO31 8DF | PH |

| T1 - Oak (English) (Oct 2022) | T2 - Cypress (Leyland) (Oct 2022) |

T1 - Oak (English) (May 2023)

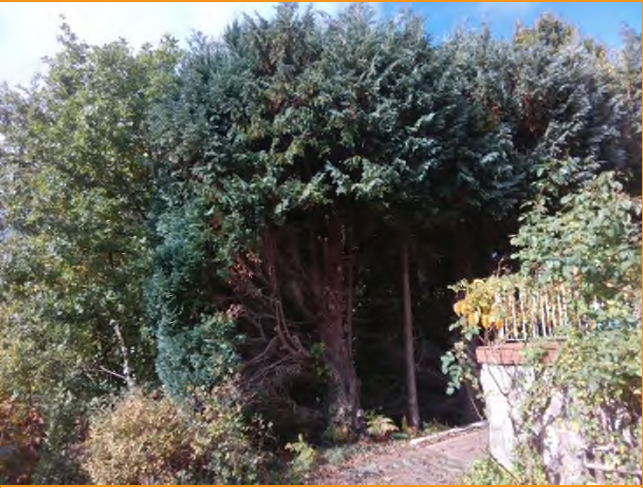
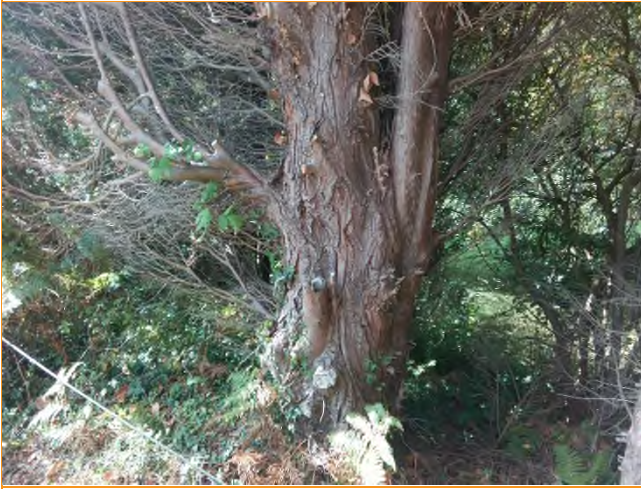
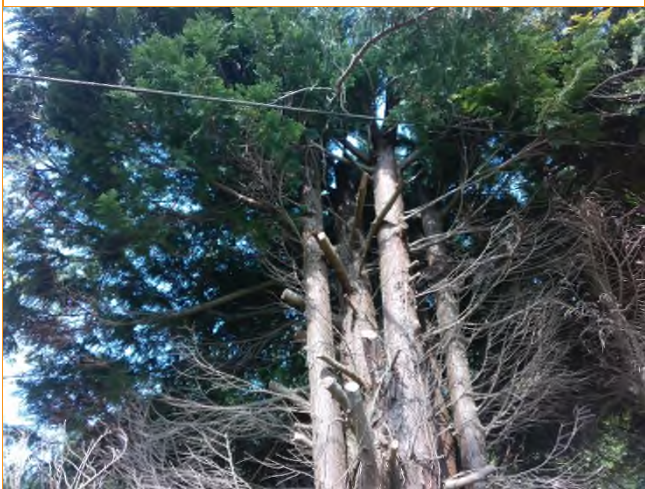
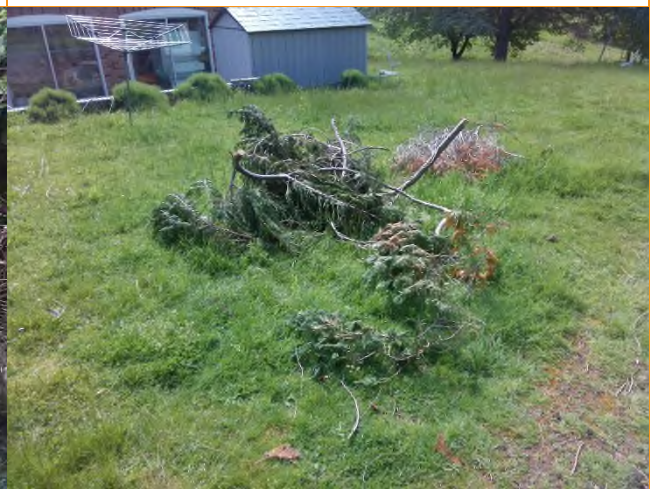
| Tree No | Common Name | Age Class | Condition | Height (m) | Crown Spread (m) | Stem diam. (mm) | Dist to bldg. (m) | Roots Implicated | Pruning history | Recommendation | Tree work constraints | Notes | Owner address | Owner |
|---|---|---|---|---|---|---|---|---|---|---|---|---|---|---|
| T2 | Cypress (Leyland) | Mature | Fair | 4.2 | 4 | 440 | 2.5 | Y | No significant recent management. | Fell close to ground level (approx. 50mm) (conifer). | | Reduced in height and laterals branches over policy holder side. Additional three low lateral branches removed | Woodlands Hungerford Bursledon Southampton SO31 8DF | PH |

| T2 - Cypress (Leyland) (Oct 2022) | T3 - Cypress (Leyland) (Oct 2022) |

T2 - Cypress (Leyland) (May 2023)

| Tree No: | Species | Works Required | CA | TPO | Ownership |
|---|---|---|---|---|---|
| T2 | Cypress (Leyland) | Fell close to ground level (approx. 50mm) (conifer) | Yes | No | PH |

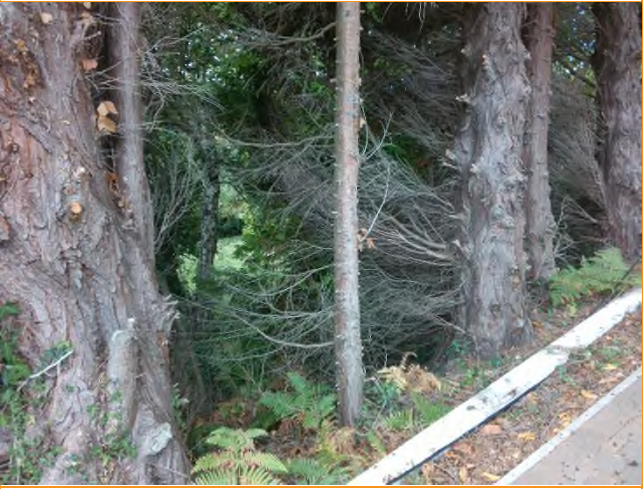
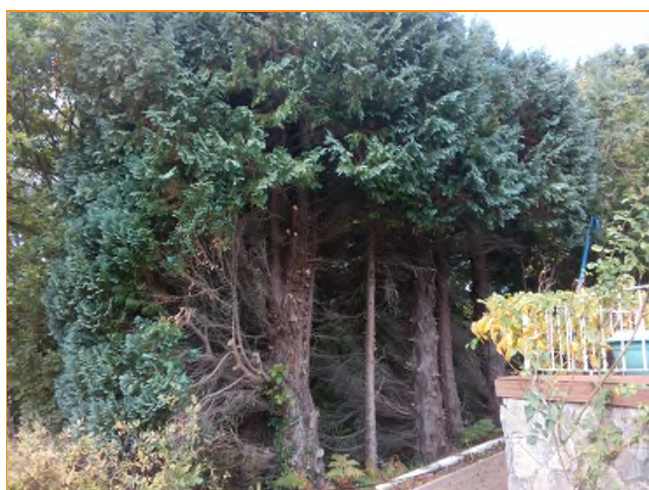
| Tree No | Common Name | Age Class | Condition | Height (m) | Crown Spread (m) | Stem diam. (mm) | Dist to bldg. (m) | Roots Implicated | Pruning history | Recommendation | Tree work constraints | Notes | Owner address | Owner |
|---|---|---|---|---|---|---|---|---|---|---|---|---|---|---|
| T3 | Cypress (Leyland) | Semi-Mature | Fair | 4.2 | 3.0 | 80 | 2.7 | Y | No significant recent management. | Fell close to ground level (approx. 50mm) (conifer). | | | Woodlands Hungerford Bursledon Southampton SO31 8DF | PH |

T3 - Cypress (Leyland) (Oct 2022)

| Tree No: | Species | Works Required | CA | TPO | Ownership |
|---|---|---|---|---|---|
| T3 | Cypress (Leyland) | Fell close to ground level (approx. 50mm) (conifer) | Yes | No | PH |

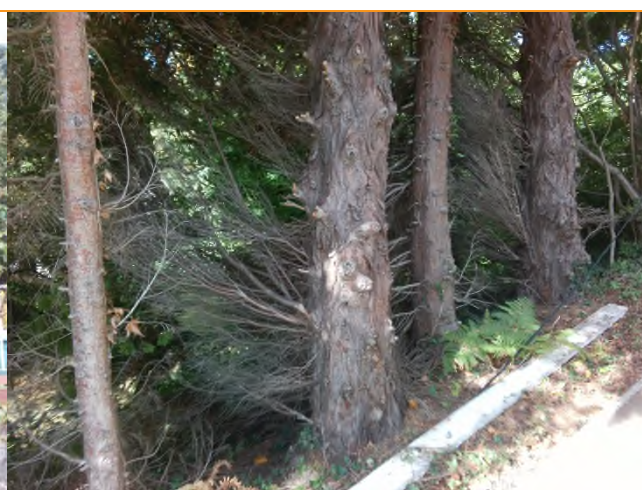
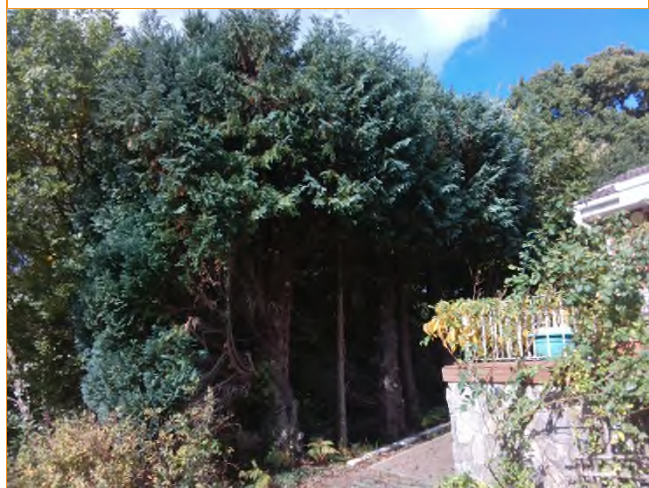
| Tree No | Common Name | Age Class | Condition | Height (m) | Crown Spread (m) | Stem diam. (mm) | Dist to bldg. (m) | Roots Implicated | Pruning history | Recommendation | Tree work constraints | Notes | Owner address | Owner |
|---|---|---|---|---|---|---|---|---|---|---|---|---|---|---|
| T4 | Cypress (Leyland) | Mature | Fair | 4.2 | 5.0 | 360 | 2.8 | Y | No significant recent management. | Fell close to ground level (approx. 50mm) (conifer). | | | Woodlands Hungerford Bursledon Southampton SO31 8DF | PH |

T4 - Cypress (Leyland) (Oct 2022)

| Tree No: | Species | Works Required | CA | TPO | Ownership |
|---|---|---|---|---|---|
| T4 | Cypress (Leyland) | Fell close to ground level (approx. 50mm) (conifer) | Yes | No | PH |

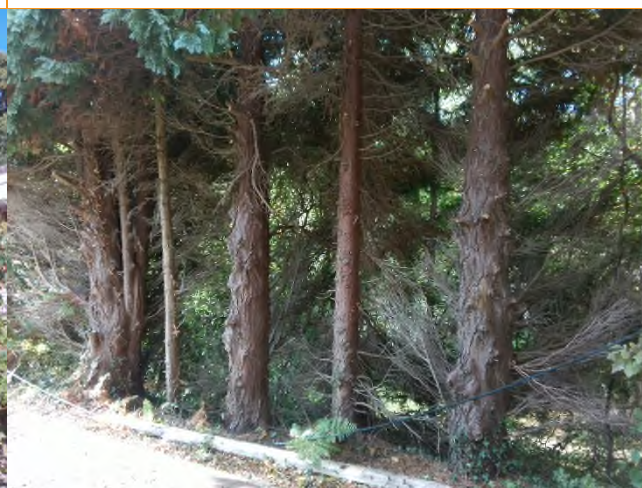
| Tree No | Common Name | Age Class | Condition | Height (m) | Crown Spread (m) | Stem diam. (mm) | Dist to bldg. (m) | Roots Implicated | Pruning history | Recommendation | Tree work constraints | Notes | Owner address | Owner |
|---|---|---|---|---|---|---|---|---|---|---|---|---|---|---|
| T5 | Cypress (Leyland) | Mature | Fair | 4.2 | 4 | 260 | 3.4 | Y | No significant recent management. | Fell close to ground level (approx. 50mm) (conifer). | | | Woodlands Hungerford Bursledon Southampton SO31 8DF | PH |

T5 - Cypress (Leyland) (Oct 2022)

| Tree No: | Species | Works Required | CA | TPO | Ownership |
|---|---|---|---|---|---|
| T5 | Cypress (Leyland) | Fell close to ground level (approx. 50mm) (conifer) | Yes | No | PH |

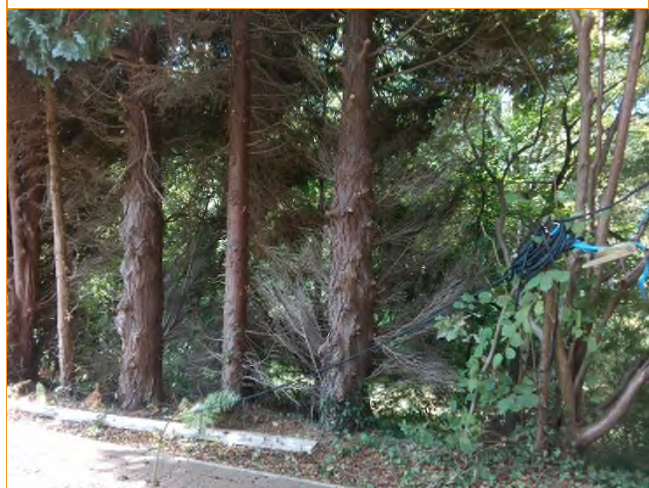
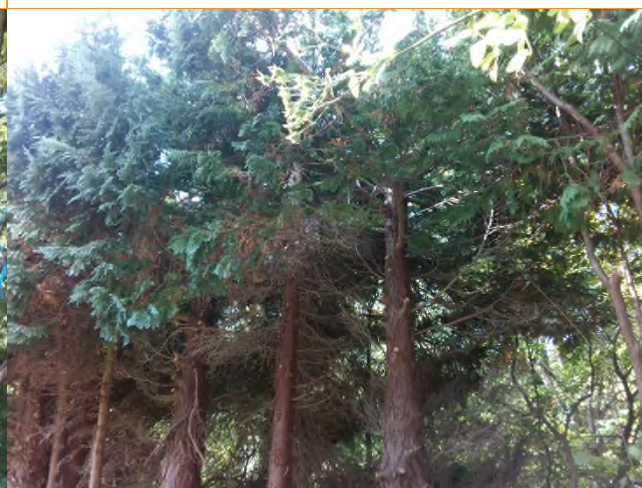
| Tree No | Common Name | Age Class | Condition | Height (m) | Crown Spread (m) | Stem diam. (mm) | Dist to bldg. (m) | Roots Implicated | Pruning history | Recommendation | Tree work constraints | Notes | Owner address | Owner |
|---|---|---|---|---|---|---|---|---|---|---|---|---|---|---|
| T6 | Cypress (Leyland) | Mature | Fair | 4.2 | 5.0 | 330 | 3.6 | Y | No significant recent management. | Fell close to ground level (approx. 50mm) (conifer). | | | Woodlands Hungerford Bursledon Southampton SO31 8DF | PH |

T6 - Cypress (Leyland) (Oct 2022)

| Tree No: | Species | Works Required | CA | TPO | Ownership |
|---|---|---|---|---|---|
| T6 | Cypress (Leyland) | Fell close to ground level (approx. 50mm) (conifer) | Yes | No | PH |
