**BISHOPSTOKE MEMORIAL HALL**

**17 RIVERSIDE, BISHOPSTOKE**

**STRUCTURAL SURVEY & APPRAISAL**

**EXISTING COMMUNITY HALL**

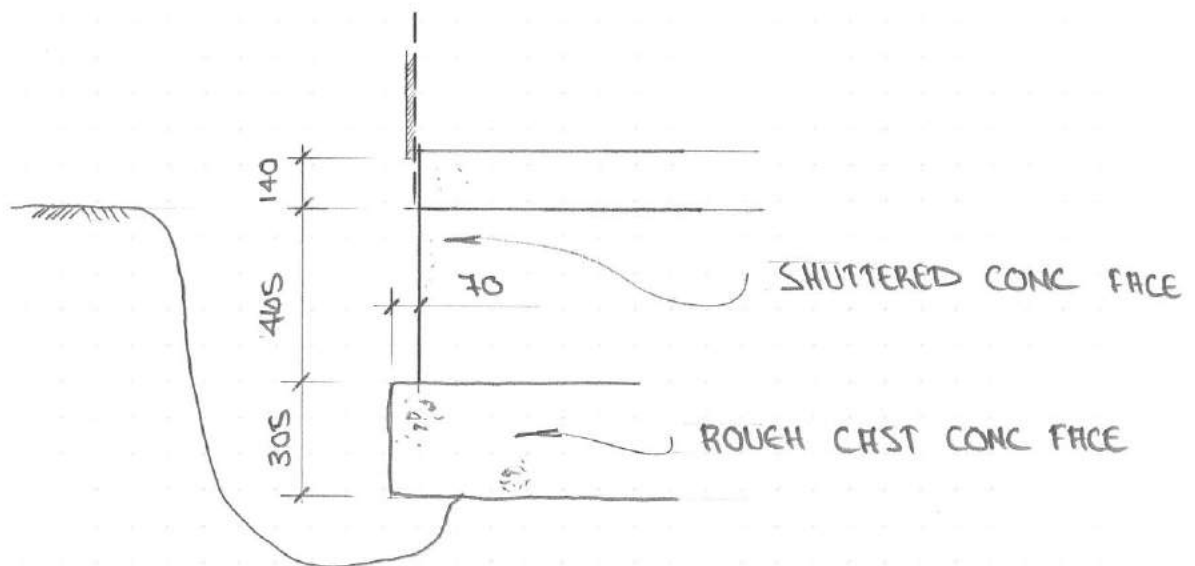
TRIAL PIT 2

DARK BROWN PLASTIC CLAY  
MANY ROOTS AT U/S OF FDN.

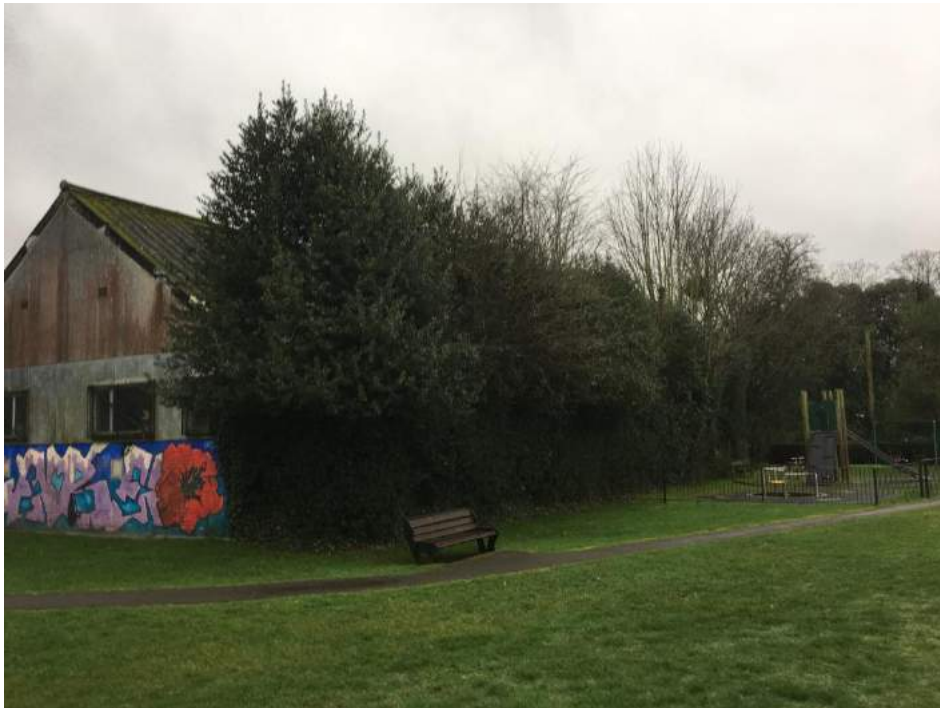
There is a dense row of trees and shrubs screening the west side of the building from the adjacent playing fields and these trees are approximately 1.5m from the building. The trial pits adjacent to the trees indicated roots at and below foundation level.

The shrinkable nature of the soil on which the building is founded, the proximity of the trees along the northern side of the building and the extensive roots identified at and below foundation level will be causing foundation movement to the existing building. It is considered that the lightweight and flexible nature of the structure is able to accommodate this seasonal movement without undue distress being exhibited in the structure. However, replacing existing cladding materials or rebuilding walls and partitions would be problematic movement is highly likely to result in cracking of more brittle finishes etc.

Photograph 3:- Mature trees close to western side of building

The foundations of any replacement building would need to take into consideration the influence of trees on the clay strata and hence it may prove necessary to adopt short bored piled foundations to found in the more stable sands and gravels. The ground floor slab of any new building would also need to be constructed as a suspended slab to accommodate ground heave.

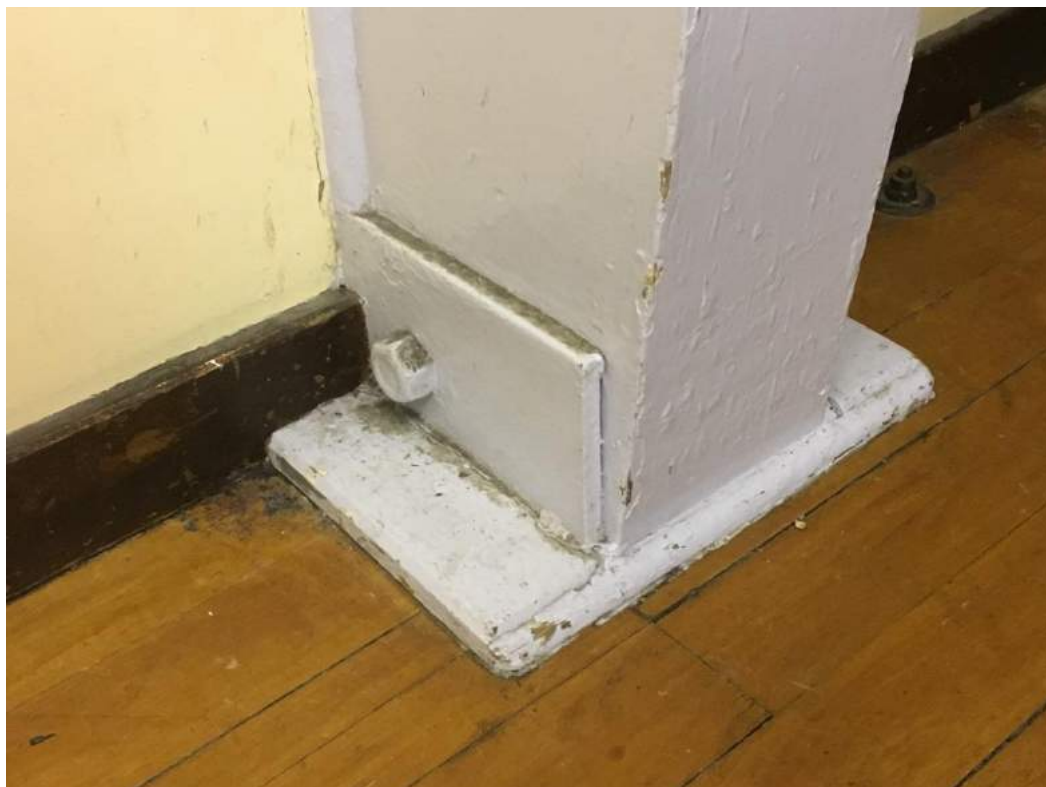
Photograph 8:- Typical cleat fixing at base of portal

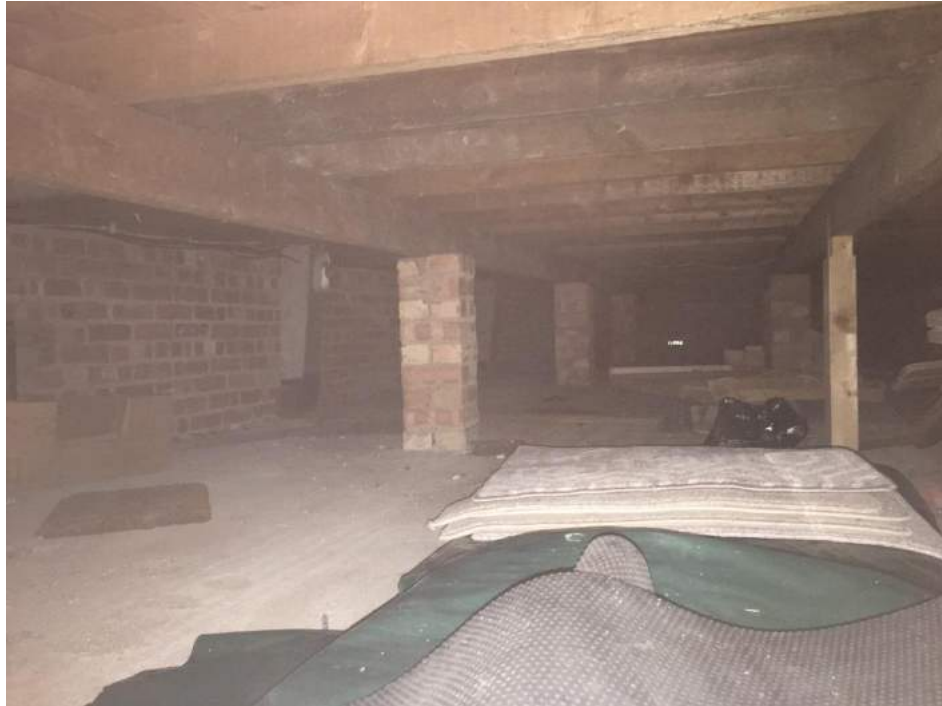
The timbers that form the raised floor of the stage and changing rooms appear from a limited inspection to be in sound condition. However, due to the amount of stored material beneath the stage a full inspection was not possible.

A preliminary design check of the timber sections used indicates that they would not be justifiable to support a basic imposed load of 1.5kN/m<sup>2</sup> let alone the 5.0kN/m<sup>2</sup> recommended for a stage loading.

Photograph 9:- Below stage void and stage structure.  
Note portal leg and cleat fixing to LHS.

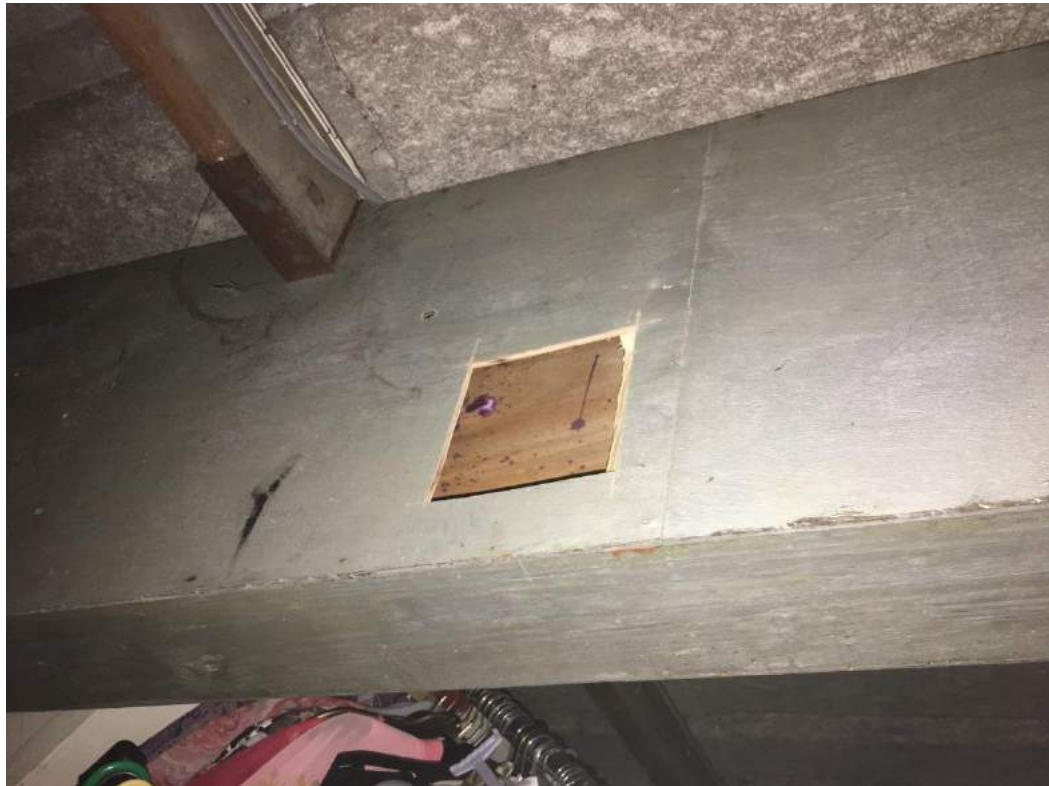
Photograph 13:- Extg hole cut in ply side wall of portal rafter

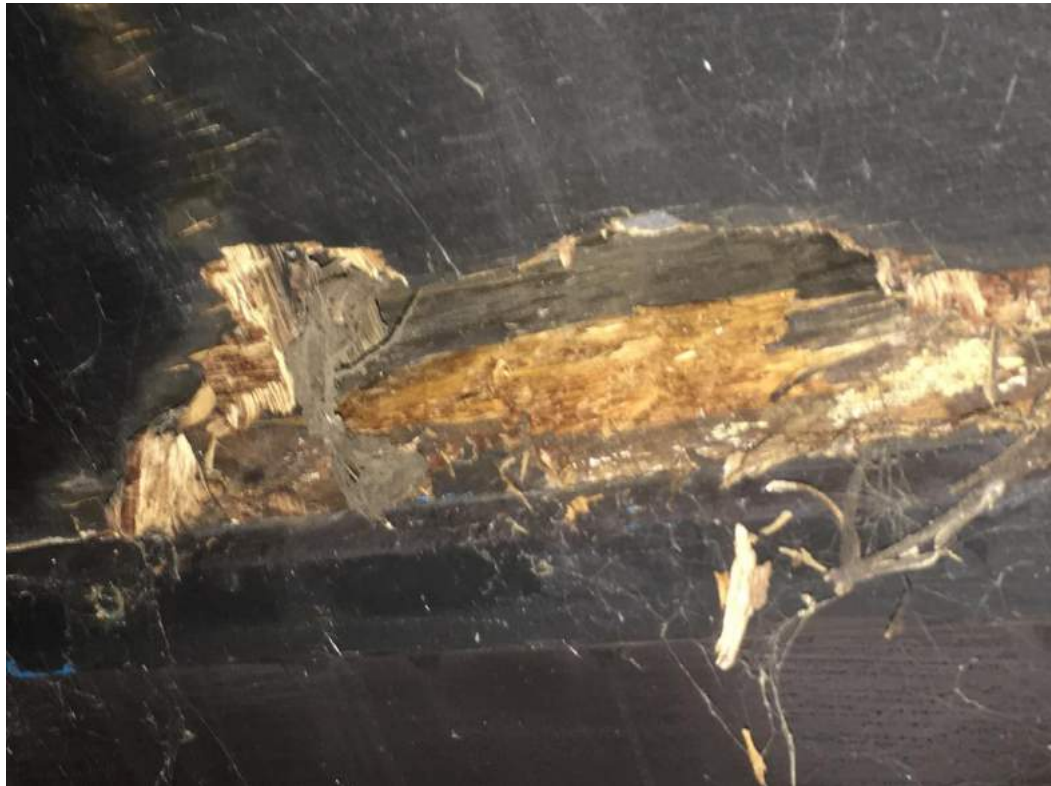
Rot affected timber roof purlins were noted at eaves level.

Photograph 15:- Rot affected purlin at back of stage

The replacement of the roof cladding and internal ceiling finishes and the introduction of insulation would need to be limited so as not to exceed the weights of the current materials. Even-so the existing timber purlins are unlikely to be adequate and would require upgrading and any timbers affected by moisture ingress would need to be replaced.

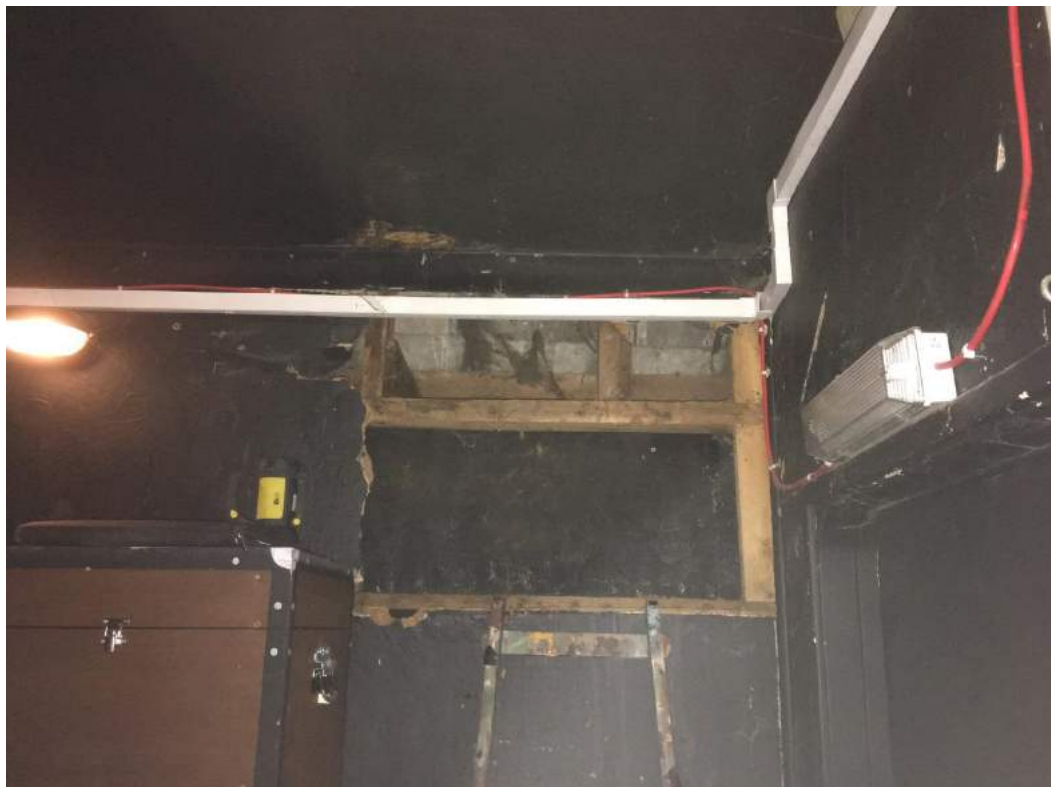
No evidence of any insulation was found within any of the external walls.

Photograph 16:- External wall construction at eaves level

Similar problems would exist with the replacement external wall cladding and internal finishes. The existing timber structure would not be adequate to support new claddings or be justifiable to modern codes. Therefore the entire external wall construction would need to be replaced.

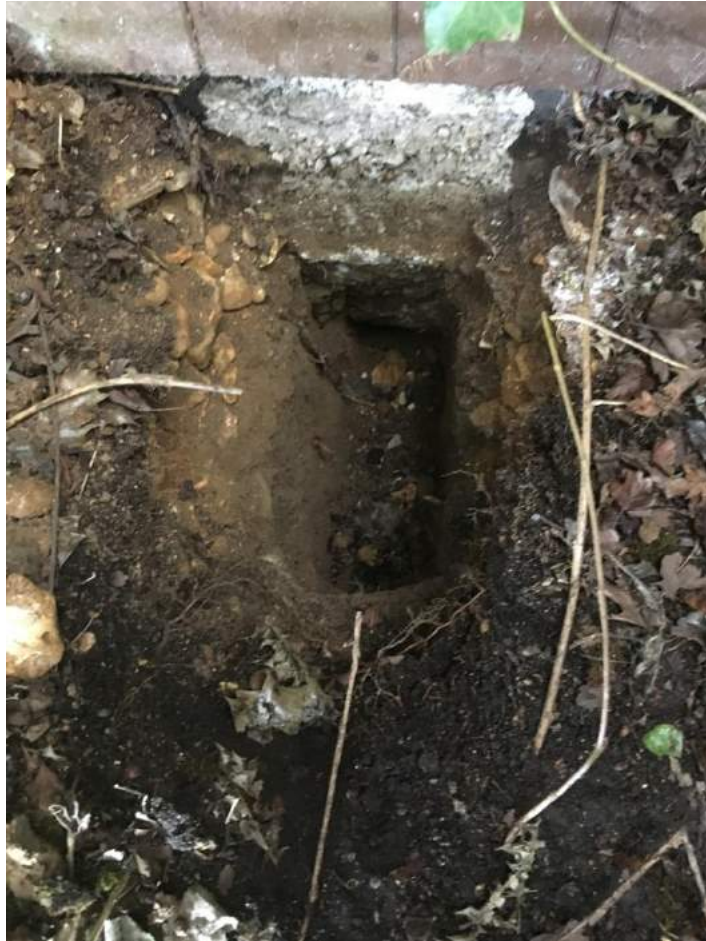
Photograph 17:- Trial Pit 1

Ground conditions at this level were found to be a light brown sandy clay.

There were numerous roots in the excavation at the underside level of the foundation.

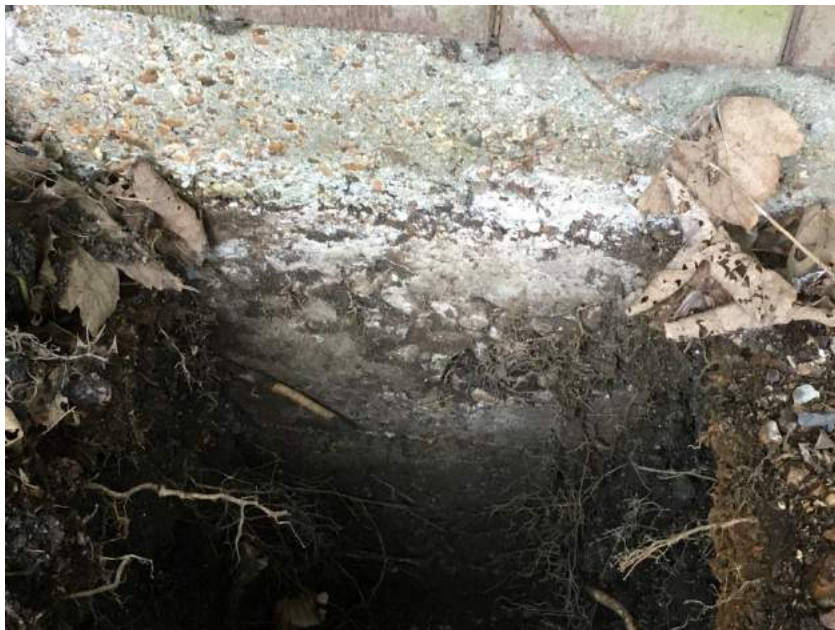
Photograph 18:- Trial Pit 2

This trial pit also revealed what appears to be two levels separate concrete pours with shuttered faces. The upper pour was consistent with the 150mm thick slab noted in trial pit 1. However, the lower concrete pour is much thicker at around 450mm, extending to a depth of 465mm below existing ground level.

Ground conditions at this level were found to be a dark brown clay.

There were numerous roots in the excavation at the underside level of the foundation.

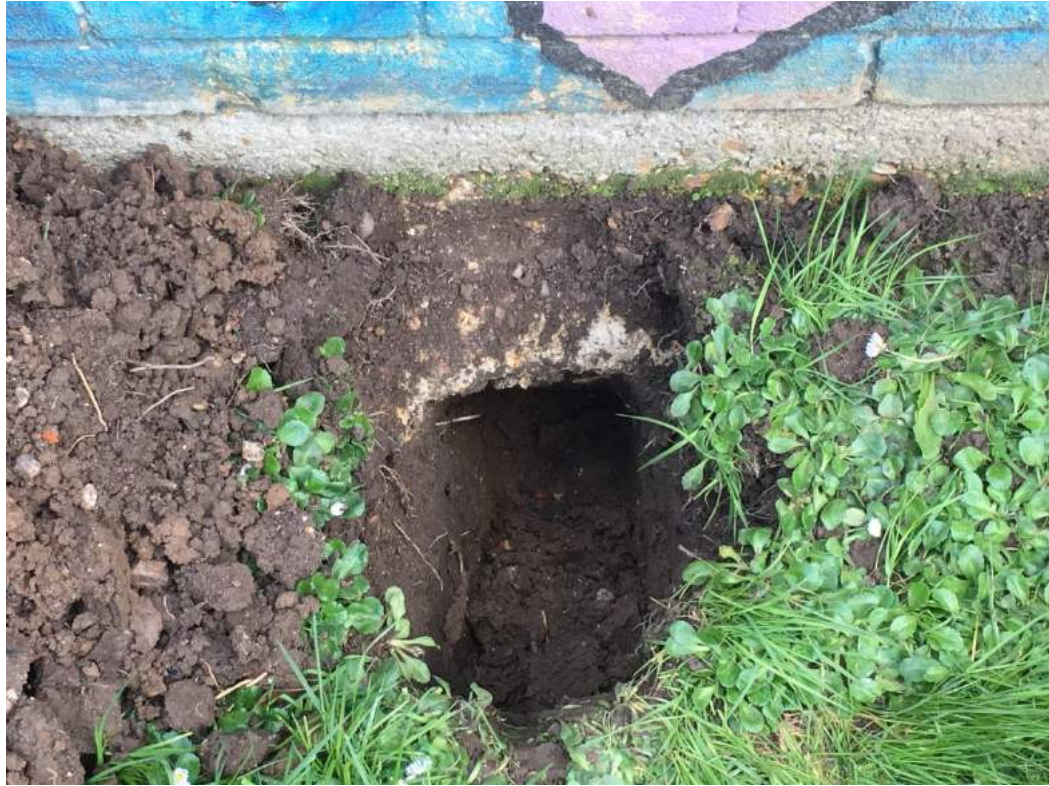
Photograph 19:- Trial Pit 3

Ground conditions at this level were found to be a dark brown clay.

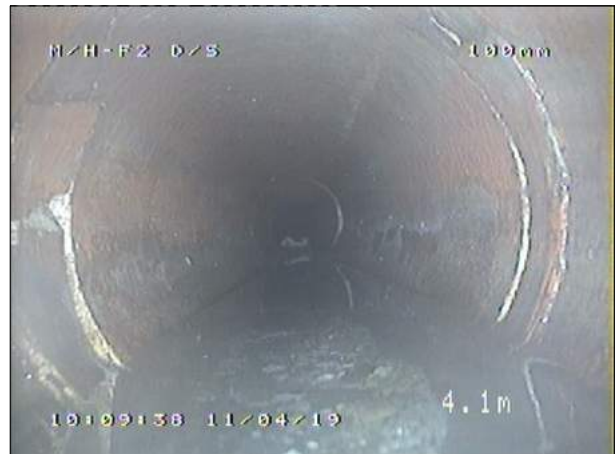
Photo: 1\_1\_10\_A.JPG  
4.1m, Broken sewer at joint, from 12 to 12 o'clock

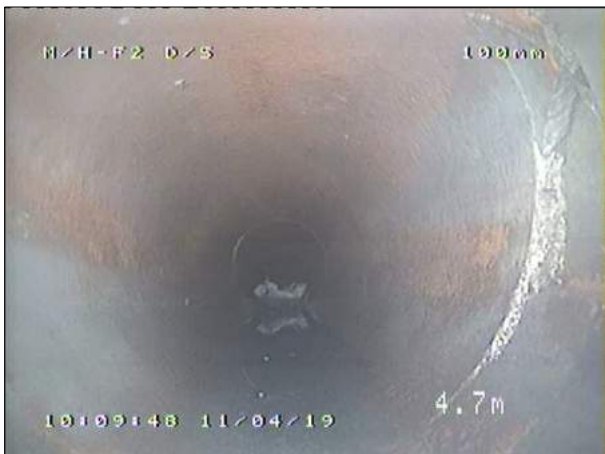
Photo: 1\_1\_11\_A.JPG  
4.7m, Broken sewer at joint, from 12 to 12 o'clock

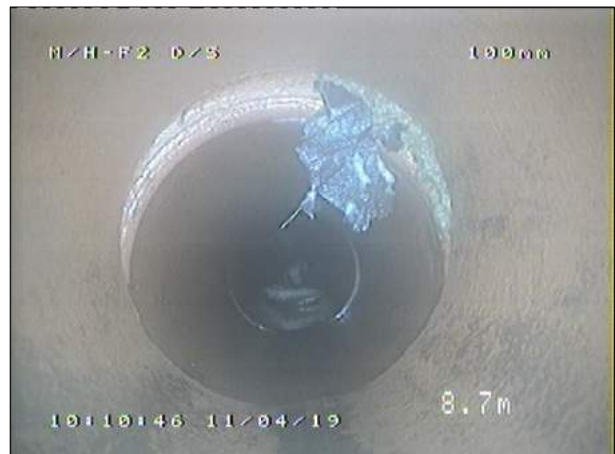
Photo: 1\_1\_12\_A.JPG  
8.7m, Joint displaced, medium (between 1.0 and 1.5 times the pipe wall thickness)

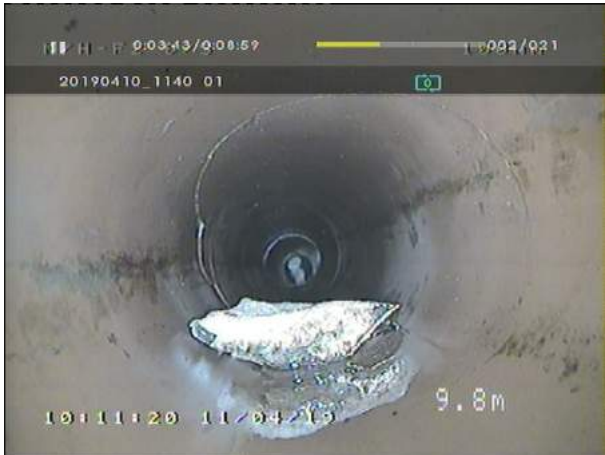
Photo: 1\_1\_14\_A.JPG  
9.8m, Fractures, multiple, from 12 to 12 o'clock, Start

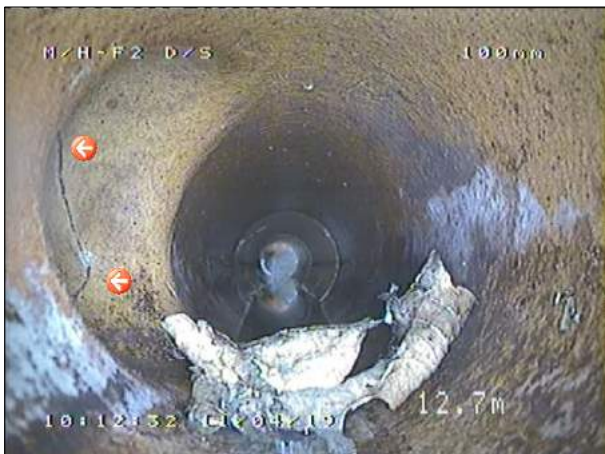
Photo: 1\_1\_20\_A.JPG  
12.7m, Junction, defective, at 9 o'clock, 100mm diameter

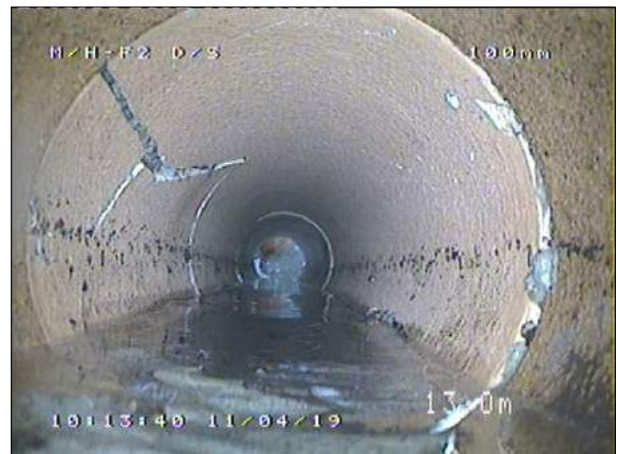
Photo: 1\_1\_21\_A.JPG  
13m, Fractures, multiple, from 12 to 12 o'clock

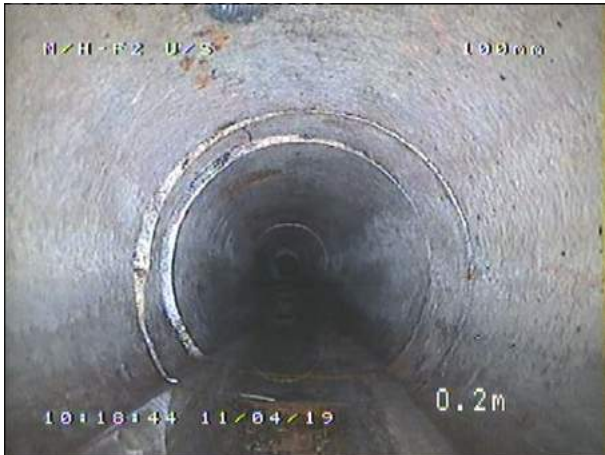
Photo: 3\_3\_28\_A.JPG  
0.2m, Fracture, circumferential at joint, from 12 to 12 o'clock,  
Start

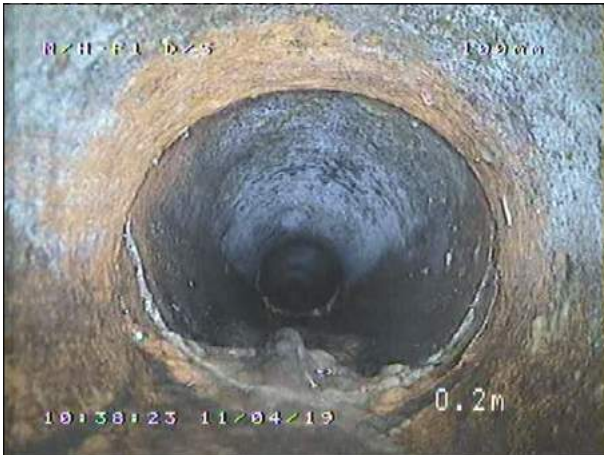
Photo: 9\_9\_63\_A.JPG  
0.2m, Fracture, circumferential at joint, from 12 to 12 o'clock, Start

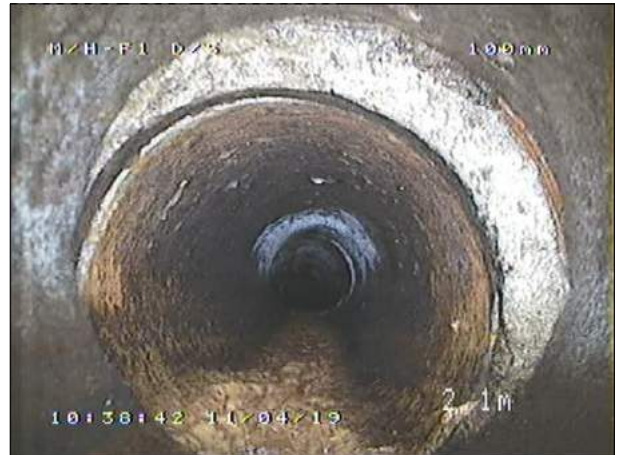
Photo: 9\_9\_65\_A.JPG  
2m, Joint displaced, medium (between 1.0 and 1.5 times the pipe wall thickness)

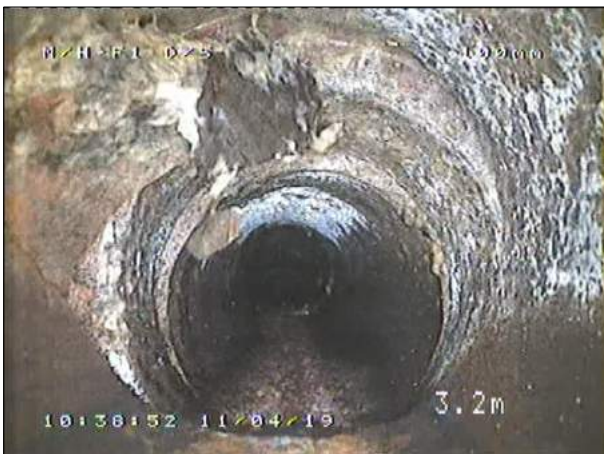
Photo: 9\_9\_66\_A.JPG  
3.2m, Broken sewer at joint, from 12 to 12 o'clock

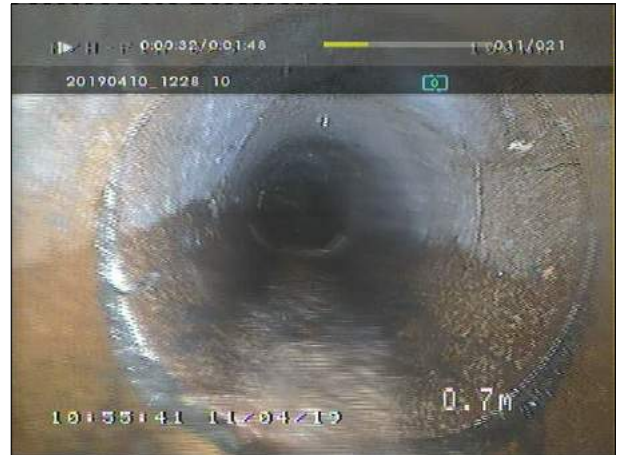
Photo: 11\_11\_82\_A.JPG  
0.7m, Fractures, multiple, from 12 to 12 o'clock, Start

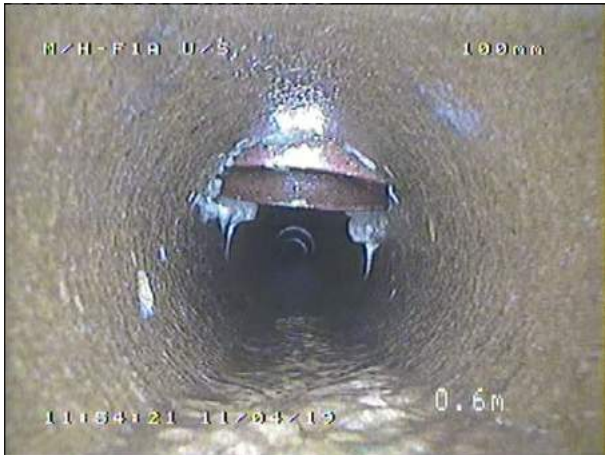
Photo: 12\_12\_87\_A.JPG  
0.6m, Connection defective, at 12 o'clock, 100mm diameter, 10mm intruding

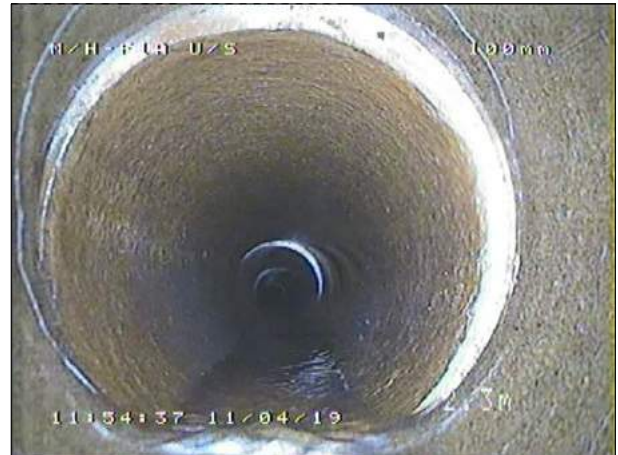
Photo: 12\_12\_88\_A.JPG  
2.3m, Fracture, circumferential at joint, from 12 to 12 o'clock, Start

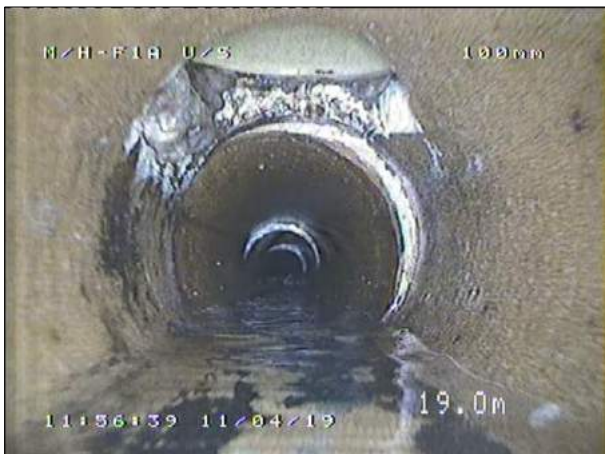
Photo: 12\_12\_90\_A.JPG  
19m, Connection defective, at 12 o'clock, 100mm diameter

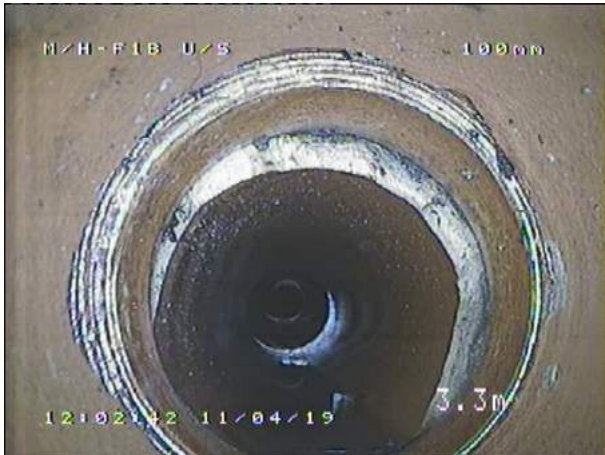
Photo: 13\_13\_101\_A.JPG  
 3.3m, Broken sewer at joint, from 12 to 12 o'clock

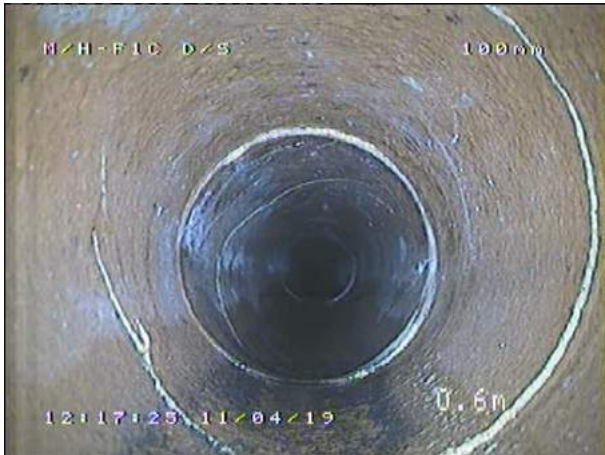
Photo: 17\_17\_128\_A.JPG  
 0.2m, Fracture, circumferential at joint, from 12 to 12 o'clock,  
 Start
