July 2023  
CBA11764 v1

# ARBORICULTURAL REPORT

Site:  
79 Ashdown Road  
Chandlers Ford  
SO53 5QX

## ARBORICULTURAL REPORT FOR RETROSPECTIVE PLANNING APPLICATION

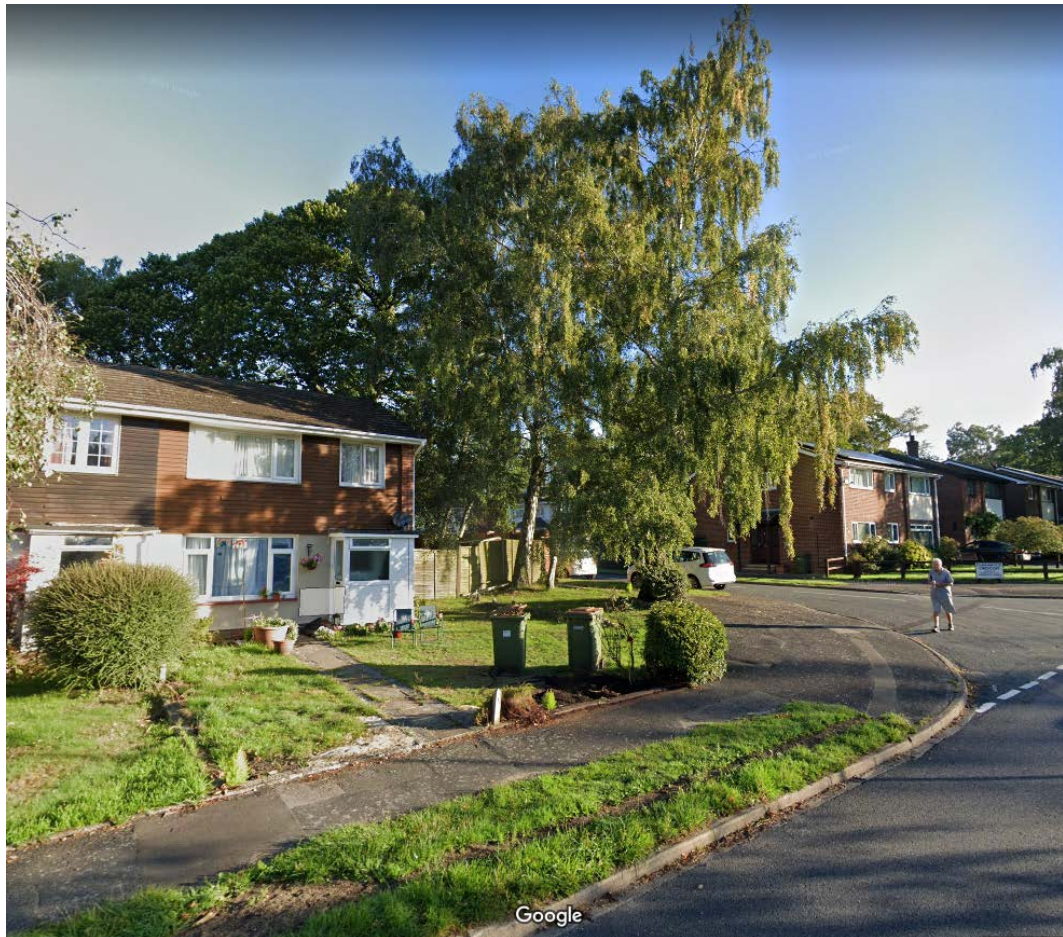
**Image 1:** Showing Google Street view from September 2020

- 6.6 In general the soft ground area appears to have been used for some form of activity when the current ground condition (lack of grass or bare earth patches) is compared to the street view of 2020 shown in Image 1 above.
- 6.7 A window frame is currently stored against the new boundary wall and a bag (appears to be a cubic meter size) is also present in the rooting area of the trees.

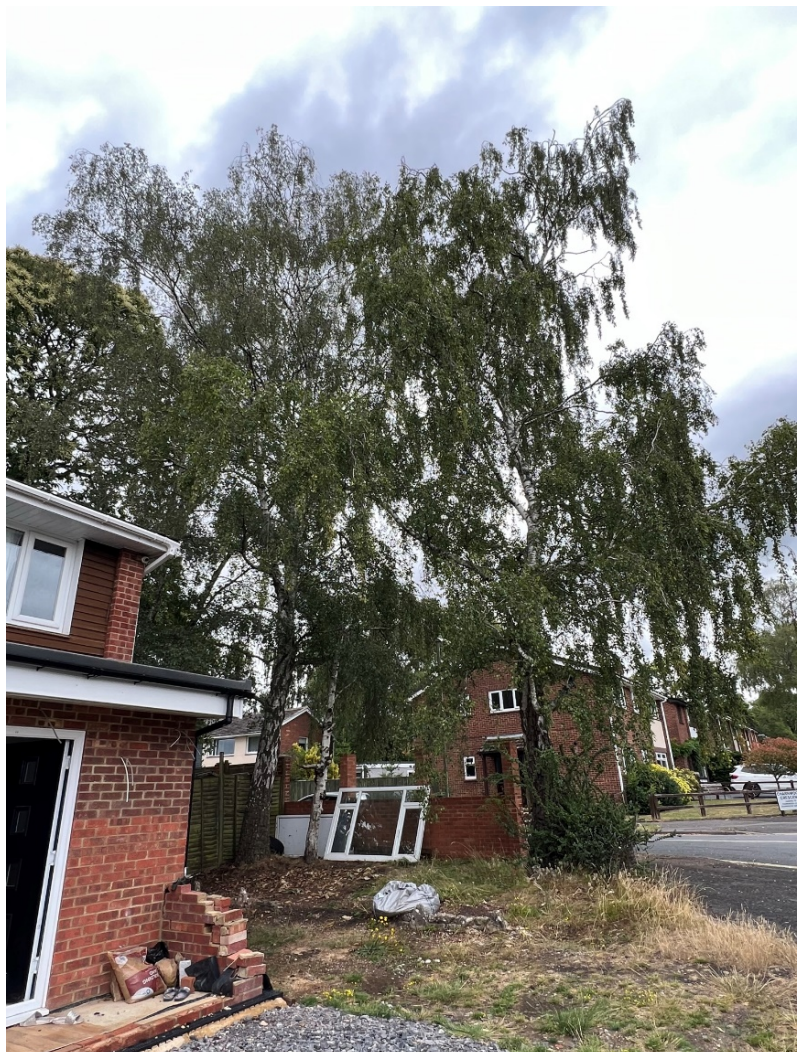
**Photograph 1:**  
Showing Tree 1 (left)  
and Tree 3 (right)  
in relation to the  
dwelling

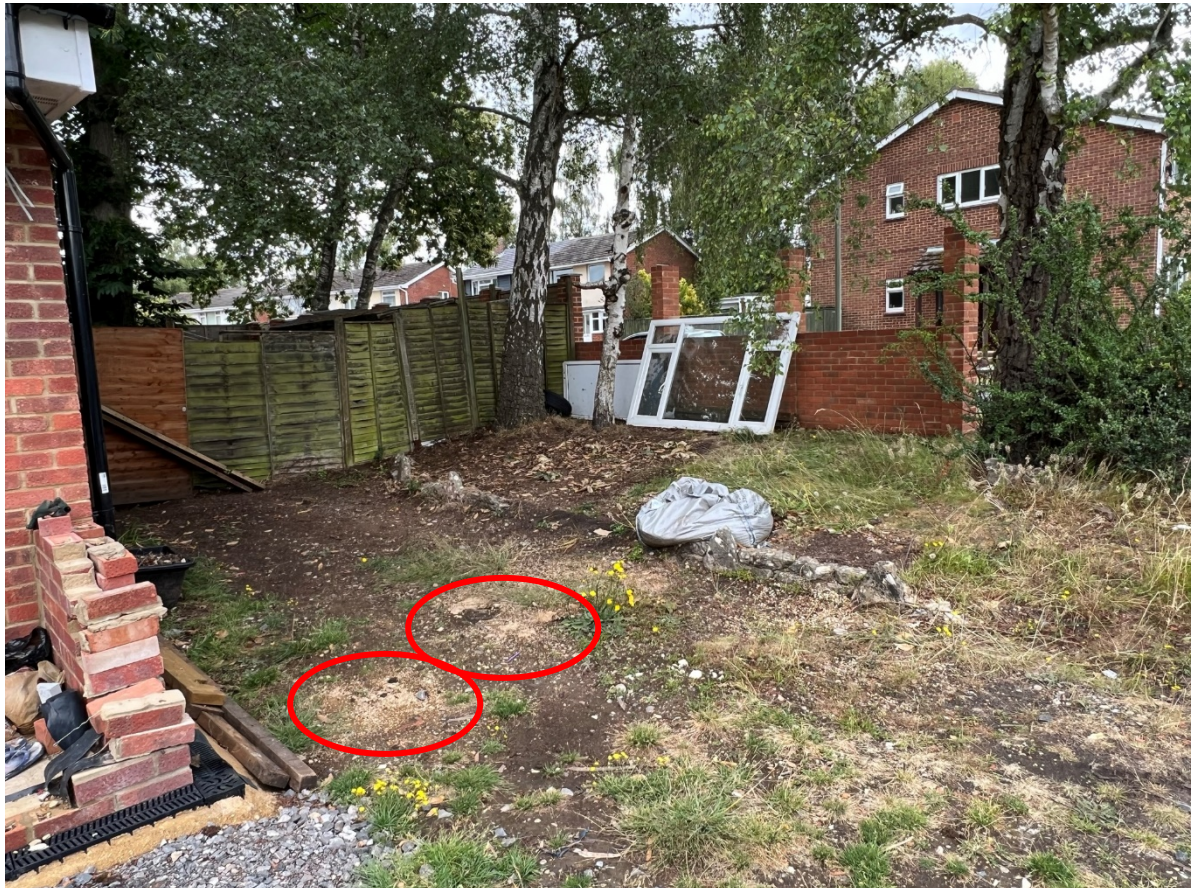
- 6.3 There is no obvious damage to the ground surface from the storage of materials within the root protection areas of the two trees.
- 6.4 Areas of grass appear to have cement/mortar on them. The client advised that no mixing took place on site and that these areas are where cement was dropped in the rooting area of the trees (see Photograph 2 below).

**Photograph 2:** Showing soft ground area near to Tree 1 (left) and Tree 3 (right) indicating areas where materials have been mixed/used

- 7.3 However, storing and mixing of materials within the root protection area can compact soils and change the rate that air, nutrients and moisture can be accessed by roots and mixing or use of wet materials can cause chemicals that are poisonous to tree roots to leech into the soils and which can then be harmful to the trees.

- Remove all building materials and loose spoil that is within 7m of the trunk (window frame and bag).
  - Aerate the soil within 6.5m of the centre of the trunk by inserting a garden fork into the ground to the depth of the spikes and spaced at approximately 50cm gaps; fill the gaps with a horticultural sand or grit to allow air and nutrients to enter the ground and relieve any compaction that may have occurred.

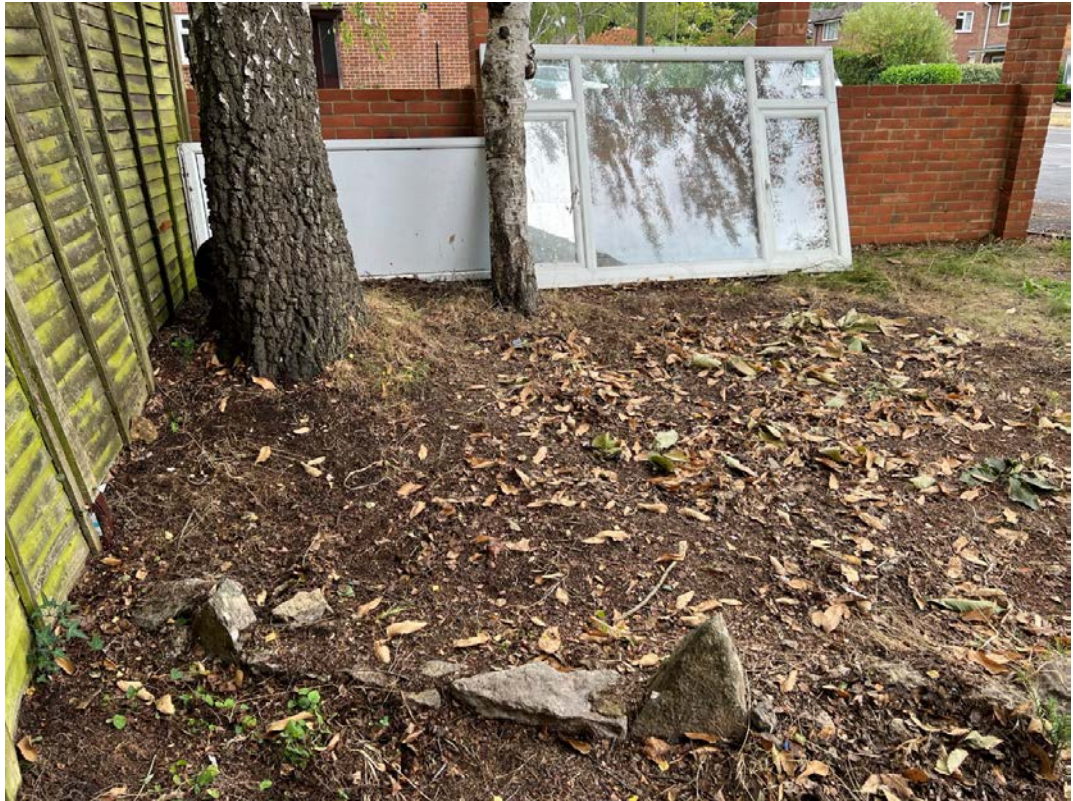
- 4.4 Tree 1 is considered to be of a mature age class and has a trunk diameter of 570mm at 1.5m above ground level. This tree grows with Tree 3 and as such the crown is naturally distorted through competition for light. Minor deadwood was noted throughout the crown. The tree had an overall appearance of being a little sparser and with a leaf colour not as strong as Tree 3. The tree has low branches over the public footpath.

**Photograph 3:** Showing the ground adjacent to the trunk of Tree 1

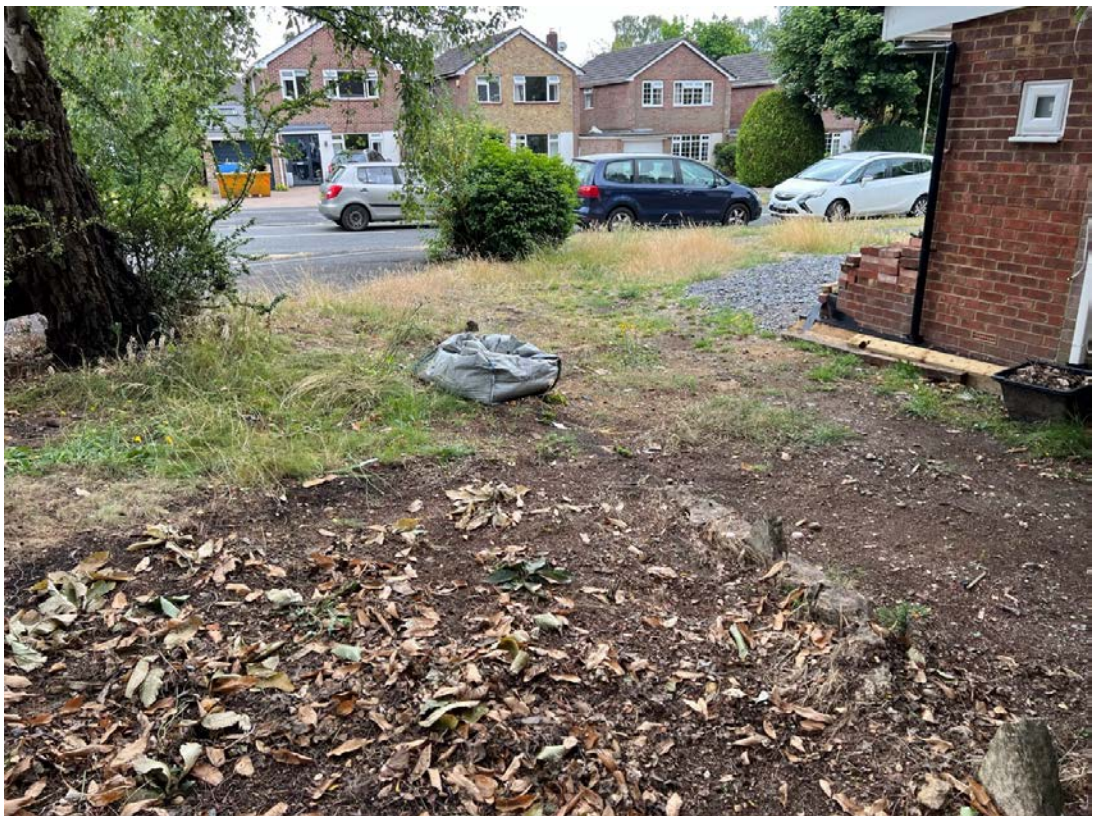
- 6.1 Of the three trees, the middle tree is dead and has been for some time. This is considered to have died naturally and not as a result of the works on site.

**Photograph 4:** Showing Tree 2 and the proximity to the newly constructed porch

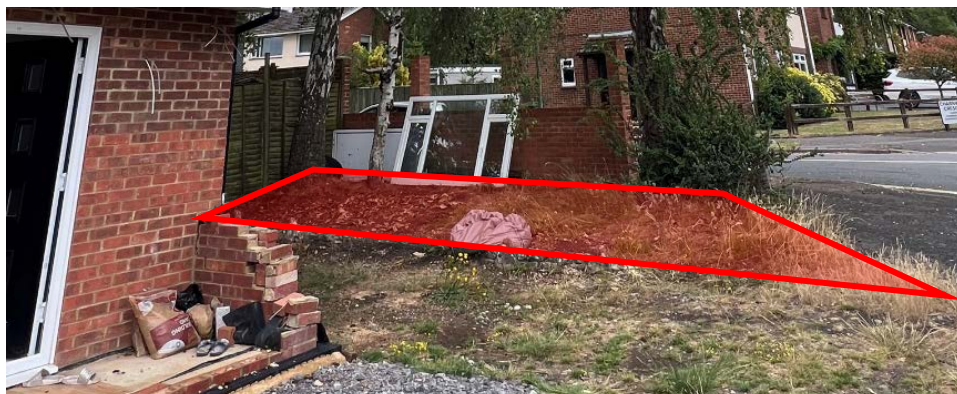
**Image 2:** Approximate area to mulch

- Mulch to a depth of 100mm with good quality wood chip up to the line of the decorative stones in the lawn between the trees and the dwelling, up to the boundary.
