**Desk study and preliminary risk assessment report**

**Cockpit Barn, Knowle Lane, Horton Heath**

Alderbury Homes Ltd

July 2021

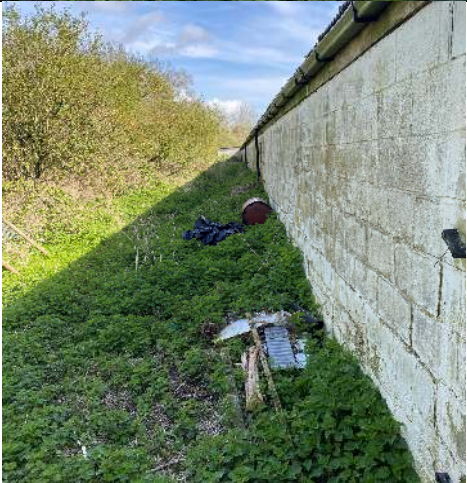
| Zone A | |
|---|---|
| Western side of poultry house. Discarded material includes asbestos cement roof sheet, metal storage drum, metal, plastic and wood | |

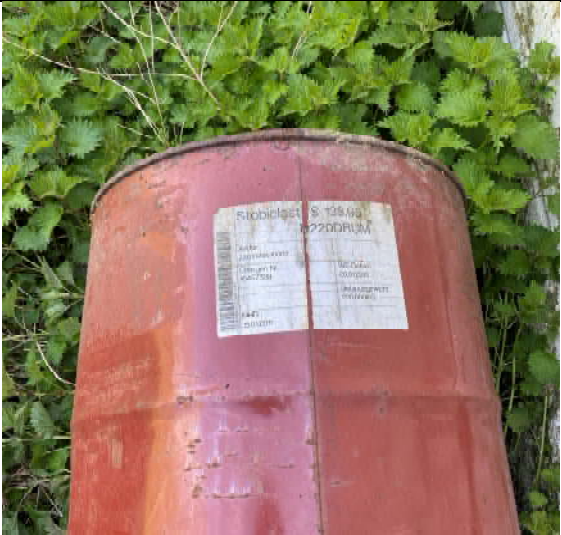
| Zone A | | |
|---|--|---|
| Discarded metal storage drum. Contents identified as Stobielast 133.95 which is a binder for safety surfacing and is generally used in children's play areas. Advised used to coat and bind asbestos cement roofing material. | | |

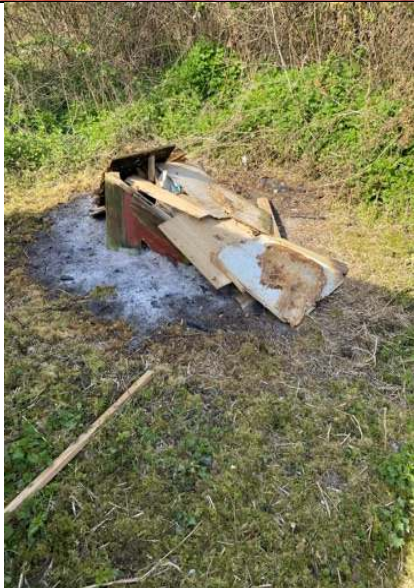
| Zone A | | |
|---|--|---|
| Area used for bonfires towards the centre of the west side of the poultry house | | |

It is also recommended that the identified stacks of debris and bonfire residue are removed, and the locations clearly marked. Shallow soil samples should be obtained from these locations.

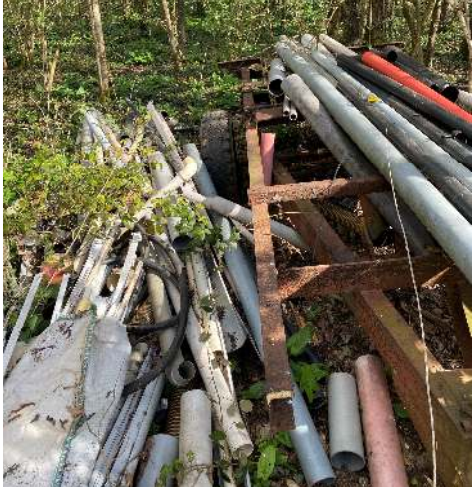
| Zone A | | |
|---|--|---|
| Discarded materials in the central north of Zone A. | | |

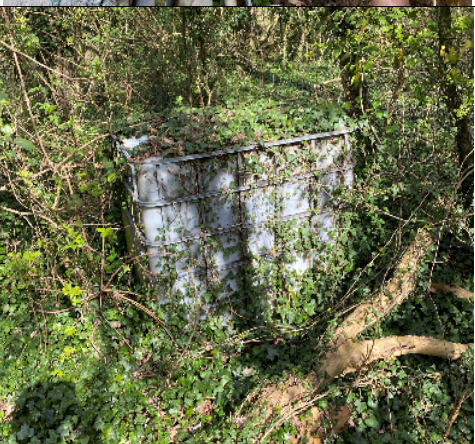
| Zone A | | |
|---|--|---|
| Upside down intermediate bulk container (IBC). No contents noted and previous contents unknown – advised possibly to transport cleaning chemicals | | |

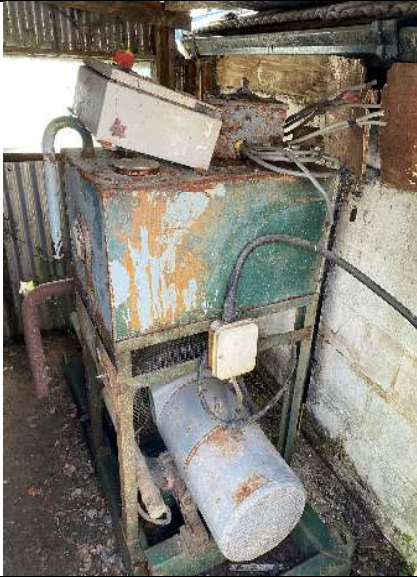
| Zone A | |
|---|---|
| Machinery within corrugated metal covered area, identified as back-up generator with fuel storage. Concrete slab to floor, attached directly to block wall of poultry house | |

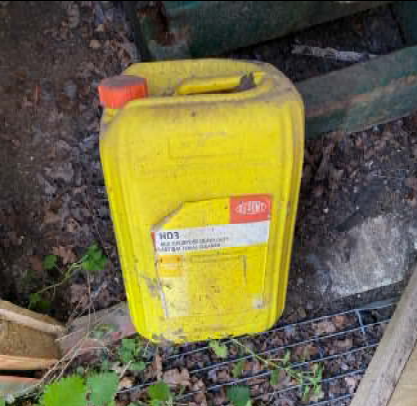
| Zone A | |
|---|---|
| Storage container found in corrugated metal covered area. Identified as multipurpose heavy duty antibacterial cleaner | |

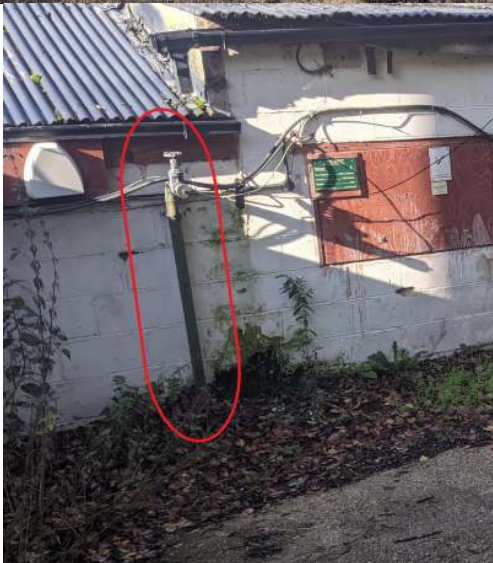
| Zone A | |
|---|---|
| Fuel filler point for tanker delivery | |

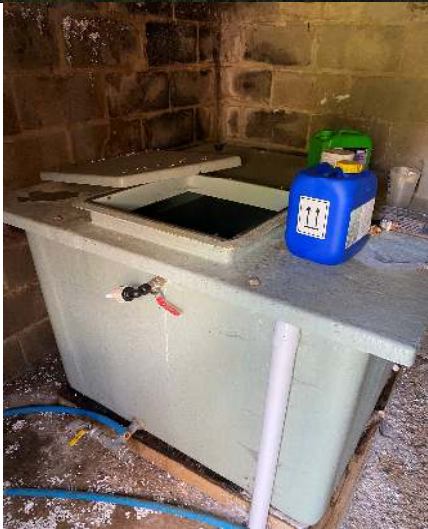
| Zone A | | |
|---|--|---|
| Block-built external structure on central western side of poultry house. Currently containing a tank used to deliver antibiotics and water to chickens. Previously contained fuel storage tank. Concrete to floor | | A photograph of a block-built external structure, likely a concrete tank, used for delivering antibiotics and water to chickens. The structure is situated on a concrete floor and has a blue container on top. |

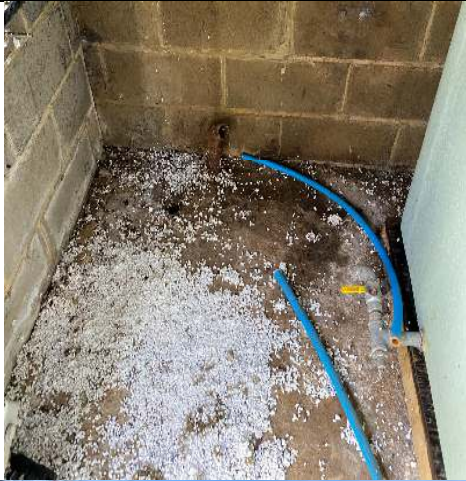
| Zone A | | |
|---|--|---|
| <p>Pipework through wall from historic fuel tank, adjacent to current antibiotic and water tank. This reportedly leads beneath the centre of the poultry house to join up with the tanker delivery point at the eastern entrance. The debris on the floor is polystyrene.</p> | | |

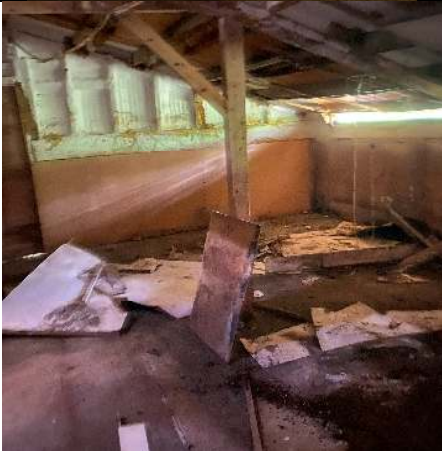
| Zone A | | |
|---|--|---|
| Torn down roof and side panels in northern section of chicken shed | | A photograph showing significant structural damage to the interior of a chicken shed. Large sections of the roof and side walls have been torn down, leaving exposed wooden beams and debris on the floor. The remaining structure is in a state of collapse. |

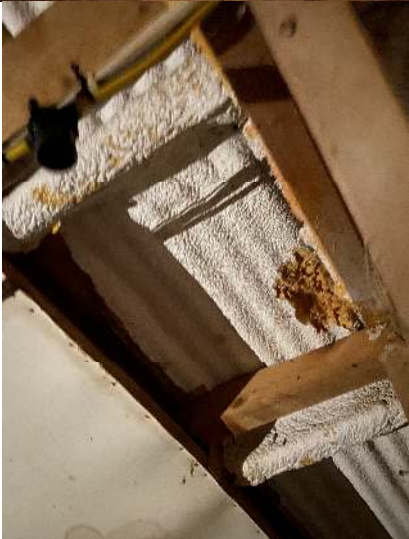
| Zone A | | |
|---|--|---|
| Damaged asbestos cement in chicken shed roofing. Roofing material coated with binding agent. | | |

It is recommended that a preliminary targeted and general site coverage intrusive investigation is undertaken, to be supervised by an appropriately qualified and experienced engineer. Additionally, an asbestos survey should be undertaken on the structures.

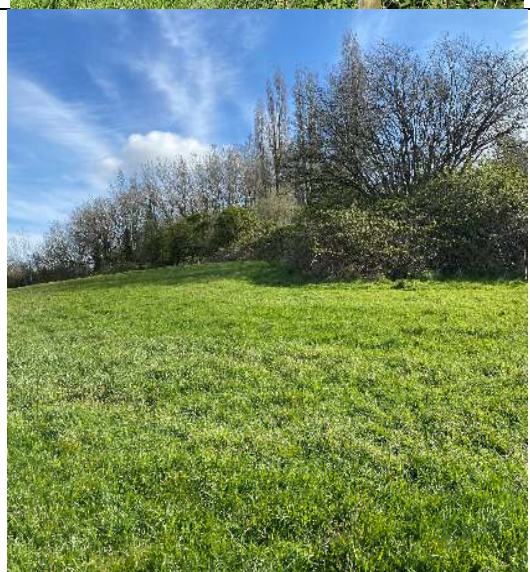
| Site walkover photographs and commentary – Zone B | |
|---|---|
| View from B towards western boundary of A. Also, the area suspected of manure/waste poured from the higher ground of A onto the lower ground of B. | |

Initially the manure/bedding was spread on the slope leading down towards Zone B, however this practice ceased in the late 1960s since which time the manure has been disposed of off-site. Based on the information presented above, and the generic use of poultry manure as fertilizer in agriculture it is considered that the risk of pathogens that are hazardous to human health remaining in the soils after 50+ years is minimal.

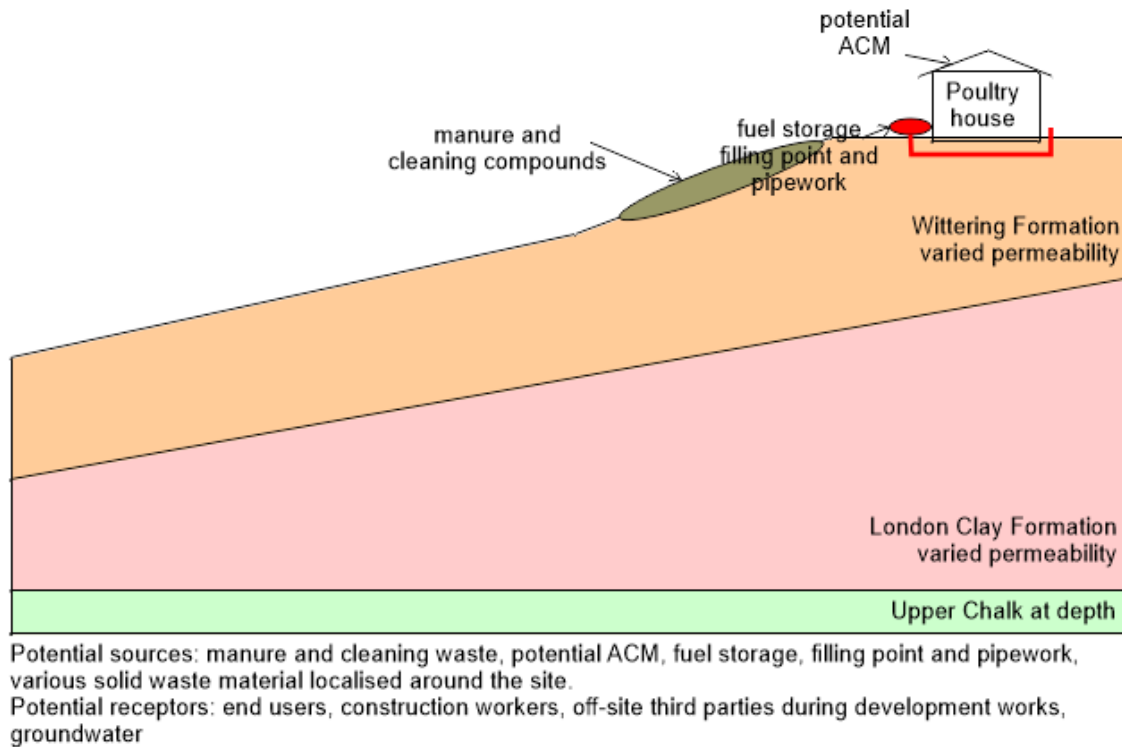
**Figure 6: Simplistic ground model**

In summary, potential sources of contamination have been identified in the form of potentially contaminated shallow soils, representative of an unknown risk to construction workers, off-site third parties and end users via direct contact, inhalation or ingestion. In addition, there is the potential for shallow groundwater within the underlying soils (variable permeability) to have been impacted.
