17<sup>th</sup> July 2023

Reference MB230703

Arbor-Eco Consultancy were commissioned by Miss S Knee, to provide an arboricultural report comprising of a tree constraints plan, following a tree survey of an individual Oak tree (*Quercus robur*). A letter of mitigation along with an Arboricultural Method Statement is provided for the remediation of land following the construction of a double garage within the RPA of the tree.

**Project**  
7 Oakhill Close, Burseldon.

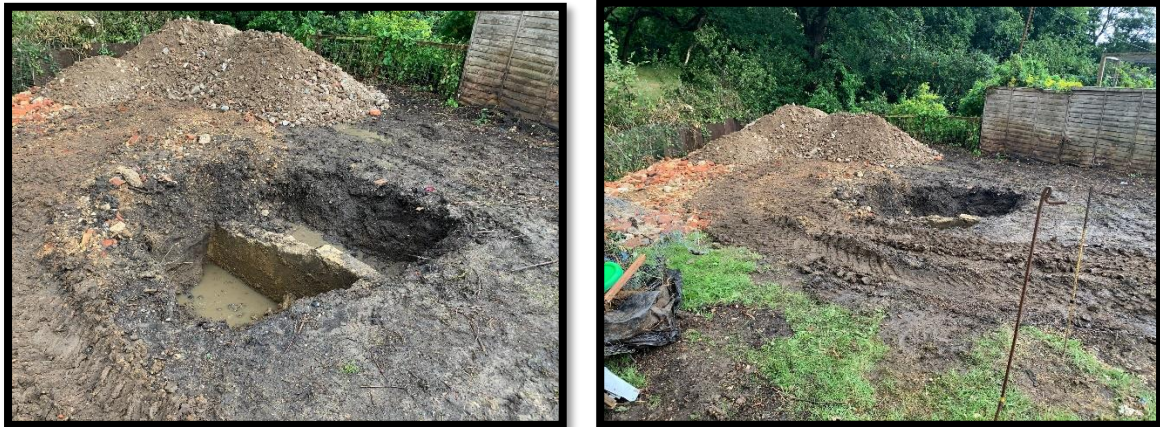
An additional tree has been taken into consideration, however, this off-site tree whilst has a default RPA within the footprint of the property is highly unlikely to have been influenced by the development work due to a previously constructed defunct cesspit that will have deflected any rooting material into the adjacent field and property. This tree is shown as T2 on the Tree Constraints Drawing MB230703-01 and a number of photographs are shown at Plate 1.

**Plate 1: Defunct cesspit location and excavated evidence.**

Prior to the construction of the garage block (for retention) a defunct cesspit existed and is shown on Plate 1 and on historical OS map on Fig 1.

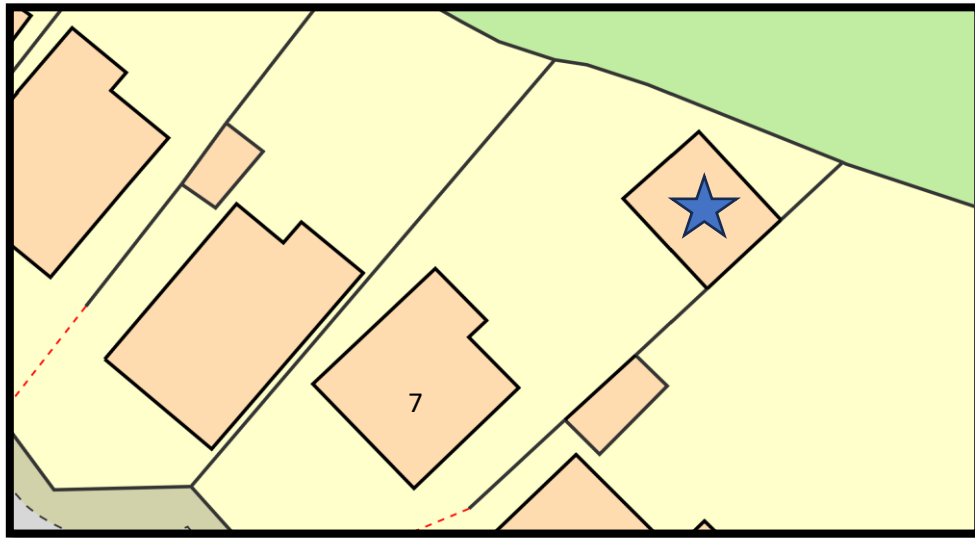
Fig 1: \*Location of defunct cesspit.

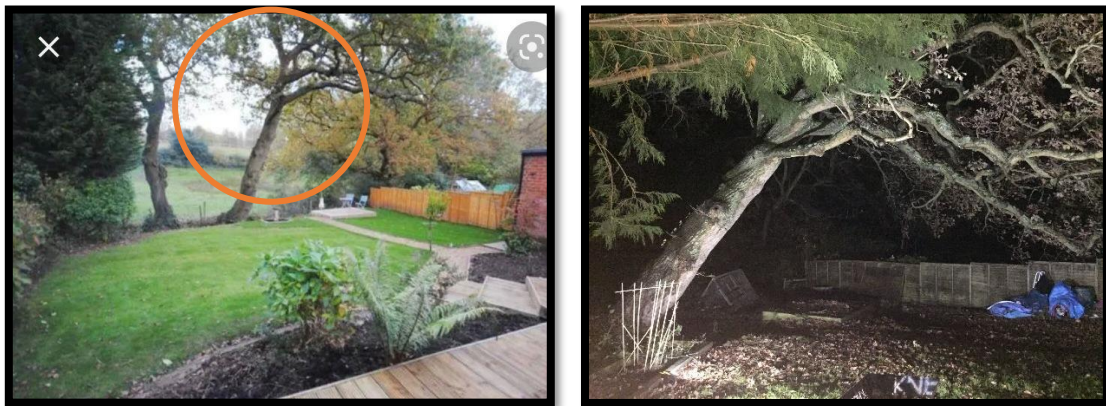
Further to the cesspit being discovered, a few years ago an adjacent tree (see Plate 2) within the garden was the subject of root heave (potentially due to flooding within the SINC) and the tree fell into the garden and damaged the property. See Plate 2.

Plate 2: Original tree and tree root failure.

The tree was subsequently removed in accordance with the Town and Country Planning (Tree Preservation) (England) Regulations 2012, Part 4 – Applications for Consent under Tree Preservation Orders, for a dangerous tree.

The Local Authority confirmed the loss and the mitigation was to plant a tree of the same species within 10 m of the original tree stem. This was duly carried out, however, considering the size of the garden (regardless of the new construction) there is very little space to support two mature Oak trees (*Quercus robur*) in the opinion of Arbor-Eco Consultancy. The new tree, has not grown particularly since planting, and I suggest that it is potted until all building debris has been removed

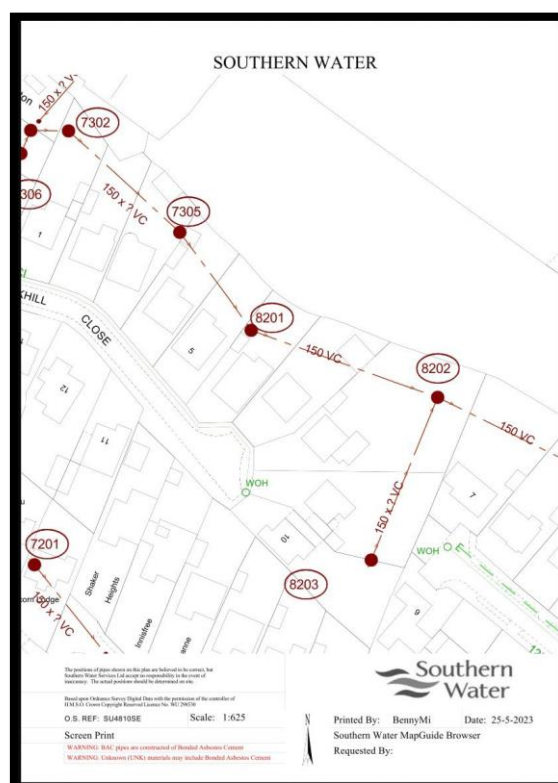
Finally, Southern Water have provided a drawing showing the location of a sewer pipeline that dissects the rear aspect garden of the property to the south of T1. This pipeline is to be renewed under statutory licence and therefore, whilst a mitigation program can be arranged, the disturbance of grown may further exacerbate the decline of the tree. This must be a consideration in the Decision of the Planning Application.

1. An historical cesspit lay over the land and within the footprint of the new building.
2. A companion tree suffered root heave and the void remains with no root structure.
3. A sewer pipeline dissects the garden and was excavated to the south of the tree which again, is likely to deflect ant roots from T1. See Fig 2.
4. The tree grows from the inner lip of the existing land drain between the property and the SINC.

**Fig 2: Sewer pipeline location and 'run'.**

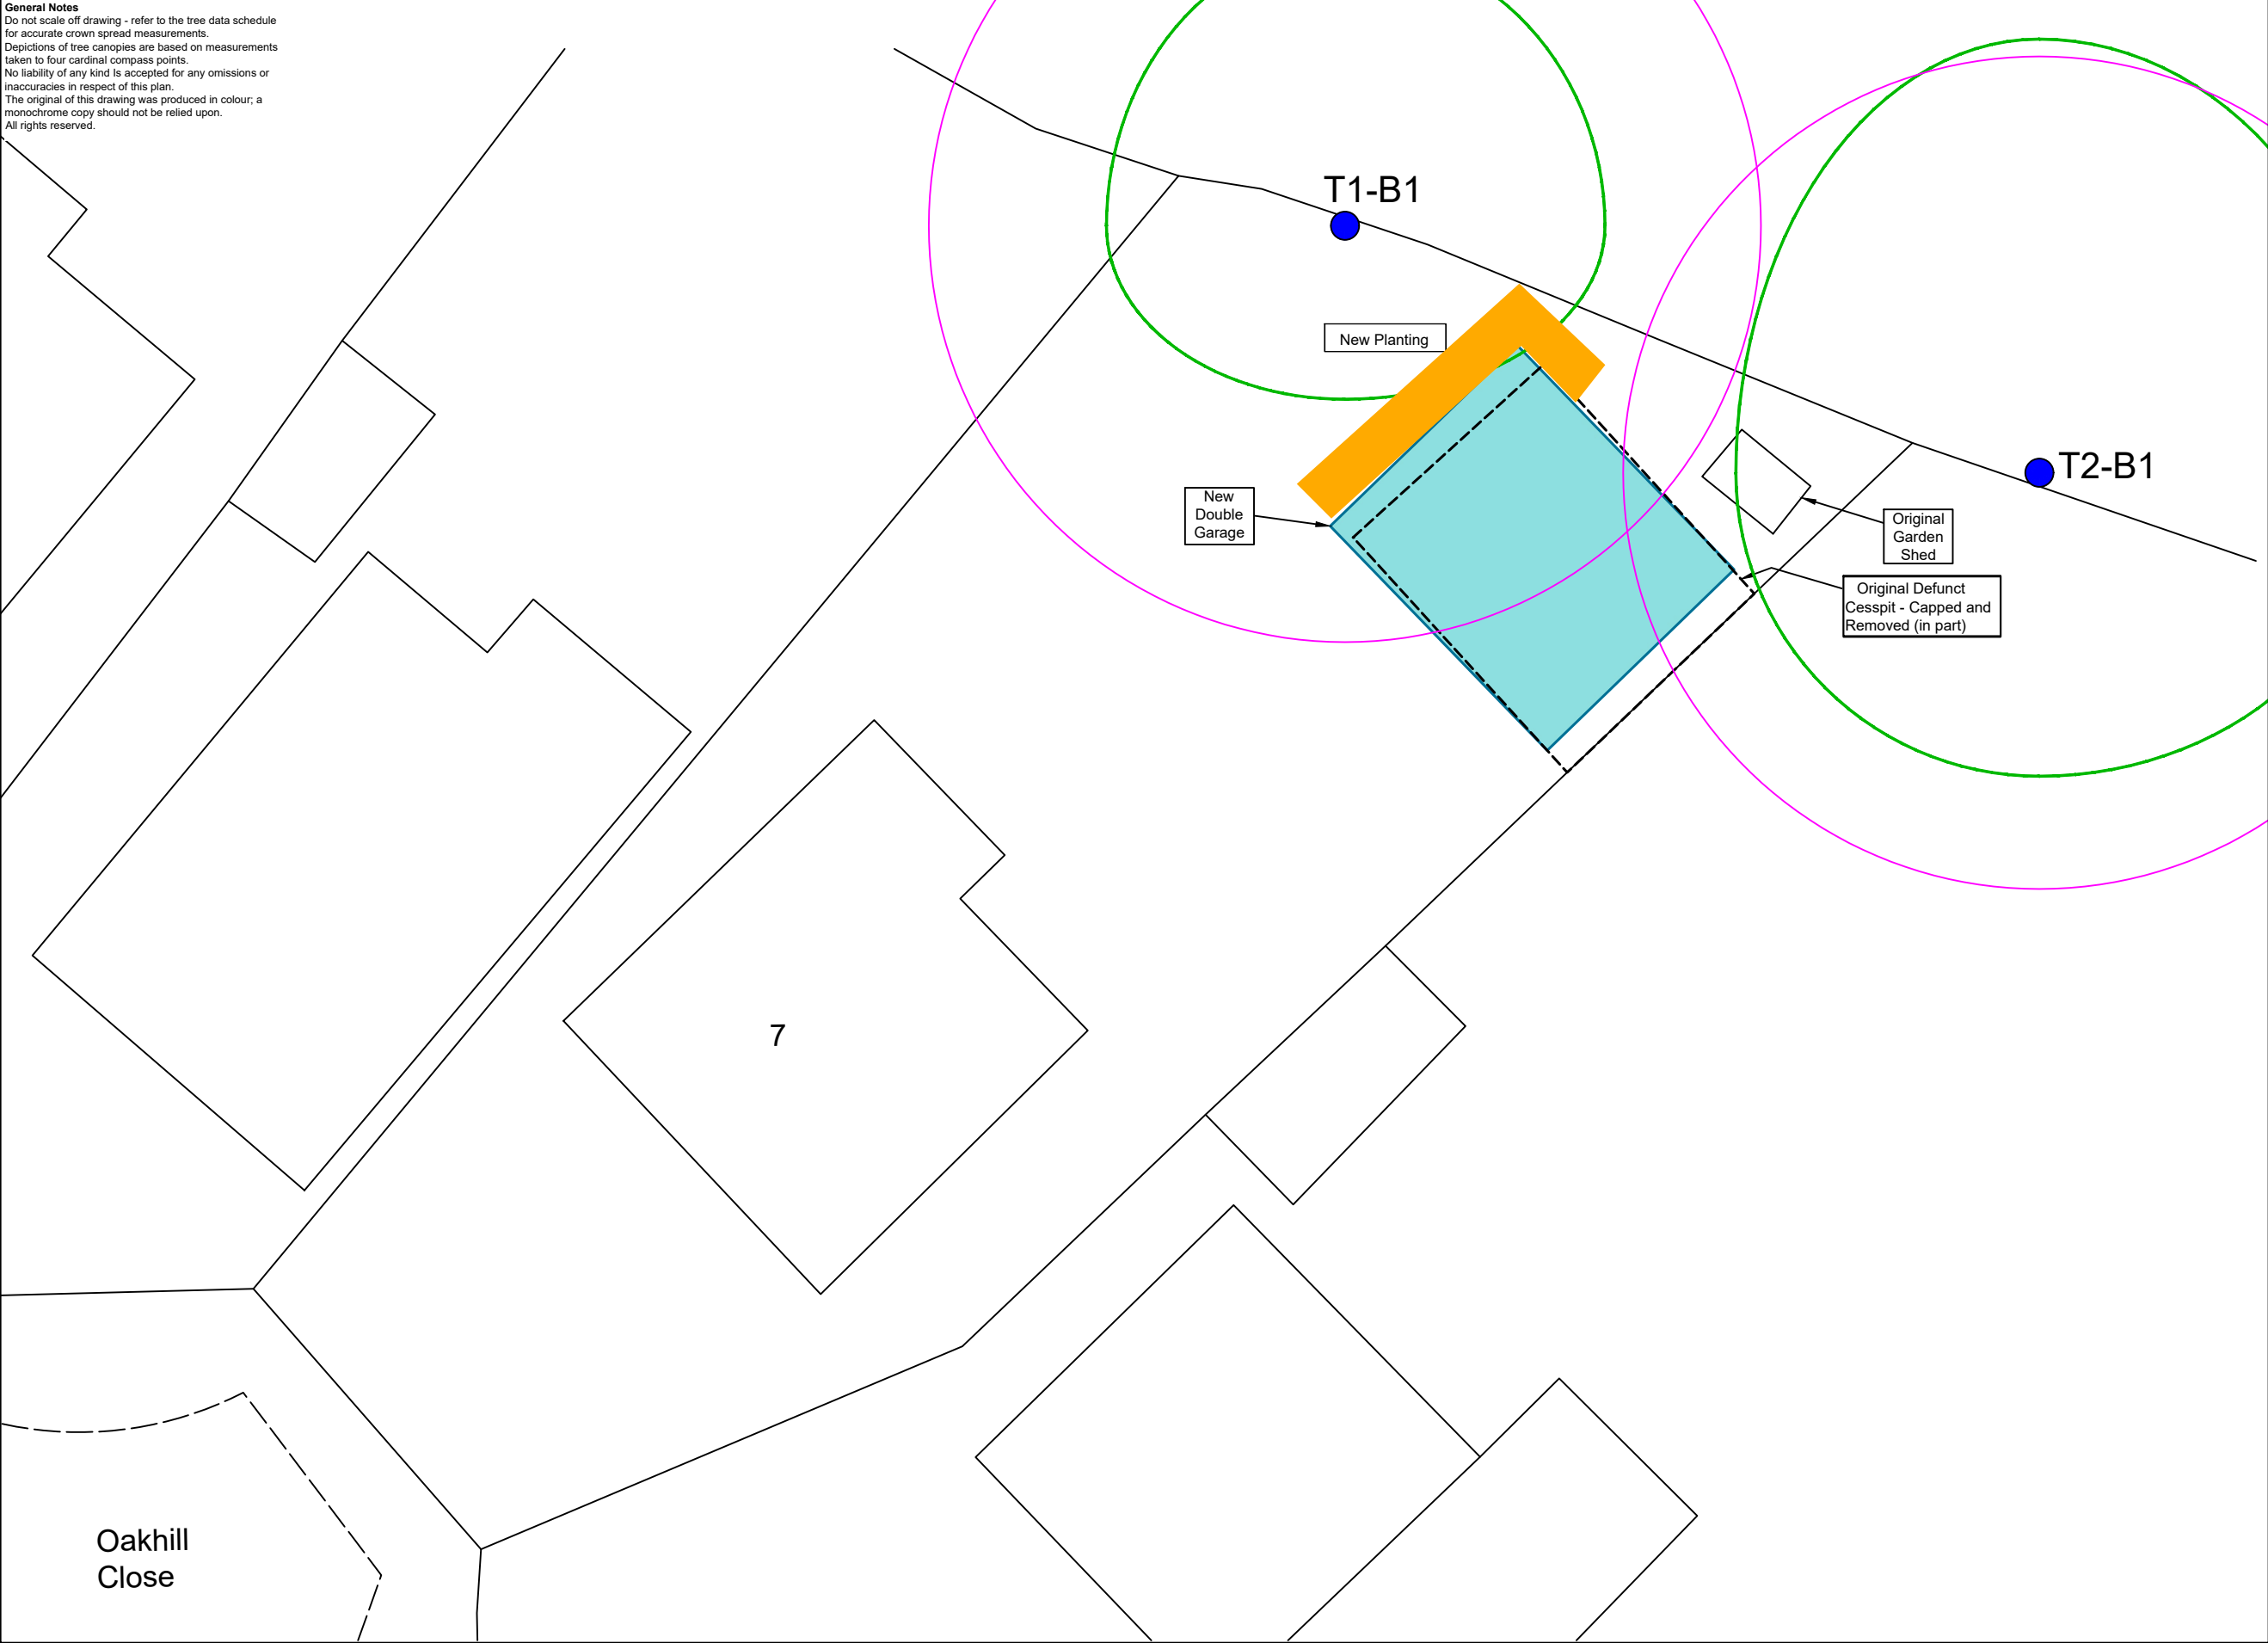
**Drawing Title**  
**Tree Constraints Plan**

T1, as shown on Tree Constraints Drawing MB230703-01 indicates that the default RPA is within the influence of the constructed garage block.

T2, as shown on Tree Constraints Drawing MB230703-01 indicates that the default RPA is within the influence of the constructed garage block, however, the impact of the development is deemed to be insignificant due to a previous structure within the default RPA. This tree is an off-site tree at a distance so as not to be influenced by the development due to historical structures within the site.

In terms of providing assistance to the biodiversity of the site, the owner has already expressed a wish to plant herbs such as Lavender (*Lavandula angustifolia*), Rosemary (*Salvia rosmarinus*), Thyme (*Thymus vulgaris*), Sage (*Salvia officinalis*) and Oregano (*Origanum vulgare*). These are some of the best pollinators according to the RHS. These will be planted within the gardens space and in addition, a narrow section of land adjacent to the building will be utilised solely for pollinating plants as is shown on Tree Constraints Drawing MB230703-01, enclosed.
