July 2023  
CBA11759 v1

# ARBORICULTURAL REPORT

Site: 71 Lakewood Road  
Chandlers Ford  
SO53 5AE

**Client:** Paul Skiba – Lakewood Tree Surgeons  
**Site:** 71 Lakewood Road, Chandlers Ford, SO53 5AE  
**Principal Consultant:** Stefan Rose *BSc (Hons), Tech Cert ArborA, TechArborA*  
**Date:** July 2023

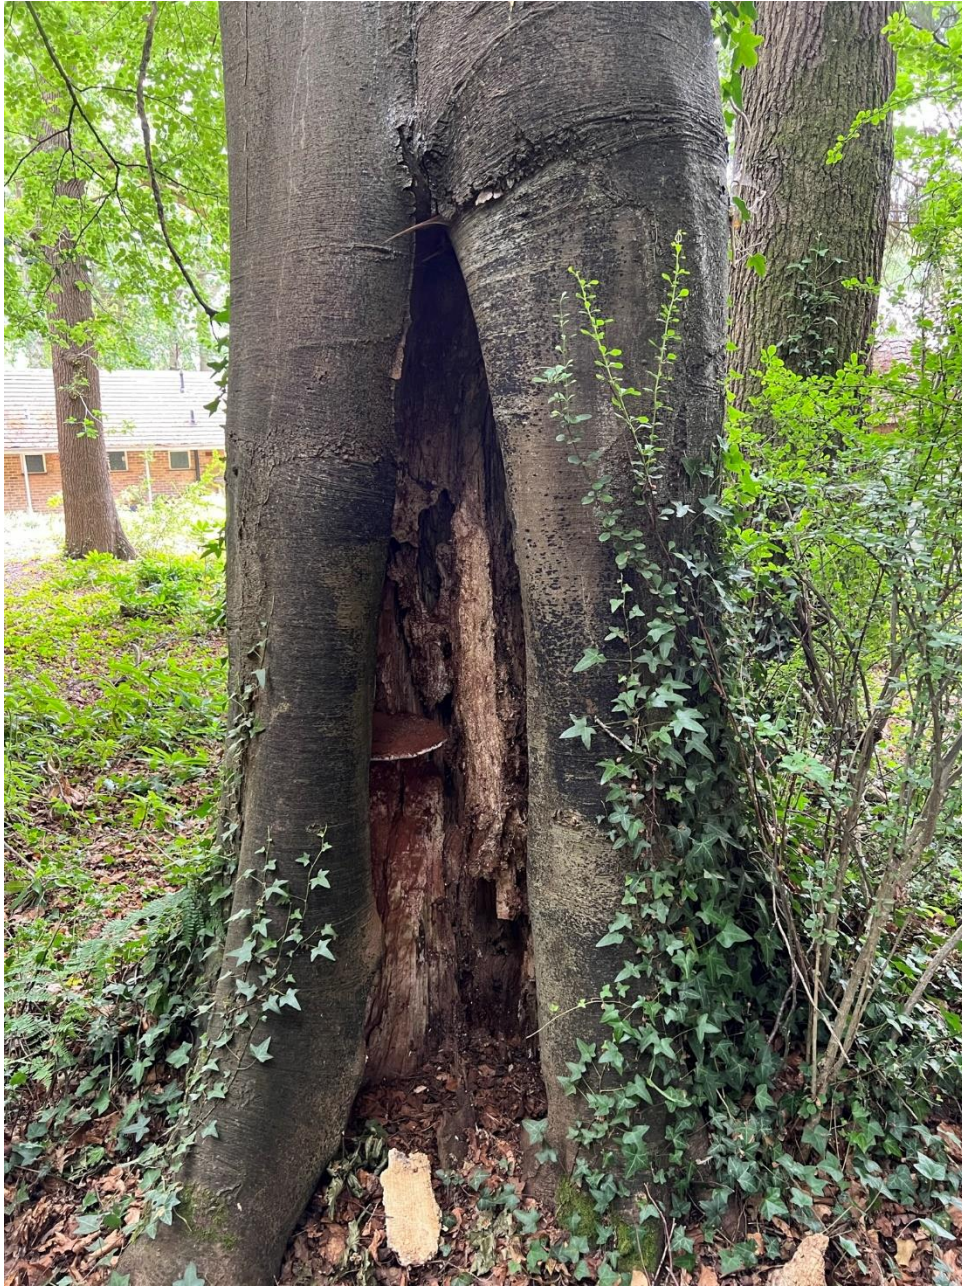
There is a significant open cavity on the western side of the trunk. This is open from ground level to a height of 2.1m and an opening width of 360mm. The open depth of the cavity is approximately 650mm.

The cavity extends vertically at least 800mm (extent of probe length) higher than the cavity opening, suggesting the minimum length of the cavity is at least 2.9m in height.

When tapped with a plastic headed mallet the resonance was of a hollowing sound on either side of the cavity extending round east and west for some 300-400mm with a more solid sound on the southern and eastern side suggesting that there is still sound wood on this side of the trunk.

2.3 **Photograph 9:** Showing the cavity at base of the Beech trunk on its west side

- 3.8 Whilst the tree has the appearance of being healthy physiologically, structurally the tree is compromised to such an extent that the retention of the tree in our view is not viable or sustainable. With clear views of this tree from a public place being very limited and the structurally compromised trunk we would recommend that this tree is felled to at least a standing stump of approximately 5m in height to provide an ongoing wildlife habitat.
- 3.9 Tree 2, the Oak, now in leaf does appear to have a live crown, albeit limited. Our recommendation for this tree is that works to remove the major deadwood is undertaken and at the same time undertake a further assessment of the crown and the areas of bark necrosis and wildlife holes to further inform on the health of the tree.

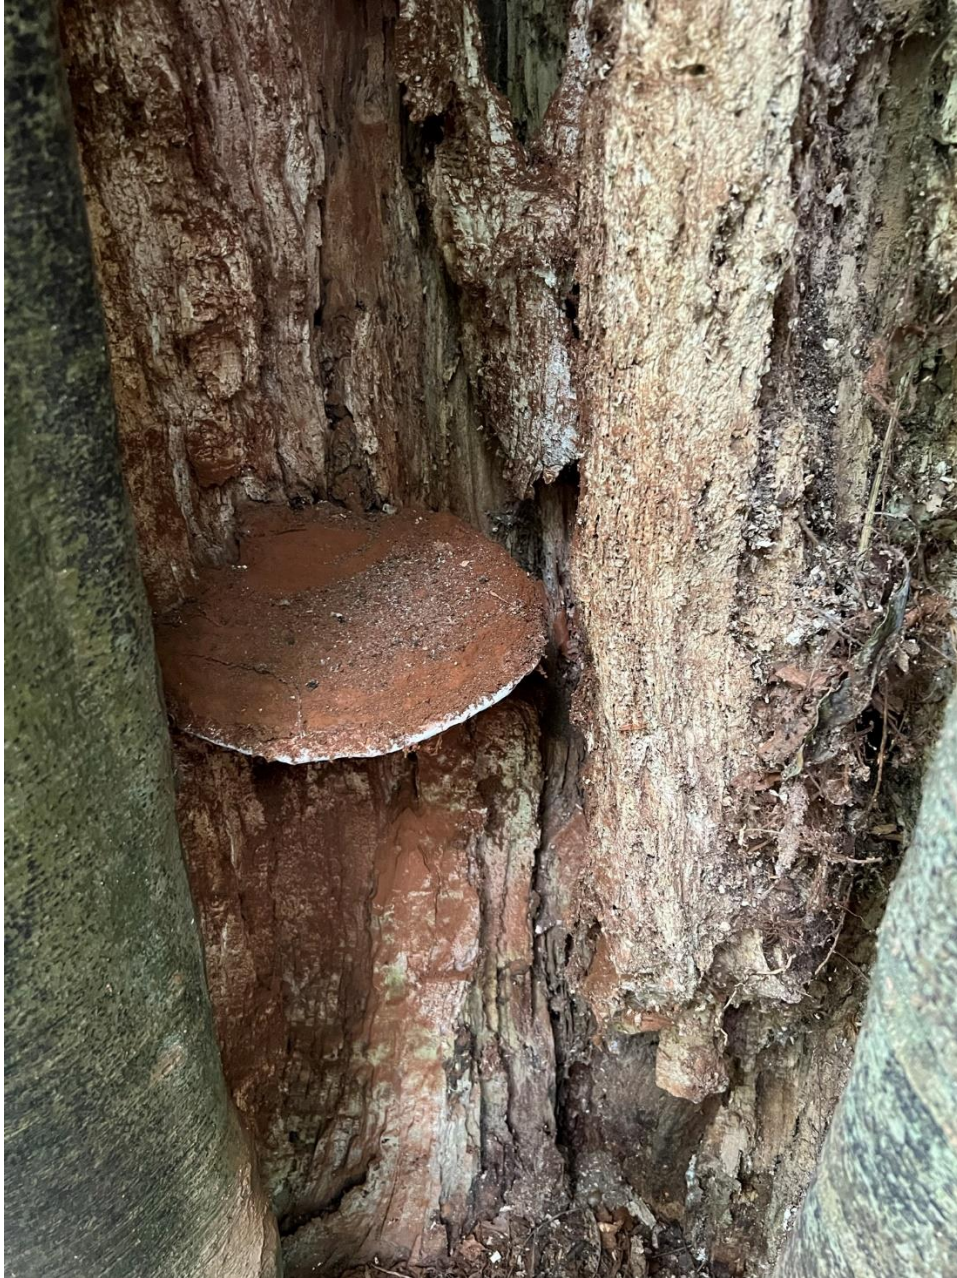
Within the cavity is a fungal fruiting body of *Ganoderma* fungal fruiting body which is growing approximately 900mm above ground level on the northern side of the opening. The decay fungi known as *Ganoderma Australe* is a decay fungus, *Principles of Tree Hazard Assessment and Management*, David Lonsdale, 2001 states:

2.4 **Photograph 10:** Showing the fungal fruiting body in the cavity of the beech trunk

- 3.4 There is a risk of sudden wind throw with inherent safety risks associated with a very large tree falling in an urban environment. The fungal fruiting body present on the northern side of the trunk will have reduced the trees resilience to wind loading. The UK has generally south westerly winds which would suggest if the tree were to fail it would fall north easterly. The Beech is tall enough that should it fall, it would reach the neighbouring house and there is not sufficient surrounding trees to be able to stop the tree falling in a northerly direction.

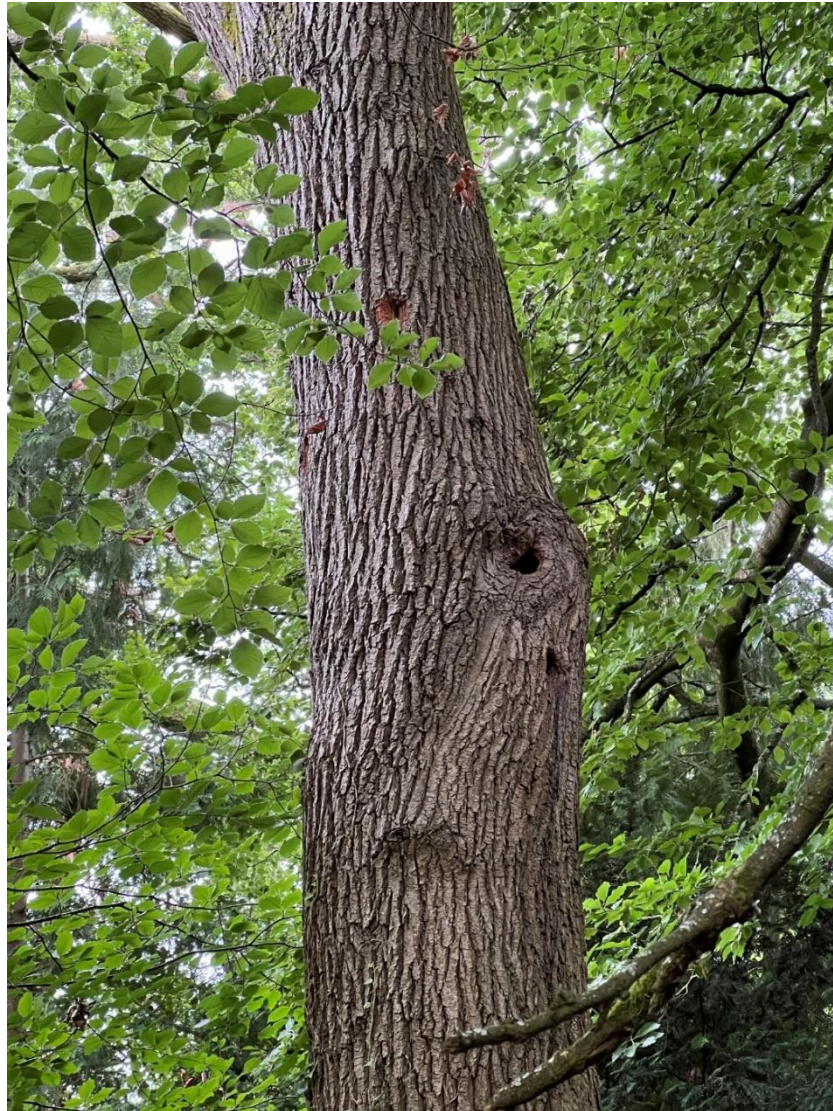
Old pruning wounds were present with the majority occluded over. Some of these had wildlife holes present suggesting that the pruning wounds whilst occluded have areas of decay within them.

There were also numerous wildlife holes that have been made within the trunk itself.

2.10 **Photograph 11:** Showing an example of the wildlife holes in the trunk of the Oak

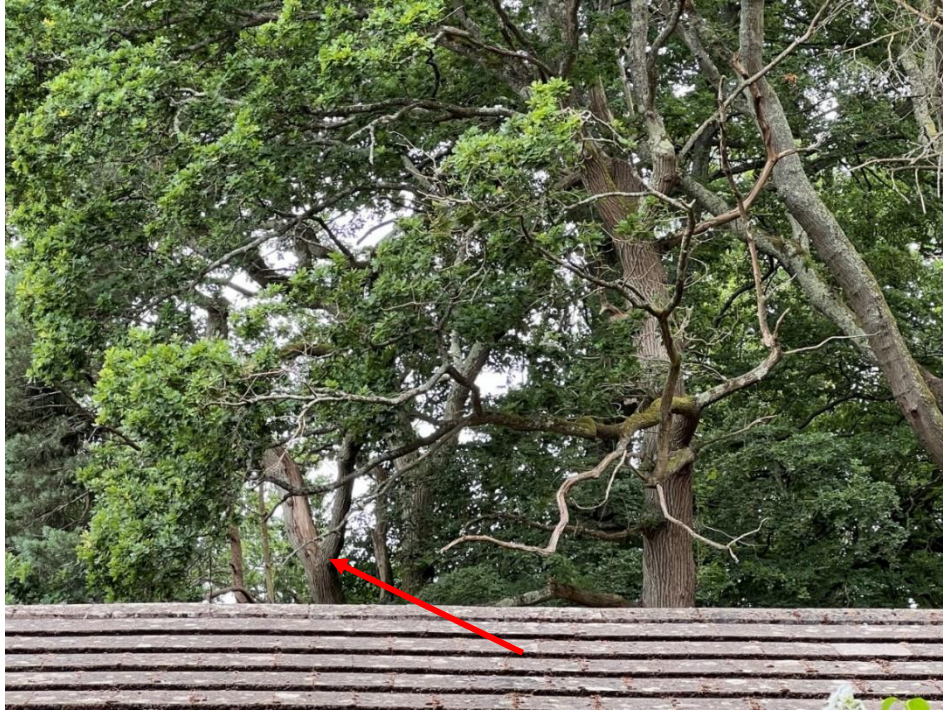
The two structural trunks form the crown with the majority of structural branches within the crown being biased towards the southern side. Whilst bark necrosis is present on numerous branches, the larger more obvious area is on the base of the southern structural trunk on its upper side.

2.12 **Photograph 12:** Showing the bark necrosis on the southern trunk of the Oak

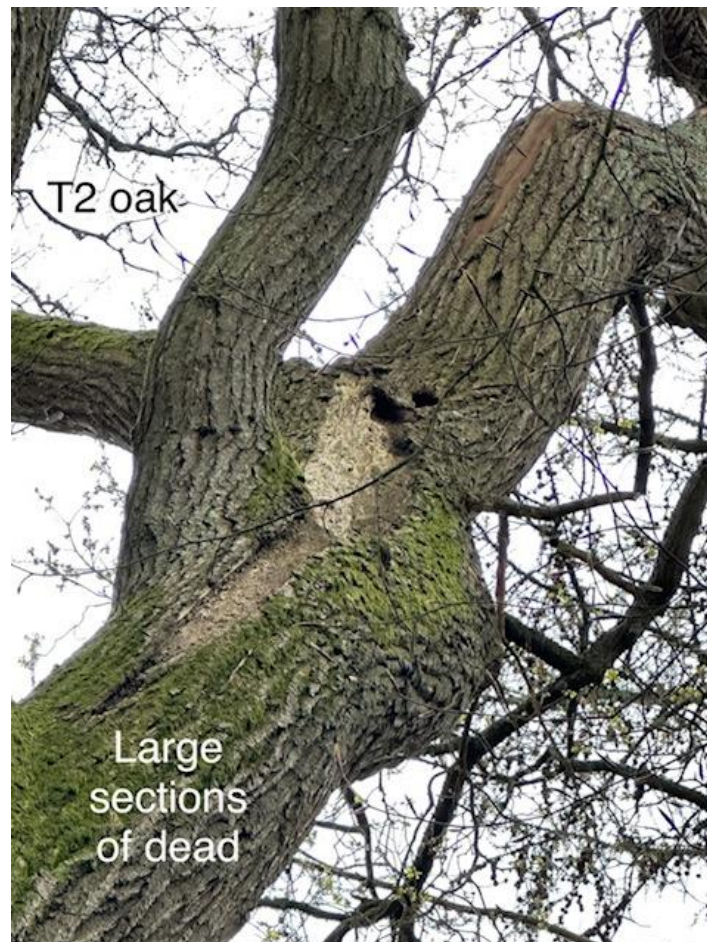
2.13 **Photograph 13:** Showing an example of the bark necrosis on the Oak

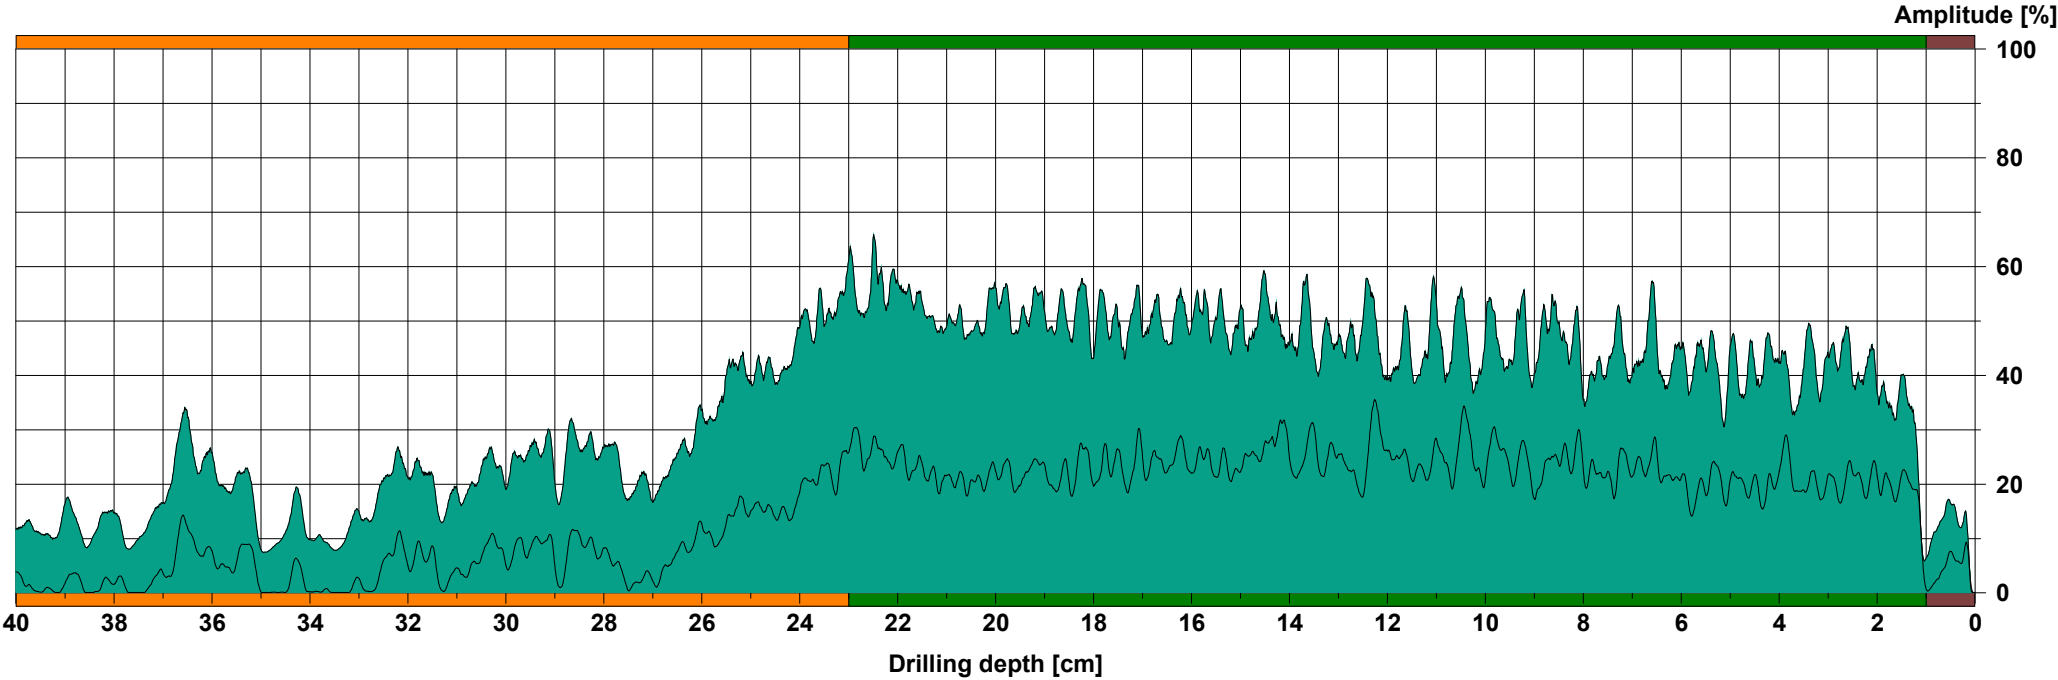
BEECH 90 W

| From | 0.00 cm to | 1.00 cm | : Bark |
| From | 1.00 cm to | 23.00 cm | : Sound Wood |
| From | 23.00 cm to | 40.00 cm | : Decay, Crack, Cavity |

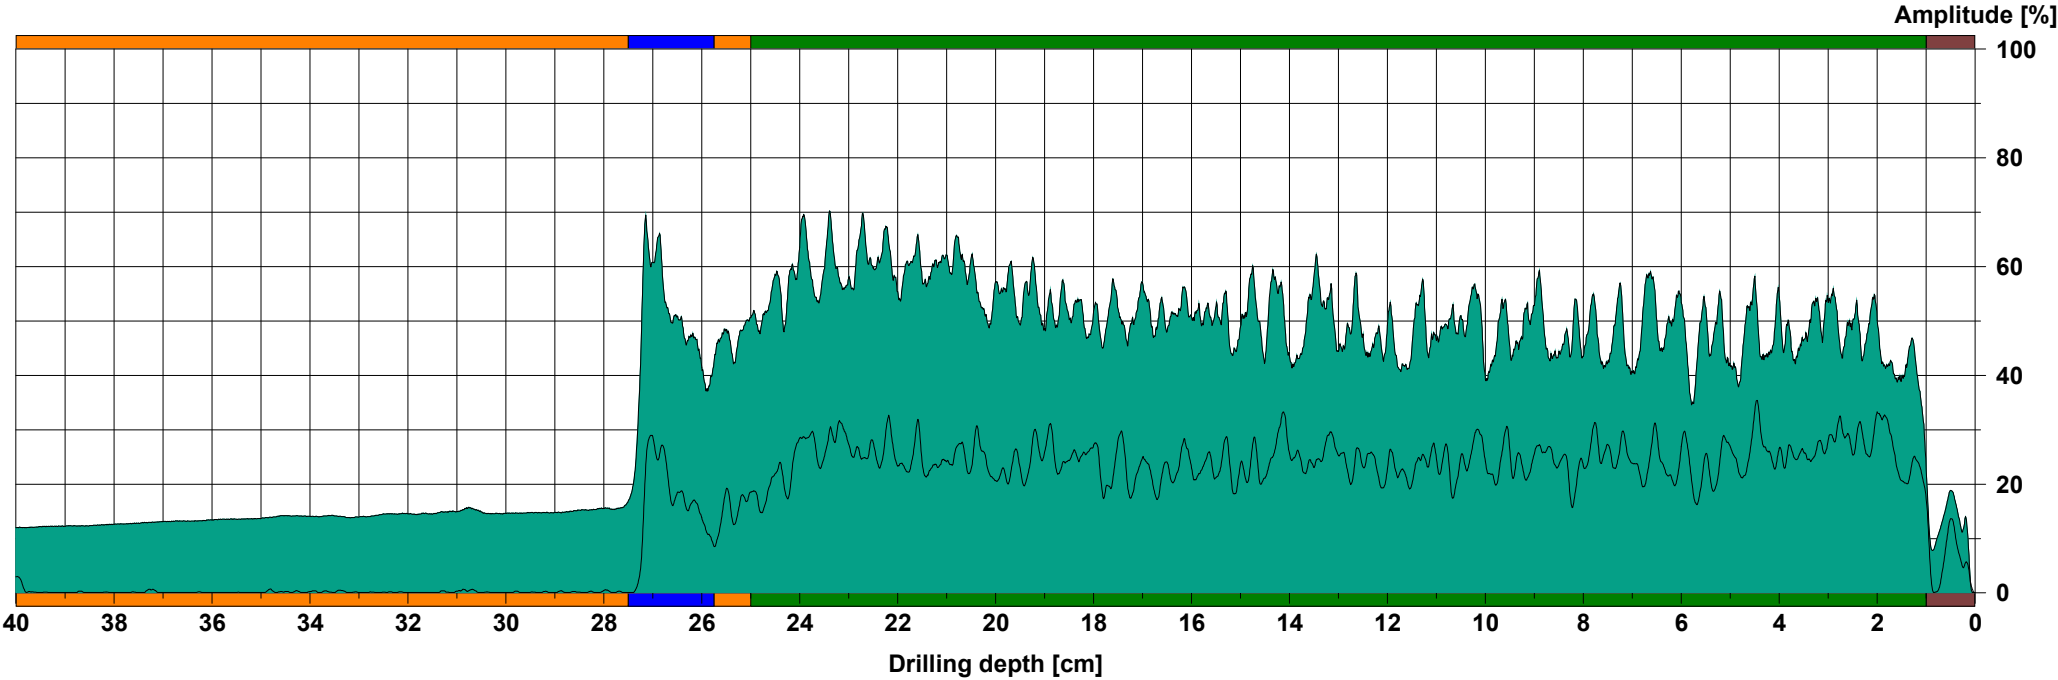
BEECH 90 N

| From | 0.00 cm to | 1.00 cm | : Bark |
| From | 1.00 cm to | 26.50 cm | : Sound Wood |
| From | 25.00 cm to | 25.75 cm | : Decay, Crack, Cavity |
| From | 25.75 cm to | 27.50 cm | : Reaction wood |
| From | 27.50 cm to | 40.00 cm | : Decay, Crack, Cavity |

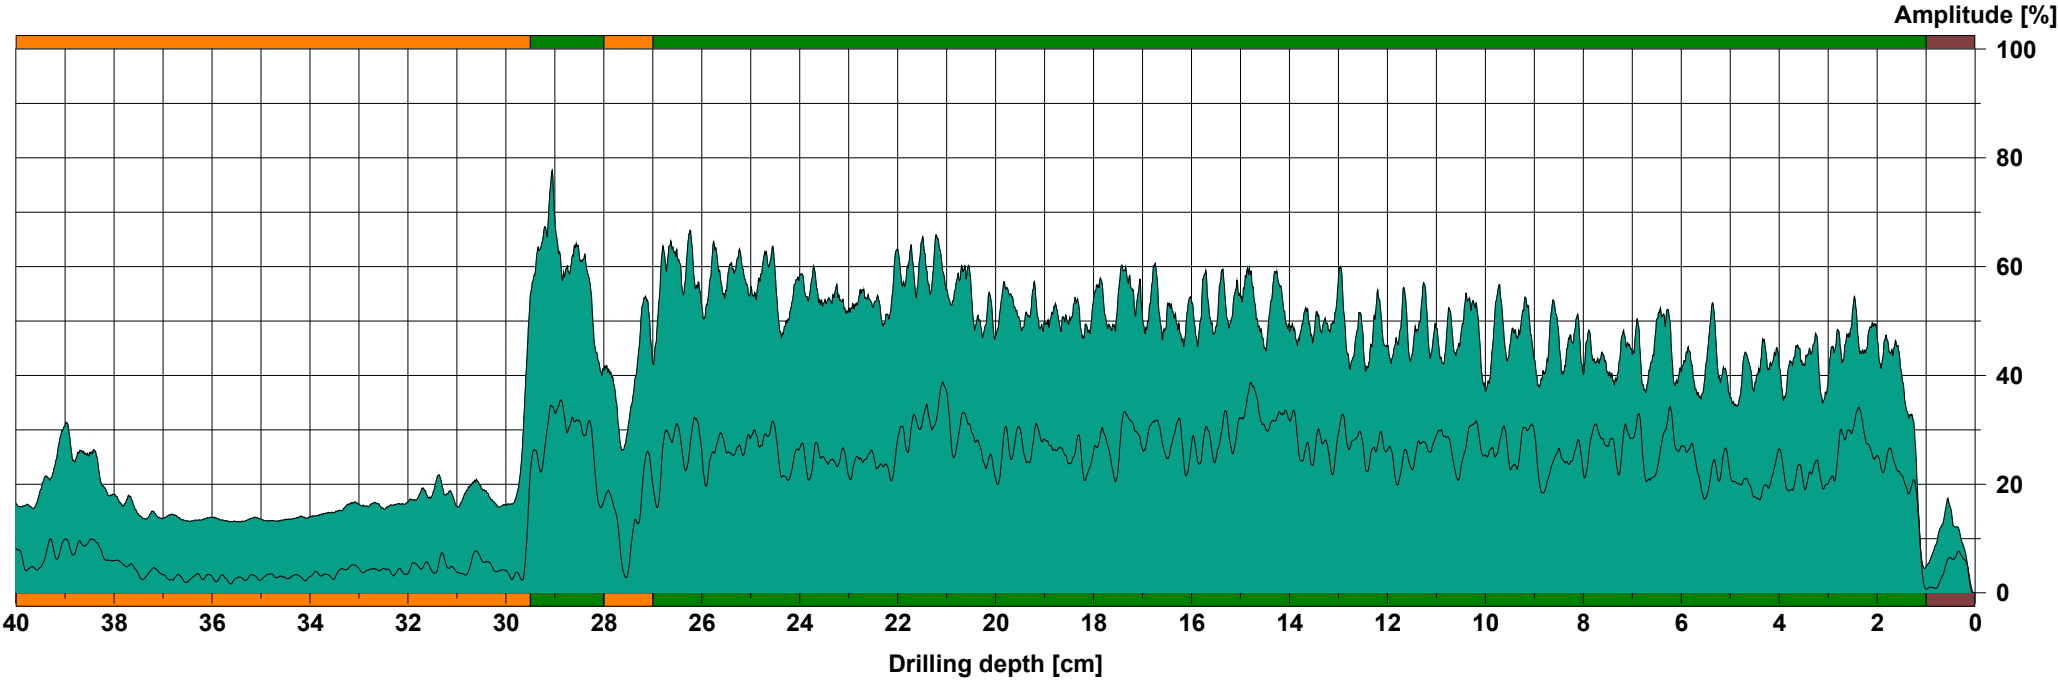
BEECH 90 S

| From | 0.00 cm to | 1.00 cm | : Bark |
| From | 1.00 cm to | 27.00 cm | : Sound Wood |
| From | 27.00 cm to | 28.00 cm | : Decay, Crack, Cavity |
| From | 28.00 cm to | 29.50 cm | : Sound Wood |
| From | 29.50 cm to | 40.00 cm | : Decay, Crack, Cavity |

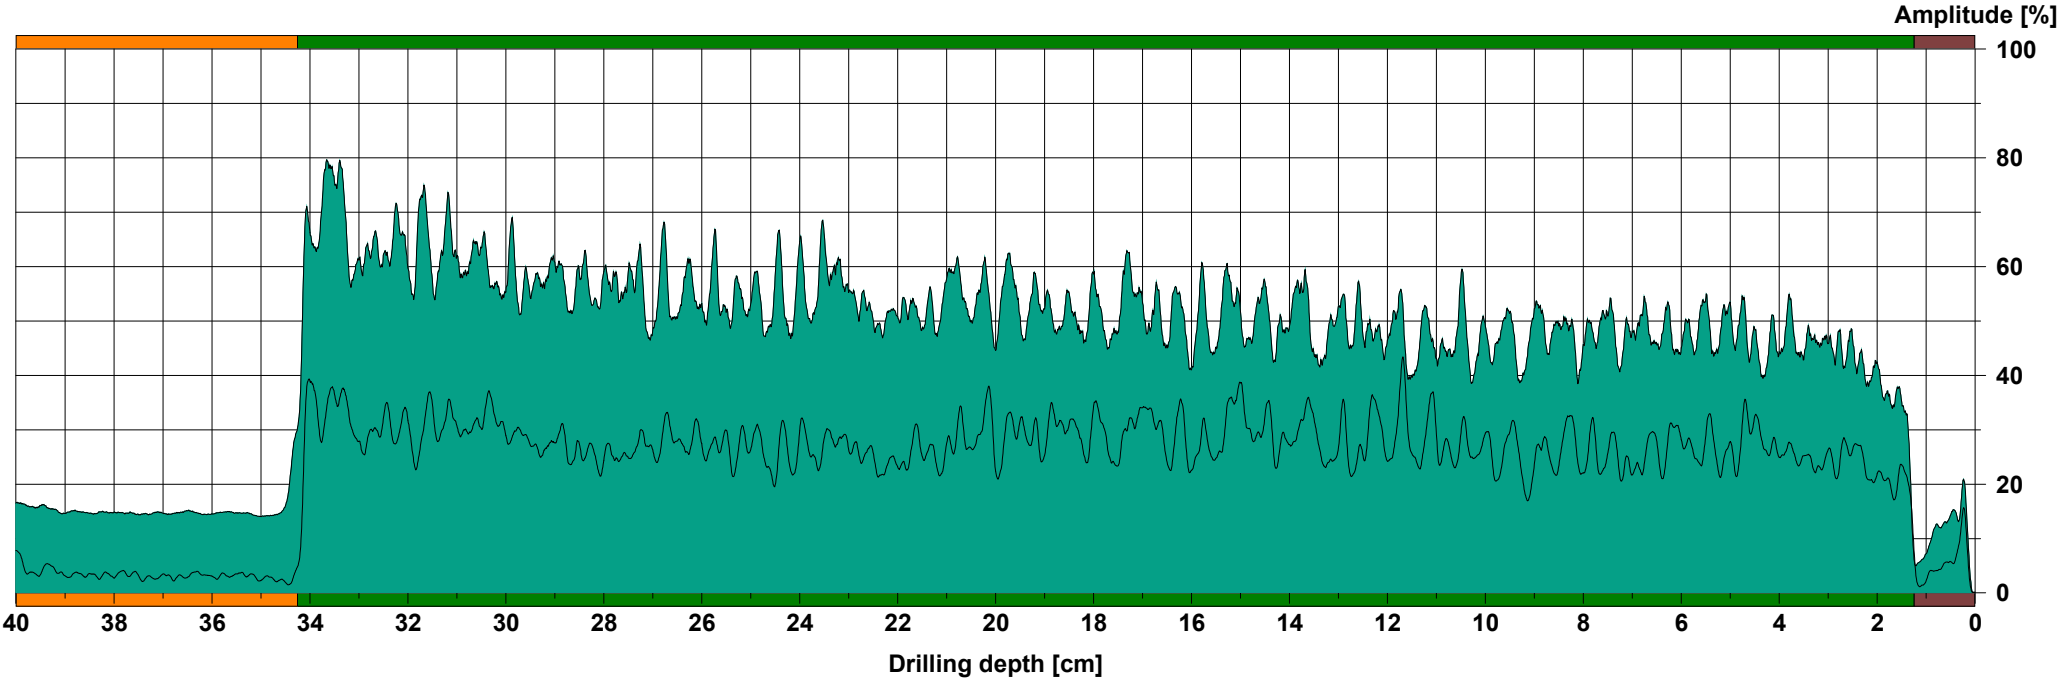
BEECH 90 SW

| From | 0.00 cm to | 1.25 cm | : Bark |
| From | 1.25 cm to | 34.25 cm | : Sound Wood |
| From | 34.25 cm to | 40.00 cm | : Decay, Crack, Cavity |
