## **Resistograph Report**

**Vivid Housing Limited**

**No.135,  
Woodlands Way,  
Bursledon,  
Hampshire, SO31 8LG**

**Prepared by  
Richard Daubeney  
Our Ref 0823-RD  
22nd of August 2023**

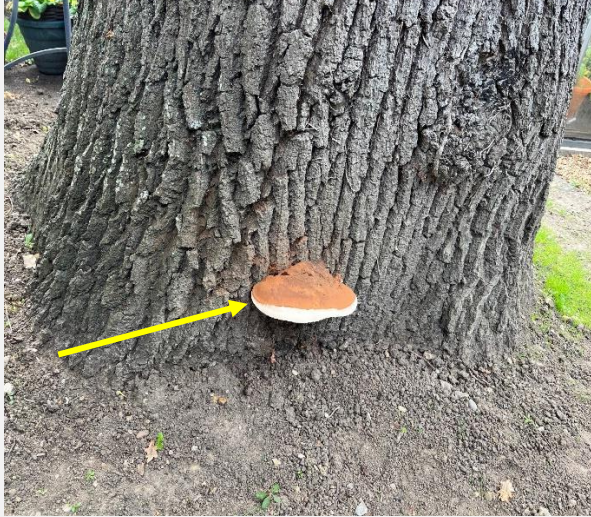
The mature English Oak tree T1 located on the site has previously been subjected to tree inspection as part of a management program. At the time of inspection, gross defects were recorded, given the age of the tree present, this was expected. The residential site is a mixture of lawn and patio to the rear of the single storey property, with further lawn area and concrete based driveway to the front. The garden has one tree being the mature English Oak T1. The tree has been historically reduced in height. A fresh *Ganoderma australe* fungus bracket was noted at ground level to the North side.

T1 North side of stem. *Ganoderma australe* (fruiting bracket)

Based on the above information. I would recommend a crown reduction in 3m in height and lateral spread to be reduced by 2m to be carried out, this would help to lessen the pressure to the lower section of the stem. I advise an inspection 3 years from the date of this report to ensure there are no further changes to the tree's health and condition.
