## **Resistograph Report**

**Vivid Housing Limited**

**No.133,  
Woodlands Way,  
Bursledon,  
Hampshire, SO31 8LG**

**Prepared by  
Richard Daubeney  
Our Ref 0823-RD  
22nd of August 2023**

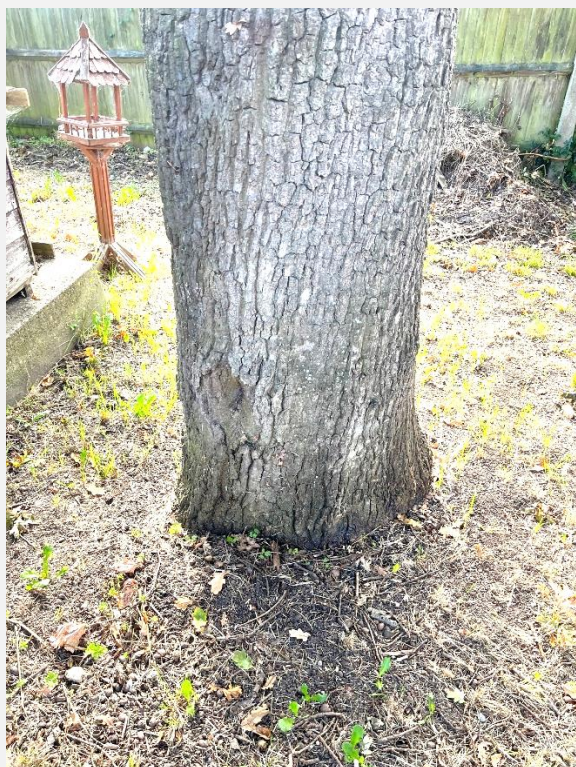
**T2 Looking to Southeast.**

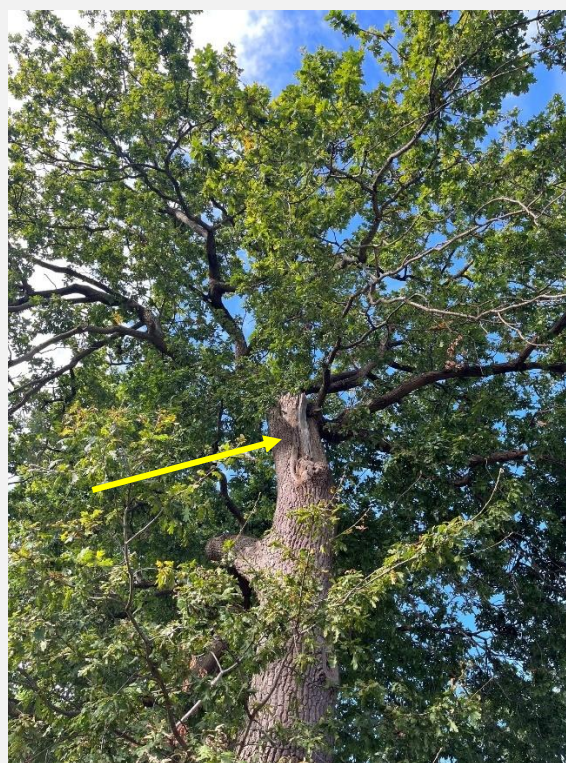
The mature English Oak tree located on the site have not previously been subjected to tree inspection as part of a management program. The English Oak tree is located in rear garden within the lawn area. The tree had a historic reduction carried out to the crown. It was noted a large tear out wound located at 7m above ground level. Likely a historic secondary stem which tore out at that point which caused the large wound. The crown is weighted to one side due to the loss of the stem tear out. It was noted at ground level that there might have been markings of fungus brackets located close to ground level around the Northwest side of stem, due to the distinct colouring to the bark, but without the evidence of the fungus this is not confirmed on the day of the inspection.

**T2 Extensive tear out wound to Southeast side.**

Following the above results including the observations of the large tear out wound and stem cavity, it would be therefore be advisable to crown reduce by 3m all round, subject to outcome of a climbing inspection for the cavity and tear out wound. Once the crown reduction is completed this will help to reduce the end loading to the canopy spread reducing the pressure to the stem particularly where the wounds/cavity are located, I would recommend a further inspection 3 years from the date of this report to ensure there are no further changes to the tree's health and condition.

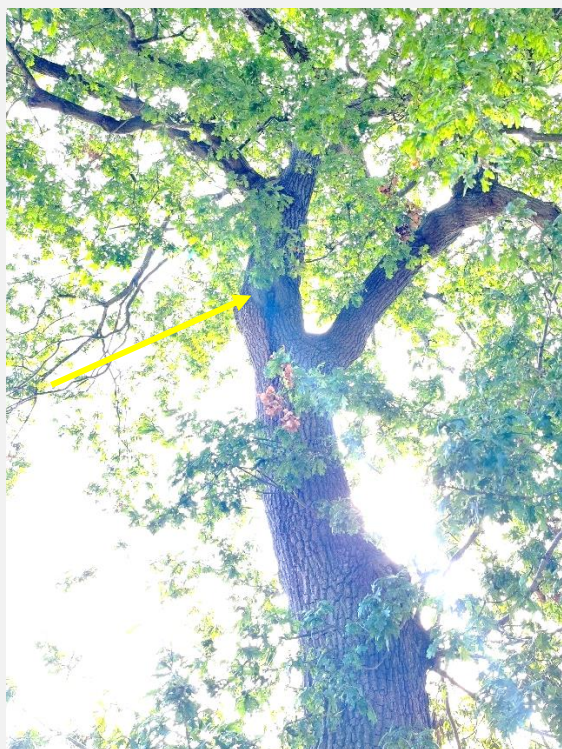
**T2 Looking South towards cavity on stem.**

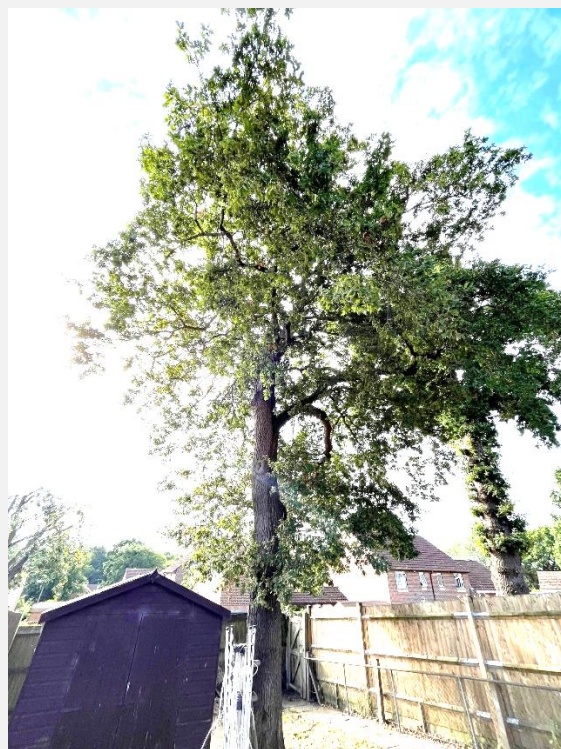
**T2 Looking South.**

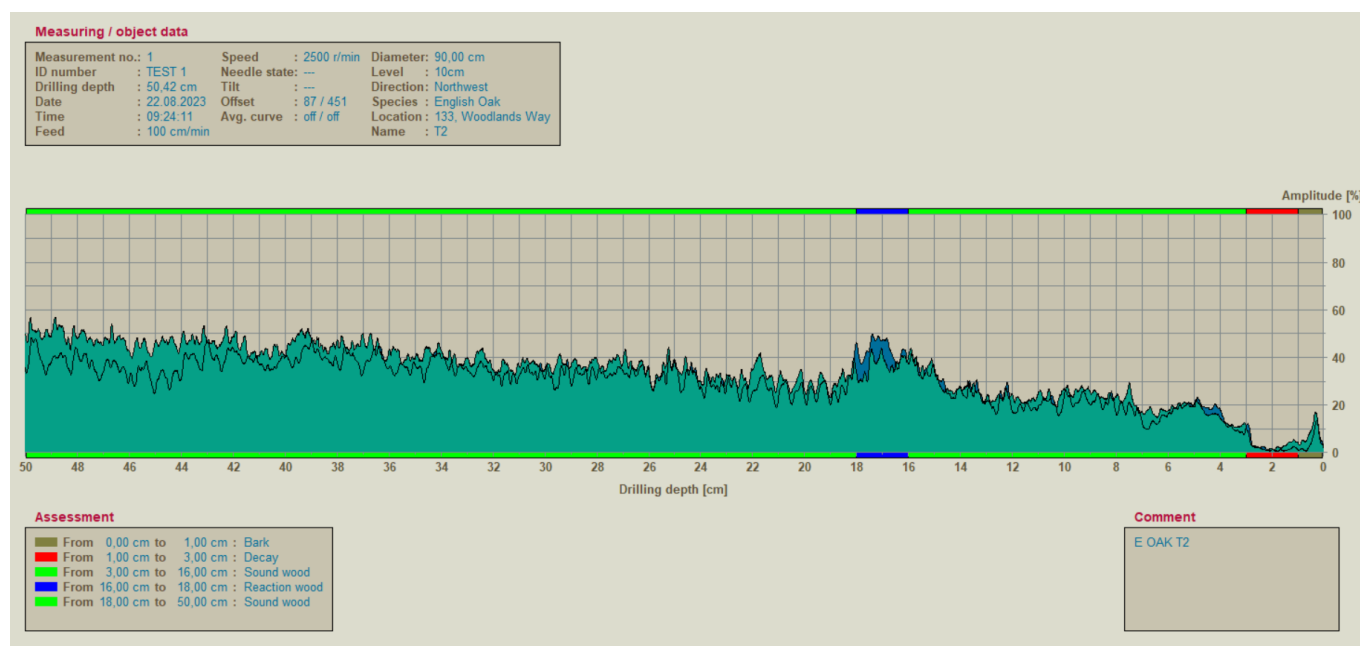
### T2, Measurement 1

T2 English Oak held no gross defect upon resistograph inspection with a T/R ratio of over the industry recommended 30% point. Based on the readings provided it would suggest that the likelihood of failure at test point is not significant. However, following the readings taken from the resistograph, it showed that there is a small column of decay within the stem to the Northwest side, but not significant at this time, there are good areas of reaction wood within the remaining areas of the stem.
