**VISUAL TREE ASSESSMENT REPORT  
(VTA)**

**RUNNYMEDE ESTATE,  
RUNNYMEDE, WEST END,  
SOUTHAMPTON**

**NAPIER MANAGEMENT SERVICES LTD**

**Report Number: MB230104**

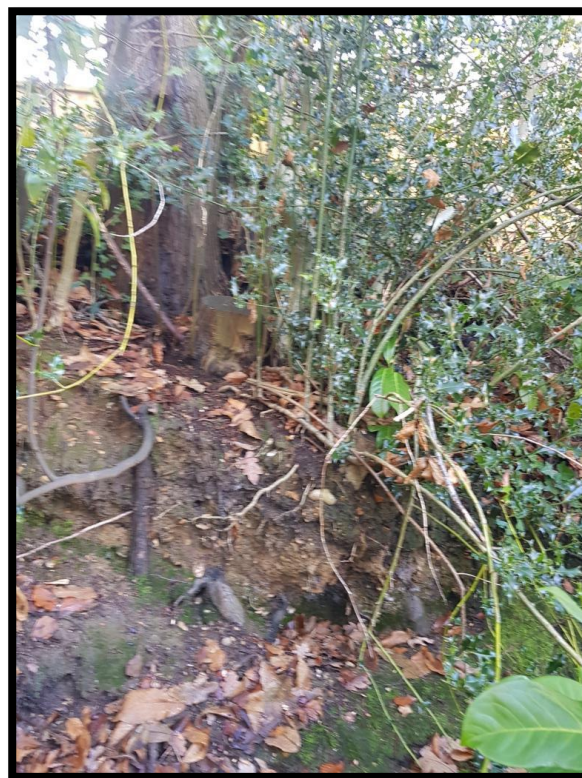
**4.1.1** It must be noted that all of the trees are subject to compacted rooting areas as all of the trees were within the boundary of a residential communal garden. In addition, equipment, vehicles and pedestrian traffic would have passed across the rooting zone of a number of the trees to carry out planting, maintenance, manage the trees and maintain the land. Erosion from weather has exposed many of the roots especially those growing upon the embankment. It may be pertinent to instruct a land surveyor to determine the structural safety of the bank due to erosion as shown on Plate 2. The structural integrity of the tree relies on the soil to root adhesion and if this is lost the trees will become unstable.

**Plate 2: Bank erosion and exposed roots.**

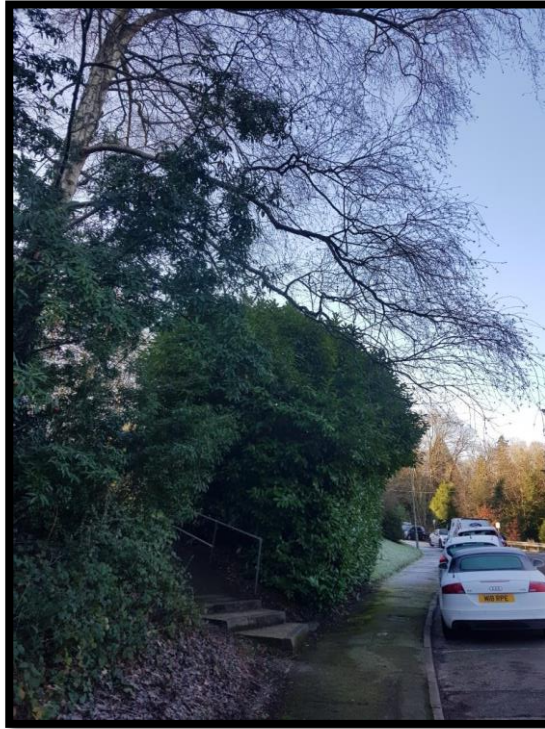
**4.1.2** Tree number 5 was observed to be growing adjacent to the highway and footway of Runnymede with low hanging branches. See Plate 3.

**Plate 3: Tree number 5 whips vehicles beneath the branches.**

Trees and vegetation that overhang the highway should be crown-lifted to at least 5.2 m to allow safe passage of high sided vehicles as well as being cut back sufficiently from the edge of the carriageway to allow clearance for wing mirrors. Trees and vegetation that overhang footways and footpaths should be crown-lifted to at least 2.5 m and cut back to ensure the footpath/way is at least 1.2 m in width. This is to allow safe passage for all footpath/way users including wheelchairs, mobility scooters, etc.
