# Arboricultural Assessment of 88 Lakewood Road, Chandlers Ford, SO53 5AA

Carried out by Matthew Rowden on behalf of Peter  
Robertson, Proposer and correspondent for the application  
for the above address.

This report is to survey one tree on the site for the potential to cause damage and/or harm. I refer to the current guidance set out within NTSG Common sense risk management of trees 2011. The risks that I have assessed are: Likelihood of damage to property (indirect or contact), tree failure through structures, and personal harm or injury.

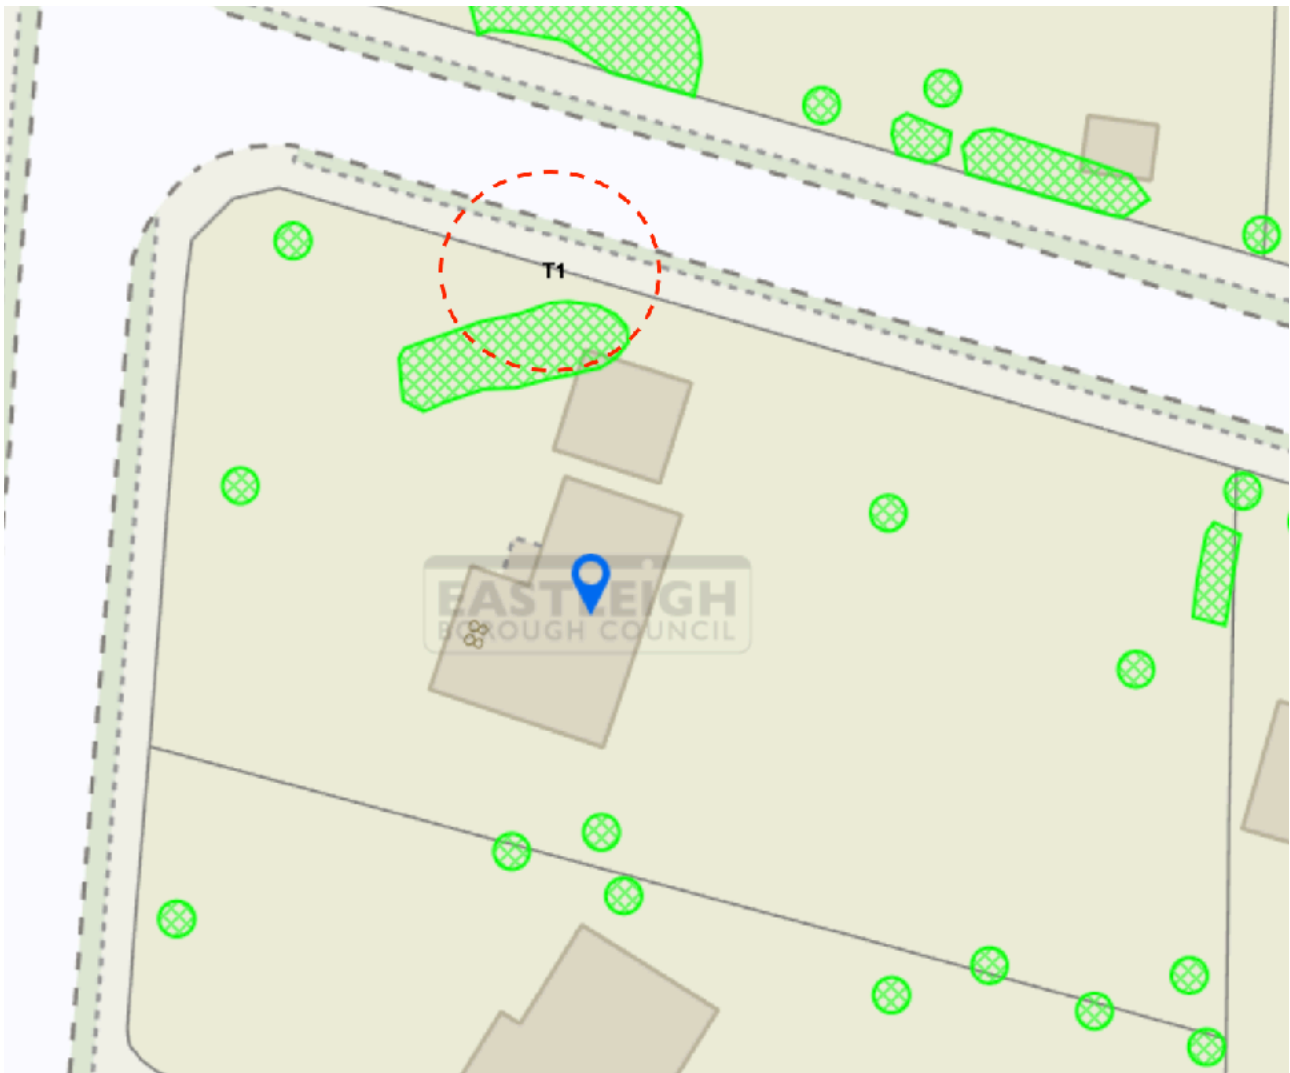
## Appendix 2: Tree location plan

The site is a residential property located off Lakewood road at number 88, Chandlers Ford. The tree in question is a mature sweet chestnut tree located at the front of the property, to the Northern Boundary of the site. The tree is covered by a preservation order ref:247-E, and is within 15m of the structure and overhangs Coultas road. The tree will henceforth be referred to as "T1".

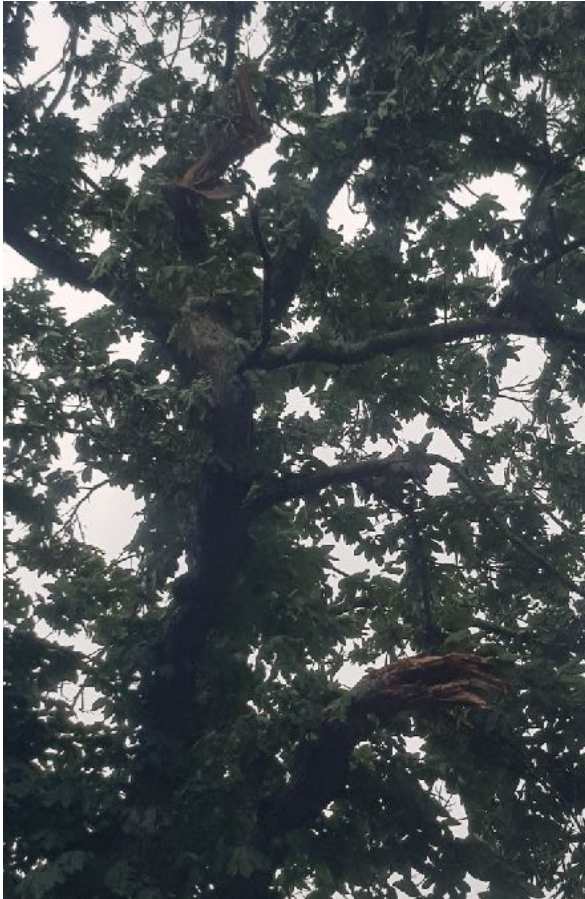
- ii. The tree lost two large limbs on September 16th, outside of any abnormal weather events, after two of the rainiest, most miserable and below average temperature summer months on record. With this in mind, I discount summer limb drop as a possible cause.

Two substantial limbs have failed, leaving large tears that can be easily colonised by opportunistic pathogens

- T1- Fell: Replace with a 14-16 standard sweet gum or Indian bean tree. Action as soon as reasonably practicable (treat as critical priority).

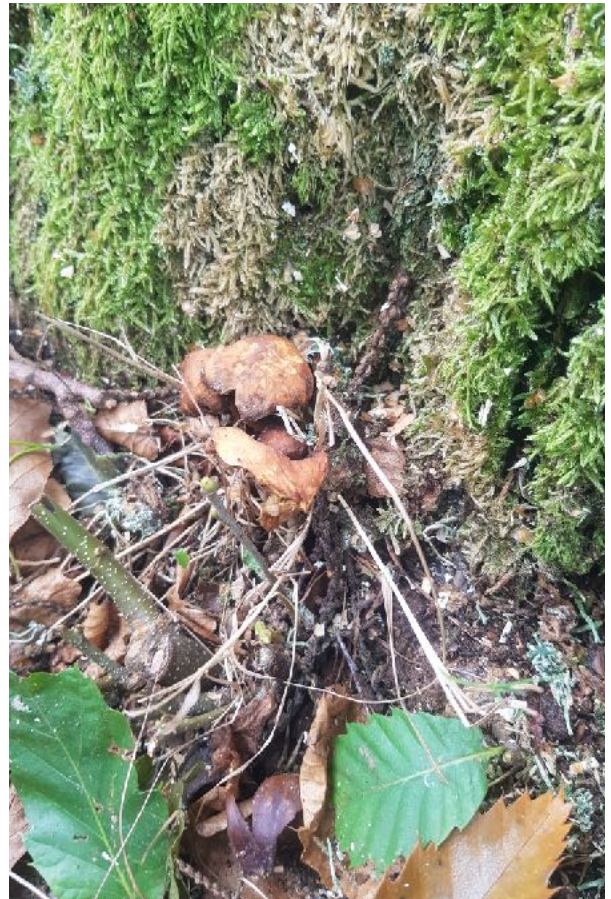
- iv. There is a fungal fruiting body to the North aspect of the stem at ground level: this, I identified as *Armillaria mellea*, or honey fungus, confirmed via the Tim Moya associates app.
- v. No black rhizomorphs were visible during inspection.
- vi. Coultas road qualifies as target range 3 within the QTRA mechanism.

- i. Honey fungus is an opportunistic pathogen that is commonly spread through the soil via rhizomorphs.
- ii. The signs of this are yellow fruiting bodies (pictured), and black rhizomorphs. The rhizomorphs are some of the biggest organisms in the world, so their presence in the soil alone is not enough to suggest the tree has been colonised, but a fungal fruiting body (sexual stage of infection) is. This also ties in with the symptoms: discoloured foliage, reduced growth, dieback of the branches and death.

*Armillaria mellea* fruiting body identified at base of stem and confirmed via TMA app.

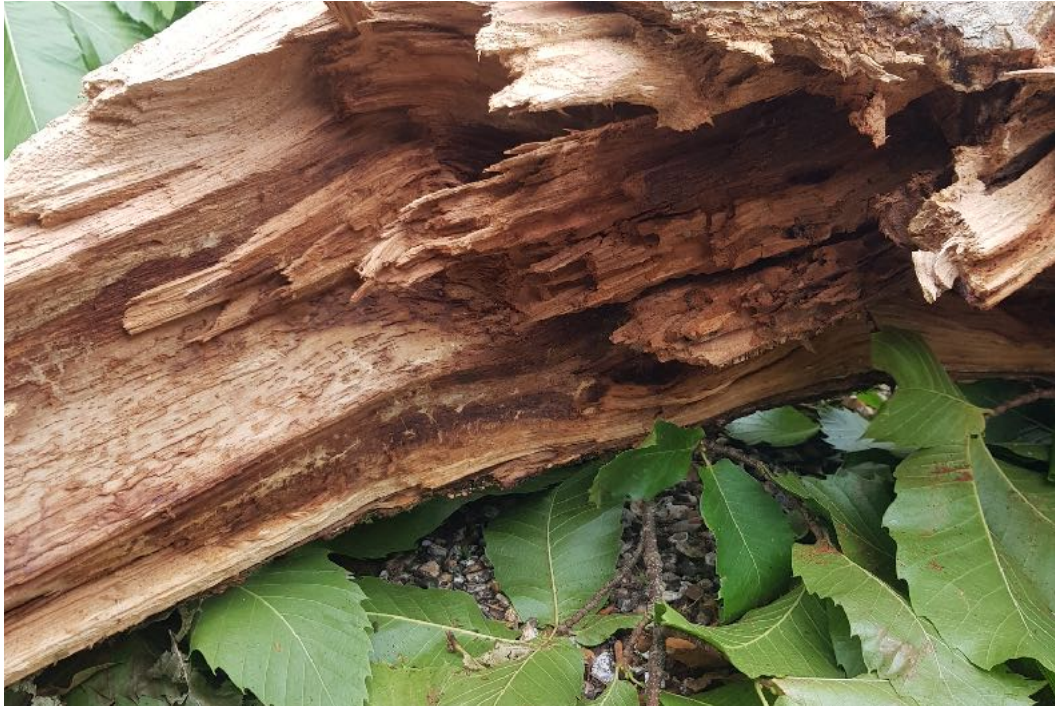
- iii. The detritus from the two failed limbs has been left as evidence: on inspection (see appendices) there appears to be a significant amount of cellulose rot at the points of failure, suggestive of fungal colonisation of the woody substrate. If it has manifested itself in the upper canopy limbs, it is likely that that same level of decay extends across the rest of the upper canopy. This has exposed the heartwood which is showing advanced stages of cellulose (brown) rot, with large bits of the substrate just falling away. This suggests that the heartwood of the limbs in the upper canopy is severely compromised, and unlikely to be adding such in the way of structural support: the sapwood is providing the majority (if not all). Studies by Arantes and Goodall 2014 suggest that "Mechanical property loss caused by brown rot fungi have been reported to be as much as 70%

- v. This cellulose decay has been shown in reference Q to entail up to a 70% strength loss.

Advanced stages of cellulose decay shown within the middle of one of the failed limbs: All limbs on the ground exhibit the same issue, and may be viewed by the tree officer upon visiting site.
