Mr. Peter Cooper – 07771966990 TPO ref

Bentwood House Netley Hill Estate, Southampton SO19 6AN – tree location and photos

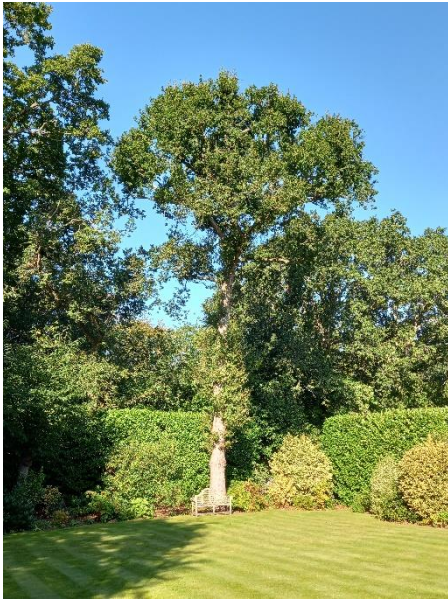
T1 is healthy. The structural condition is compromised by a combination of historical crown lifting which has left it with a long, clear stem (with some epicormic response), and it is weighted east over the garden. There is a lack of buttressing to the rear of the tree – no tension roots are apparent at the base on the west side. There are limited buttresses visible to the east (compression side), and slightly larger ones to the south.

Photo 1 - T1 from east - whole

The owner is requesting a fell: it has been in management for many years: the overlifting is the result of a consent reference T/12/70650 from 26.03.2012 where no dimension was given to the upper limit of the crown lift, resulting in the current form. The crown was reduced at the same time, and a subsequent reduction was consented in 2021, and given the overlifting, this is prudent but limiting the future potential of the tree.

The owner is happy to have two (2 no) trees conditioned as a replacement in the rear garden, one native oak *Quercus robur* and one *Liquidambar styraciflua* are suggested.

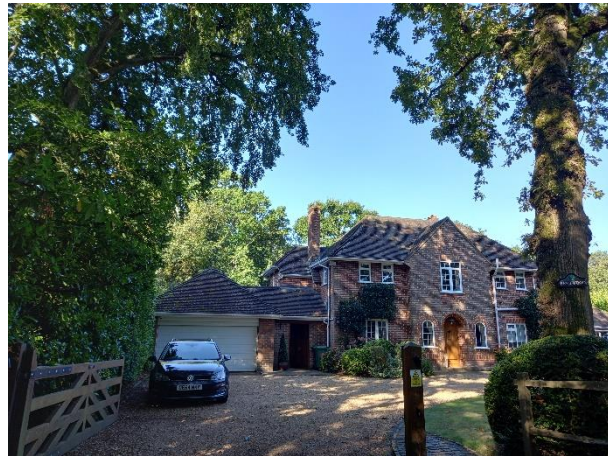
T1 is an oak in the rear garden of the property. It is just visible behind the house from the access road.

Photo 2 - visibility from access road

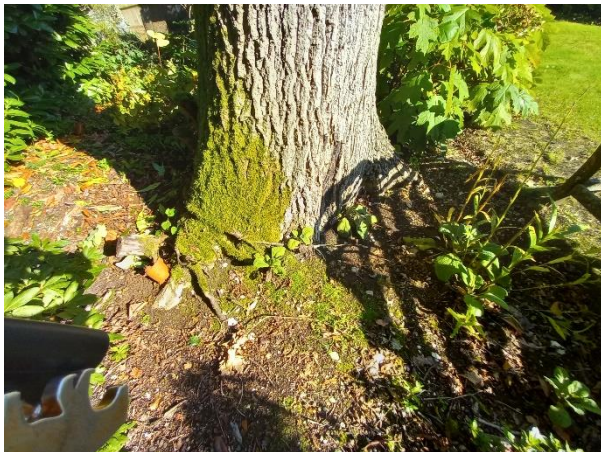
Photo 3 south side of base, no buttressing on tension side, slight buttress on compression side

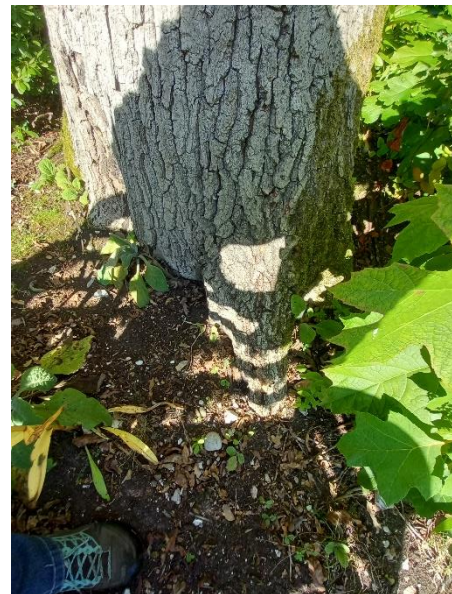
Photo 4 west side of base, no buttressing on tension side

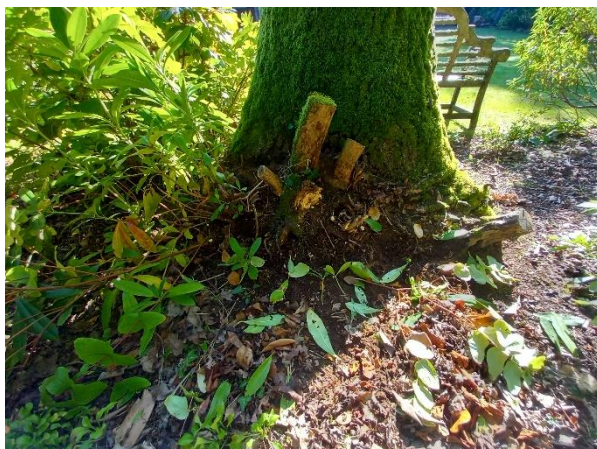
Photo 5 rear (west) side of base (stumps not from oak). Also lacking buttresses.
