## **Tree Survey and Recommendations**

**DELEMERE GARDENS, FAIROAKS**

**28th October 2021**

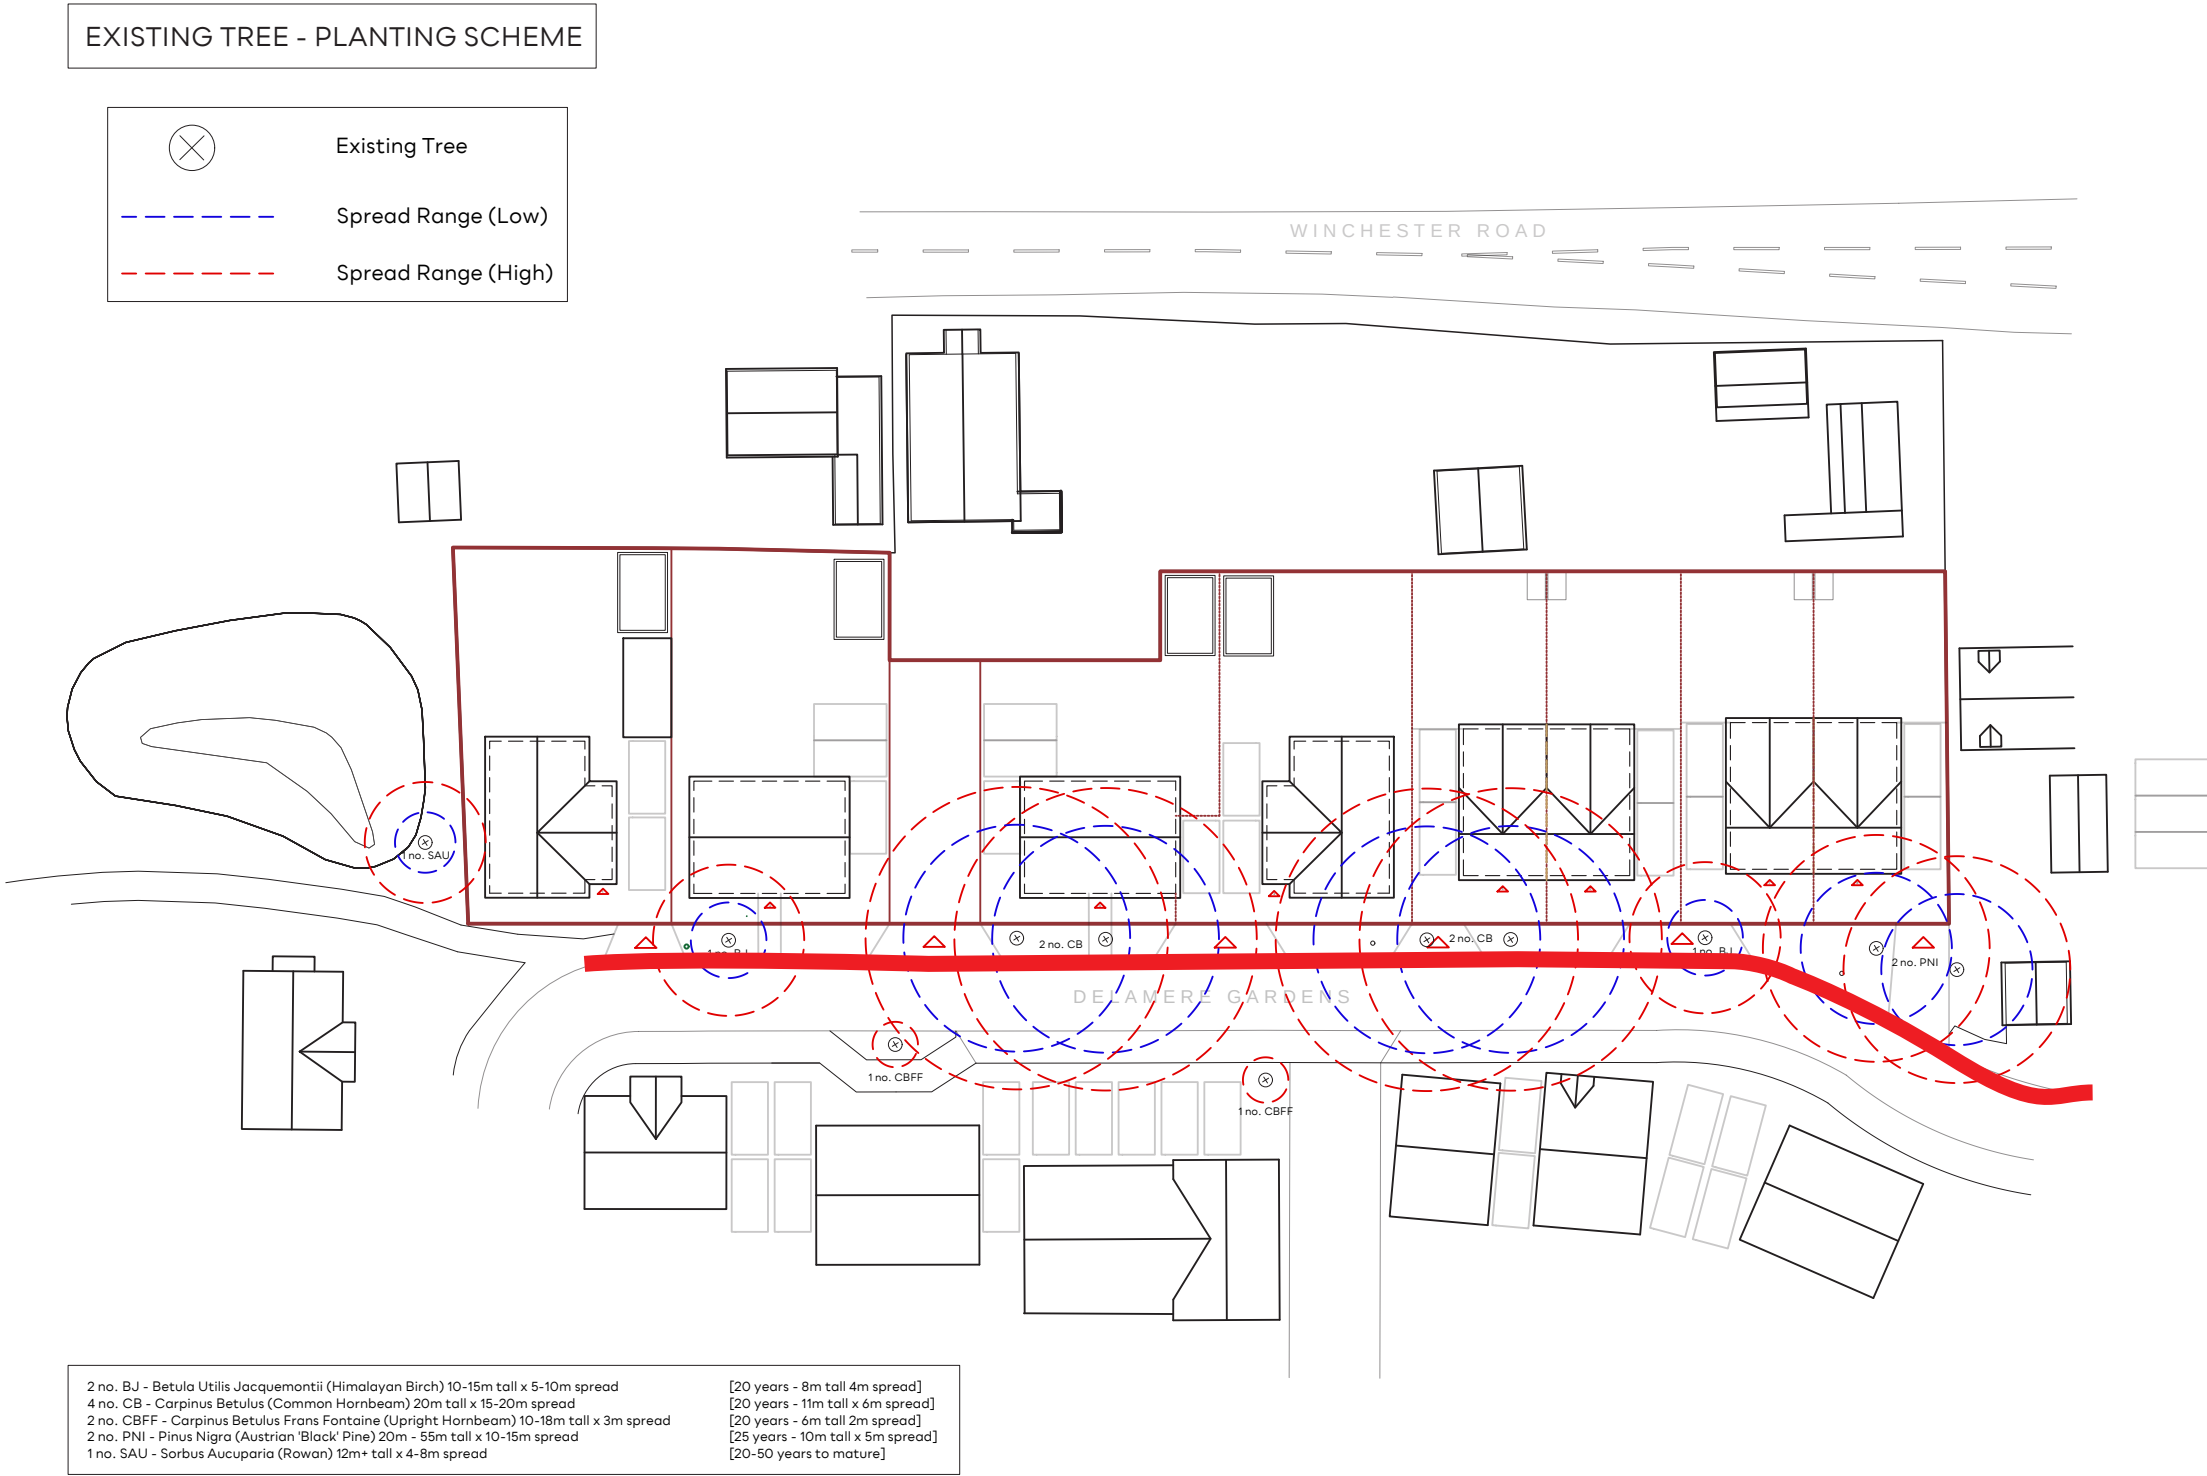
1. EXISTING TREE PLAN

The plan illustrate the potential sizes that the original trees will grow to. Due to the narrow verge and the proximity to the road it is clear as the trees start to grow to there full size they will grow into the carriageway. This will clearly cause a problem and in reality the vehicles such as bin lorries, removals vans and box vans will strike the trees branches. In reality this will passively prune the branches leaving very lopsided trees which will potentially become unstable if they grow to there full potential.

As shown on the plan a number of the trees would also potentially grow to a size that would potentially impact on the light levels of the existing properties to the Western side of Delamere Gardens.

Additionally the indicated size also demonstrates that the trees, if to reach their full potential, are too close together and would develop irregular shaped canopies.

The trees do not appear to have been planted in a tree pit.

Due to the proximity to the road, there is a high potential that the roots will damage the kerb and carriageway in future.

In conclusion the majority of the trees should be replaced with a more suitable species

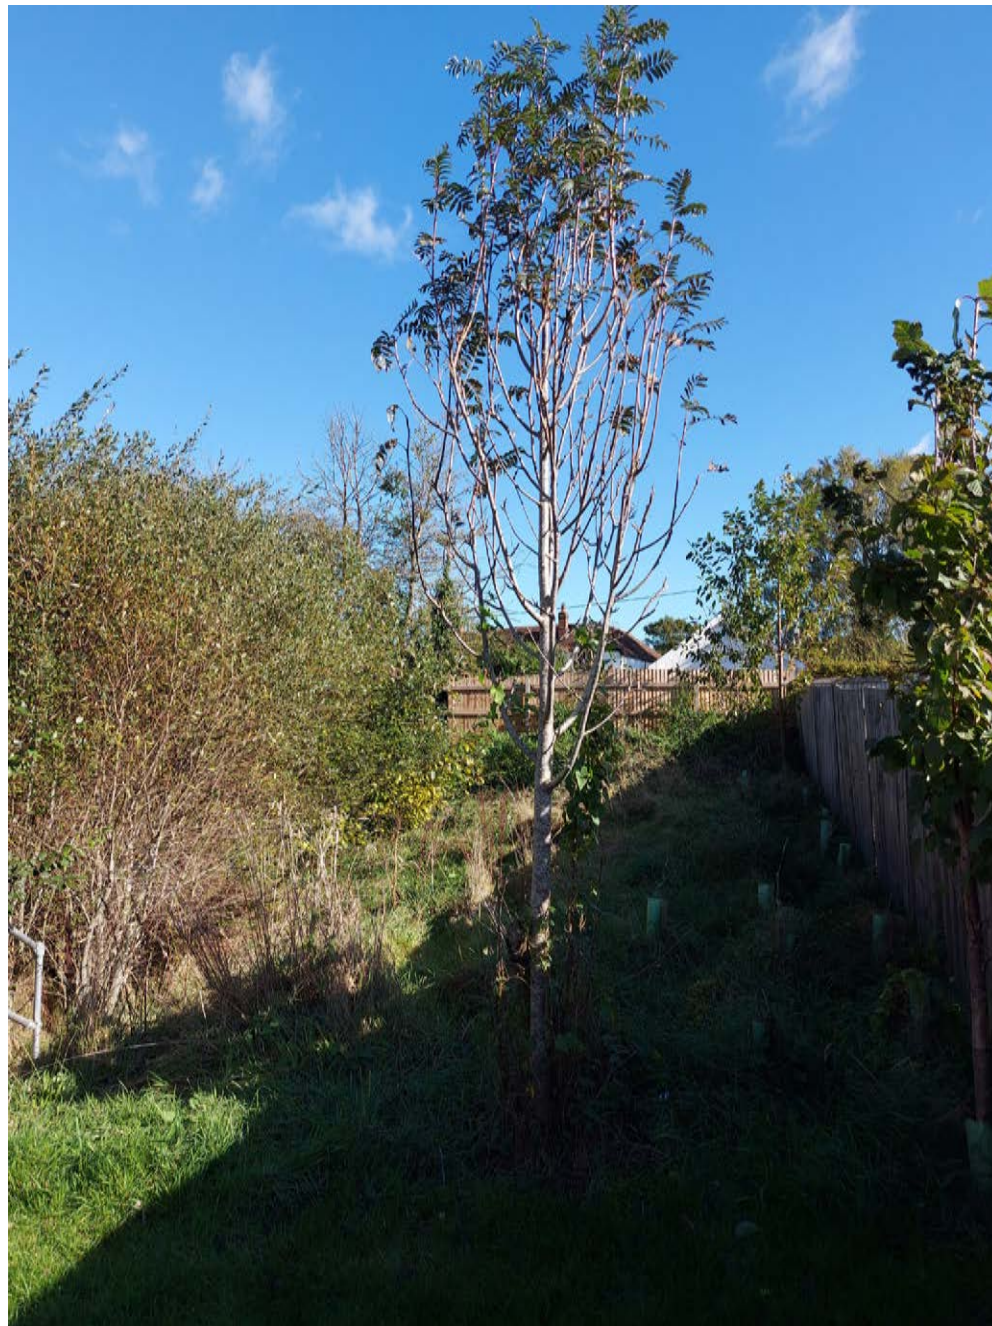
**Tree Number:** 1

**Description:** Single lateral with poor canopy growth, signs of die back in the canopy

**Recommendations:** Tree be removed and replaced with a better specimen of a suitable species.

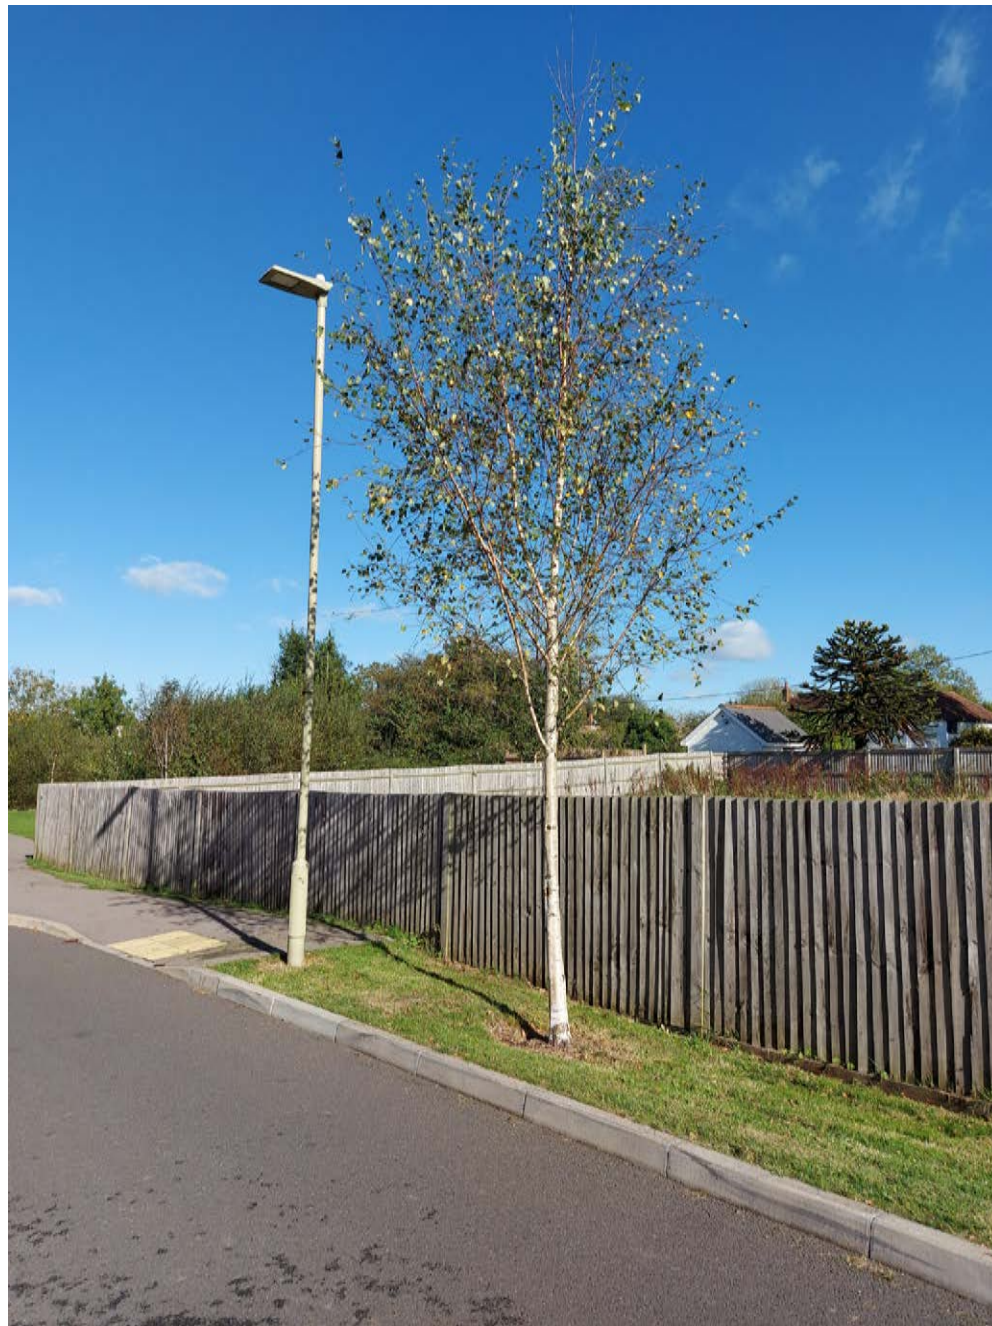
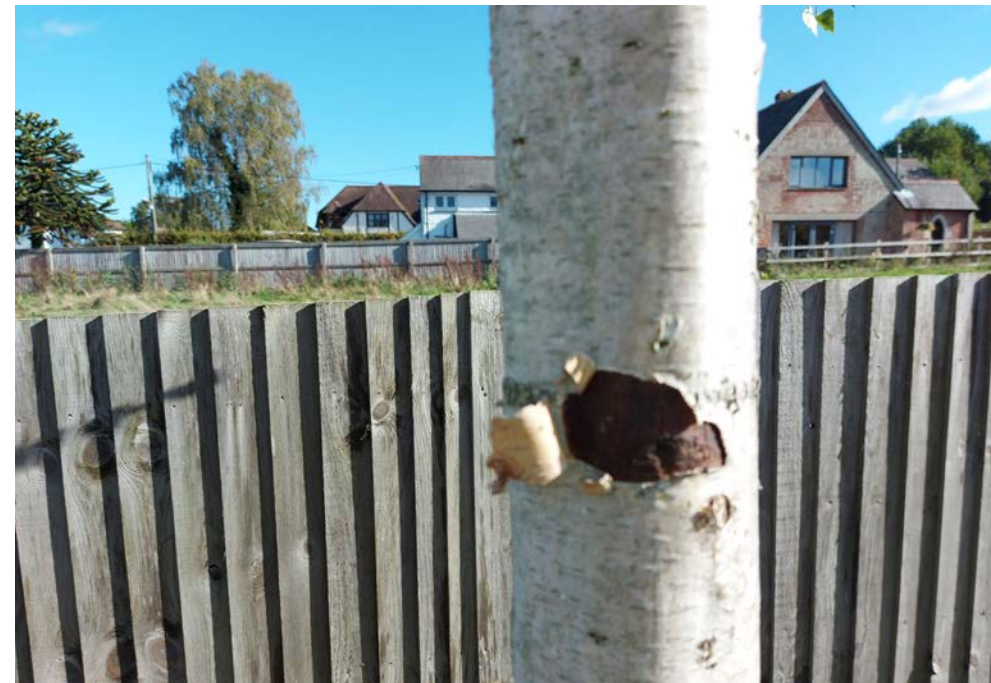
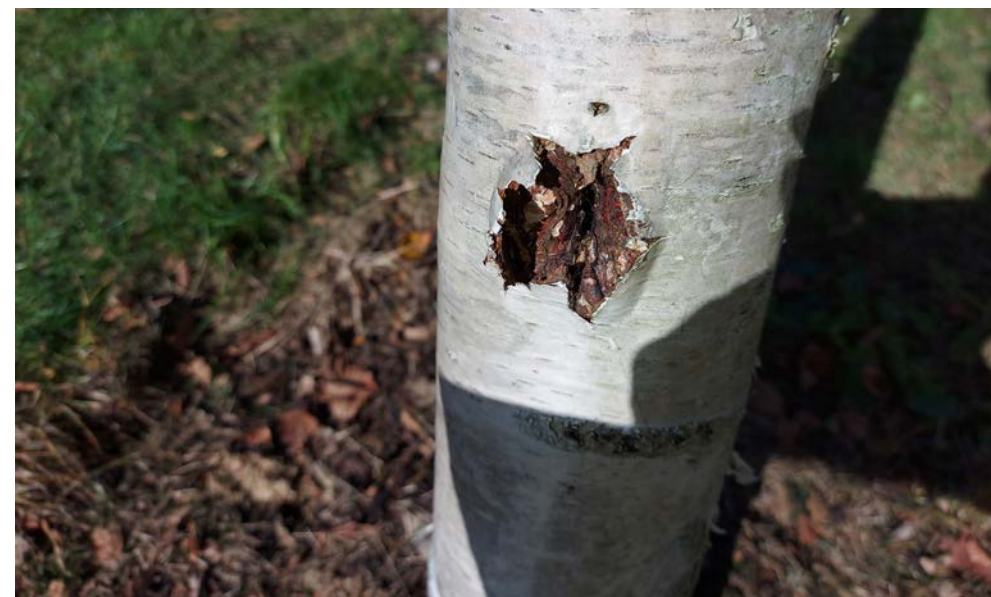
**Tree Number:** 2

**Description:** Well developed tree with good form and shape. Initial signs of decay to the main trunk

**Recommendations:** Due to initial levels of decay to the main trunk there is potential for reduced life span. Tree be removed and replaced with a better specimen of a suitable species.

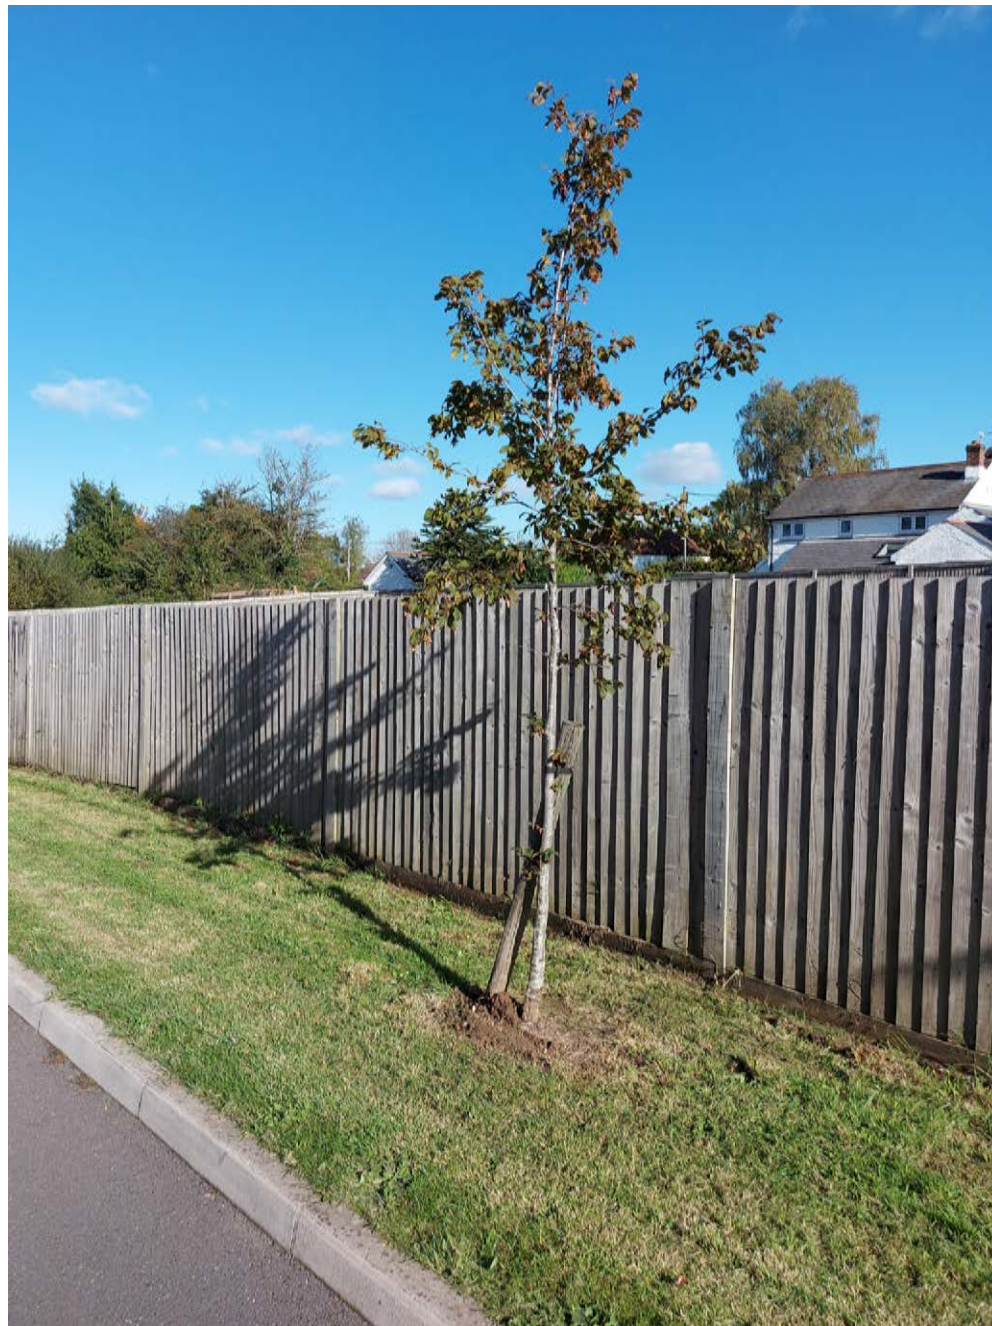
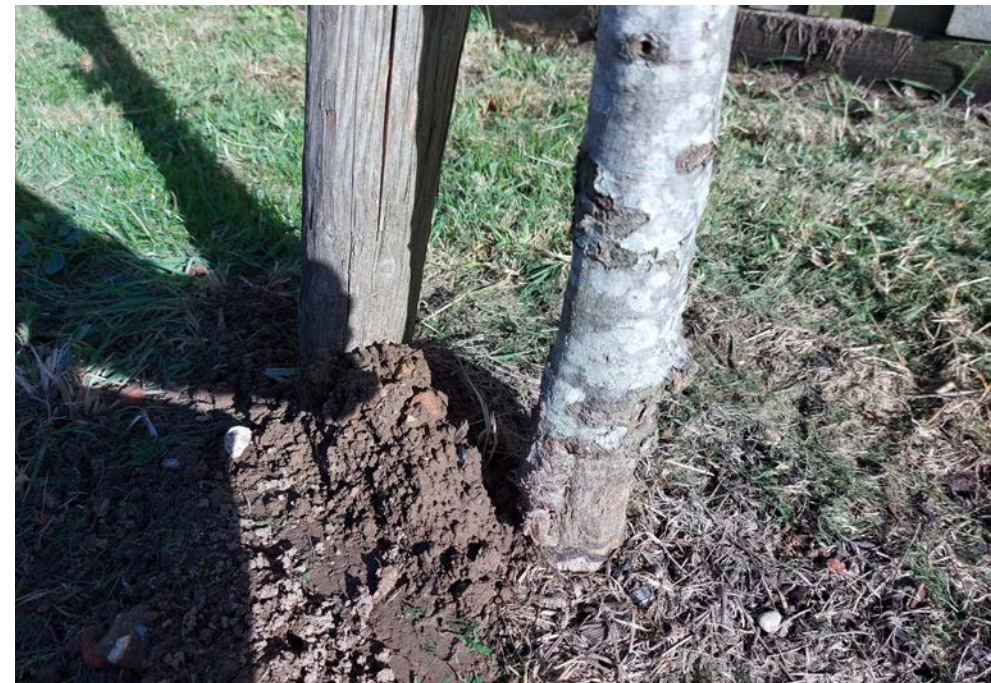
**Tree Number:** 3

**Description:** Very poor growth, severe strimmer damage to the base of the trunk

**Recommendations:** Very unlikely to survive due to the level of strimmer damage. Tree be removed and replaced with a better specimen of a suitable species.

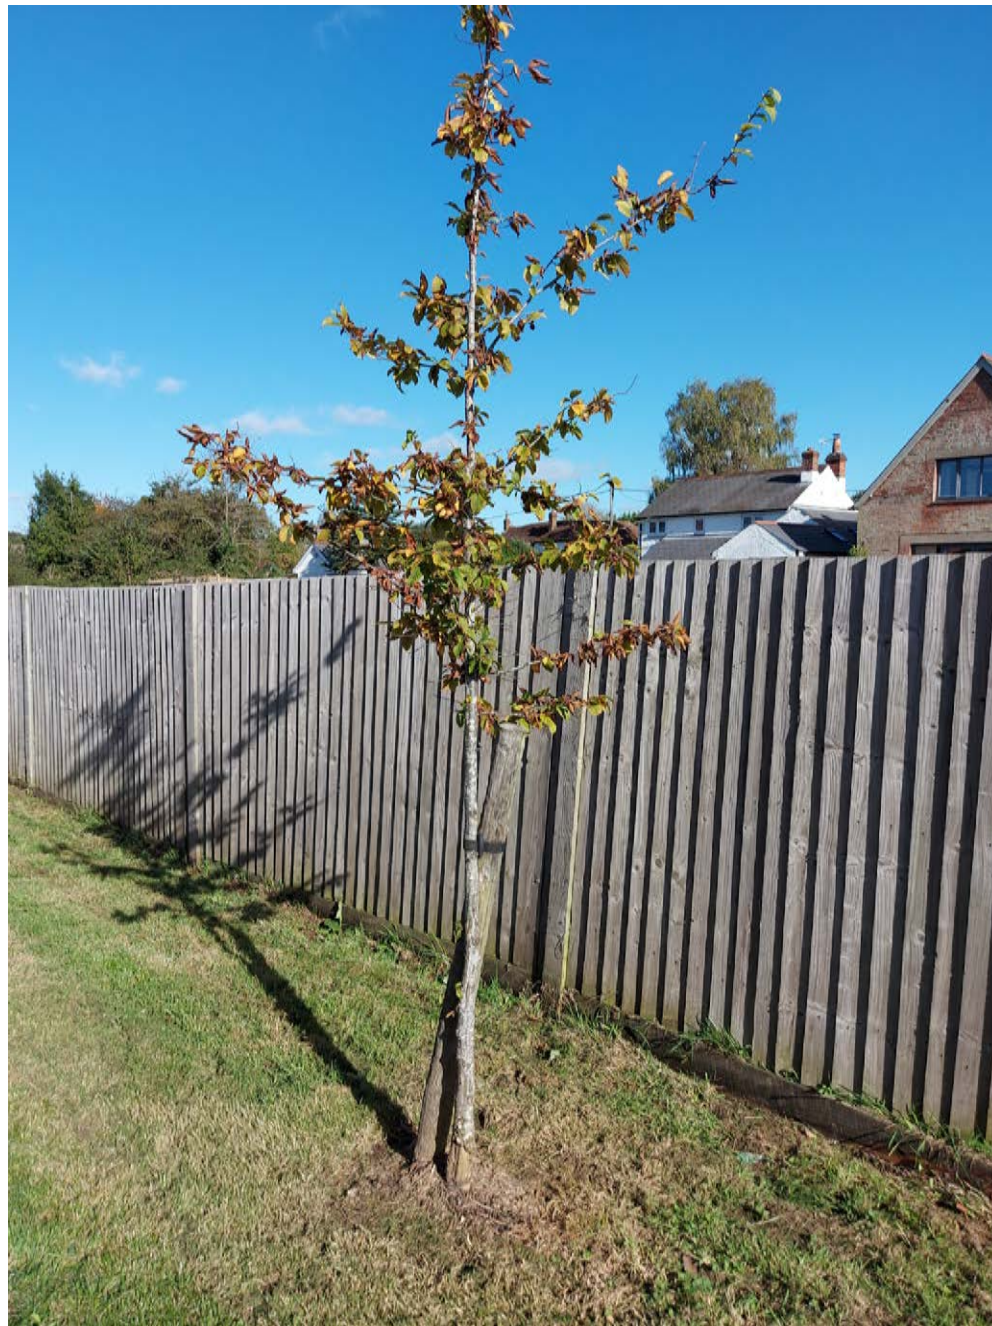
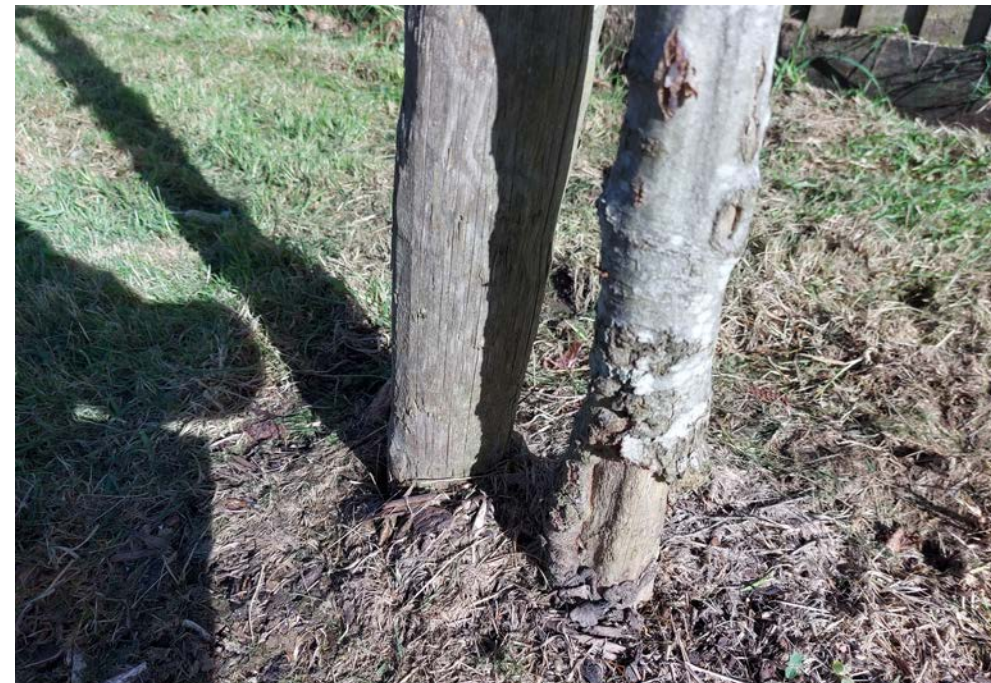
**Tree Number:** 4

**Description:** Very poor growth, severe strimmer damage to the base of the trunk.

**Recommendations:** Very unlikely to survive due to the level of strimmer damage. Tree be removed and replaced with a better specimen of a suitable species.

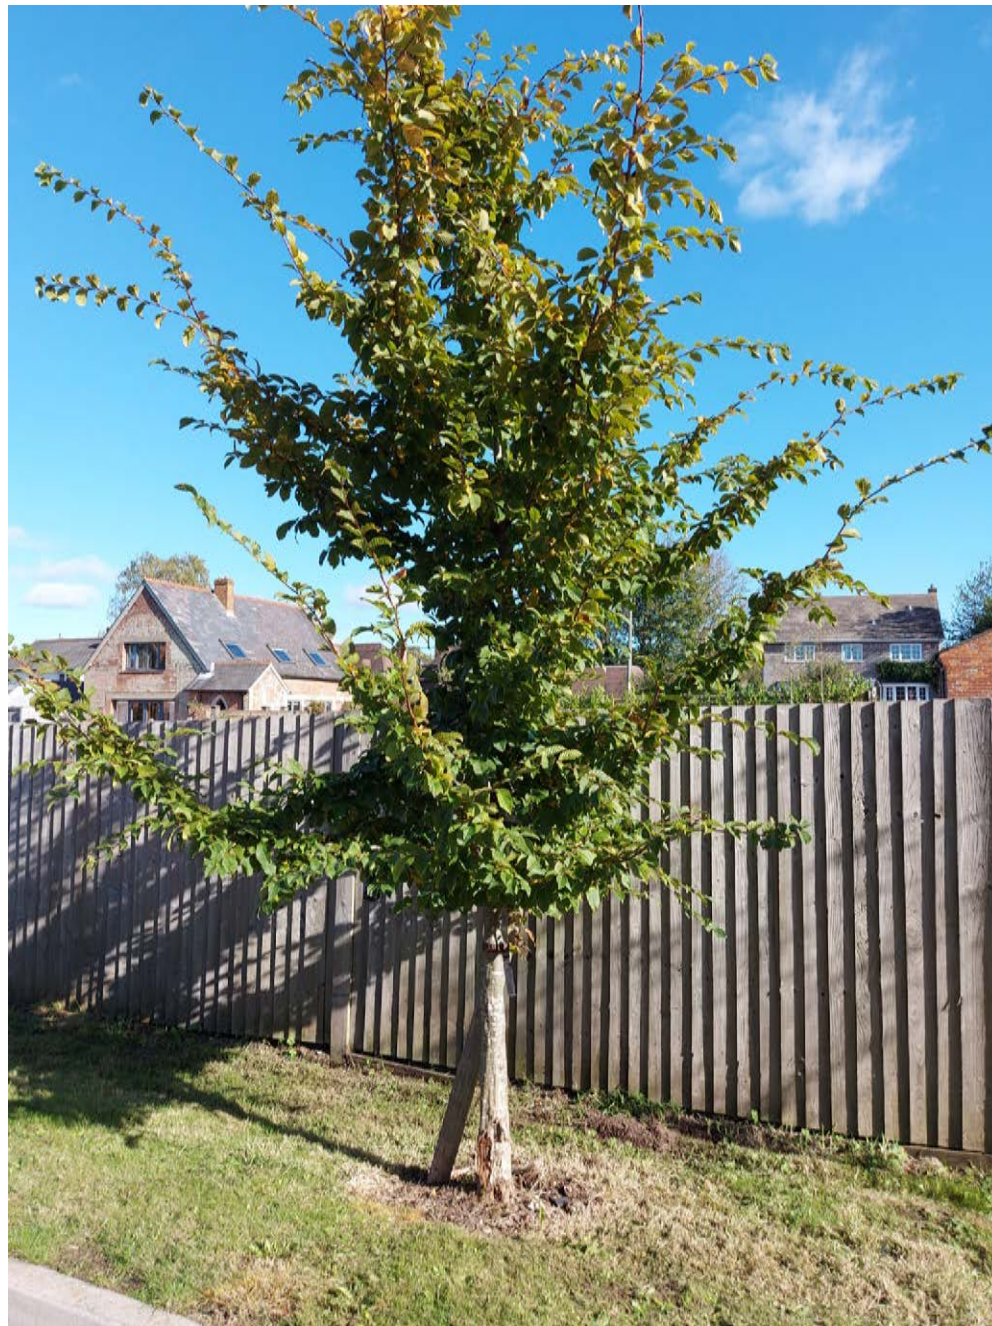
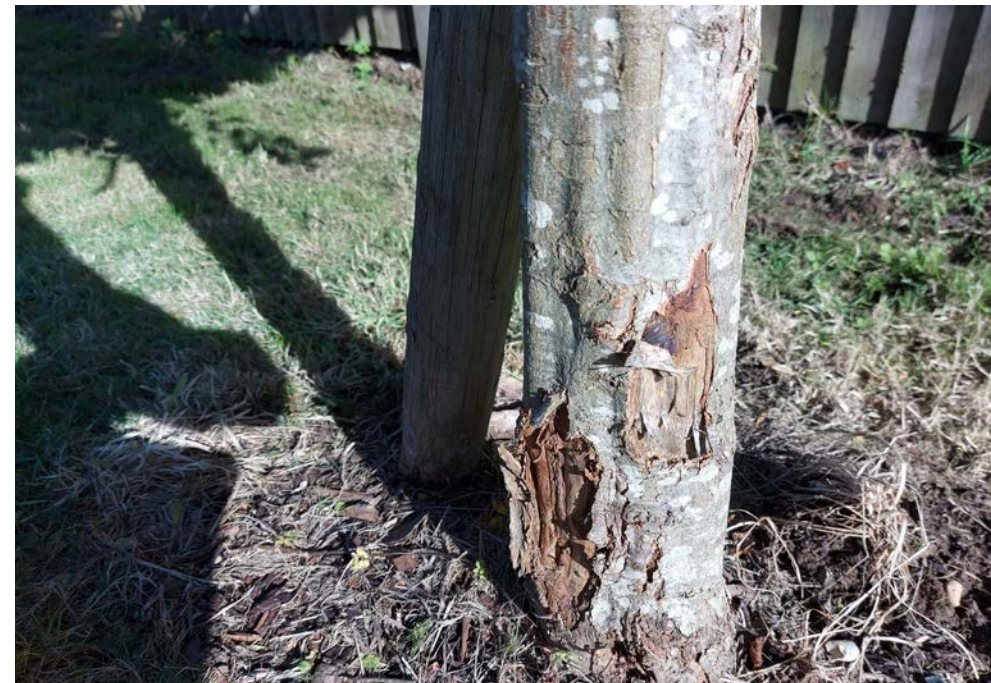
**Tree Number:** 5

**Description:** Prospering more than the other hornbeams, but bark split and signs of decay within the trunk as well as signs of strimmer damage.

**Recommendations:** Very unlikely to survive long term due to the signs of decay. Tree be removed and replaced with a better specimen of a suitable species.

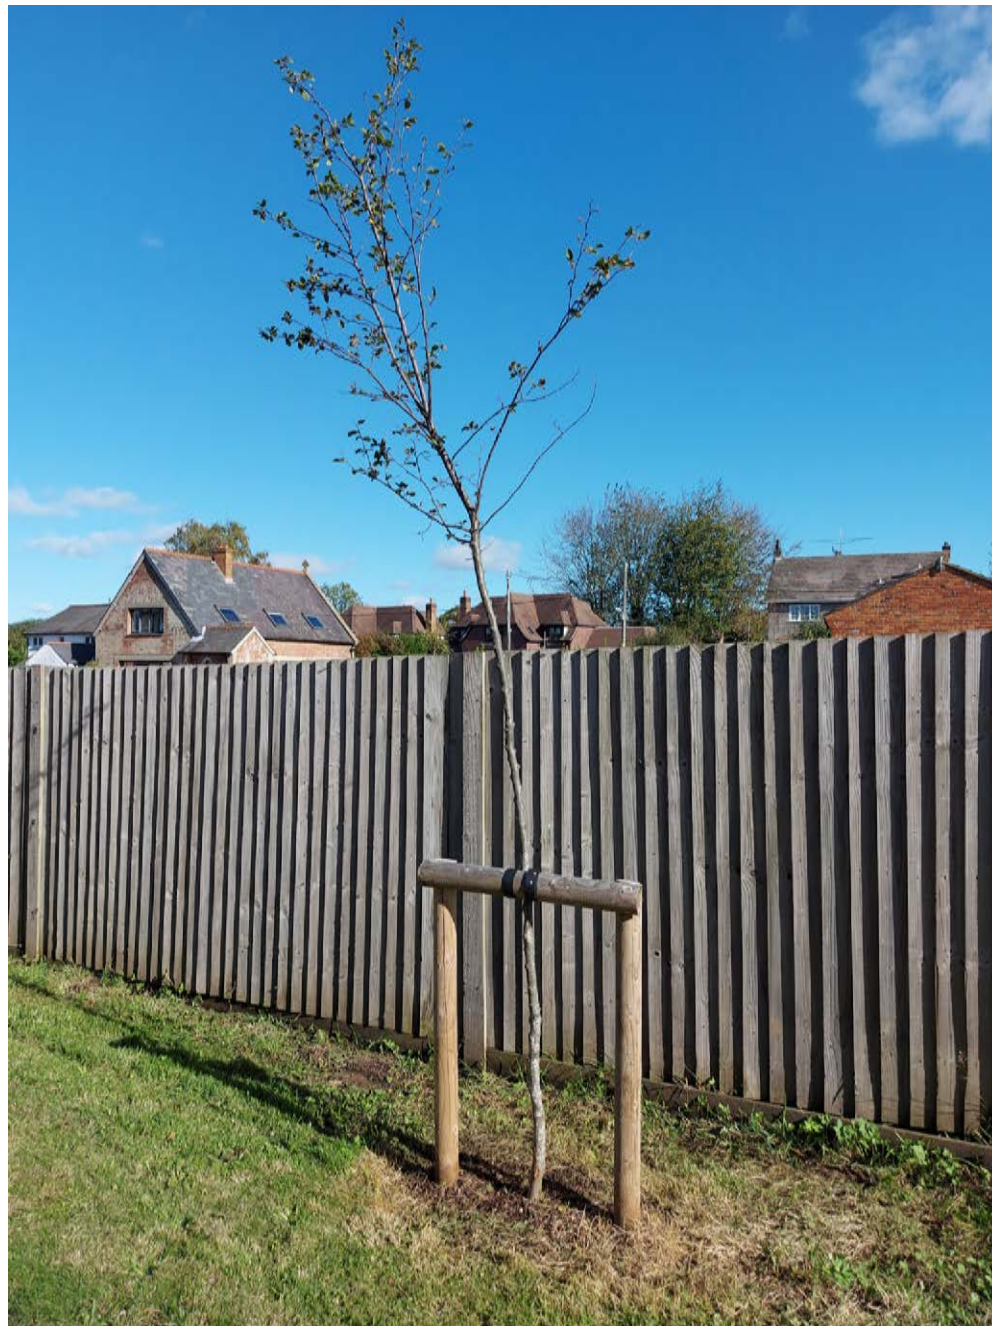
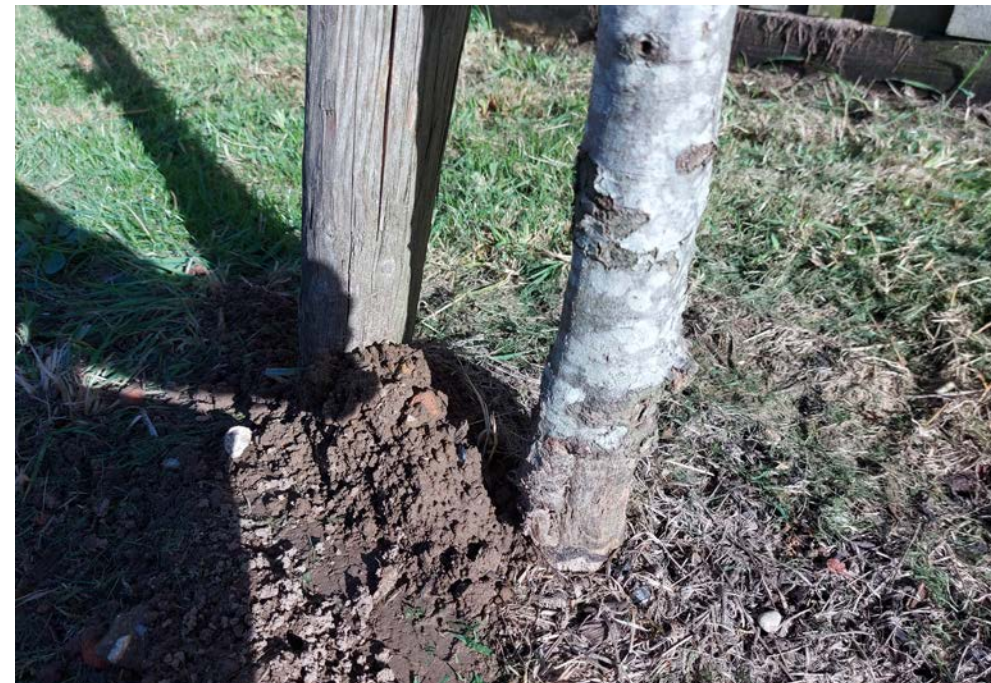
**Tree Number:** 6

**Description:** Very poor growth, strimmer damage to the base of the trunk. Very poor canopy with signs of die back.

**Recommendations:** Very unlikely to survive due to the level of strimmer damage. Tree be removed and replaced with a better specimen of a suitable species.

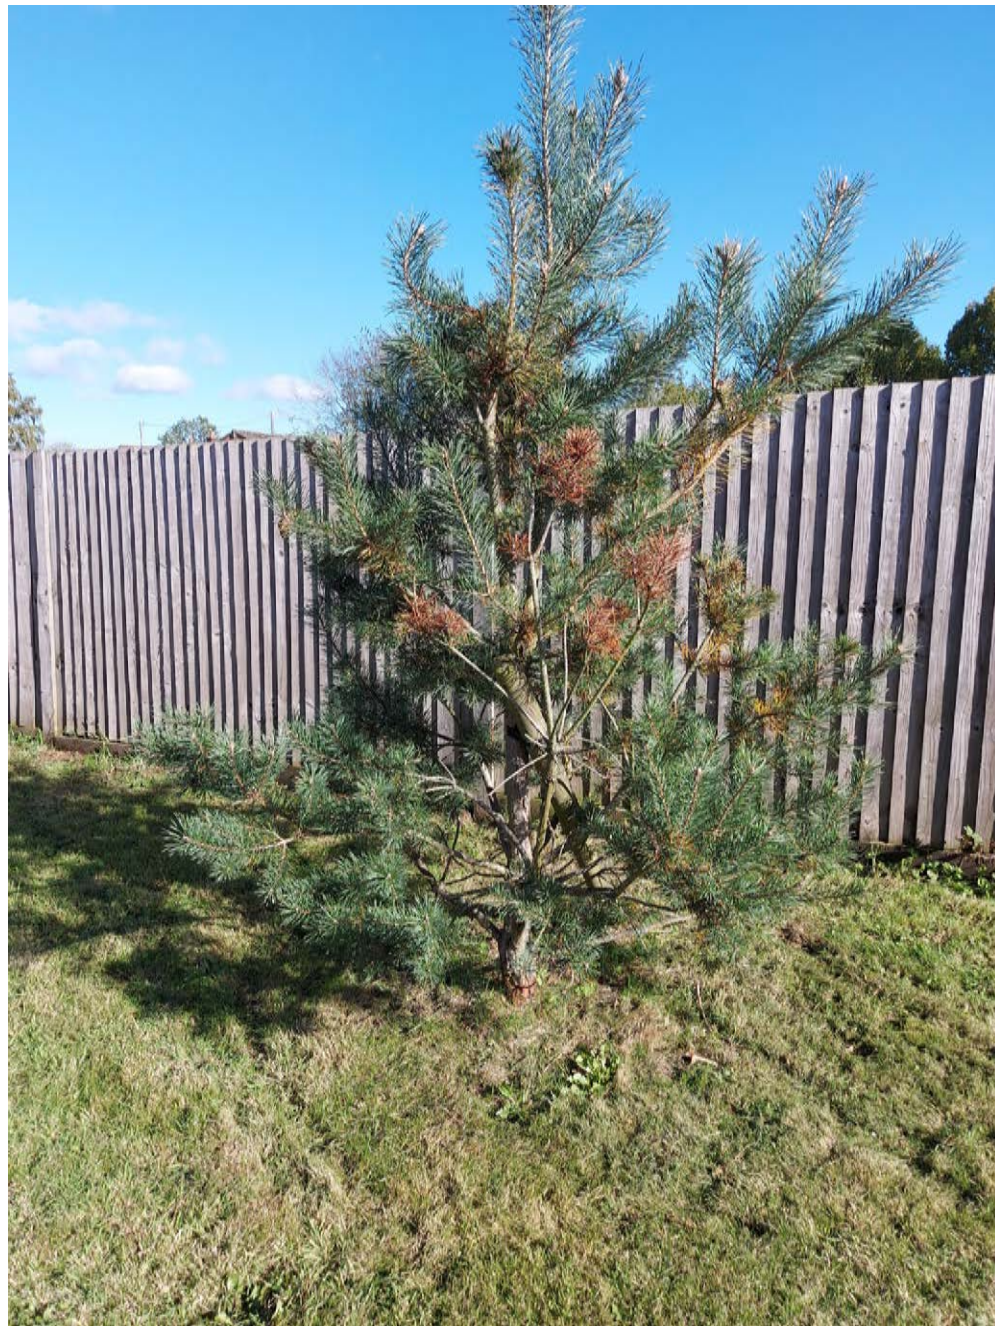
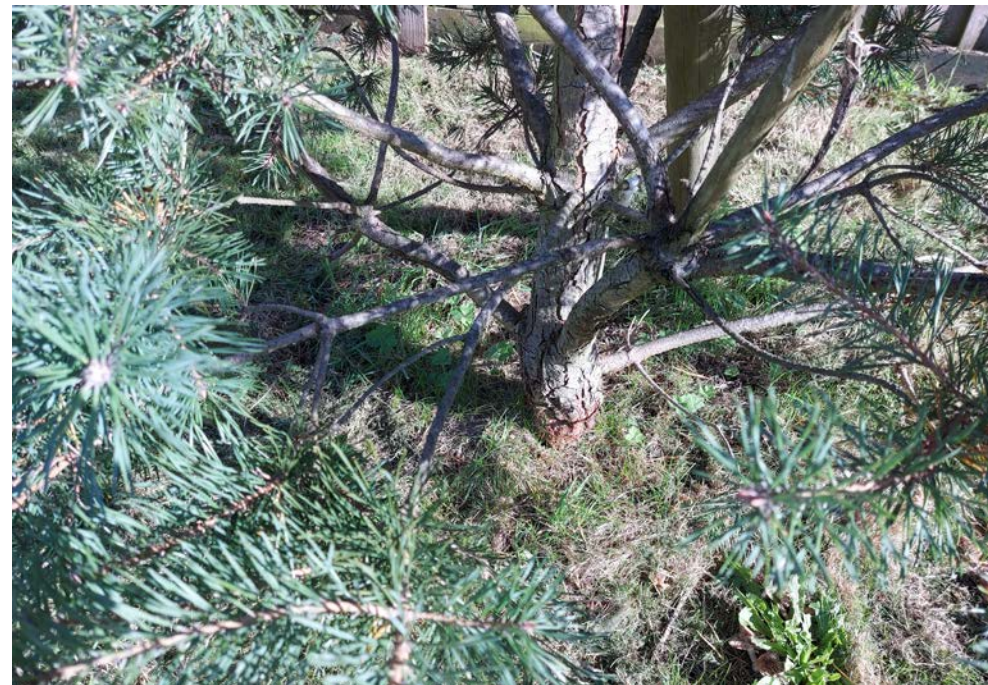
**Tree Number:** 7

**Description:** Evidence of strimmer damage, signs of die back. Generally good form and shape.

**Recommendations:** Inappropriate species for the location. Recommend relocation to the wild area to the east of the Sorbus Tree No 1

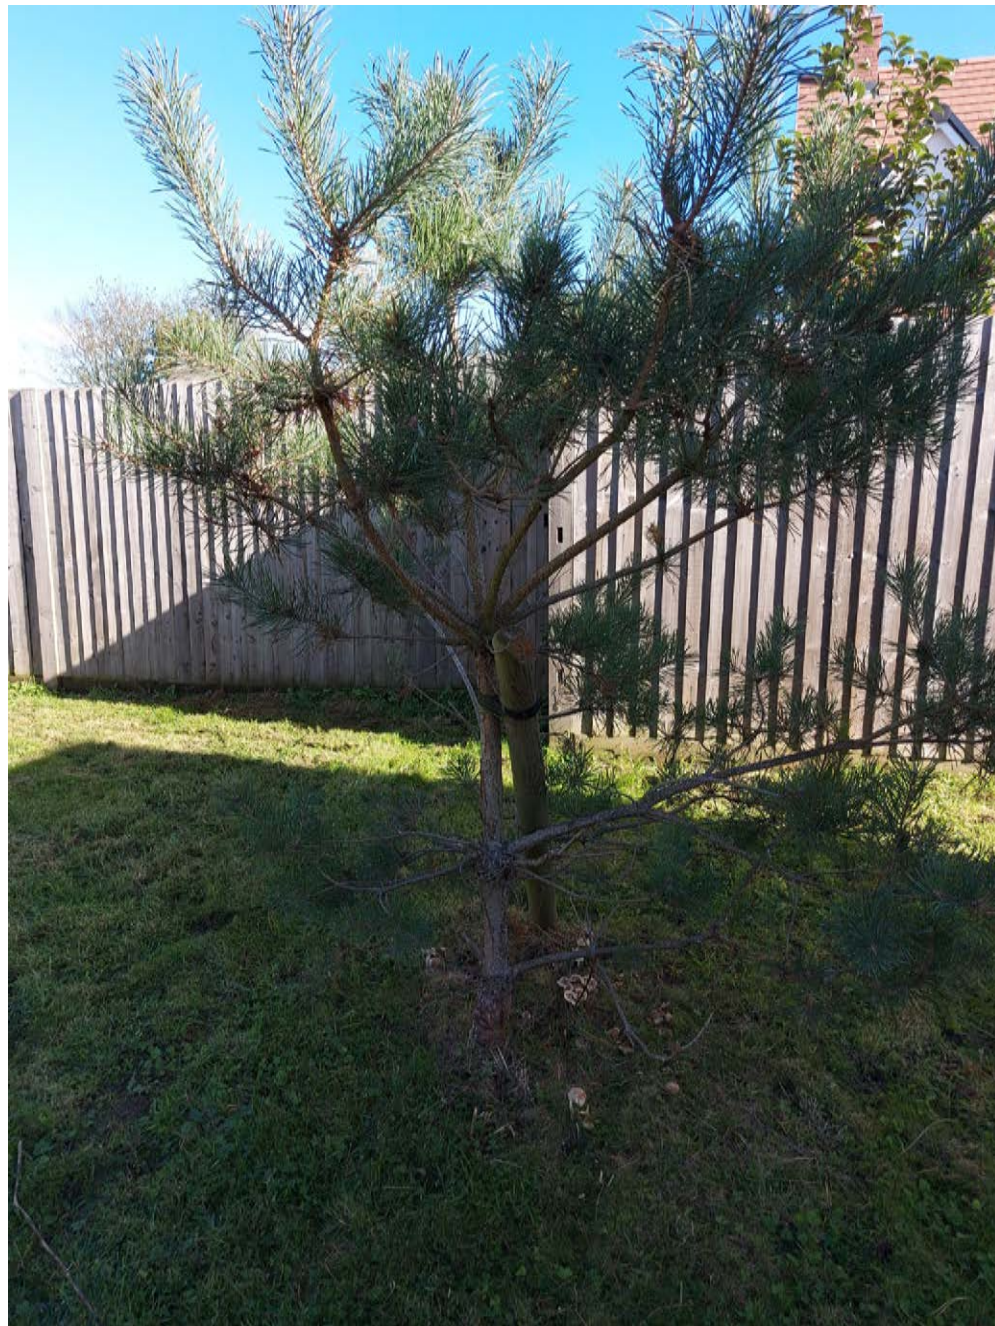
**Tree Number:** 8

**Description:** Evidence of strimmer damage. Poor shape with no clear central leader

Due to the proximity to the substation and the tree will grow to a considerable size.

**Recommendations:** Inappropriate species for the location. Tree be removed and replaced with a better specimen of a suitable species.
