# Arboricultural Consultancy for Lloyds Bank

**Re: Mr & Mrs Penny , 56 Wilderness Heights, West End, SO18 3PS**

# GEOTECHNICAL

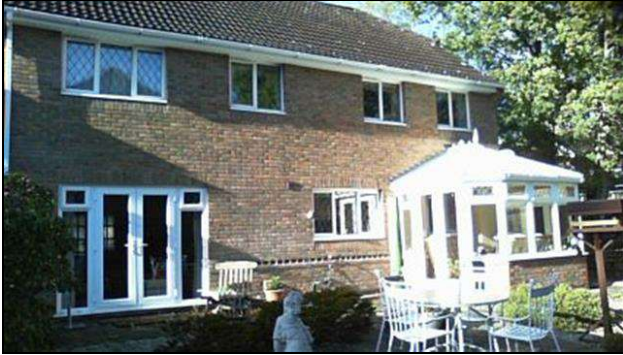
Rear

We understand that the current damage relates to the rear conservatory, where cracking indicates downwards movement.  
ANDY KINDLY CHECK PRICES

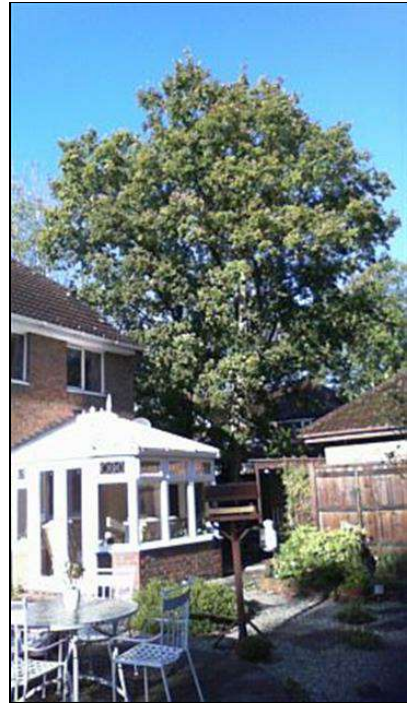
With due regards to species profile, size and proximity, TG2 (Oak) is considered the dominant feature proximate to the focal area of movement and accordingly, where vegetation is confirmed as being causal, we have identified them as the primary cause of the current subsidence damage.

TG2 - Oak

Consequently, we have advocated the complete removal of TG2 as it will offer the most certain arboricultural solution likely to restore long-term stability.

| Tree No. | Species | Age Cat | Approx. Height (m) | Distance to Building (m) * | Ownership | Action | Requirement |
|---|---|---|---|---|---|---|---|
| TG2 | Oak | 3 | 17 | 3.7 | C - Insured | Remove | Remove close to ground level; do not treat stumps due to translocation risk. Where such a risk exists, we advise that any emergent regrowth is removed annually. |

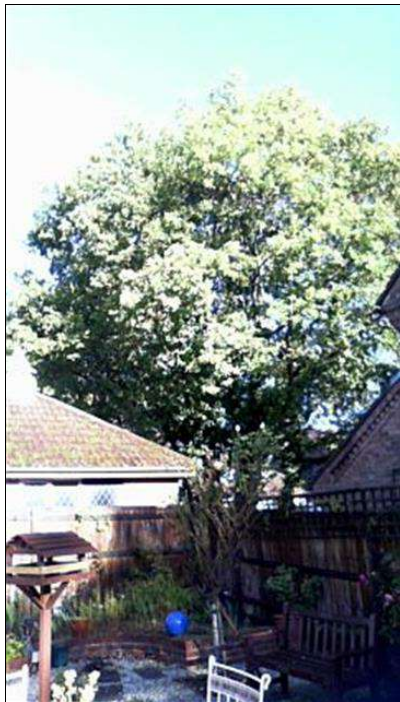
TG3 - Oak

| Tree No. | Species | Age Cat | Approx. Height (m) | Distance to Building (m) * | Ownership | Action | Requirement |
|---|---|---|---|---|---|---|---|
| TG3 | Oak | 3 | 16 | 15 | A - Third Party | Action to avoid future risk | Crown reduce overall canopy by 30% (minimum) to achieve a crown volume reduction in line with BRE IP7/06. Maintain at reduced dimensions by re-pruning back to points of previous reduction on a 3 year (max) cycle. |

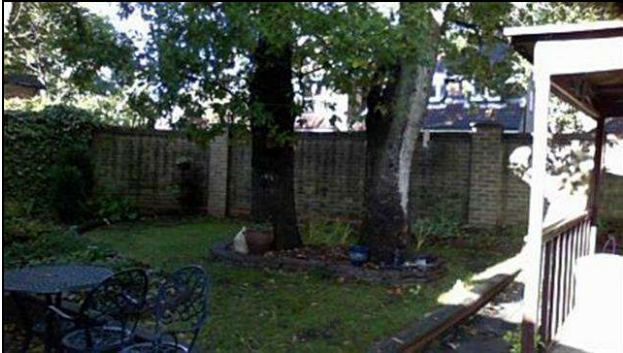
TG2 - Oak

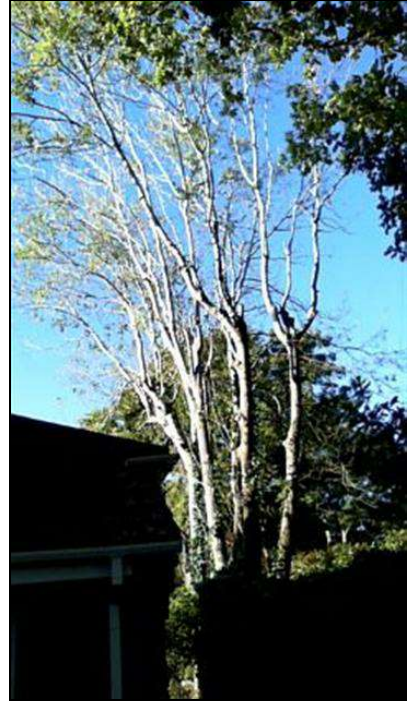
TG1 - Ash

| Tree No. | Species | Age Cat | Approx. Height (m) | Distance to Building (m) * | Ownership | Action | Requirement |
|---|---|---|---|---|---|---|---|
| TG1 | Ash | 2 | 15.8 | 1.65 | C - Insured | Action to avoid future risk | Do not allow to exceed current dimensions by way of regular pruning. |

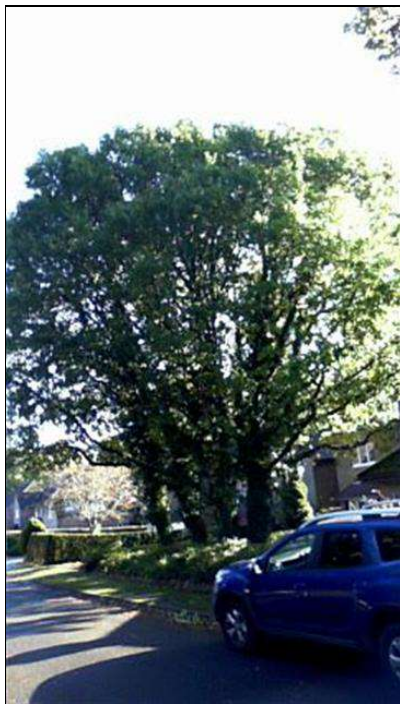
TG3 - Oak

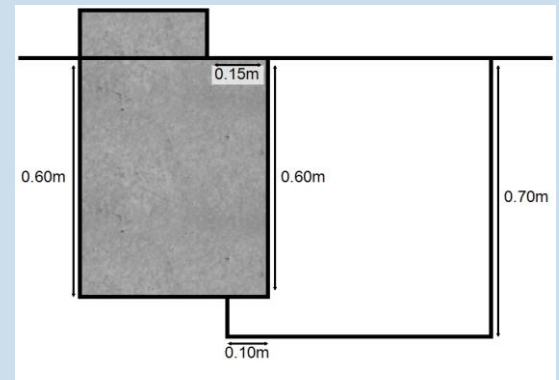
Conservatory foundation comprised of concrete to 600mm bgl, with a total projection of 150mm from the elevation. Underside of foundation (USF) was exposed to 100mm back from the face of the foundation and probed 500mm back from the face of the foundation.
