# Arboricultural Report

SUBSIDENCE INVESTIGATION AT:

34 Lakewood Road  
Eastleigh  
Hampshire  
SO53 1EW

| Reference No: | SU2206173 |

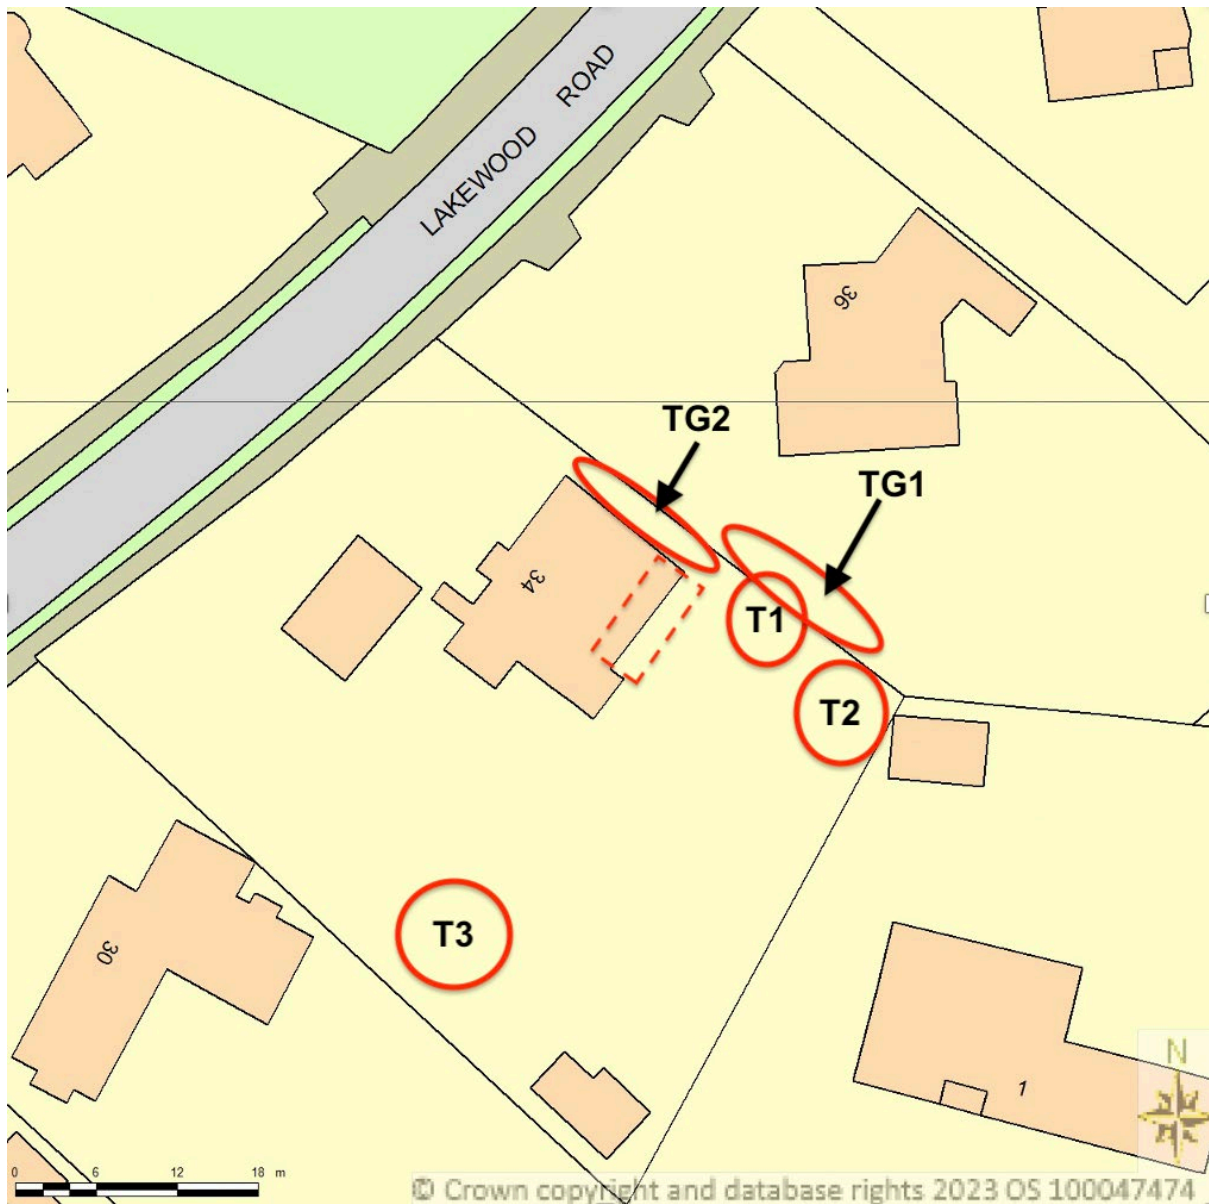
Tree plan showing area of damage with dashed red line.

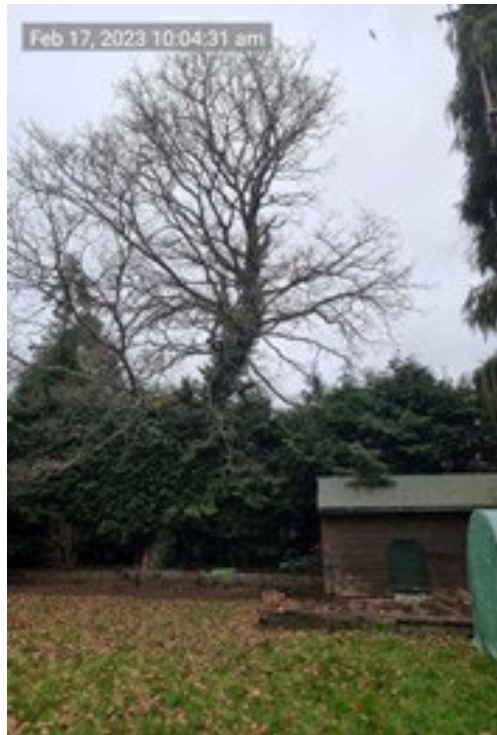
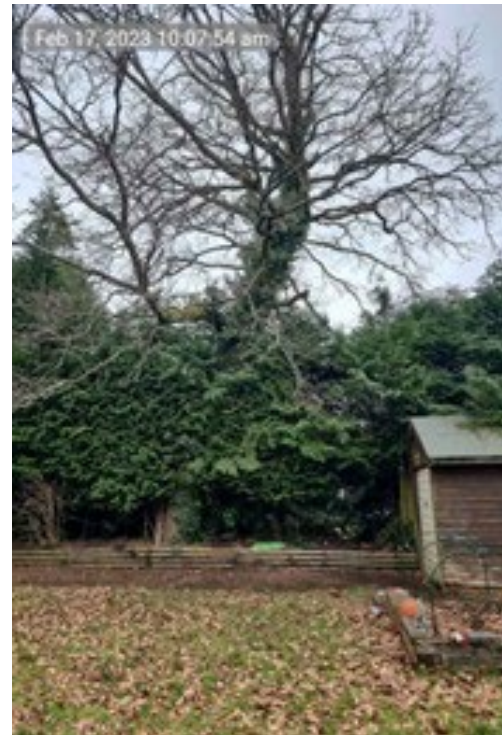
- Oak (T1) has a high-water demand and is within the 50% distance for damage in the C&R study. Laboratory analysis of the roots found below foundation depth during the site investigation identified them as *Quercus* spp.

| Ref. | Species | Tree owner/<br>location | Dist.<br>to<br>dmg.<br>(m) | C&R<br>50% | C&R<br>75% | C&R<br>Max. | NHBC | Recommendation |
|---|---|---|---|---|---|---|---|---|
| T1 | Oak | Insured | 5 | 10 | 13 | 30 | | Remove close to ground level and treat stump with herbicide to inhibit regrowth. |

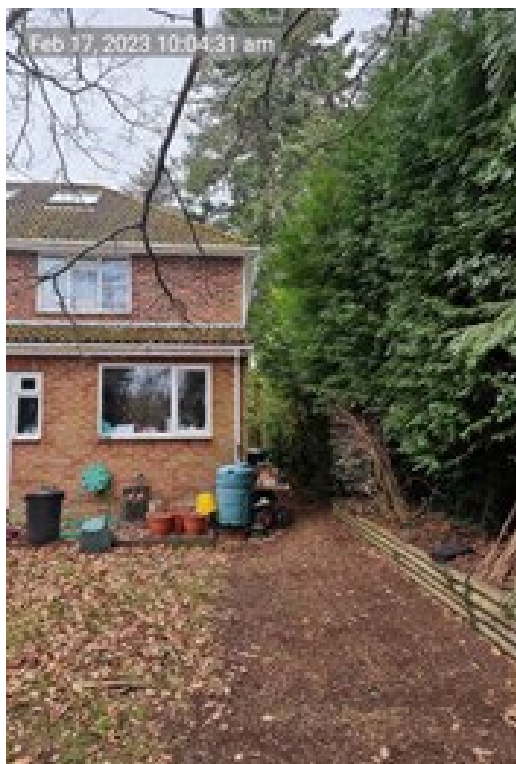
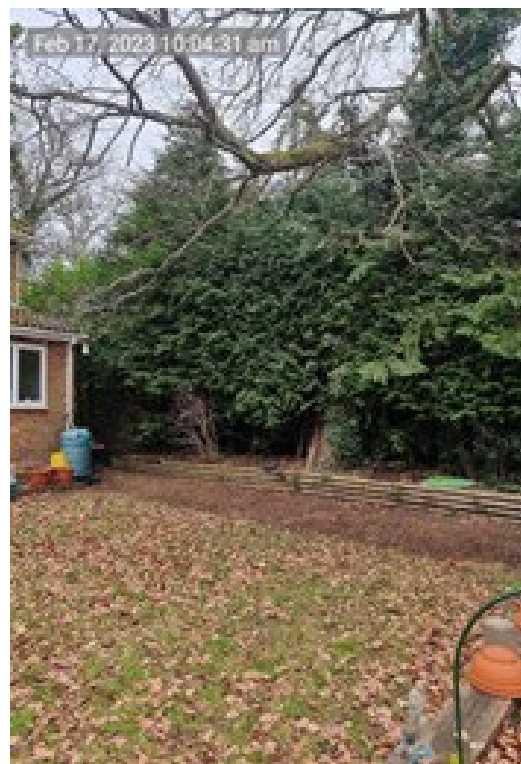
- Lawson cypress (TG1) has a high-water demand and is within the 50% distance for damage in the C&R study. Laboratory analysis of the roots found below foundation depth during the site investigation identified them as *Cupressus* spp.

| Ref. | Species | Tree owner/<br>location | Dist.<br>to<br>dmg.<br>(m) | C&R<br>50% | C&R<br>75% | C&R<br>Max. | NHBC | Recommendation |
|---|---|---|---|---|---|---|---|---|
| TG1 | Lawson cypress | Neighbour<br>(36 Lakewood Road) | 1.5 | 3 | 4 | 20 | | Remove stems within 5m of property |

| Ref. | Species | Tree owner/<br>location | Dist.<br>to<br>dmg.<br>(m) | C&R<br>50% | C&R<br>75% | C&R<br>Max. | NHBC | Recommendation |
|---|---|---|---|---|---|---|---|---|
| TG1 | Lawson cypress | Neighbour<br>(36 Lakewood Road) | 1.5 | 3 | 4 | 20 | | Maintain remaining section at no more than current size through regular maintenance |

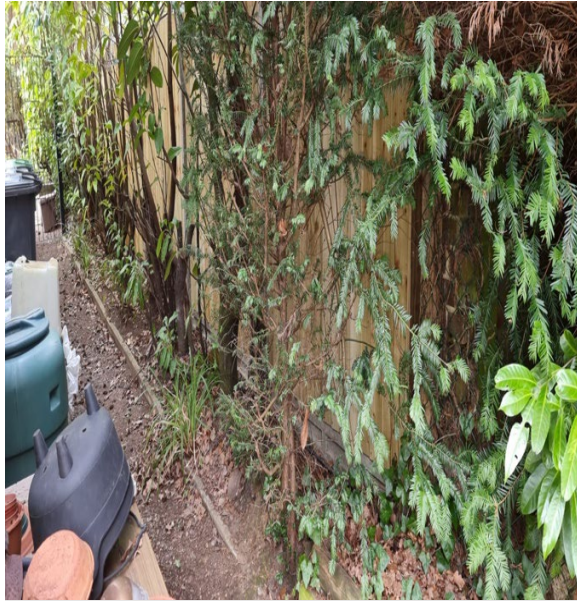
**TG2**

- Bay laurel, yew (TG2) is within 50% of the radius of influence defined by NHBC. Laboratory analysis of the roots found below foundation depth during the site investigation identified them as

| Ref. | Species | Tree owner/<br>location | Dist.<br>to<br>dmg.<br>(m) | C&R<br>50% | C&R<br>75% | C&R<br>Max. | NHBC | Recommendation |
|---|---|---|---|---|---|---|---|---|
| TG2 | Bay laurel,<br>yew | Insured | 1 | | | | 2 | Remove close to ground level, and treat stump with systemic herbicide to inhibit regrowth |

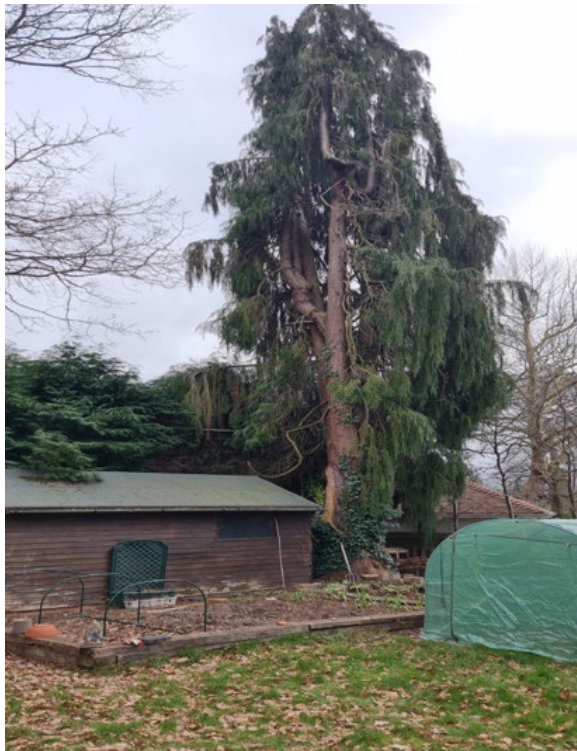
**T2**

- Western red cedar (T2) has a high-water demand and is within the maximum distance for damage in the C&R study. Laboratory analysis of the roots found below foundation depth during the site investigation identified them as *Cupressus* spp.

| Ref. | Species | Tree owner/<br>location | Dist.<br>to<br>dmg.<br>(m) | C&R<br>50% | C&R<br>75% | C&R<br>Max. | NHBC | Recommendation |
|---|---|---|---|---|---|---|---|---|
| T2 | Western red cedar | Insured | 15 | 3 | 4 | 20 | | Maintain the current management regime of periodic pruning to maintain the tree within $\pm 10\%$ of its current size. |

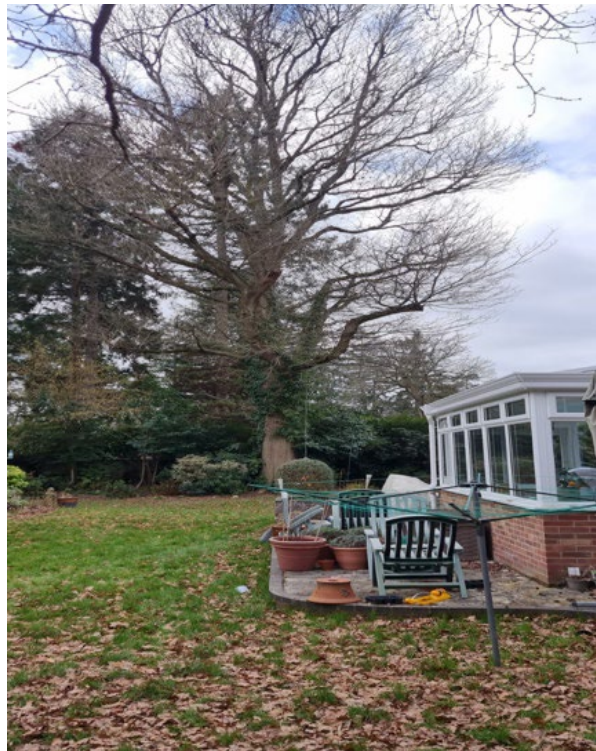
**T3**

- Oak (T3) has a high-water demand and is toward the outer limit of the zone of influence defined by NHBC. Laboratory analysis of the roots found below foundation depth during the site investigation identified them as *Quercus* spp.

| Ref. | Species | Tree owner/<br>location | Dist.<br>to<br>dmg.<br>(m) | C&R<br>50% | C&R<br>75% | C&R<br>Max. | NHBC | Recommendation |
|---|---|---|---|---|---|---|---|---|
| T3 | Oak | Insured | 31.5 | 10 | 13 | 30 | | Maintain the current management regime of periodic pruning to maintain the tree within $\pm 10\%$ of its current size. |
